**Corrugated Iron Buildings in Britain: Cultural
Significance and Conservation Challenges**

Volume II

Elizabeth Induni

Degree of Doctor of Philosophy in Architecture

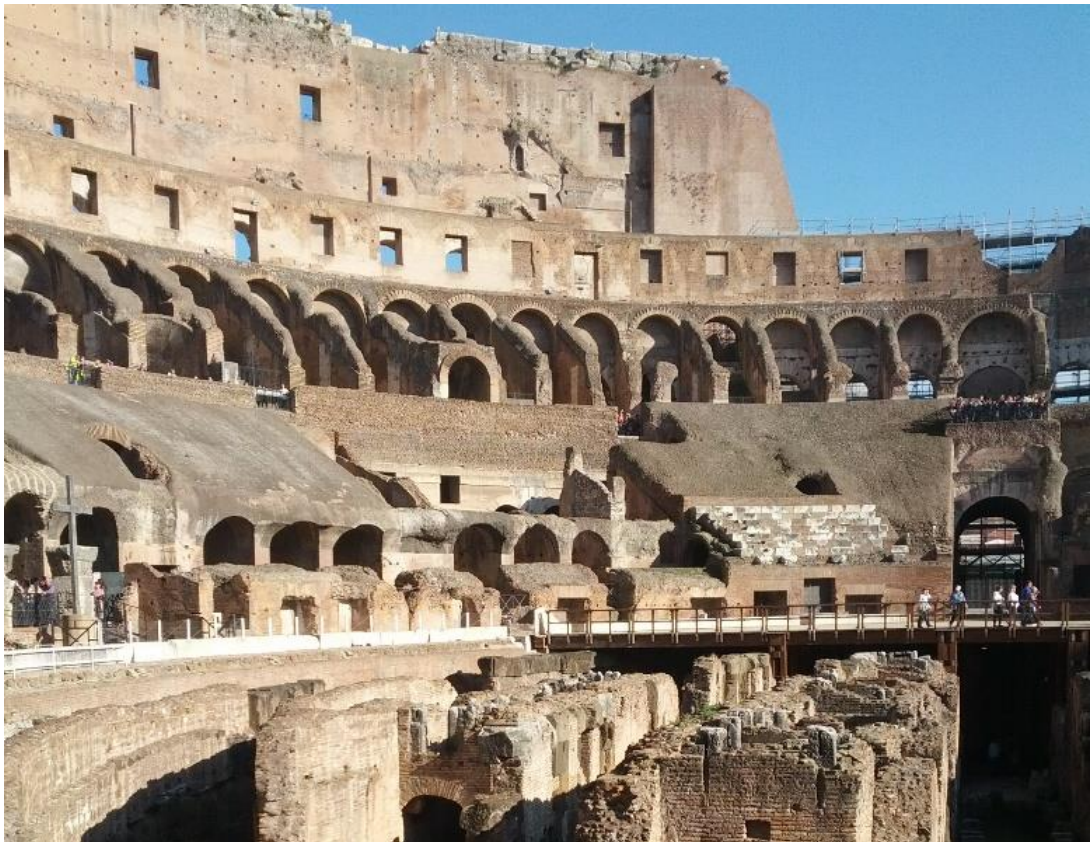
Figure 3.4. The Colosseum, Rome. The architecture visible in this image is composed of a random mixture of stone, brick and concrete, highlighting the indifference of Roman builders to stone: they simply used the cheapest and most adaptable material in any given circumstance. In reality the classical buildings were often not made from stone, but a mixture of brick, concrete and stone. Even the much-revered Palladio in the fifteenth century did not build from solid stone. His valorisation of classical architecture in the Italian town of Vicenza is largely built from brick and covered by imitation stone. Photograph by the author.

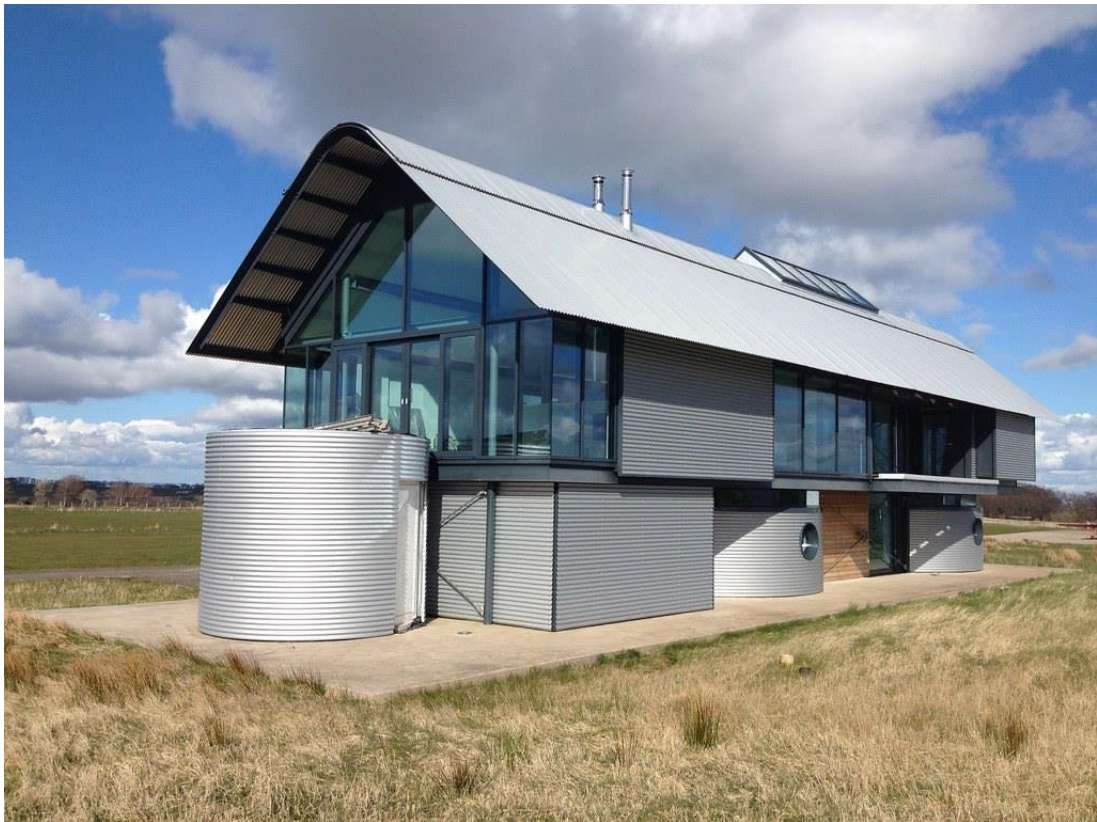
Figure 3.9. Strathaven Airfield House designed by Richard Murphy. Image reproduced with permission.

The structure is a simple cantilevered steel frame and the proposed roof and wall cladding is mill-finished corrugated aluminium, a material which resonates with local farm cladding and indeed the cladding of the adjacent hangars.³⁶⁹

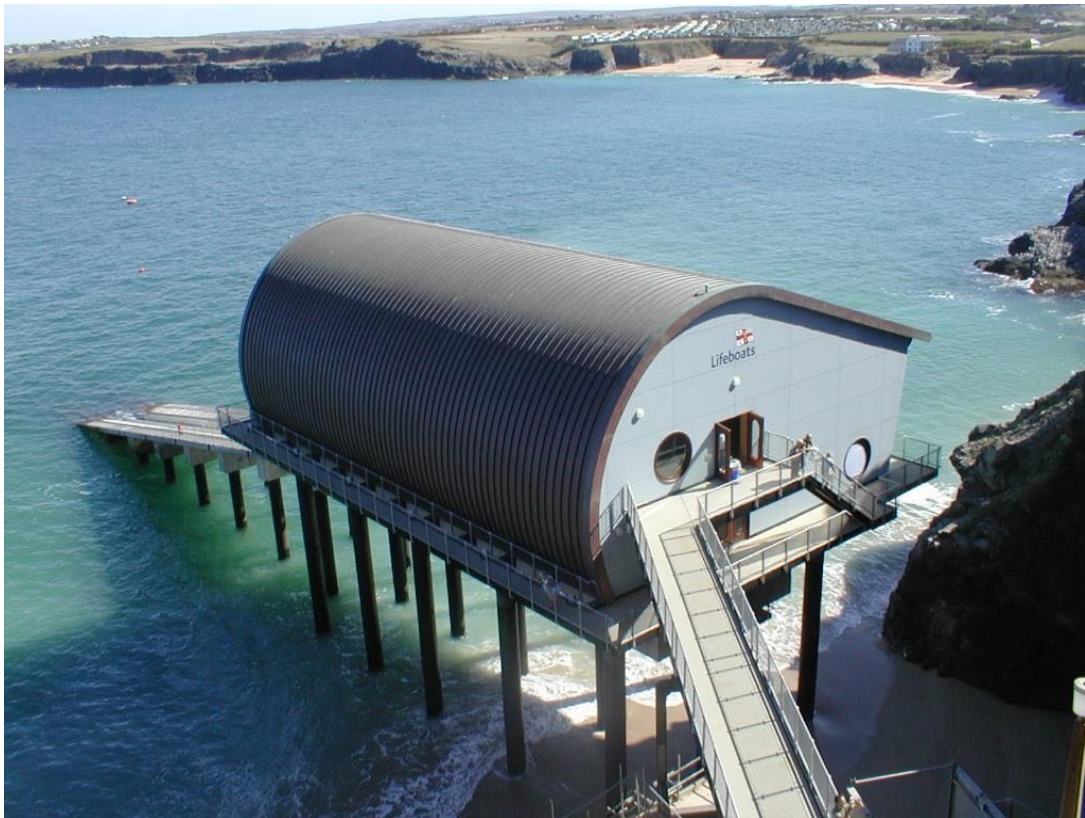
Figure 3.10. Padstow lifeboat station. Photograph by Benjamin Evans.

More modern employments of corrugated iron also suggest how its ‘newness’ is associated with a favourable reception. The new lifeboat station at Padstow, designed by Poynton Bradbury Wynter Cole Architects uses corrugated cladding and has also won awards for engineering, by Institute of Structural Engineers, the British Construction Industry and the Cornish Building Group.³⁷⁹

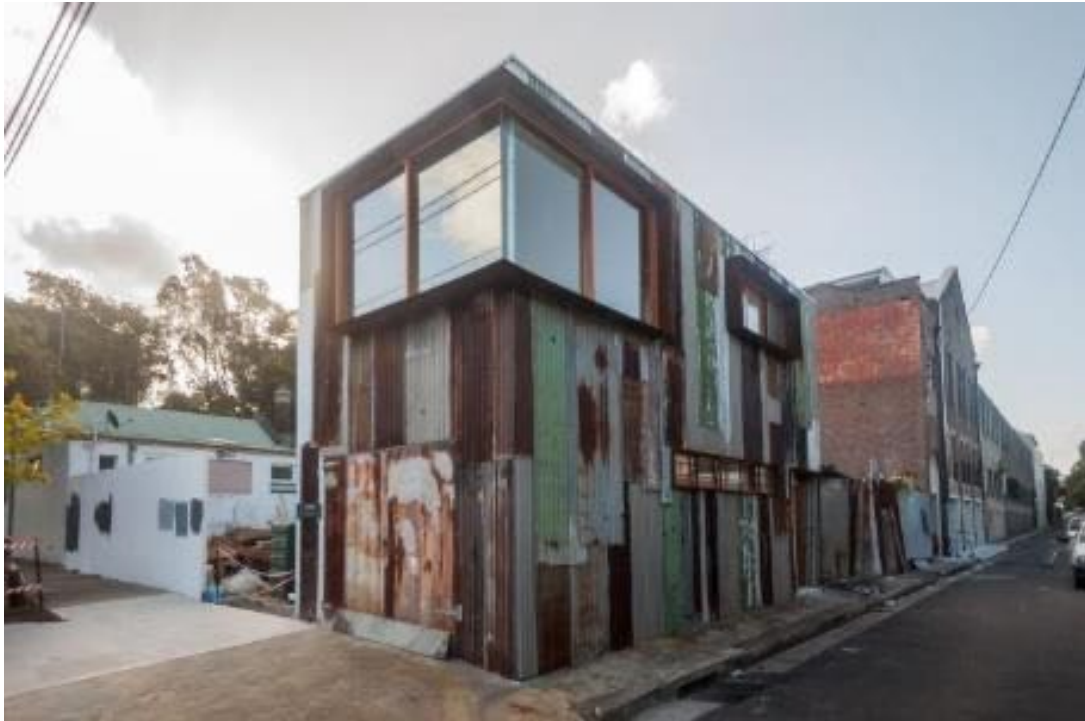
Figure 3.12. 'Tinshed,' Australia, designed by Raffaello Rosselli. In an unusual decision, Rosselli has used the material in its broken and battered form. Apparently, when the builders finished the initial build, he felt it was not battered enough and adjusted the sheet of corrugated iron to make it look wobblier. Perhaps it should be no surprise that this exciting use of corrugated iron is being created in Australia. Image reproduced with permission.

In Australia the corrugated iron shed is iconic and, as discussed earlier, Murcutt's buildings even appear on a national stamp. Rosselli's buildings uses this icon, but treats the corrugated iron differently. Instead of choosing to clad a modern building in new corrugated cladding, he has decided not to replace the original tin. By doing this he has chosen to perpetuate the historical narrative of the suburb's industrial past. Rosselli's Tin Shed is using the aesthetic of rusted corrugated iron, to not just imply age value, as the building is old in Australian terms. He has restored it, and in the process has perpetuated its history by maintaining its character. The decision to do so reflects the building's aesthetic values as well as its age value.

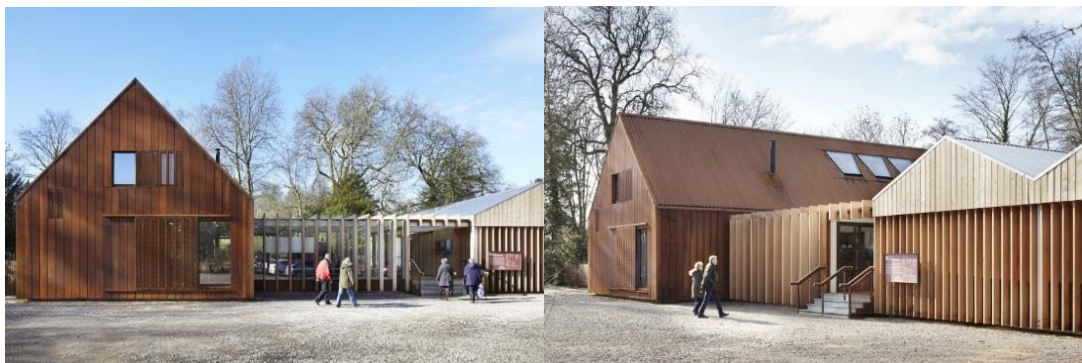
Figure 3.13. A successful use of Corten and corrugated iron at Mottisfont Abbey, designed by Burd Haward architects.

Not as extreme as Rosselli's Tin Shed is the visitor centre at Mottisfont Abbey (see below), which uses a material called Corten, designed to give the appearance of rusty corrugated iron without actually rusting.

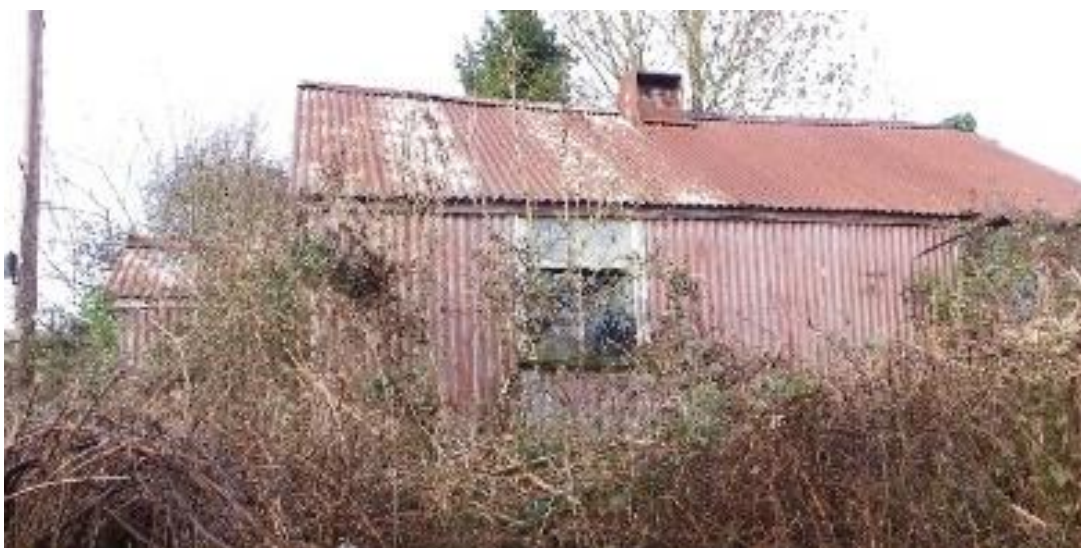
Figure 3.14. An abandoned corrugated iron chapel at Rodhuish in Somerset. Its designation and at-risk status is unknown, but if it remains unoccupied and unmaintained its life expectancy is very limited in this condition. Photograph by the author.

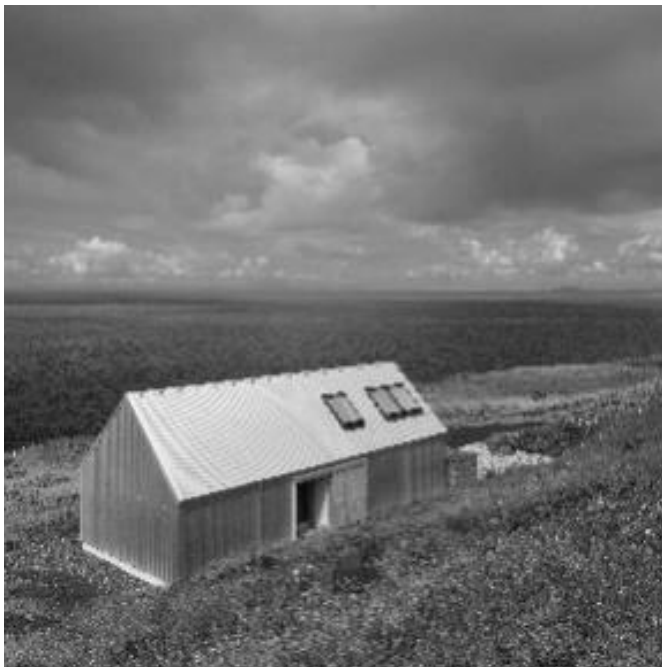
Figure 3.15. 'Tin House': functional corrugated iron is used by Nick Thomson as a main component of a house on the Isle of Skye. However, the apparent concentration on functionality is also a style statement because the building consciously echoes the Highland tradition of prefabricated corrugated iron. Photograph by Nick Thompson.

Tinhouse celebrates corrugated metal sheeting, commonly used on the agricultural buildings of the rural landscape. It does so in a thoroughly contemporary way by using mill finished corrugated aluminium as the external cladding for both roof and walls.³⁸⁹

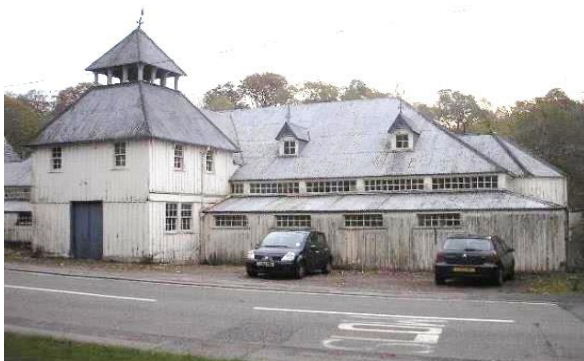
Figure 4.2. Drill Hall, Golspie, Sutherland. One of the fascinating deployments of corrugated iron that was impractical as a case study. The image was taken in October 2009 and the condition has deteriorated significantly since then. The Drill Hall is a striking example of how difficult it can be to find truly beneficial re-use for buildings that were created to fulfil highly specific uses.

Many corrugated iron buildings are complex hybrids of timber and metal construction, which pose additional issues that complicate the discussion of their corrugated iron elements. An excellent exemplar of these practical limitations on the choice of case study subjects is the Drill Hall at Golspie. This is a complex hybrid structure, too large to adequately survey from ground level and in desperate need of effective maintenance.

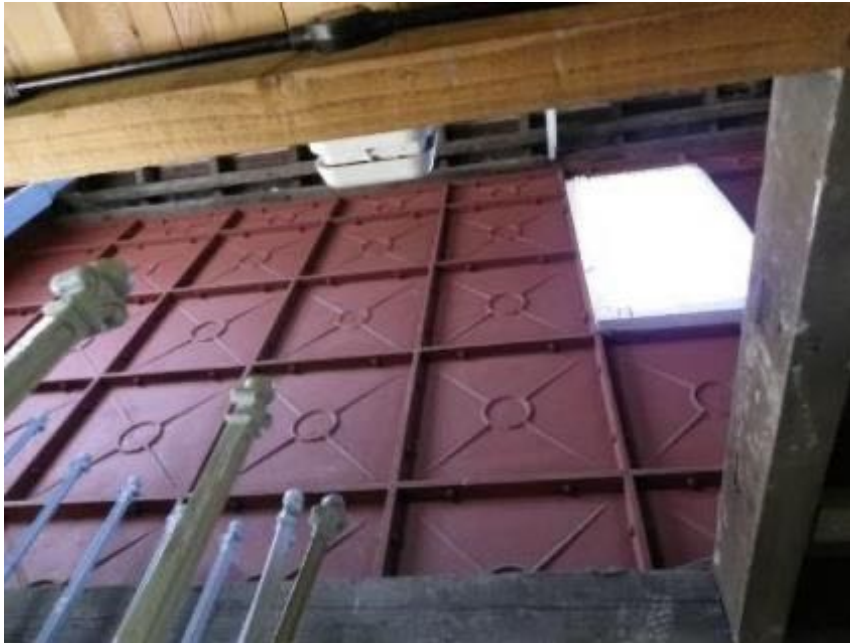
Figure 4.3. The wall of a house at the Black Country Museum – made from cast iron tiles. Metal buildings have never been as economical to building compared with other materials.

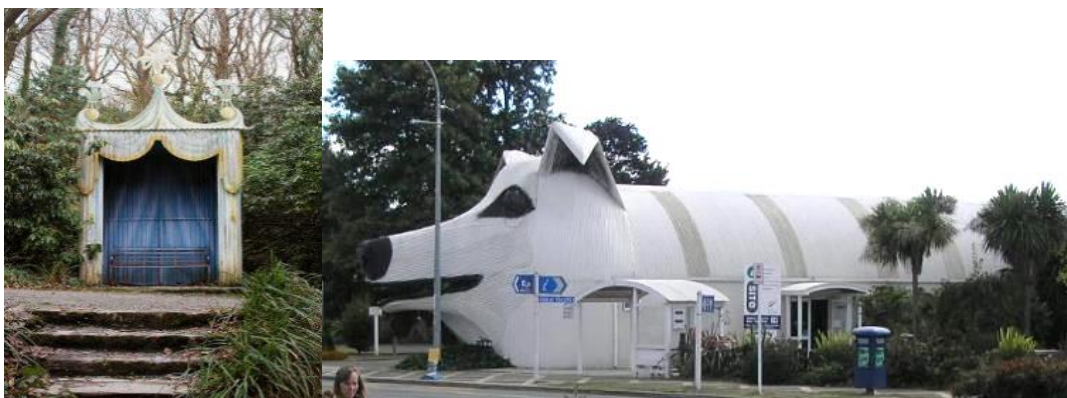
Figures 4.4 and 4.5. Corrugated iron as art. Its lightweightness and rigidity have allowed its use in some distinctly non-utilitarian buildings, and it is even possible to be frivolous with it. *Left*, gazebo, Portmeirion, North Wales. Photograph by Bruce Induni. *Right*, corrugated dog, Tirau, New Zealand. Two corrugated sheep sit adjacent. Photograph by John Wood.

Also excluded from the cases studies is any example of corrugated iron being used for primarily artistic effect. The reason for this is scarcity of corrugated iron art in Britain. With the exception of Clough Williams-Ellis whimsical masterpiece of Portmeirion, this research has not been able to locate any British examples of corrugated iron used primarily as art.

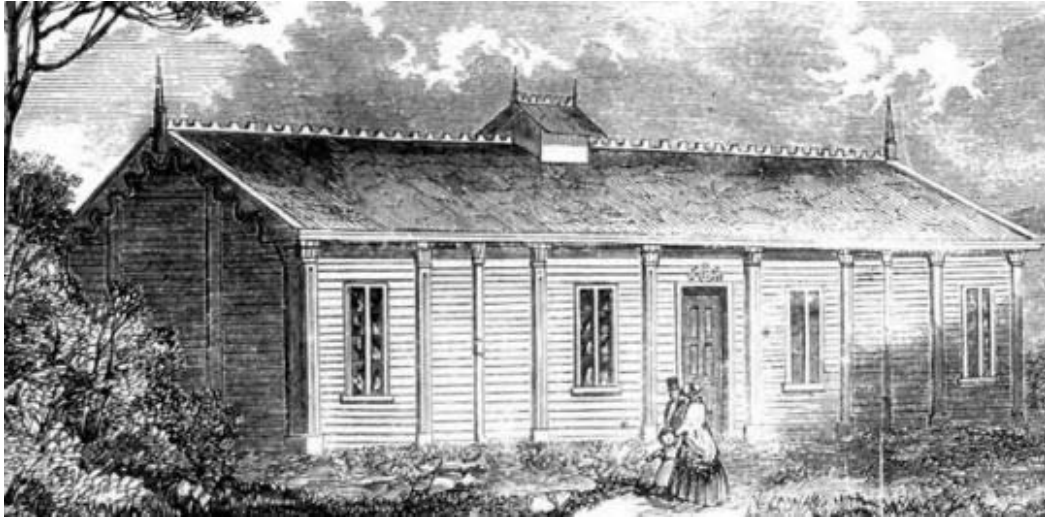
Figure 4.9. 'Ballroom for Balmoral' by E. T. Bellhouse, 1851. The Balmoral ballroom was only one of a number of designs that Bellhouse produced for the different markets. Image from *Illustrated London News* (22 November 1851).

Nothing in Bellhouse's design of the Balmoral ballroom suggests that he was trying to reinvent the architectural form of buildings, rather he was maintaining existing building style but substituting iron for traditional materials. At Balmoral, Bellhouse took Palmer's radical, new material and tamed it to reproduce a traditional form of building – a straightforward substitution of cast iron for wooden posts and corrugated iron for wooden planks. A feature of Bellhouse's system of combining horizontally corrugated iron with specially shaped cast iron framing,⁴²¹ was that it provided an accurately shaped junction between the corrugated iron panels and the cast iron frame. To do this required accurately shaped cast iron components but produced an exceptionally weather-proof building.

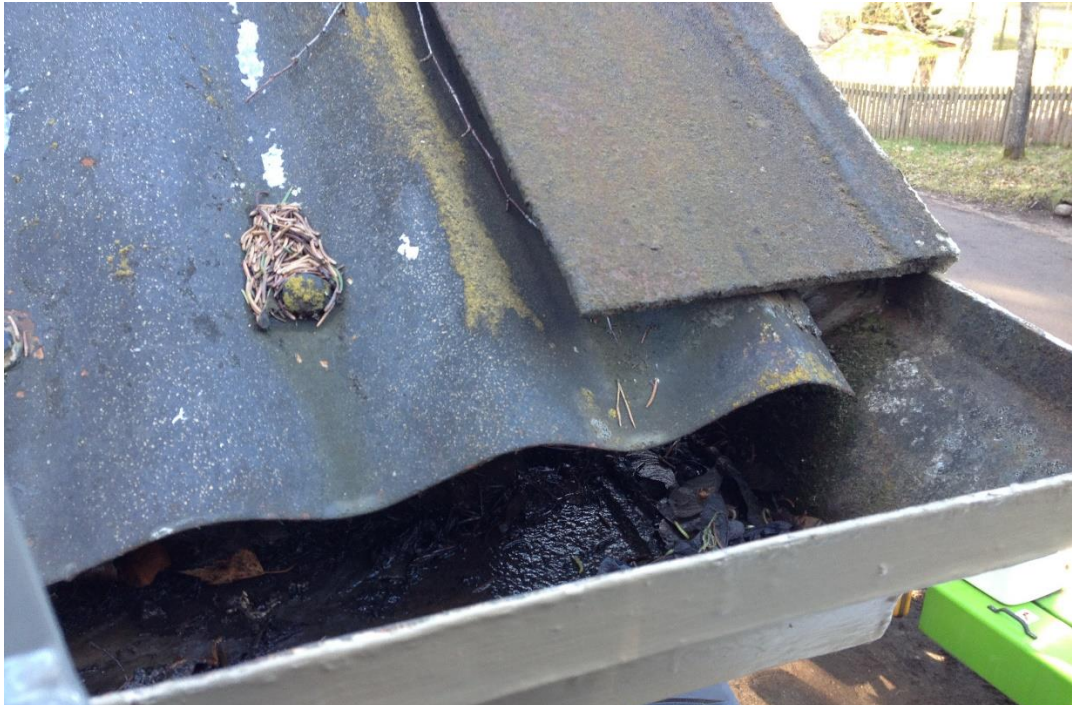
Figure 4.10. Balmoral ballroom guttering. Photograph by the Factor of Balmoral, 2014.

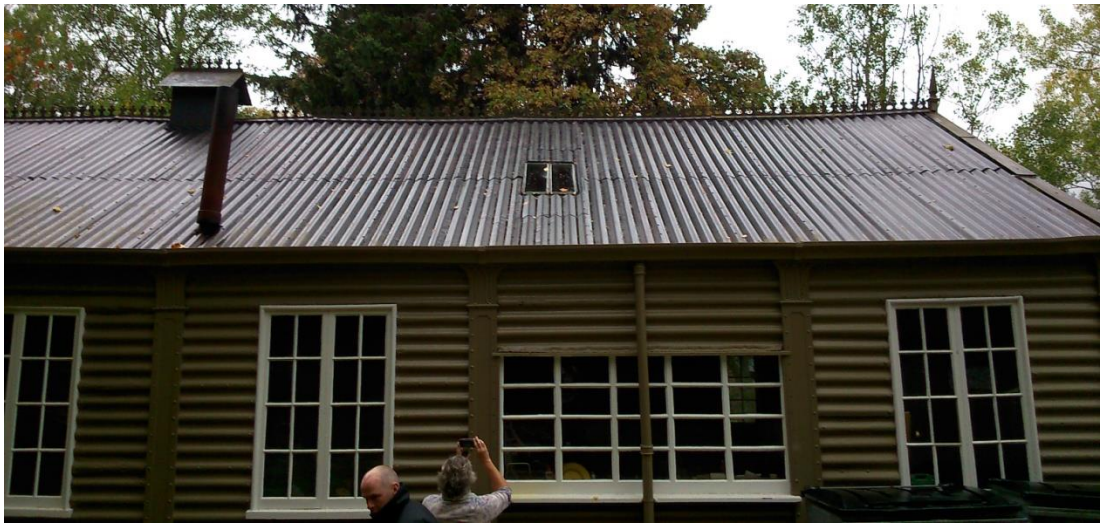
Figure 4.11. Ballroom roof. The roof has been completely replaced in new corrugated iron, but the date of the renewal is not known. This is a realistic strategy because the redundancy inherent in roofing sheets is negligible: they have to be waterproof.

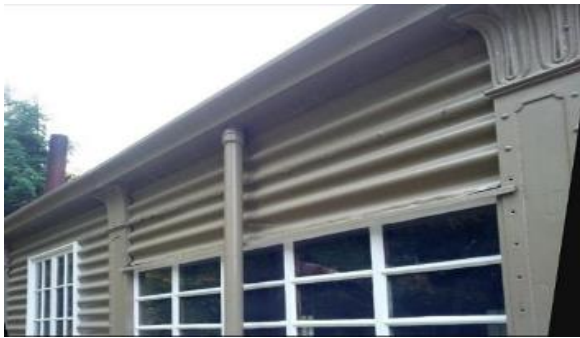
Figure 4.12. The integral cast iron guttering system. Functioning as designed, as are the replacement downpipes. The empty bolt holes in the cast iron column to the right of the image are worthy of note, as they are where the original corrugated iron has been removed to form a modified window.

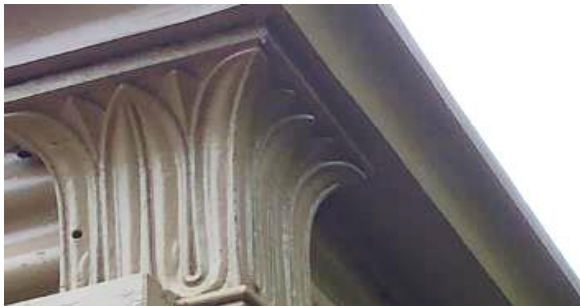
Figure 4.13. Frame detail of the ballroom. The frame has no significant decay problems and has good paint adhesion.

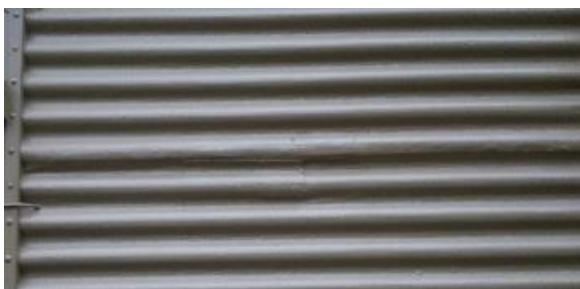
Figure 4.14. Original wrought iron corrugated panels on the walls. In generally excellent condition with only light surface corrosion pitting. This suggests that paint film maintenance has not always been consistent.

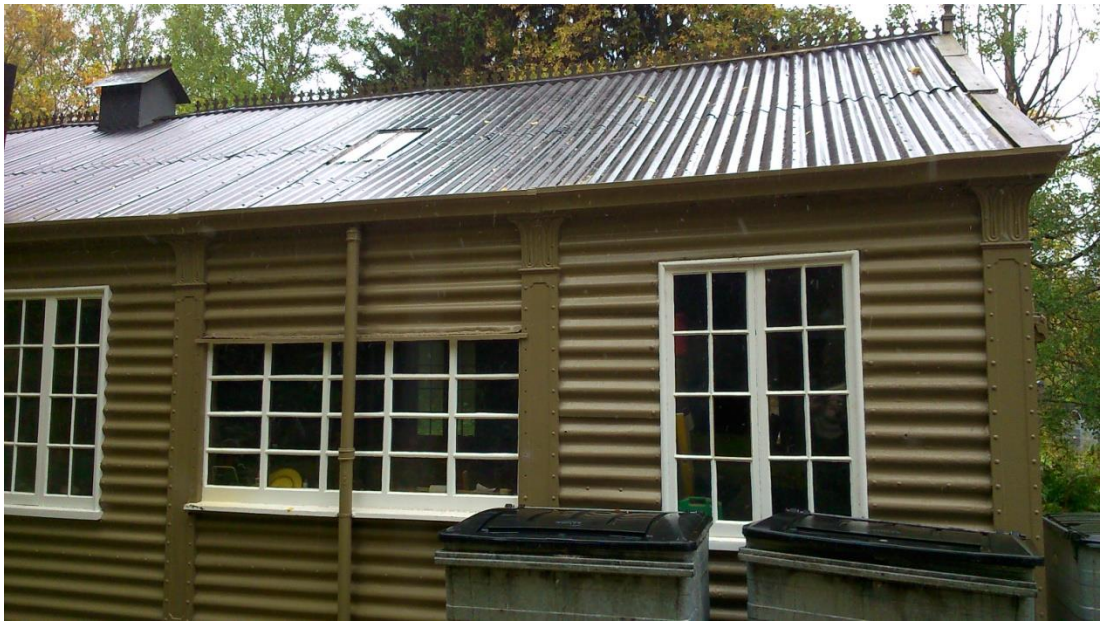
Figure 4.15. Window detail of the ballroom. The windows are all softwood replacements, except for two longer and lower windows (one shown centrally in this image) the form of the replacements appears to follow the original design. The paint condition is variable and needs maintenance.

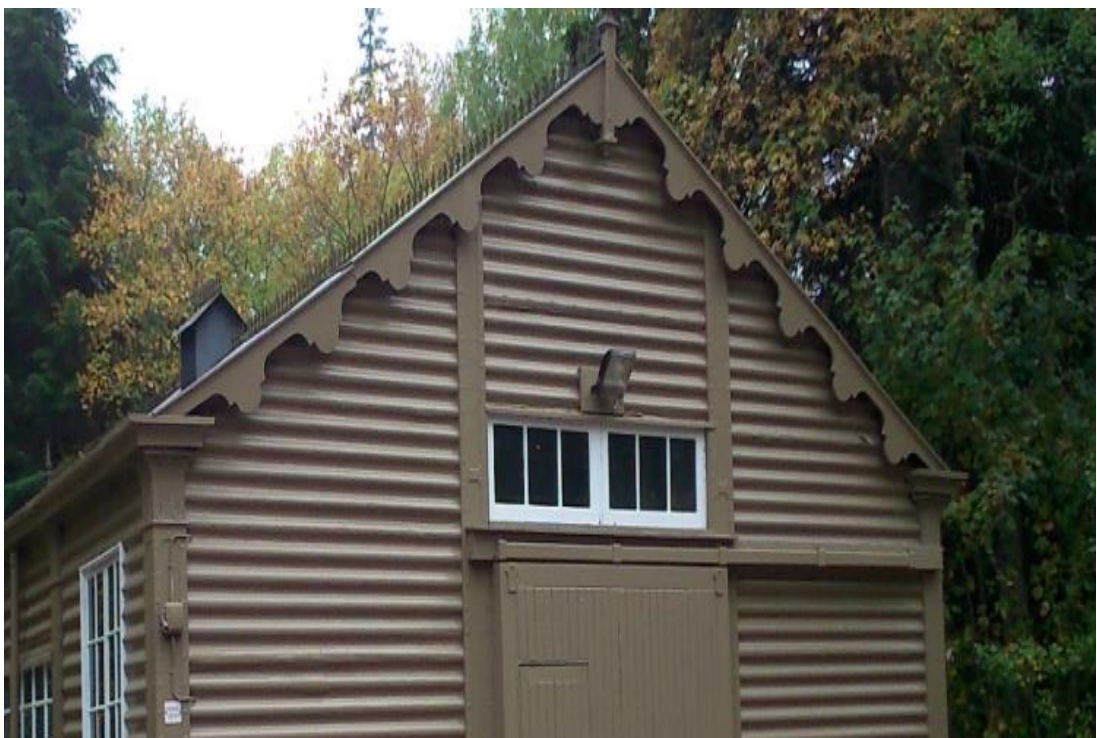
Figure 4.16. The most significant external details are the cast iron framing and the original corrugated wrought iron panels, but additional details include the decorative barge boards, and roof detailing with an elaborate ventilator and cast iron brattishing along the crest. It is unclear if these details have been replaced, but they are in excellent condition.

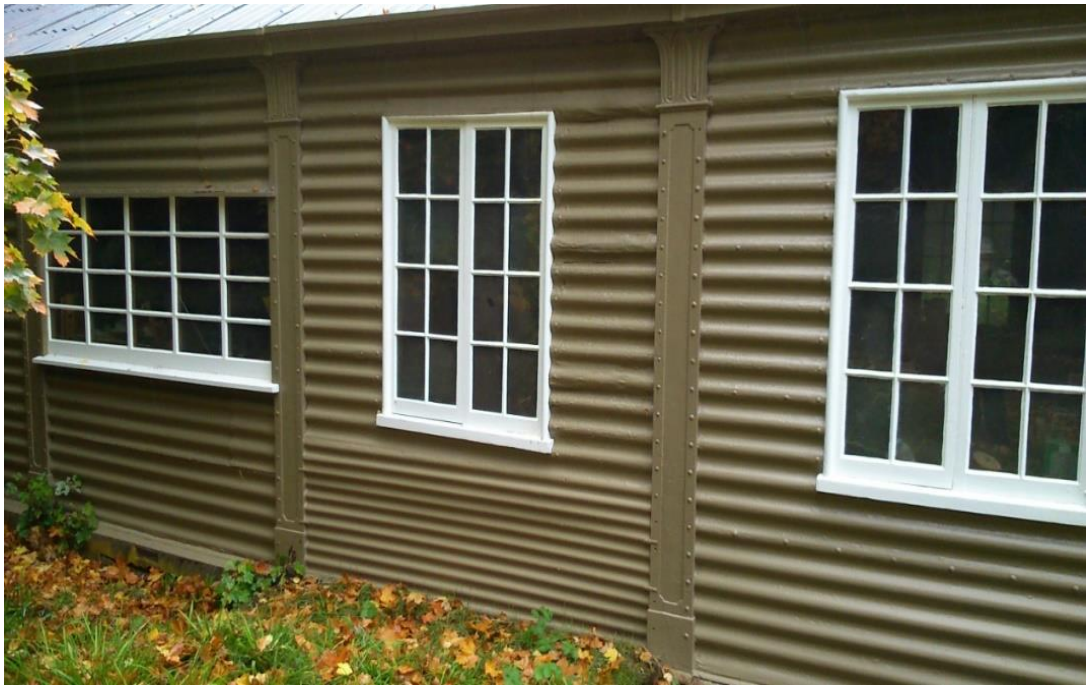
Figure 4.17. Recent repairs to the ballroom using steel. Modern, steel-based, corrugated iron has been used to repair the lower part of the central panel. This repair is probably connected to the removal of the original door and its replacement by window. It is not clear how the narrow pitch of the repair corrugated iron has been matched to the profile integral to the cast iron frame.

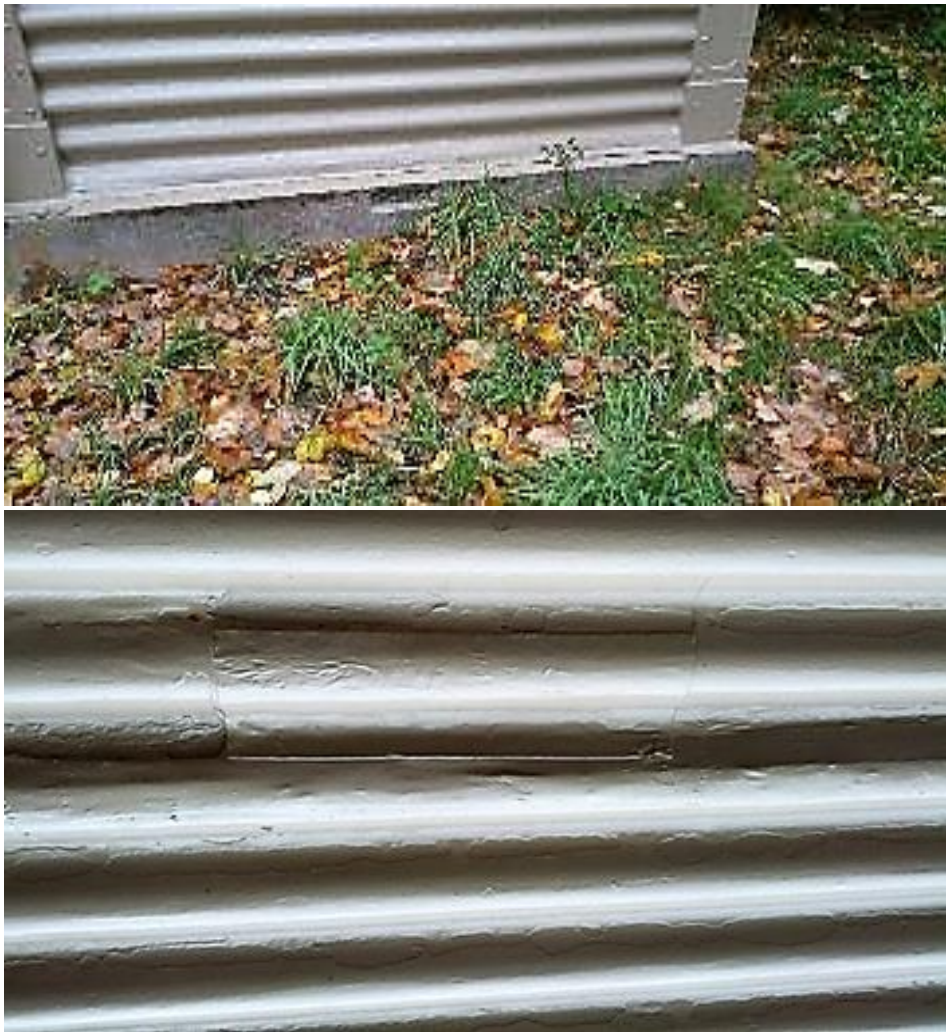
Figures 4.18 and 4.19. Repairs to corrosion damage using glass fibre reinforced resin. Though skilfully done, the change in surface texture caused by these repairs is noticeable. Against these disadvantages resin repair is cheap and highly weather resistant in the short and medium term. It is relatively easy to remove and retreat and allows the maximum retention of historic material. Balancing the pros and cons of conservation strategies is rarely straightforward.

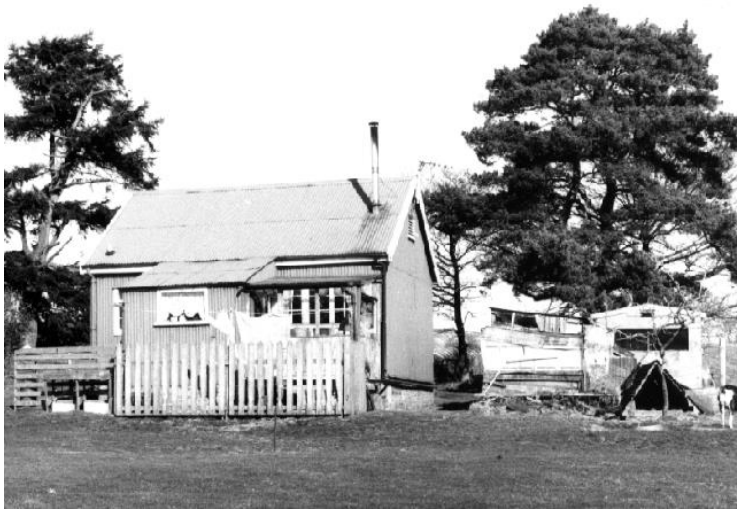
Figure 4.21. The Shooting Lodge, Morden, Dorset. This cottage, much loved by its occupiers, started life as a shooting lodge in a different location. The owners have demonstrated that ingenuity is one of the most important elements of adaptability by reusing the old corrugated iron from removed during roof repairs by making it into a new goat shed.

are the Morden Shooting Lodge and the Corfe Castle Isolation Hospital. Despite their highly specific original design intention, both have found successful new beneficial use as domestic houses. Interviews with their owners⁴²⁸ emphasised the success of this adaptation: they were felt to be excellent places to live. Building on this corroborative evidence, it appears reasonable to suggest that the Balmoral ballroom does provide a strong positive indication that corrugated iron buildings can be moved, adapted and given new beneficial use without compromising their fitness for purpose.

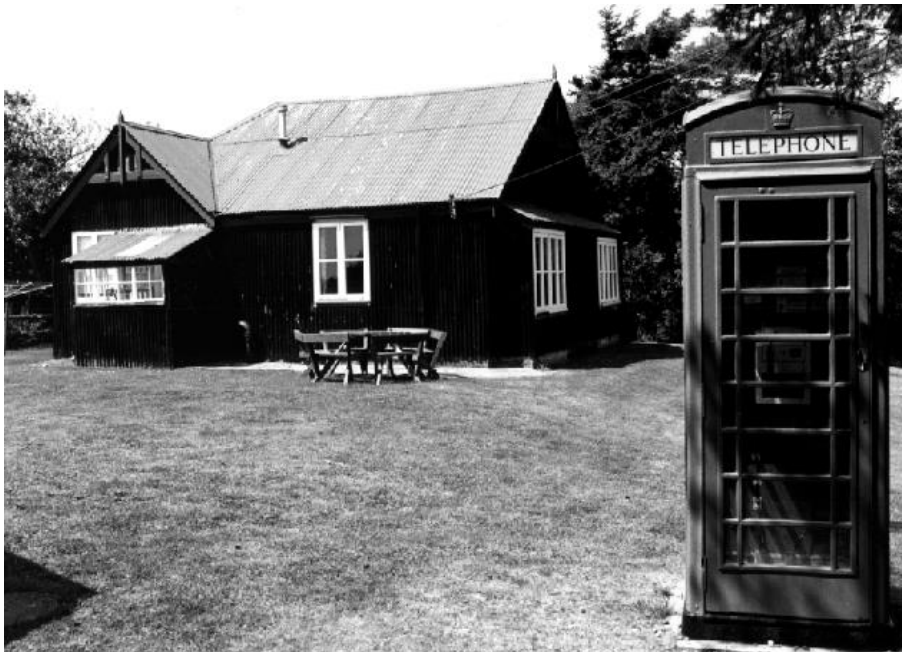
Figure 4.22. The Isolation hospital, Corfe Castle. Now in the ownership of the National Trust, who have refurbished the building and use it as accommodation for seasonal letting; very popular with tourists staying in the area. It was constructed in the early twentieth century as a hospital and nurse's accommodation, to treat infectious diseases such as smallpox and diphtheria. The National Trust has successfully adapted the buildings as holiday cottages, carrying on the hospital theme by using old hospital beds as part of the décor. Photograph by the author.

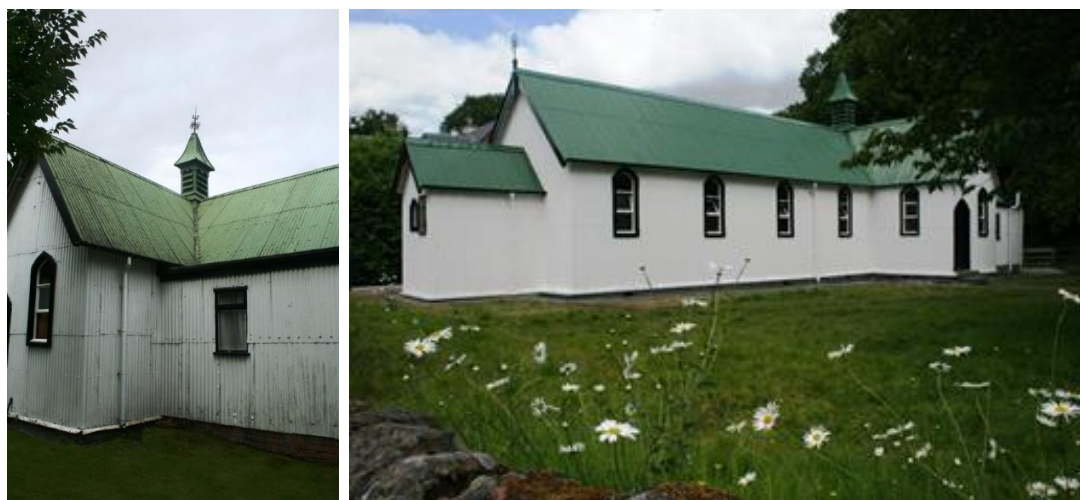
Figure 4.28. A general view of the church before and after repair. Note the dark staining at the lower edge of many sheets of corrugated iron. This is caused by biological growth which is benefiting from moisture trapped in the lap of the sheets. It is a sign that the corrugated iron is not seating well and is allowing moisture penetration. The general dowdiness indicates that the paint needs renewal. Photograph by Sonya Linskaill.

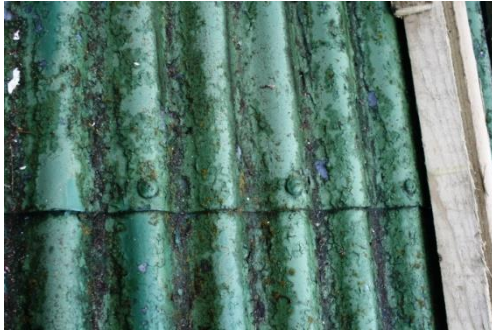
Figure 4.29. Corrosion protection: This image shows the failure of more recent paint on the roof. Although the underlying paint film appears to be largely intact, and there is no evidence that the galvanising has failed, this still needs attention. Most importantly, it looks horrible and is an invitation for any hostile fewer to suggest that the whole building needs demolition. Technically this failed paint is trapping water which is likely to speed up corrosion of the underlying metal. Photograph by Sonya Linskaill.

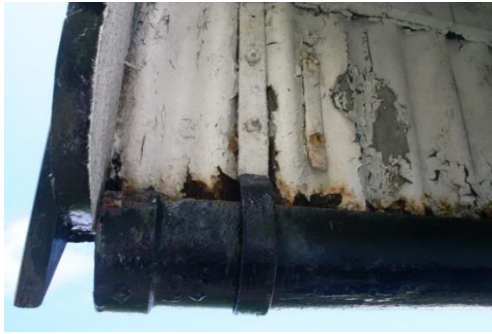
Figure 4.30. The condition of the corrugated iron in the underside of the eaves illustrates the generally poor condition of all the roofing sheets. The only area where repair rather than replacement was deemed impractical was the roof, where there was extensive damage to the corrugated iron. Severe corrosion had taken place at the lower edge where the corrugated iron came into direct contact with the cast iron guttering and its fixings; also damaged by corrosion was the joint between the ridge piece and the roofing sheets. Photograph by Sonya Linskaill.

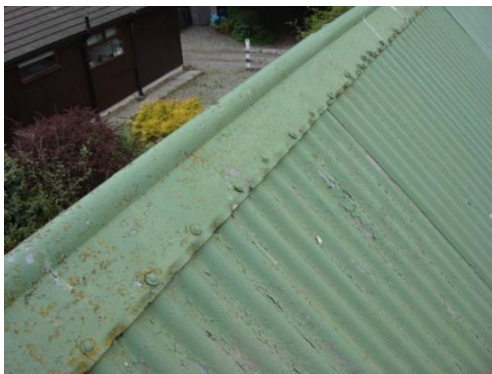
Figure 4.31. Ridge piece (at top of roofing sheets). Dismantling showed that significant amounts of water had entered the roof because of the poor quality of this detail. There is a poorly shaped lap between the ridge piece and the roofing sheets. Photograph by Sonya Linskaill.

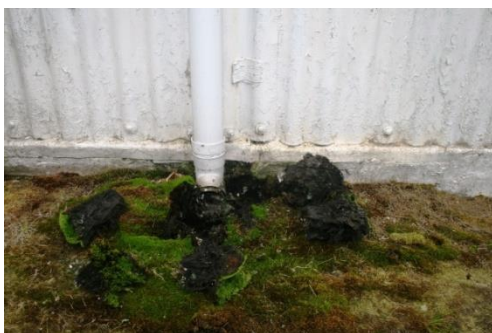
Figure 4.32. Before repair, the downpipes appeared to be working correctly but discharging directly into the soil adjacent to the walls. This was causing excessive moisture to be drawn into the plinth wall, the civil beam of the wooden frame and the lower edge of the corrugated iron, causing them all to decay. Conservation often fails to see beyond the immediate object, but in this case the architect has installed a functioning subsurface drainage system. The drain is now repaired and functioning correctly. An interesting conflict arose between the architect and building control over the proposed installation of a French drain. Such drainage systems are a commonplace in conservation specifications but were not acceptable to the local building control officer. Photograph by Sonya Linskaill.

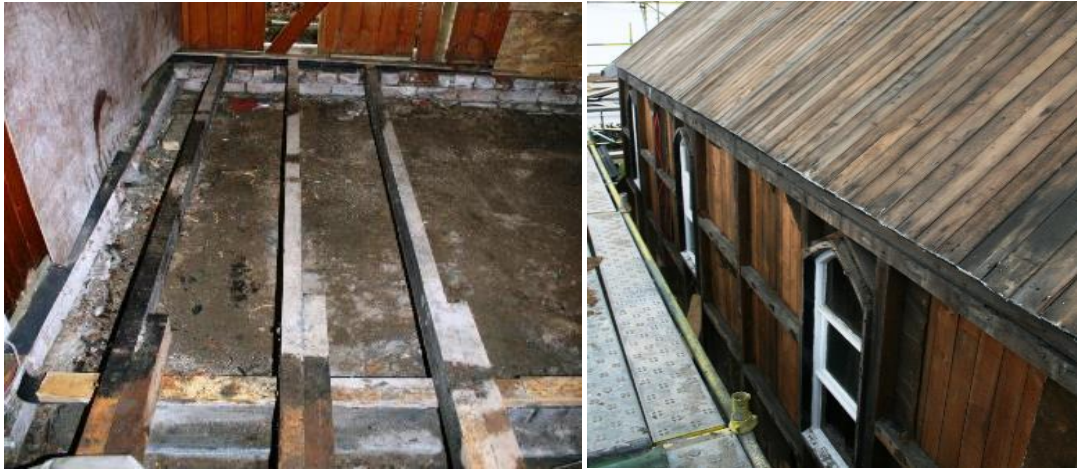
Figure 4.33. Details of wooden frame. St Fillan's follows the standard nineteenth century approach to constructing corrugated iron chapels. This used a wooden frame to support (and be stiffened by) the corrugated iron cladding. In this way an air gap is automatically created between the corrugated sheets and the internal timber boarding. The gap allows ventilation which minimises the build-up of condensation on the inside face of the corrugated iron and thus produces a durable form of construction. Historically, this durability depended largely on the high quality of timber used in the framing. The durability of the wood masked a fundamental problem: corrugated iron sheeting is inherently prone to accumulate condensation on its inner surface. The quality of wood currently available to repair the original framing does not match that of the original. Photographs by Sonya Linskaill.

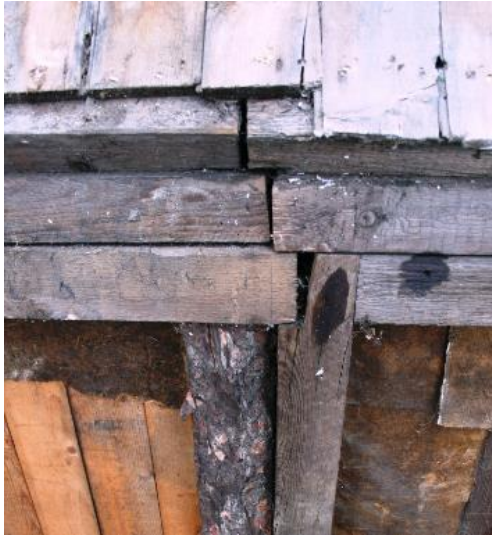
Figure 4.34. This image illustrates the prefabricated framing of St Fillan's. Each prefabricated section of the walls had a square frame butted against its neighbour. The image is complicated by the paler section of wood (middle left, under the upper wall plate) which appears to be a replacement.

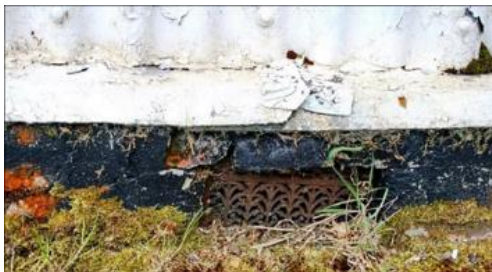
Figure 4.35. Detail of the lower edge of the wall cladding, showing how condensation and leakage has decayed the lower rail of the structural framing and allowed the wall to sag. Photograph by Sonya Linskaill.

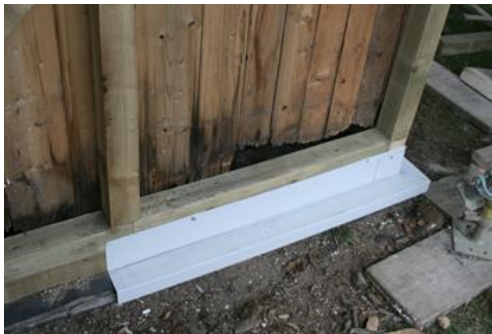
Figure 4.36. A particular vulnerability of prefabricated corrugated iron buildings is rainwater removal from the lower edge of the walls. Conservation at St Fillan's has departed from the original design and improve the drainage detail by inserting a preformed metal sill behind and under the corrugated iron. Photograph by Sonya Linskaill.

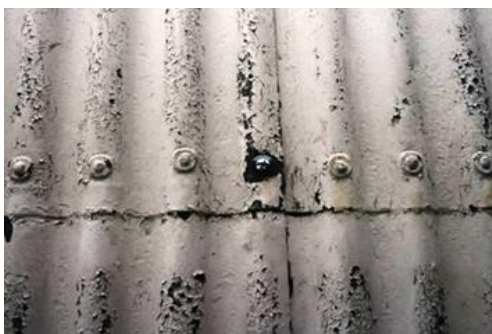
Figure 4.37. A peculiarity of St Fillan's is the quantity of fixings used to secure the edge of walling sheets. It is highly unusual to nail in the trough of every corrugation as has been done here. This oddity would seem to match the poor quality of the roof board meeting (see above) and is another indication of an inexperienced being used to erect the church. Photograph by Sonya Linskaill.

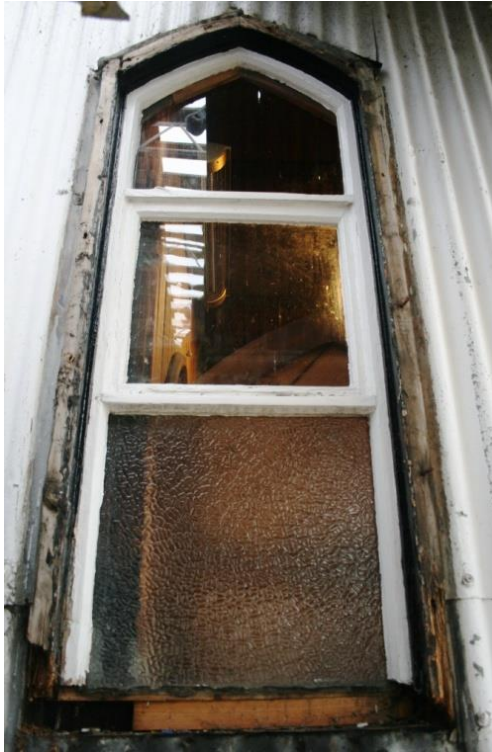
Figure 4.38. One of the nave windows during dismantling of the church. Note that the glazing is applied to a fully finished subsidiary frame and not directly to the wall framing that surrounds it.

Only the windows in the nave are originals. Those in the eastward extension appear to date from the extension of the church using second-hand materials from Tyndrum railway station, which was done in the 1960s. Photograph by Sonya Linskaill.

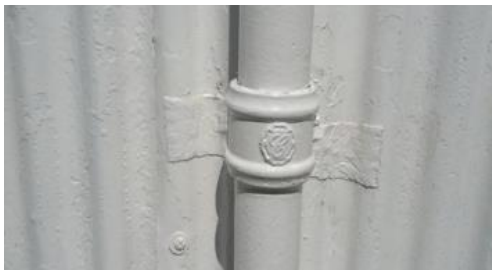
Figure 4.39. Patch repairs to localised corrosion damage caused by the electrolytic reaction between the cast-iron of the downpipe and the galvanised steel corrugated cladding. The repairs been formed in glass fibre and there is a risk of ultraviolet light attack. Care will be needed to keep them well painted in order to prevent this. Photograph by Sonya Linskaill.

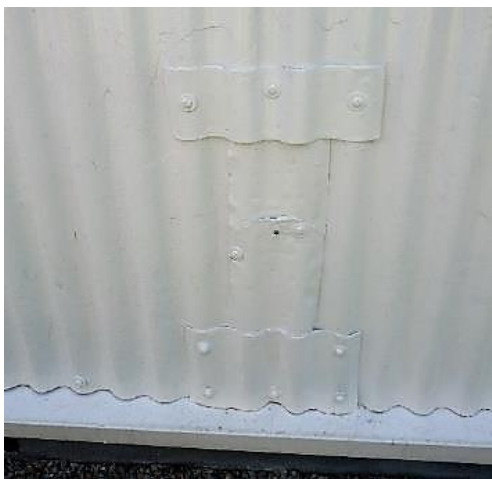
Figure 4.40. Patch repairs are nailed to the original corrugated iron. These appear to have been done at some considerable time in the past. It is not clear how well they have been waterproofed all-weather matching corrugated iron for the patches was obtained. They do, however, appear to be working satisfactorily. The conservation approach to the repair at St Fillan's has not chosen to make good pre-existing repairs, but to retain them. Photograph by Sonya Linskaill.

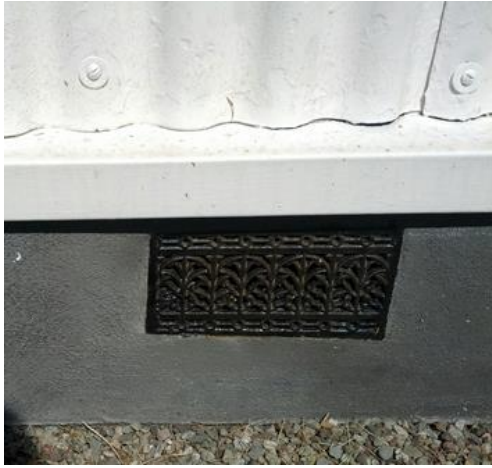
Figure 4.41. A metal cover has been added at the bottom of the wall-sheets to throw condensation and rainwater clear of the brick plinth. The rainwater down-pipes have been modified to connect closely with newly installed drains. Just as importantly the original cast-iron ventilation grills have been cleaned and repaired to continue subfloor ventilation to the interior. Photograph by Sonya Linskaill.

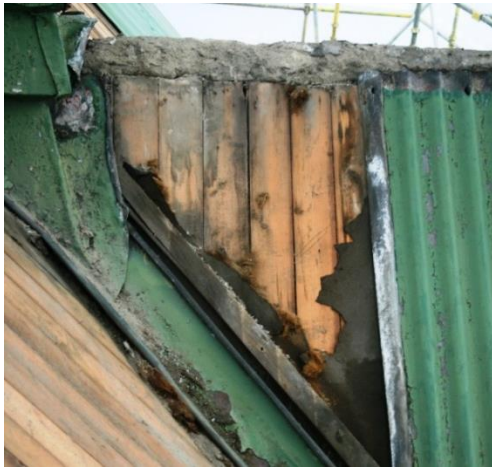
Figure 4.42. Glass fibre insulation introduced into the airspace between the corrugated iron and the internal timber boarding when the eastward extension was added in the 1960s. Such insulation carries a severe risk of timber decay and cladding corrosion because it restricts the ventilation. Omitting new insulation emphasises that the repairs have sought to preserve the authenticity of the building, and by doing so to maintain its cultural significance. Photograph by Sonya Linskaill.

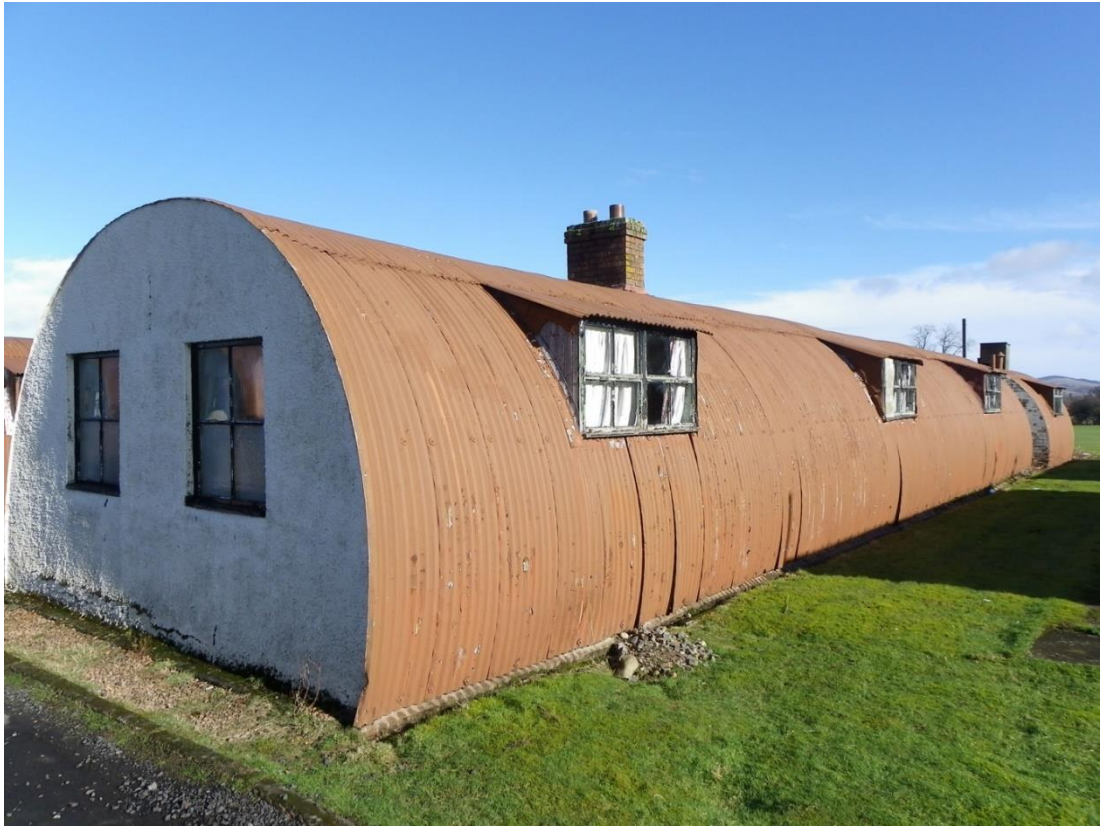
Figure 4.49. Corrugated iron Nissen hut at Cultybraggan. The Camp preserves an extraordinary example of corrugated iron architecture's survival; but this survival does not mean that it can be easily conserved. Although huts like this appear to be in reasonable condition, hidden defects in the framing, heating system combine with the need for external maintenance to make conservation a daunting task. Photograph by the author.
