**Corrugated Iron Buildings in Britain: Cultural
Significance and Conservation Challenges**

Volume II

Elizabeth Induni

Degree of Doctor of Philosophy in Architecture

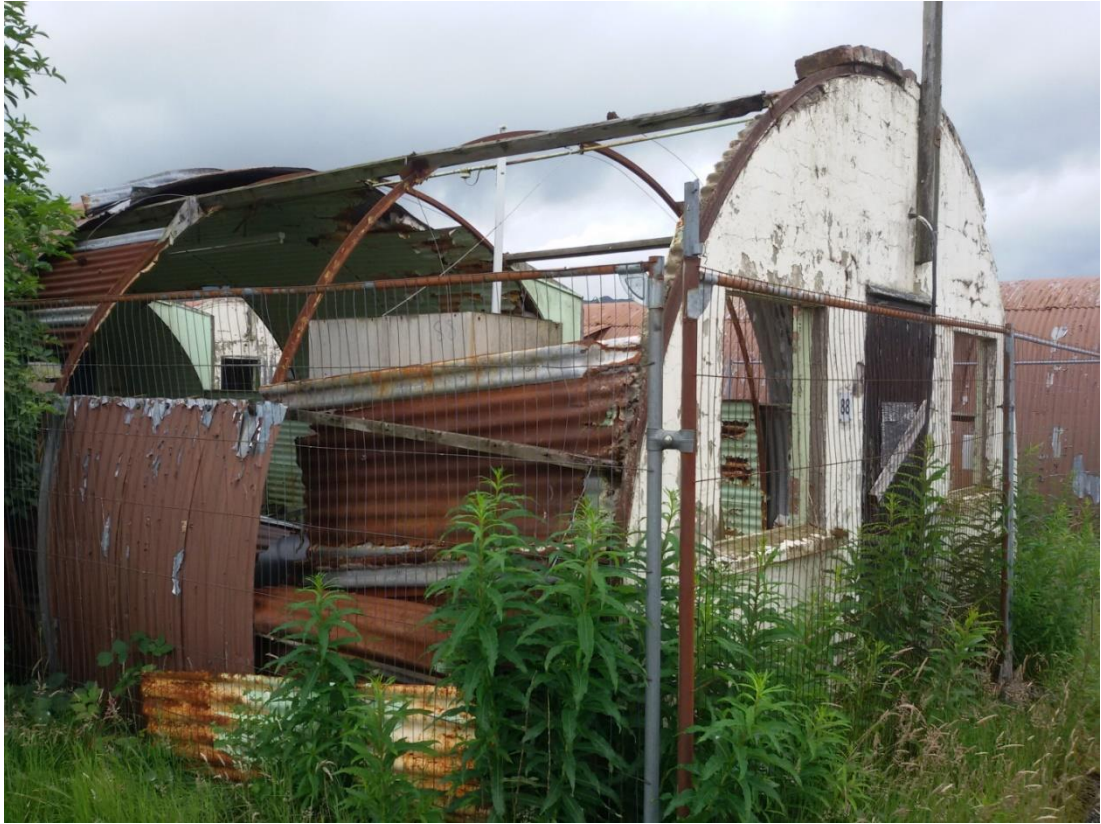
Figure 4.50. The poor condition of many of the huts, partly due to the quality of the materials used. The steel and the galvanising are likely to have been compromised because of wartime shortages, and because the buildings were only seen as temporary. Photograph by the author.

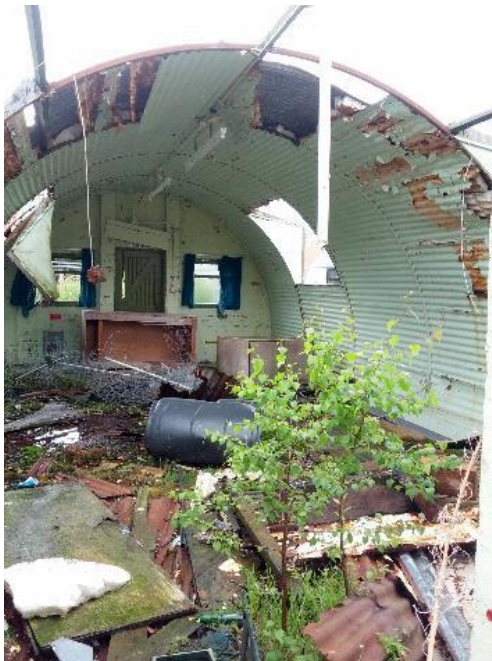
Figure 4.51. The climate at Cultybraggan is particularly hostile, with high rainfall, extreme cold, and strong winds. Wind, especially, will have damaged the huts by driving moisture between the lap joints of each corrugated sheet. The internal corrosion visible here had started before the corrugated iron cladding and lining had been cannibalised to repair other huts. Photograph by the author.

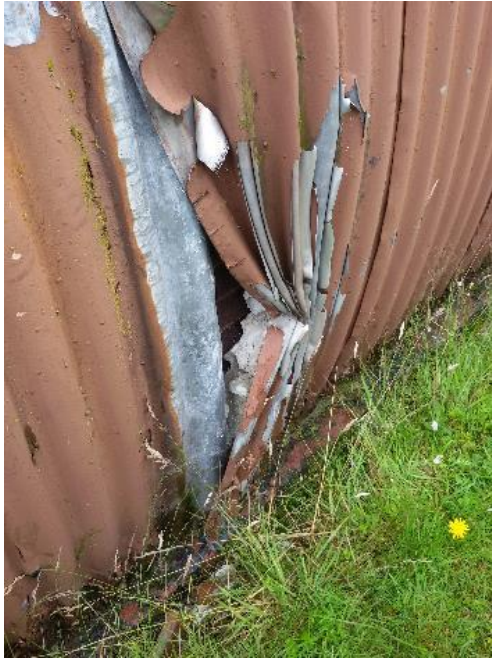
Figure 4.52. Every aspect of the site provides difficult maintenance challenges. This damage has been caused by an accidental impact from a ride on lawnmower. Such incidents are probably inevitable when the Comrie Development Trust Has to rely on volunteer labour for grounds maintenance. The damage reveals that the underlying corrugated iron is in surprisingly good condition, but unless repairs are carried out swiftly water ingress will do rapid damage. Photograph by the author.

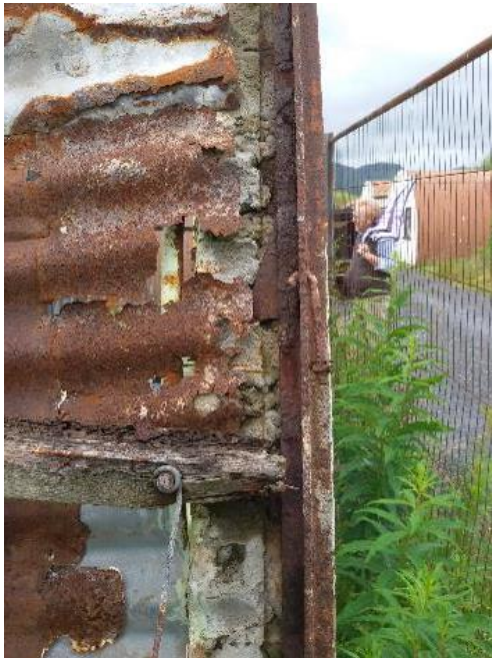
Figure 4.53. A further vulnerability of the basic design is the termination of the corrugated iron at the end walls. This has yet to be satisfactorily addressed. Water penetrating along and through the end wall is trapped between the masonry and the corrugated iron causing rapid decay of the metal. Photograph by the author.

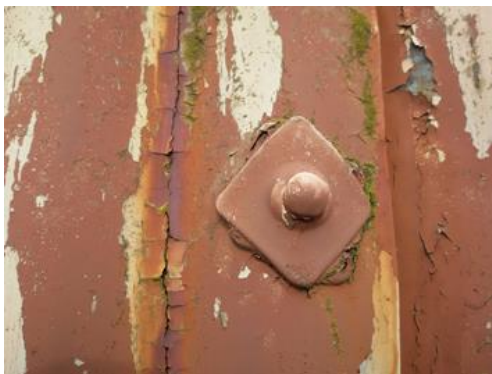
Figure 4.54. Though not the case here, fixings generally are a source of water ingress. Thermal expansion of the corrugated iron is a real problem, and fixings have to be flexible enough to accommodate this without coming loose. This is a major challenge and the fixings frequently fail in the long term. Photograph by the author.

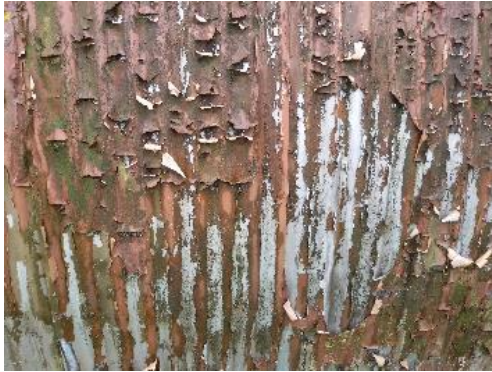
Figure 4.55. The three-year gap between the end of military use and the takeover by the Comrie Development Trust, was a damaging break in repainting and general maintenance and has caused major paint failures. These failures are starting to permit corrosion of the corrugated iron. Photograph by the author.

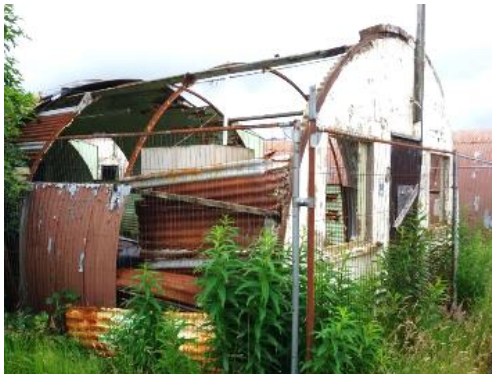
Figure 4.56. Cannibalisation has revealed the frame of this hut emphasising that the corrugated iron is more or less self-supporting, and the main function of the frame is to tie the sheets together rather than holding them up. The render here has failed primarily because thermal expansion of the corrugated iron relative to the masonry has stressed it to breaking point. Photograph by the author.

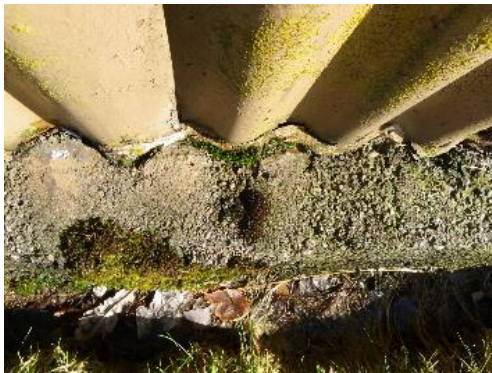
Figure 4.58. One major problem, found on many of the huts, is the reinforcement of the lower edges of the corrugated iron with bricks and concrete. This has been poorly executed and is trapping water between the concrete and the metal which will accelerate corrosion of the corrugated iron. Photograph by the author.

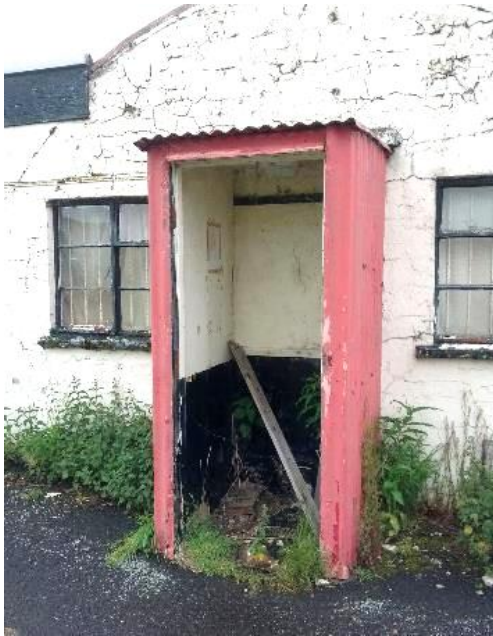
Figure 4.59. Because Cultybraggan was a prisoner-of-war camp and functionality was its main design motivation, there is no decorative detail. However, some intriguing details of camp life do survive such as this phone booth. Photograph by the author.

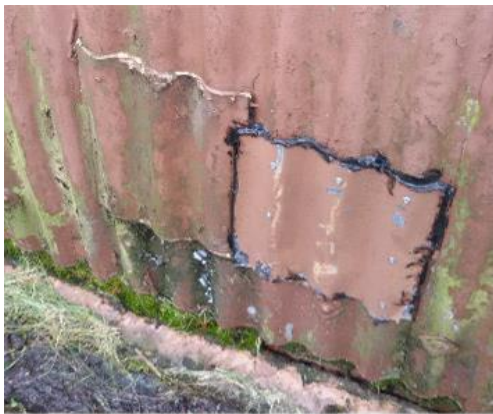
Figure 4.60. Patch repairs are attractive from a conservation point of view because they involve the minimum loss of original material. Here, however, they depend on the cannibalising of other huts to obtain the patch material and the use of potentially corrosive metal fittings to secure the patch. Adding a sealant to make the patch waterproof is essential, but there is no reason to do it as unattractively as this. Photograph by the author.

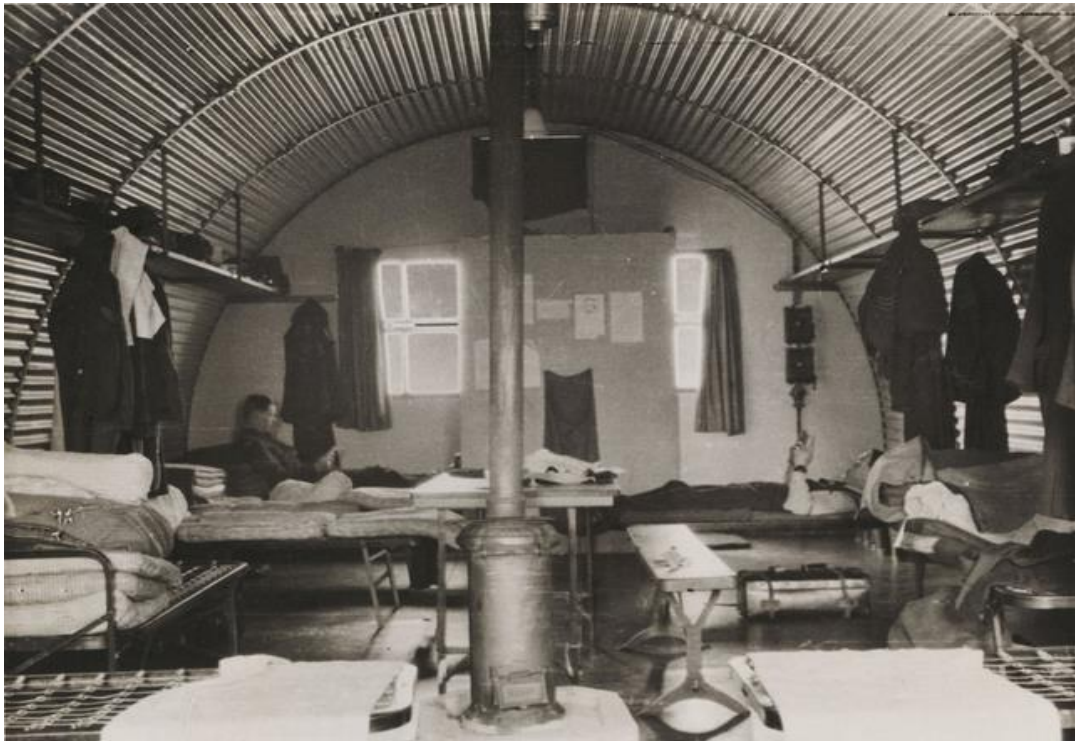
Figure 4.62. The lack of insulation in Nissen's design makes condensation on the inner faces of the hut unavoidable, thus damaging the fabric of the hut itself and making any productive use problematic. The picture illustrates the incompatibility between the conditions that were acceptable to the military during the Second World War, and modern demands for a satisfactory accommodation. Image from Australian War Memorial, accessed 23 August 2020, <https://www.awm.gov.au/collection/C1276130>.

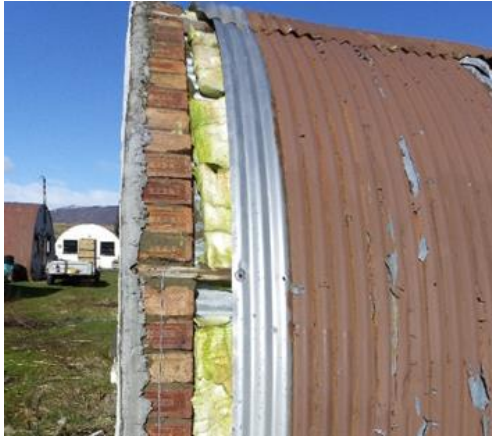
Figure 4.63. Military attempt (probably from the 1980s) to introduce insulation between the corrugated iron skins. Note the excellent condition of the corrugated iron exposed by removal of the closing sheet. This is clearly a modern replacement that calls into question the authenticity of much of the site.

The problem of condensation driven corrosion of the corrugated iron shells of the Nissen huts has no easy conservation solution. Complete dismantling, rust removal and a high-quality paint system, are all necessary parts of conserving the existing corrugated iron and metal frame, a process which requires expensive materials and demands skilled labour. It is almost certain that complete replacement of the corrugated iron at Cultybraggan would be a cheaper alternative, but this raises an acute problem of material authenticity.

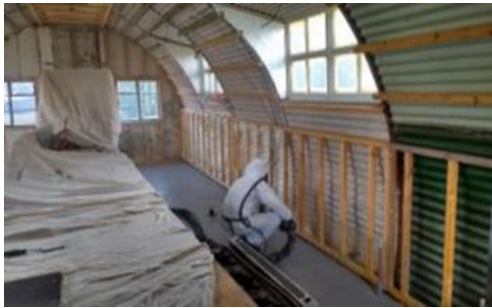
Figure 4.64. The refurbishment of two Nissen huts that will be used as part of the museum, housing the Heritage group's collection and the visitor's centre. The original corrugated iron lining has been retained and it will be interesting to see if condensation problems interfere with the museum displays. Image from Comrie Development Trust.

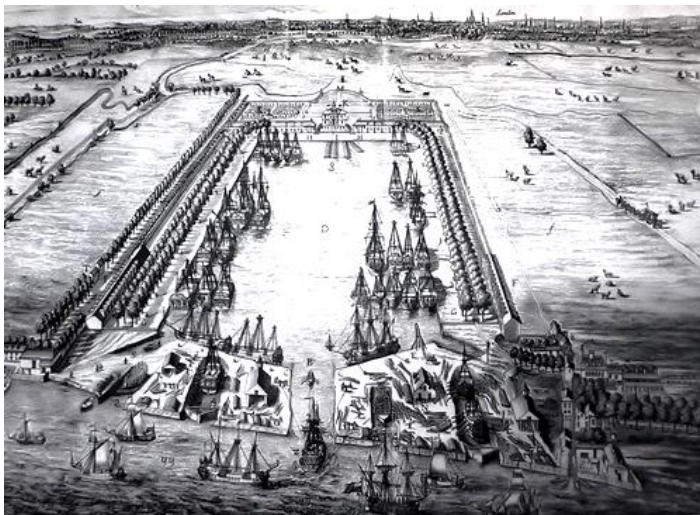
Figure A.1. Howland Great Wet Dock (drawn 1717, though originally constructed 1696). The basin was sheltered by deliberately planted trees along the quaysides. Note the two small dry docks either side of the entrance to the basin. These have lock gates whereas the main basin does not. It is probable that the water level in the main basin was maintained by a cill. There were no warehouses.

The first wet docks to be built in the Port of London were the Blackwall Dock in 1614, which was owned by the East India Company, and the Howland Great Wet dock in 1695, located on what is now the Surrey dock site south of the river Thames. Howland Dock was built as part of an eighteenth-century estate improvement rather than being part of an integrated attempt to generally improve facilities at the Port of London. With its two dry docks, basic entrance arrangements and complete lack of warehousing, it was designed as a facility for refurbishing ships and not as a way of unloading and loading goods for transport. There was no new dock construction till

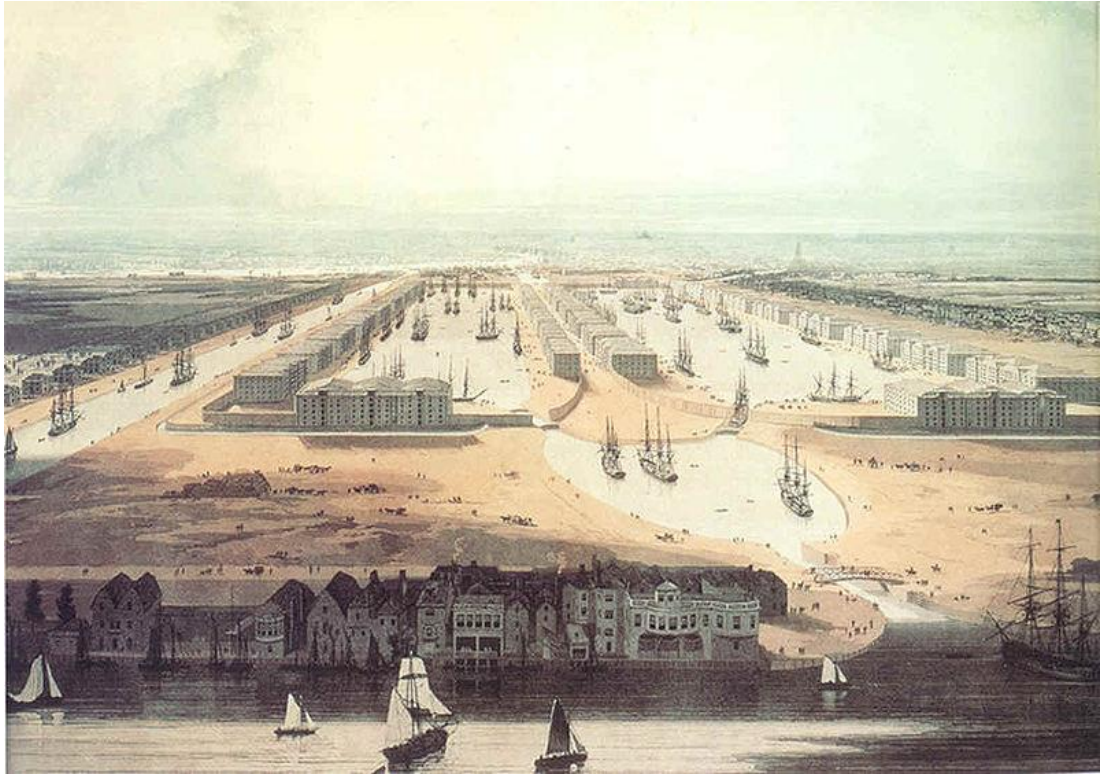
Figure A.4. Proposed layout for the West India dock showing the extensive planned warehousing.

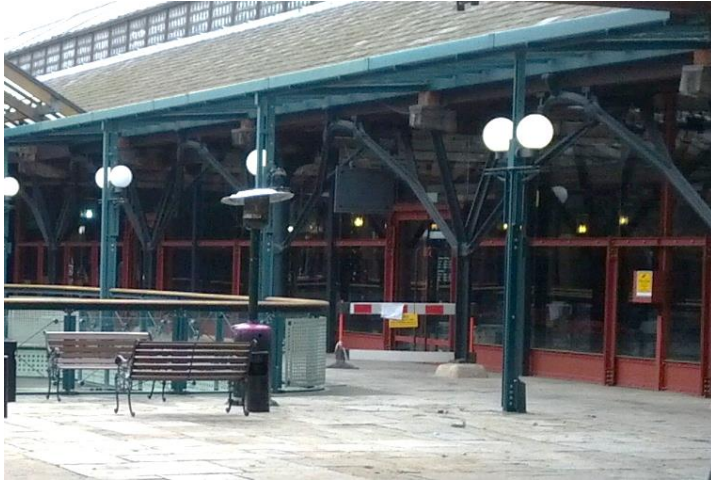
Figure A.6. The Tobacco warehouse at the London dock showing the early structural ironwork. The branching supports towards the back of the building is the iron installed by architect Daniel Alexander in 1811–14. Photograph by the author (2012).

From the point of view of this research it is the gradual replacement of timber with cast iron that is the most important feature of these warehouses whose scale pushed traditional building techniques to their limit. It is no surprise that as part of this culture of innovative use of iron that Henry Roberson Palmer developed the concept of corrugated iron for building.

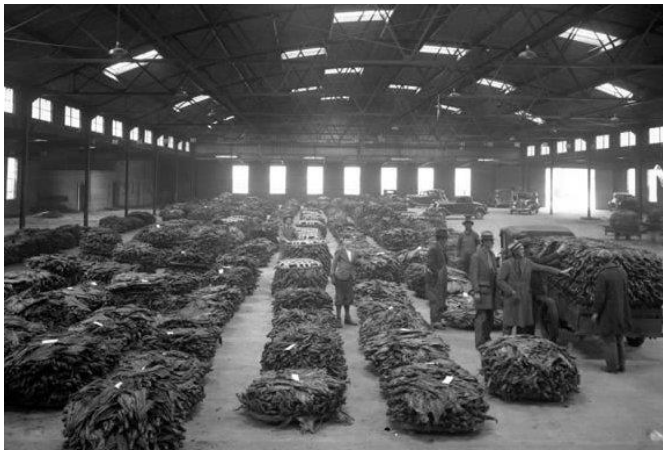
Figure A.7. 'Tobacco Warehouse' by Daniel Alexander. Much of the original 1812 building fabric survives (listed grade I). Image from St George-in-the-East Church, 'Tobacco Dock,' accessed 23 August 2020, <http://www.stgitehistory.org.uk/media/tobaccodock.html>.
