The Challenge of Geotextile Sand Containers as Armour Units for Coastal Protection Works in Australasia

Abstract

This paper outlines the historical development, practical application and evaluation of geotextile armour units installed in coastal protection structures in Australasia.

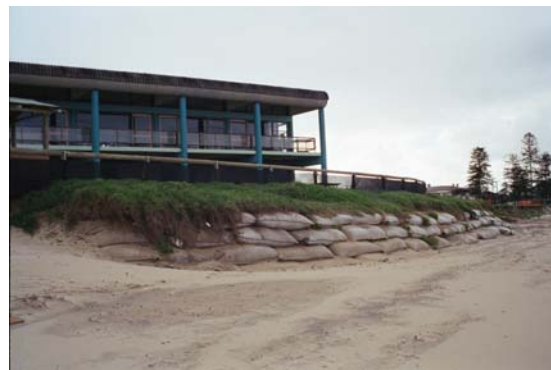
Figure 1 - Stockton Beach Surf Club

Description: 48mlong by 45m high revetment constructed of sandfilled non woven geotextile containers with a mass of just under 2t was built on a 1.5H:1V repose with an extensive self healing toe.

Evaluation and Comment: This was the first of the engineered sandbag revetments constructed to protect oceanfront properties. The option to construct in this manner was largely influenced by the uncertainty of the long term approved solution for the site and the amenity of the brick and concrete surf life saving club. Sand filled geotextile units were filled and placed by Council day labour crews, with the assistance of an excavator utilising a modified rock grab.

Despite the “temporary” nature of the structure, the non-woven geotextile containers have withstood a number of storm cycles over five years of service. This installation has outlived the original design requirements and met the objectives of protecting the surf club whilst complying with providing a ‘soft’ interim solution to the total coastal management problem at this site. The success of this revetment has lead to a number of other areas such as Belongil Spit at Byron Bay, Airlie Is in W.A, Troubridge Is in S.A. utilising similar site appropriate techniques.

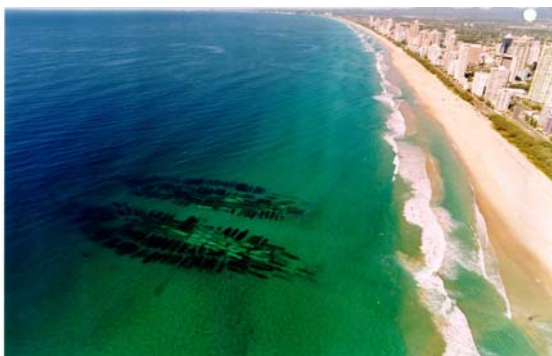
Figure 2 - Narrowneck Artificial Reef Aerial View

Construction techniques utilised to achieve objectives: Nearly 400 mega sand containers varying from 3.0 metres to 4.6 metres in diameter, were placed using a split hulled, trailing suction hopper dredge fitted with computer interfaced DGPS. The containers were accurately filled utilising a calibrated density metre, ensuring repeatability and consistency of the construction.

Materials Used: The mega sand containers were constructed from heavy duty polyester Terrafix[®] non woven geotextile.

Evaluation and Comment: The ability to fill to a pre-determined shape and accurately place very large geotextile containers at a very low unit cost was conclusively proven. Damage occurred to some bags during laying and very effective underwater patching techniques were developed. Various coatings were trialled for the crest bags with mixed success but towards the end of the construction a durable composite material was developed and tested with great success.

Although some top up is still required, monitoring has shown a clear salient at times and enhanced surfing conditions. The results from the techniques developed for this project have given confidence for other reef projects such as at Noosa to proceed.

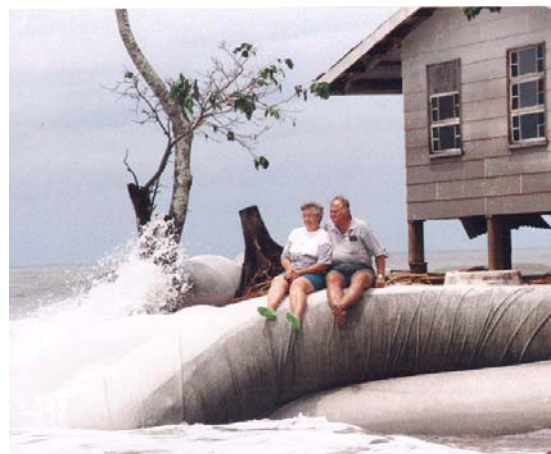
Figure 3 - Russell Heads

Materials Used: 1.2m diameter Terrafix® 1200R geotextile tubes.

Although the wave climate was such that some damage occurred, the inherent flexibility of the non woven needlepunched material utilised enabled re-alignment and settlement to follow scour contours and continue to provide stabilising protection.

Evaluation and Comment: The results of the resident’s actions have been positive. Several houses were saved as a result of these works during cyclone Justin in 1997.
