Preservation of Historic Adobe Buildings

Preservation Briefs

5

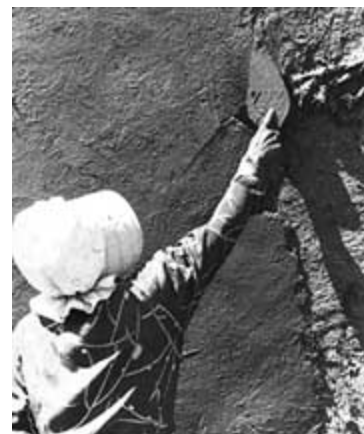
Traditional adobe repair.
Photo: Russell Lee, Farm
Security Administration
Collection, Library of
Congress.

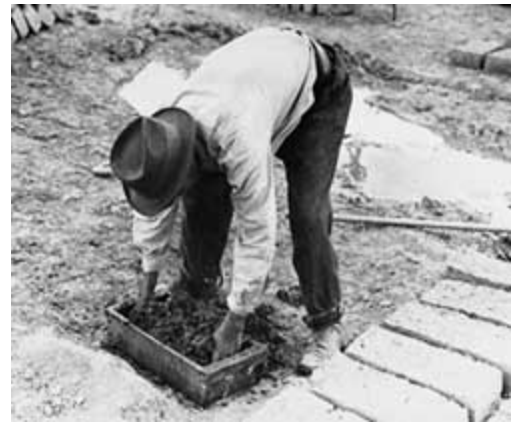
A mixture of mud and straw is pressed into a mold to form an adobe brick. After the adobe brick is removed from the mold, it must dry in the open air for a month or more before it can be used.

The adobe brick is molded from sand and clay mixed with water to a plastic consistency. Commonly, straw or grass is included as a binder. Although they do not help reinforce the bricks or give them added long-term strength, straw and grass do help the bricks shrink more uniformly while they dry. More important for durability, however, is the inherent clay-to-sand ratio found in native soil. The prepared mud is placed in wooden forms, tamped, and leveled by hand. The bricks are then "turned-out" of the mold to dry on a level surface covered with straw or grass so that the bricks will not stick. After several days of drying, the adobe bricks are ready for air-curing. This consists of standing the bricks on end for a period of 4 weeks or longer.

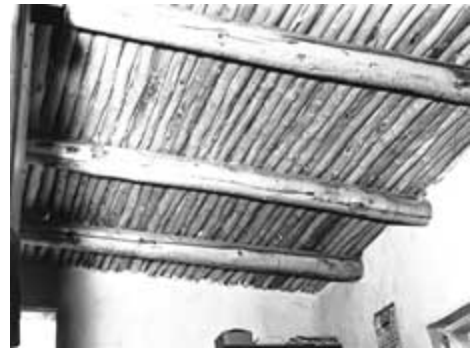
Viga logs and savinos are seen in the interior of the adobe building. Often the wooden materials that comprise the traditional flat adobe roof create interesting and pleasing patterns on the ceilings of interior rooms. Photo:

Early Southwest adobe roofs (17th-mid-19th centuries) tended to be flat with low parapet walls. These roofs consisted of logs which supported wooden poles, and which in turn supported wooden lathing or layers of twigs covered with packed adobe earth. The wood was aspen, mesquite, cedar, or whatever was available. Roughly dressed logs (called "vigas") or shaped squared timbers were spaced on close (23 feet or less) centers resting either on the horizontal wooden member which topped the adobe wall, or on decorated cantilevered blocks, called "corbels," which were set into the adobe wall. Traditionally, these vigas often projected through the wall facades creating the typical adobe construction detail copied in the 20th century revival styles. Wooden poles about 2 inches in diameter (called "latias") were then laid across the top of the vigas. Handsplit planks (called "cedros" if cedar and "savinos" if cypress) instead of poles were used when available. In some areas, these were laid in a herringbone pattern. In the west Texas and Tucson areas, "saguaro" (cactus) ribs

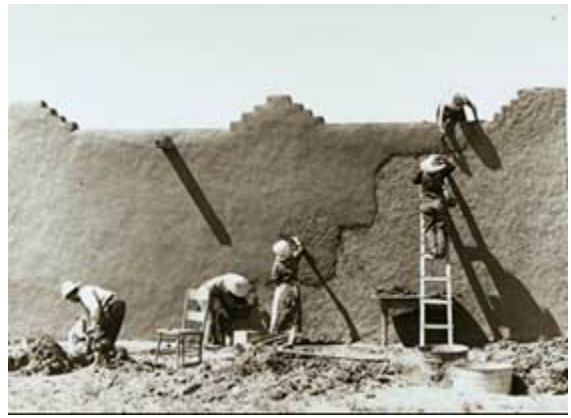
Traditionally, adobe surface coatings that protected the fragile adobe building fabric were renewed every few years. Women are seen here recoating an adobe wall with mud plaster mixed with straw at Chamisal, New Mexico. Photo: Russell Lee, Farm Security Administration Collection, Library of Congress.

Mud plaster has long been used as a surface coating. Like adobe, mud plaster is composed of clay, sand, water, and straw or grass, and therefore exhibits sympathetic properties to those of the original adobe. The mud plaster bonds to the adobe because the two are made of the same materials. Although applying mud plaster requires little skill, it is a time-consuming and laborious process. Once in place, the mud plaster must be smoothed. This is done by hand; sometimes deerskins, sheepskins, and small, slightly rounded stones are used to smooth the plaster to create a "polished" surface. In some areas, pink or ochre pigments are mixed into the final layer and "polished."

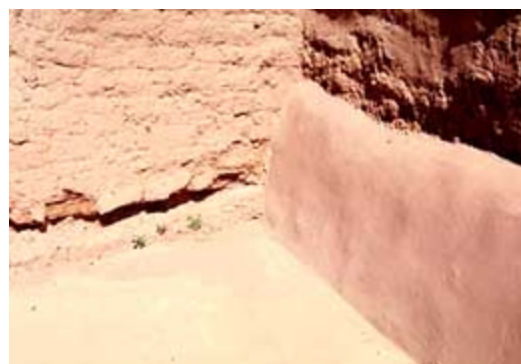
Coving at the base of this adobe wall may have been caused by salts deposited by rising groundwater and/or rainwater splash. Photo: NPS files.

In repairing "coving," the damage caused by rain splash, adobe bricks stabilized with soil cement might be considered. On the other hand, concrete patches, cement stucco, and curb-like buttresses against the coving usually have a negative effect because moisture may be attracted and trapped behind the concrete.

Once any one or all of these solutions has effectively minimized the problems of rising ground water, the coving and deterioration of the walls can be corrected by patching the area with new adobe mud and by applying traditional surface coatings. It should be remembered, however, that unless the capillary action is stopped effectively, this erosive condition will certainly continue. Most important, surface coatings and patching only repair the effects of ground water and wind erosion, they cannot cure the cause.

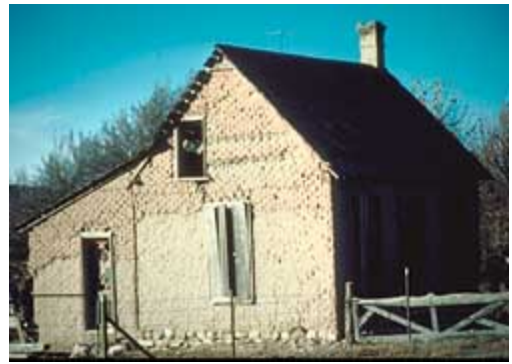
A traditional mixture of mud and straw plaster should be applied to stabilize the exterior of this house. Photo: NPS files.

When the coating has been mud plaster, the process requires that the deteriorated mud plaster be scraped off and replaced with like materials and similar techniques, attempting in all cases to match the repair work as closely as possible to the original. It is always better to cover adobe with mud plaster even though the mud plaster must be renewed more frequently.
