## PRESERVATION BRIEFS

# 22

## The Preservation and Repair of Historic Stucco

Anne E. Grimmer

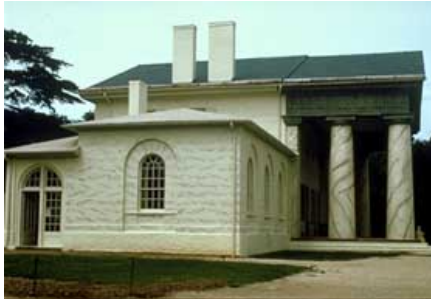
The stucco finish on Arlington House, Arlington, Virginia, was marbleized in the 1850s, approximately 30 years after it was built. Photo: NPS files.

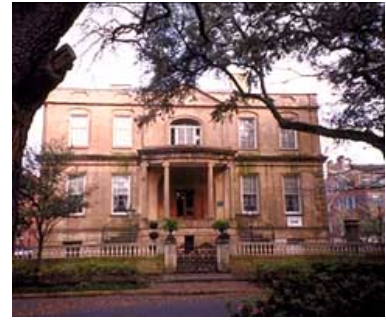
The stucco on the early-19th century Richardson-Owens-Thomas House in Savannah, Georgia, is a type of natural cement. Photo: NPS files.

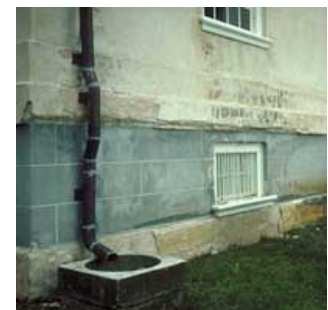
The damage to this stucco appears to be caused by moisture infiltration. Photo: NPS files.

Most stucco deterioration is the result of water infiltration into the building structure, either through the roof, around chimneys, window and door openings, or excessive ground water or moisture penetrating through, or splashing up from the foundation. Potential causes of deterioration include: ground settlement lintel and door frame settlement, inadequate or leaking gutters and downspouts, intrusive vegetation, moisture migration within walls due to interior condensation and humidity, vapor drive problems caused by furnace, bathroom and kitchen vents, and rising damp resulting from excessive ground water and poor drainage around the foundation. Water infiltration will cause wood lath to rot, and metal lath and nails to rust, which eventually will cause stucco to lose its bond and pull away from its substrate.

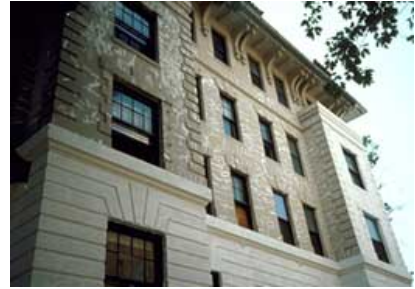
Caulking is not an appropriate method for repairing cracks in historic stucco. Photo: NPS files.

Commercially available caulking compounds are not suitable materials for patching hairline cracks. Because their consistency and texture is unlike that of stucco, they tend to weather differently, and attract more dirt; as a result, repairs made with caulking compounds may be highly visible, and unsightly. Larger cracks will have to be cut out in preparation for more extensive repair. Most stucco repairs will require the skill and expertise of a professional plasterer.

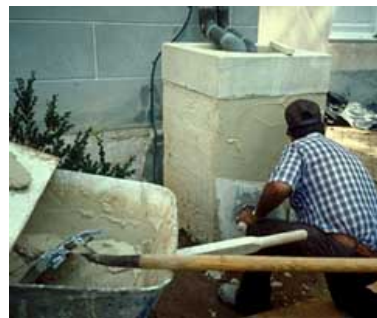
The deteriorated surface of this catch basin is being re-stuccoed. Photo: NPS files.

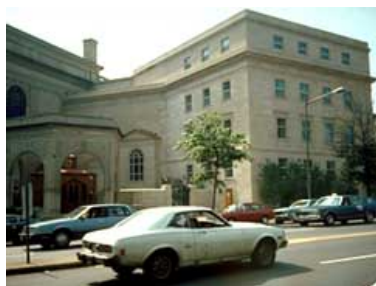
The new addition on the right is stucco scored to imitate the limestone of the historic building on the left. Photo: NPS files.
