Preserving Historic Wood Porches

PRESERVATION BRIEFS

45

Aleca Sullivan and John Leeke

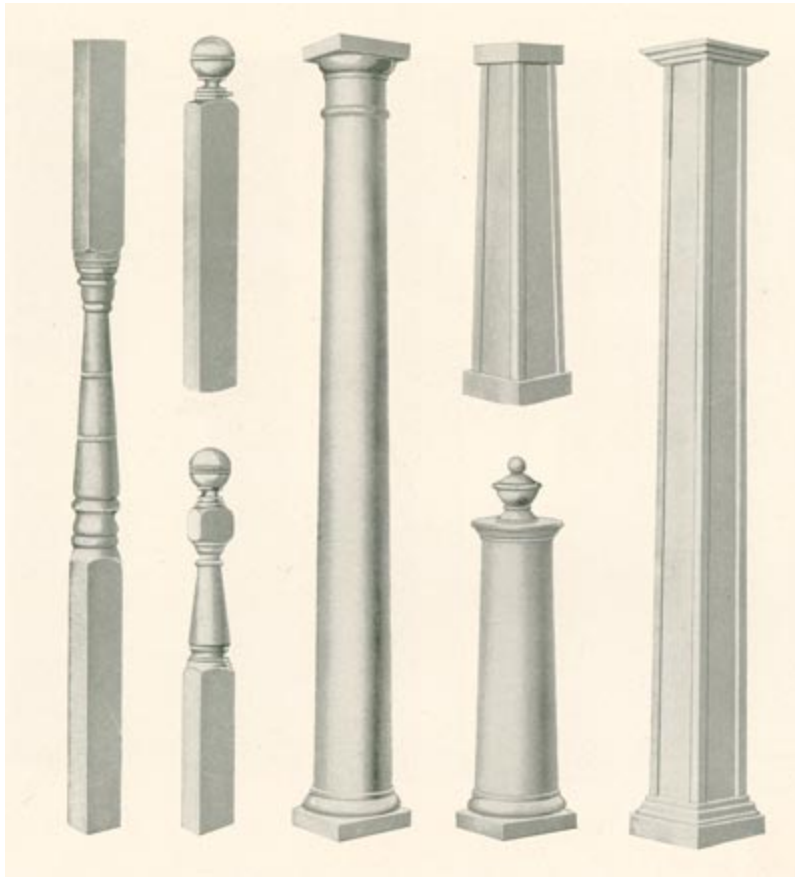
Figure 3. Throughout the late nineteenth and early twentieth centuries, millwork catalogues offered a wide variety of designs for porch parts, including columns, newels, balusters, spindles and brackets. As extolled in the Cedar Rapid Sash & Door Company's Standards Design Book, stock parts made embellishments to porches affordable both for new construction and "updating" existing homes. Courtesy of Charles Fisher.

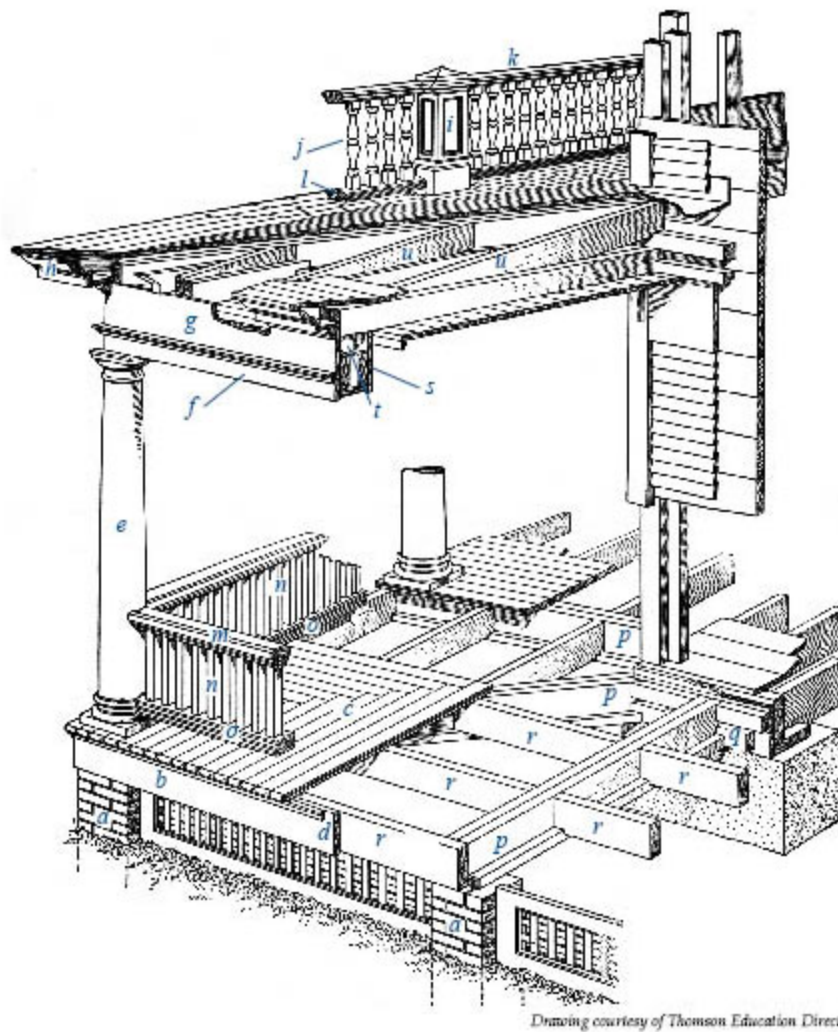
1. Pier, penetrates ground, supports floor structural system and columns
2. Fascia covering floor framing
3. Floor (or deck)
4. Bed Molding covering joint between fascia and floor
5. Column supporting entablature above

Entablature (f, g, h)

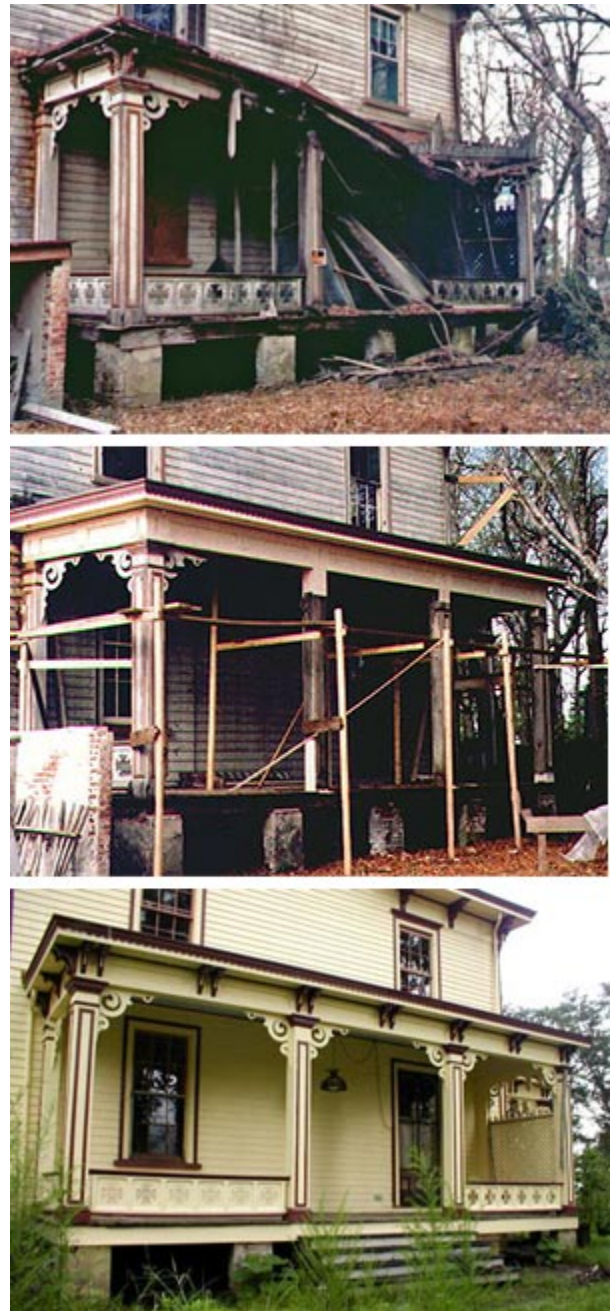
Figure 5. Even historic porches that appear to be in total disrepair may be repairable. While the roof needed replacement, much of this porch was repaired, including such features as the decorative columns, ornamental brackets, and balustrade. Photos: John Leeke.

The porch structure needs to be sound at every level. Therefore, a visual inspection of the underside of the porch is necessary to determine its condition. Major cracks in structural members, failed joints, significant wood rot, or evidence of widespread insect infestations (termites, carpenter ants or powder post beetles, for example) are usually signs of serious structural damage. Such conditions may require consultation with a professional architect, engineer or building contractor familiar with old buildings. For an adequate assessment, it may be necessary to remove facing boards to check for potential decay in the structural sill behind (Figure 5).

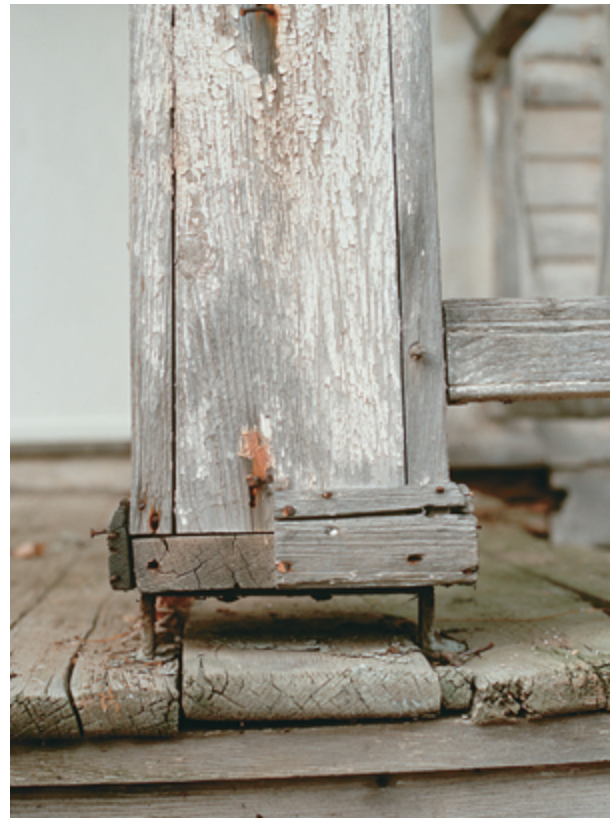
Figure 6. A traditional way to extend the life of porch posts was to place posts on metal feet, thereby providing a separation between the wood post and wood deck. This helped to prevent the wood post from rotting at the base. Early post feet were simple iron bars bent unto a stirrup shape. By the late nineteenth century manufactured cast-iron feet were common, consisting of a pair of disks separated by a short pipe. Post feet are still available today. Courtesy of Old-House Journal/Brian McNeil.

Posts, pillars or columns usually help support the porch roof or an upper deck. Establishing what the posts are made of and how they are constructed will aid in understanding how they function and may deteriorate over time (Figure 6). Although the posts on a wood porch are commonly made of wood, they may be of masonry or metal or a combination of materials. Large round columns usually are made of wood staves similar to the way barrels are constructed; smaller diameter columns may be solid. A sag in the deck below or a faltering foundation can impact the supporting role of a column or post above. Wood columns and posts are prone to water seeping into open joints, particularly in the base and the lower end of the shaft. It is not uncommon to find that older columns have had patches and replacement bases.

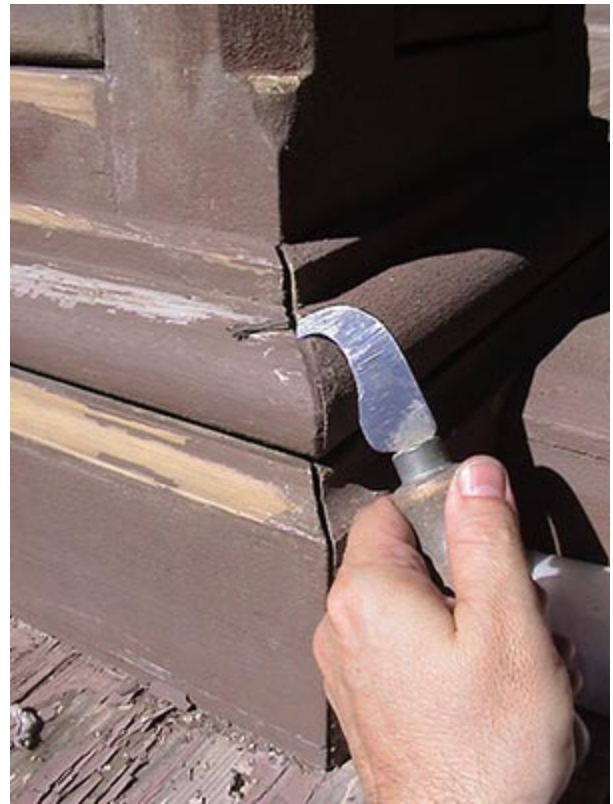
Figure 7. Common problems with porches that can contribute to serious wood decay include cracks in woodwork and joints that have opened up. Both provide an easy path for water seepage. Trapped moisture can foster peeling paint, wood decay and insect infestation. Open joints and cracks should be checked for evidence of more serious decay and marked for caulking or repair.
Photo: John Leeke.

Tightly sealed connections keep water out. Where individual boards come together, cracks in woodwork and joints can eventually become a major problem (Figure 7). Cracks are primarily caused by movement and water penetration. Movement of structural members beneath the finished woodwork can shift the position of individual boards and trim, breaking open the thin coating of paint over joints. This condition is common on porches with shallow foundations that are subject either to annual winter frost heaving or where soil conditions undergo major seasonal changes in moisture content. Changes in the moisture content of the wood itself due to repeated wetting and drying or changes in seasonal humidity can also cause noticeable expansion and shrinkage across the width of a board. This provides opportunities for water to penetrate unprotected areas.

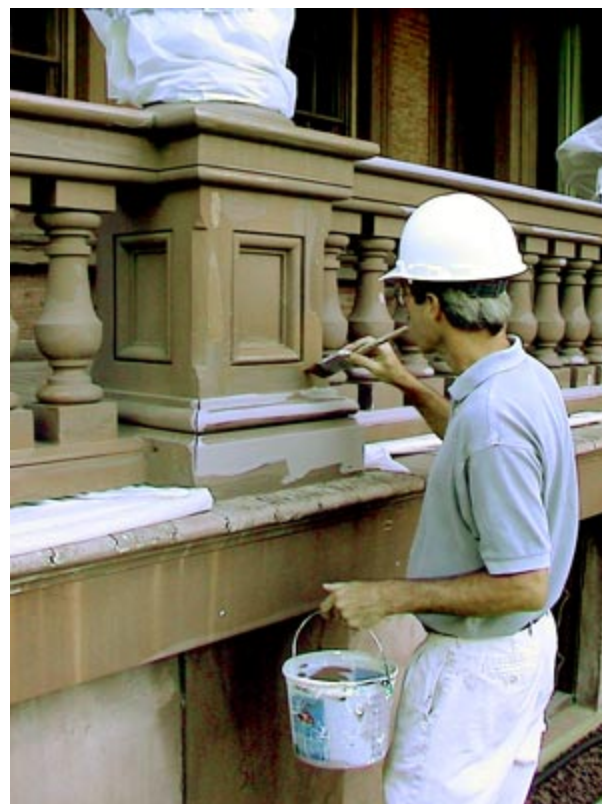
Figure 8. Decay can start when wood is left exposed to the weather or where joints open up. An inexpensive way to extend the life of the existing porch paint without jeopardizing the historic material is spot paint and caulk where needed every year or two. This cost-effective procedure is particularly effective in maintaining wood porches where the exposure to weathering is high. Photo: John Leeke.

Spot painting and resealing of open joints should be undertaken at least every other year (Figure 8). Heavily used stair treads may require more frequent paint touchup. When peeling paint or bare wood is evident, inspect to ensure it is not signaling deeper problems, such as decay. With sound wood, scrape off the loose paint, sand, prime, and repaint the area. Where lead paint is present, appropriate lead hazard precautions and procedures apply. Only top-

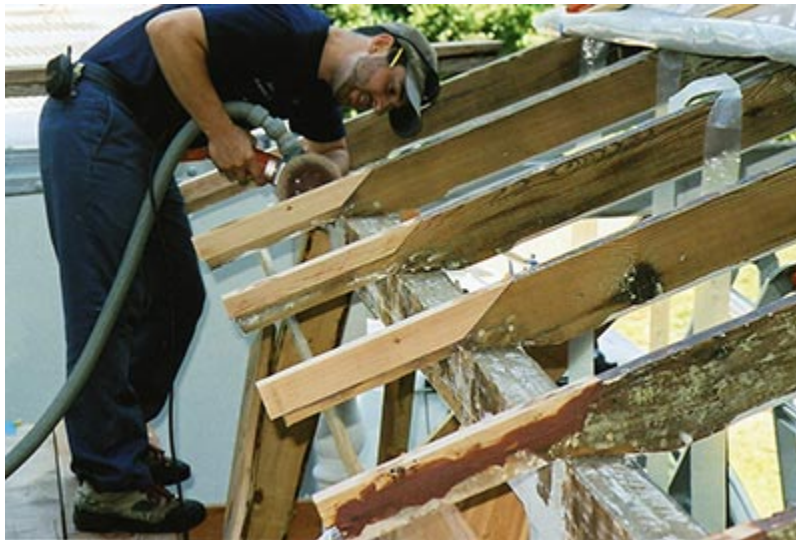
Figure 9. The ends of porch roof rafters are often susceptible to moisture decay. When concealed by a soffit or ceiling, rafters can be repaired by adding new sister boards. Where roof rafter ends are exposed, splicing new wood onto the old (dutchman repair) and use of epoxy consolidants and fillers both preserve sound historic fabric while retaining the historic appearance. Photo: Paul Marlowe, Marlowe Restorations.

This traditional technique is often used to repair localized cases of decayed wood and, when undertaken with skill and care, will serve as a permanent repair (Figure 9). If the damaged area has a structural function, temporary bracing or other support will be necessary. Otherwise the first step after removing any paint around the damaged area is to chisel or mechanically remove the decayed wood. It is best to use the same type of wood being replaced and the new or recycled wood should be seasoned to avoid shrinkage. The repair procedure involves cutting a piece of wood, called a dutchman, slightly larger than the area of damage that has been cut out. The dutchman then is laid over the damaged area and an outline scribed into the original wood surface below. Next, a chisel or router is used to follow

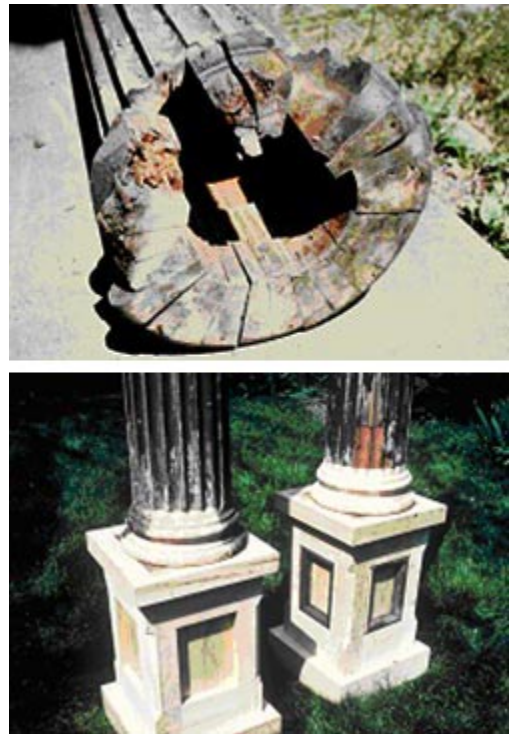
Figure 10. This nineteenth century porch column is made of wood staves, similar to the way a wood barrel is put together. After replacing the torus and making dutchman repairs to the apophyge along the base, the column and pedestal are ready to be reinstalled on the porch. Photos: NPS files.

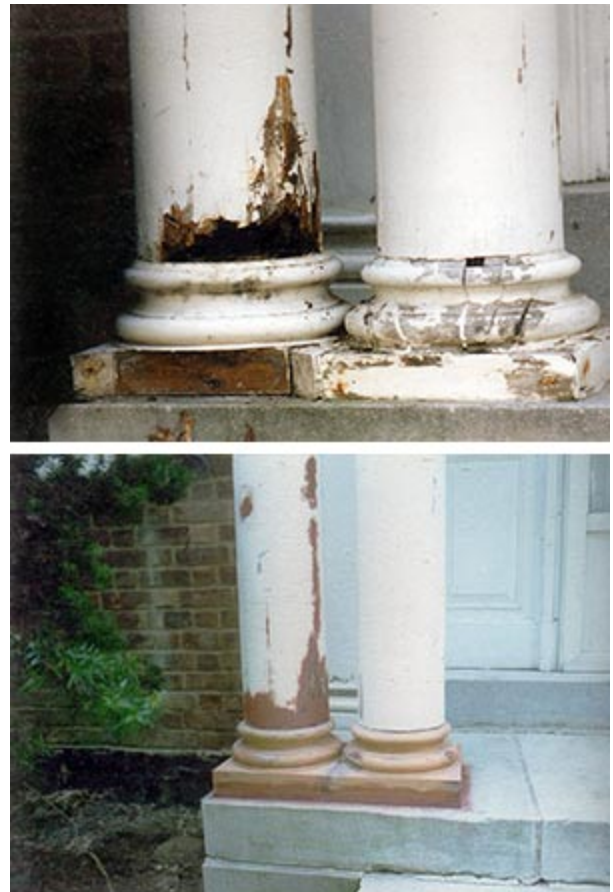
Figure 11. The lower shaft of the porch columns had decayed as water wicked up through the end grain (top). The column shafts were repaired in place by cutting out the deteriorated wood and making repairs using epoxy consolidants and fillers. (bottom). The column bases were replaced. Photos: Paul Marlowe, Marlowe Restorations.

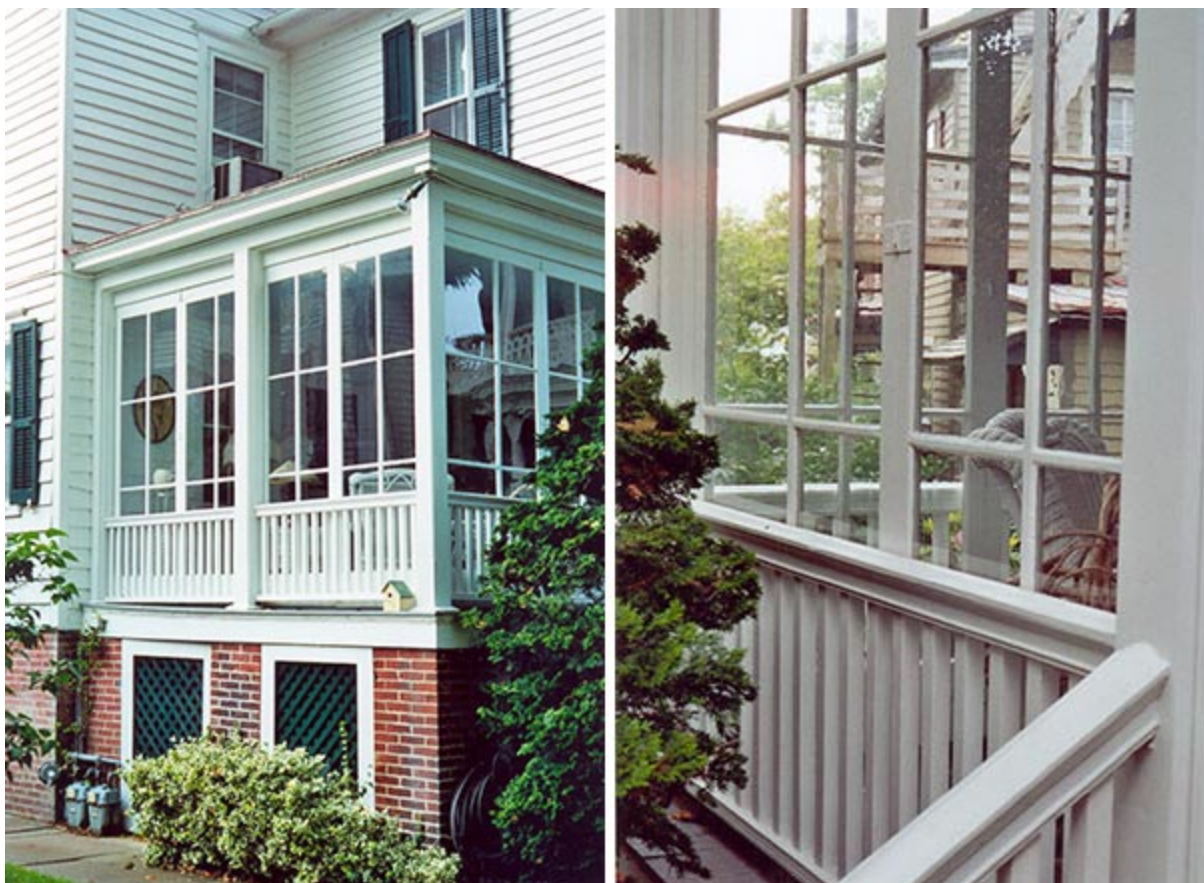
Figure 12. This old porch enclosure, located on the back side of a house, has acquired significance over time and is remarkable both in the appropriateness of its detailing for use by others today, as well as its high degree of maintenance. The enclosure is set behind the columns; the balustrade has been retained; and the light divisions and the size of the glass panes echo that of the windows above. Within each bay there are two well-crafted, inward swinging doors, providing for greater seasonal use of the porch. Photos: Charles Fisher.

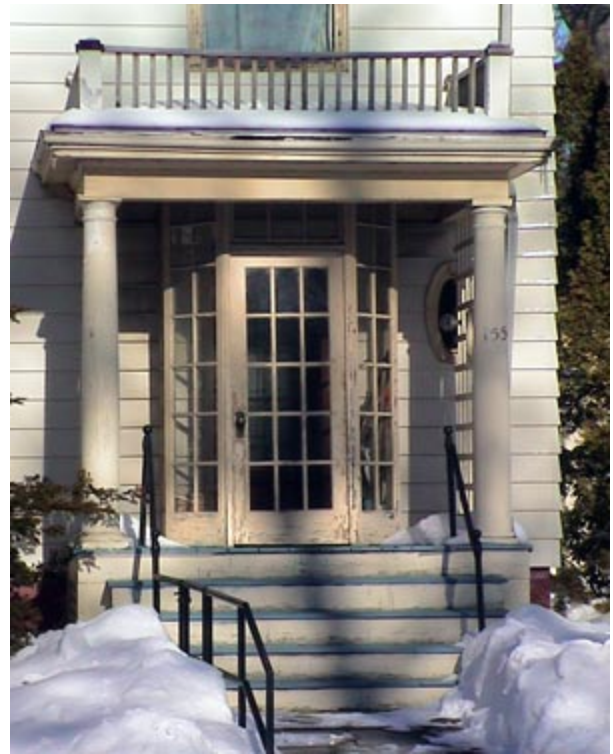
Figure 13. Particularly in New England, there is a cold weather tradition of installing temporary glass and wood panels at entrance doors, thereby creating an enclosed vestibule. These enclosures with their small divided lights were generally removed in the spring. Photo: John Leeke.

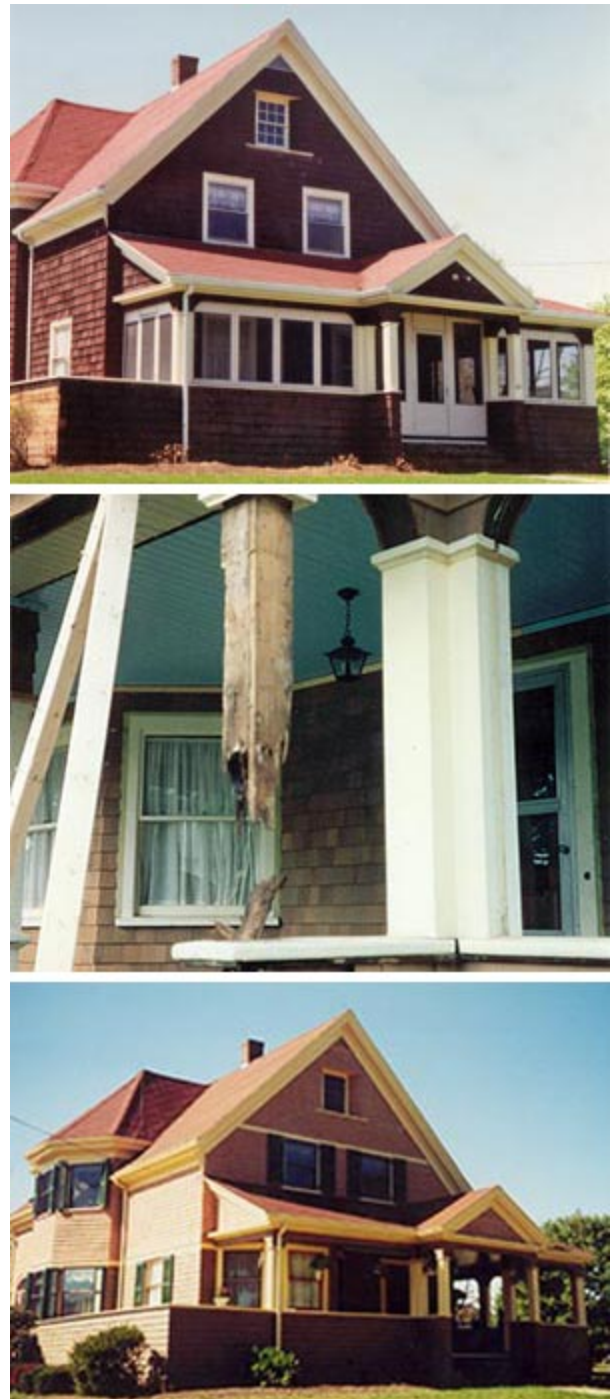
Figure 14. The enclosure of a prominent porch can dramatically change the historic character of a building. The L-shaped porch on this 1896 Shingle-style New England residence was later enclosed with aluminum windows and screens. Recent owners elected to reopen the historic porch. Among the other work, it was necessary to correct structural damage, as with this post, where beneath the wood casing carpenter ants had done serious damage. In reopening the porch, the historic character of the residence has

been brought back and the traditional use of the porch is once again enjoyed. Photos: Mark Landry, Landmark Services.

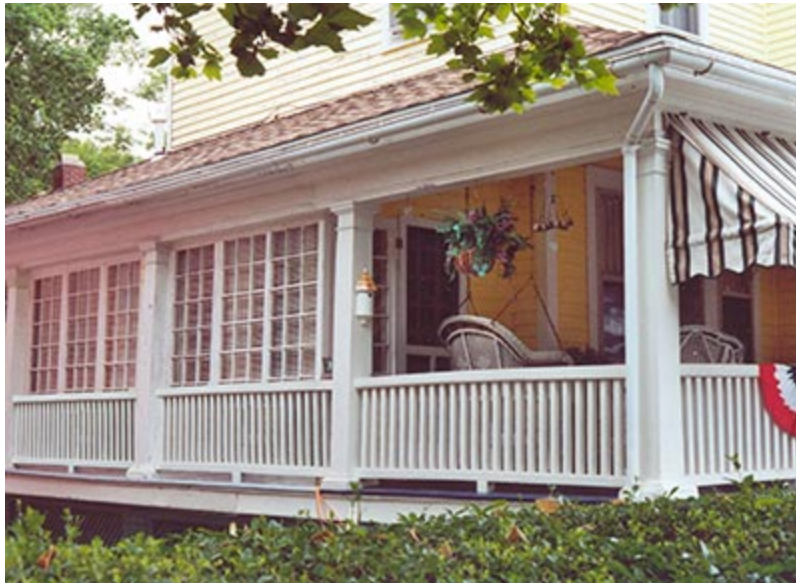
Figure 15. A traditional technique of porch enclosures still used today involves the insertion in each column bay of one or more glass enclosures set in wood frames . This enclosure is properly set back an entire porch bay from the front of the house and utilizes traditional light divisions and wood frames. The balustrade, added here for illustration purposes, shows the importance of retaining this linear feature within the enclosed bays. Photo: Charles Fisher.

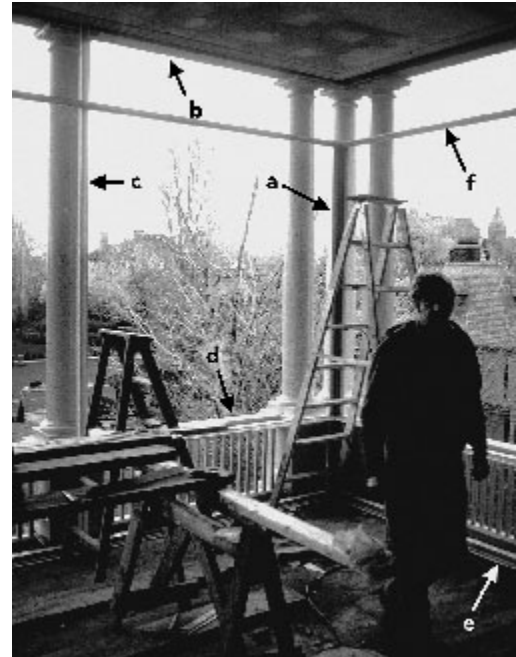
Figure 16. The use of near full glazing to enclose a porch may be appropriate depending upon the historic character of the building, location of the porch, how the interior space is to be treated, and other factors. This enclosure of a rear porch to create a conference room successfully utilizes large expanses of glass and narrow metal framing set behind existing porch elements (a through e). Where an additional horizontal support was needed (f), the frame was placed at a location that is found in many traditional insect screen enclosures. Photo: Charles Fisher.

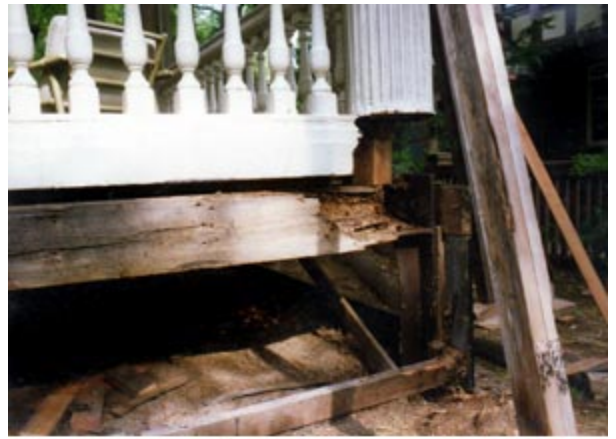
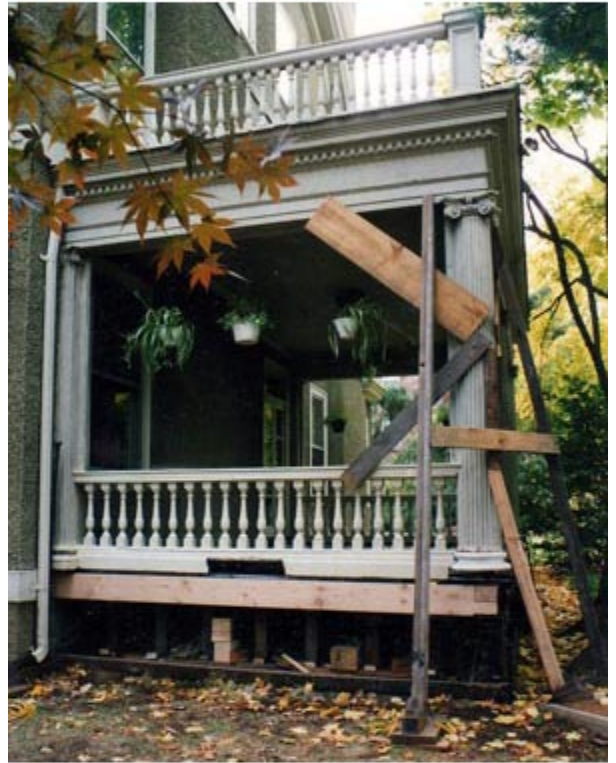
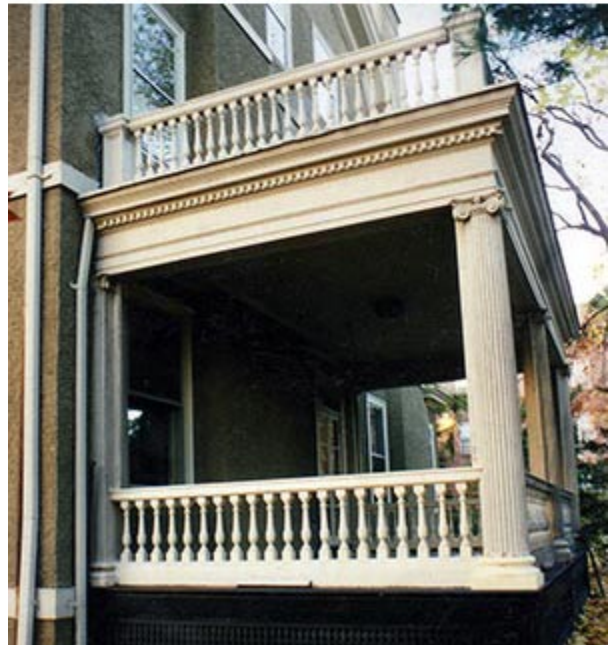
Figure 17. The porch's structural system must be capable of supporting today's loads. In this case moisture led to the deterioration of the wood girder at the corner, creating a major structural deficiency (top). A new solid timber was installed to replace the girder (middle); alternatively a built-up girder could have been used since a fascia board would conceal it. The column base was repaired and portions replaced and the balustrade and column reset and secured (bottom). Photos: Paul Marlowe, Marlowe Restorations.

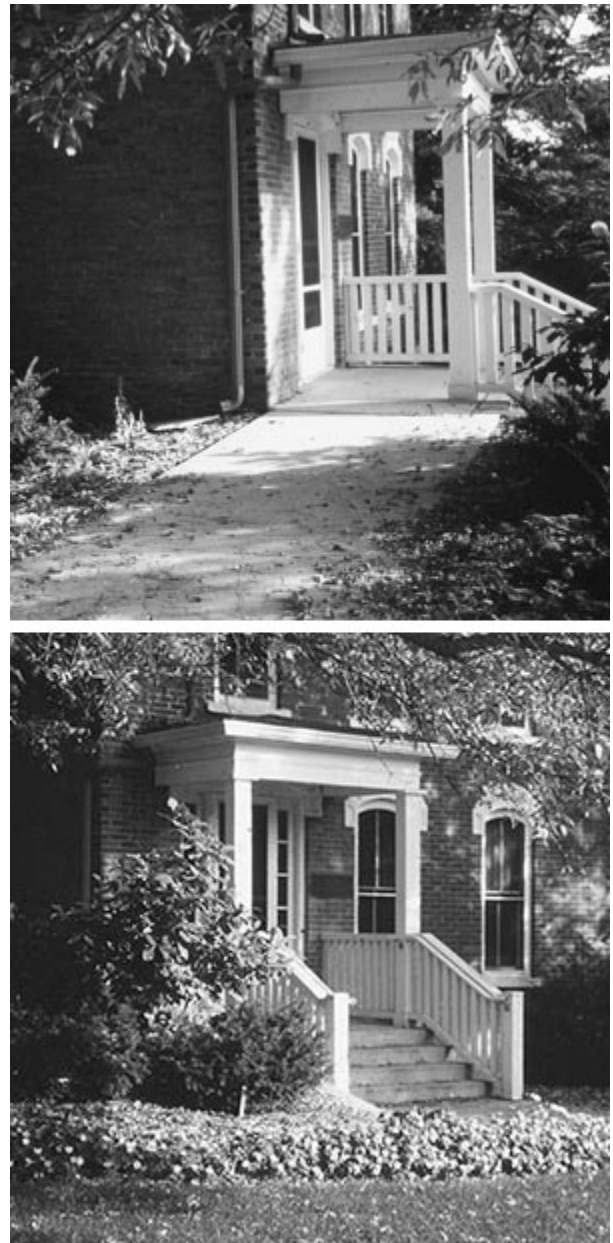
Figure 18. When a porch is used as a wheelchair accessible entrance, it may be possible to retain the historic stairs by adding a ramp parallel to the building. Through plantings and some re-grading, the new ramp built parallel to the building (left) allows retention of the historic stairs and does not impact the historic character of the entrance (right). Photo: Iowa State University Extension.

the only entrance alternative. It may be possible to retain the historic stairs by adding another entrance to the porch with the construction of a ramp parallel to the building (Figure 18).

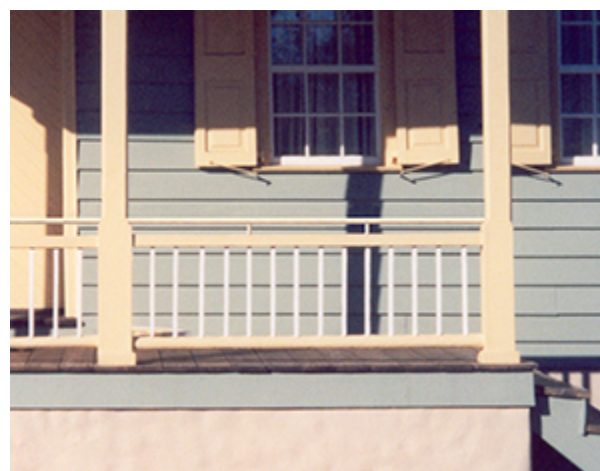
Figure 19. Historic porches generally have railings that measure 28 to 30 inches in height from the floor. When additional height is necessary for safety, a simple rail, added for illustration purposes in this photograph, can usually be installed above the historic railing. Not only does this treatment allow retention of the historic balustrade, but it also has a minimum impact to the appearance of the porch. Photo: Charles Fisher.
