Keeping A Lid On It: Asbestos-Cement Building Materials

Amy Lamb Woods

August 2000

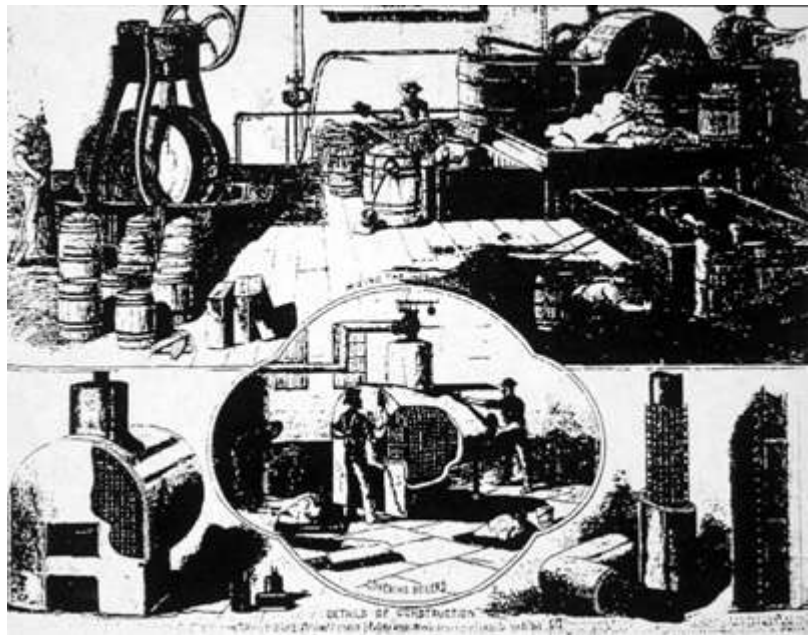
Figure 1. Manufacture of non-conducting asbestos-cement coverings for steam-pipes and boilers (*Scientific America*, 1876).²⁶

Asbestos-cement was first manufactured in the United States in 1905,⁶ introduced first in the form of a coating. It was easily installed and assumed to be indestructible when applied as a covering to boilers, steam pipes, hot blast furnaces, and stills. H. W. Johns Manufacturing Company (later Johns-Manville) became one of the leaders in the development of cement products containing asbestos.

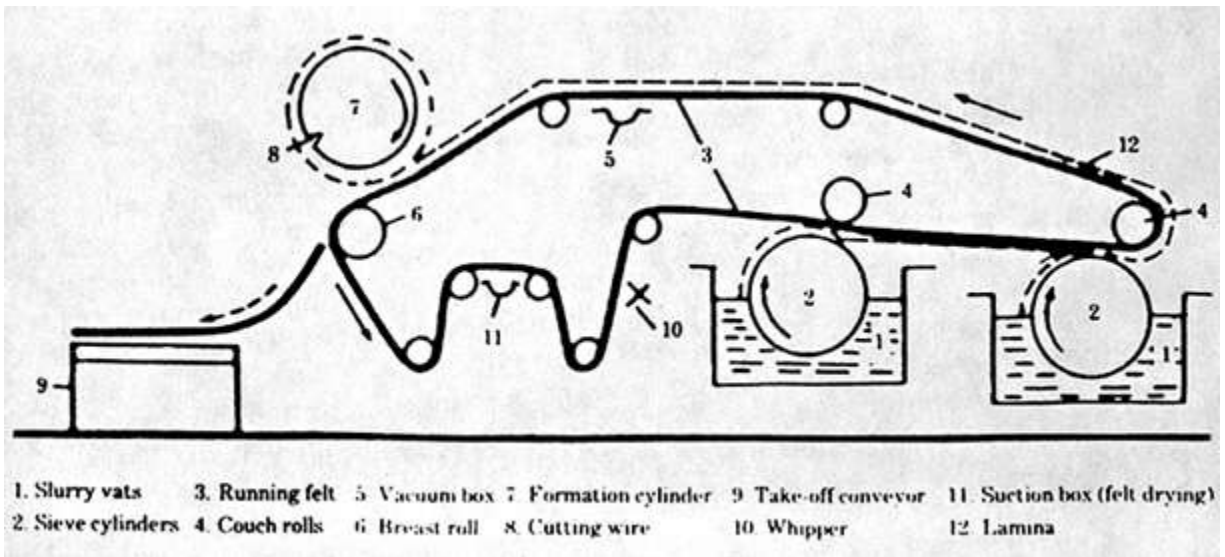
Figure 2. Simplified representation of a Hatschek machine for asbestos-cement production (Wilden, 1986).²⁷

It was not until 1907 that the invention by an Austrian engineer, Ludwid Hatschek, made possible the manufacture of pre-formed asbestos-cement products.⁸ The Hatschek machine, a wet transfer roller, was used to produce the initial asbestos-cement sheets (Figure 2), while two other manufacturing processes included the Mazza process for pipes, and the Magnani semi-dry process for corrugated sheets.⁹ After being formed, most products were steam cured to achieve the optimum microstructure for strength and durability. It is these asbestos-cement building products that have many desirable material characteristics, such as being lightweight, impermeable to water, durable, tough, resistant to rot, termites, soiling, corrosion, warping, and fire, and easy to clean and maintain. Asbestos-cement also possesses low thermal conductivity and is therefore a good electrical insulator. These highly desirable material characteristics, apparent in the new found material, sparked growth in manufacture of a plethora of forms and styles to suit different needs.

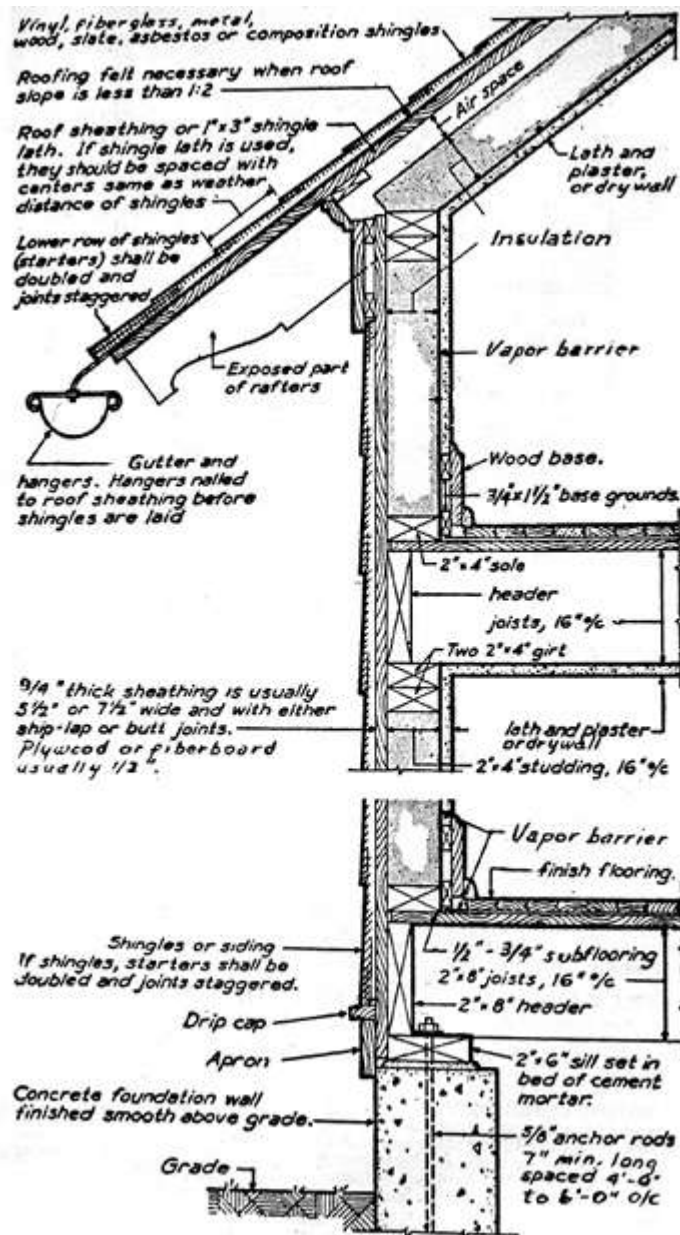
Figure 5. Partial wall section for shingle siding construction; shows a drip cap and apron in place to protect the bottom edge of siding shingles (Graf, 1985).

bumper material to the bottom row of siding to reduce vulnerability to cracking and chipping (Figure 5), and keeping branches and debris away from the roof and out of gutters.

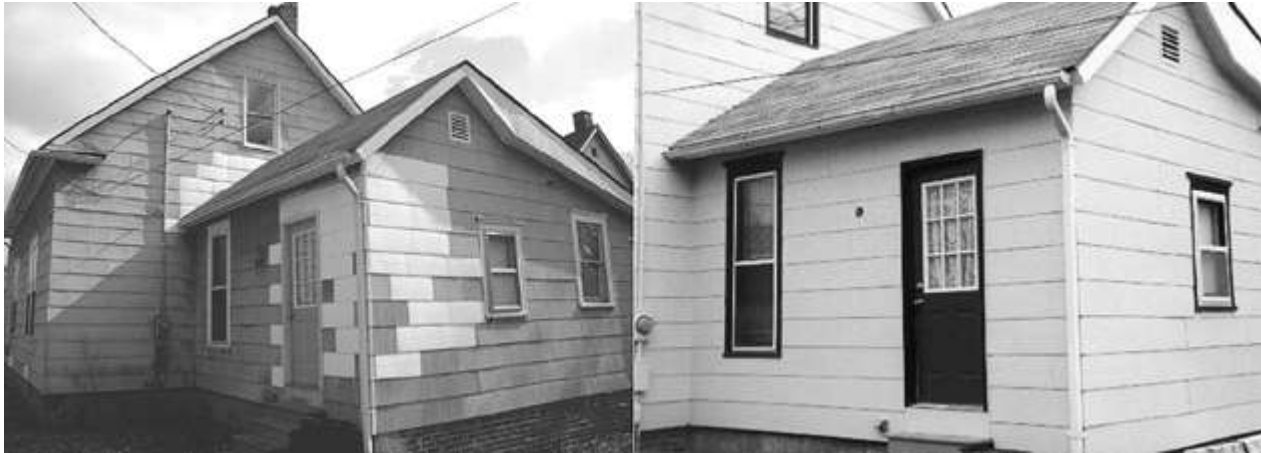
Figure 7. Replacement non-asbestos fiber-cement shingles in place, before being painted and after (photo by author).

Many varieties of non-asbestos reinforced cement or fiber-cement are currently available. Fibers that have been introduced with cement include: steel, glass, polypropylene, wood (these four being the most common), acrylic, akwara, alumina, carbon, cellulose, coconut, kevlar, nylon, perlon, polyethylene, rock wool, and sisal.²⁵ Combinations of fibers are currently undergoing research in order to get properties closely matching those of asbestos. Several companies manufacture products that replicate asbestos-cement roofing and siding shingles, flat sheets, and corrugated sheets. Some of these manufacturers include: Supradur Manufacturing Company, Cement Board Fabricators, U.S. Architectural Products, Inc., Re-Con Building Products, and GAF Materials Corp. The fiber-cement products replicate the size, shape, thickness, and structure, along with texture and color of many of the asbestos-cement products previously available. Where color matching is not found, an alternative is to replace in size and shape then paint over the entire structure for a uniform appearance (Figure 7). In addition, the hardware and the installation procedures for these products are similar to those for asbestos-cement products due to their similar characteristics and proportions.
