by Elena Marrocchino¹, Virginia Lattao^{1*}, Negar Eftekhari¹, Aida Maria Conte², Stefano Franceschini³, Salvatore Pepi¹, Marzia Rizzo¹, and Carmela Vaccaro^{1,4}

Rationalist architecture in rural villages: petro-morphological characterization of natural asbestos fibers in decorative plasters used for artificial stones

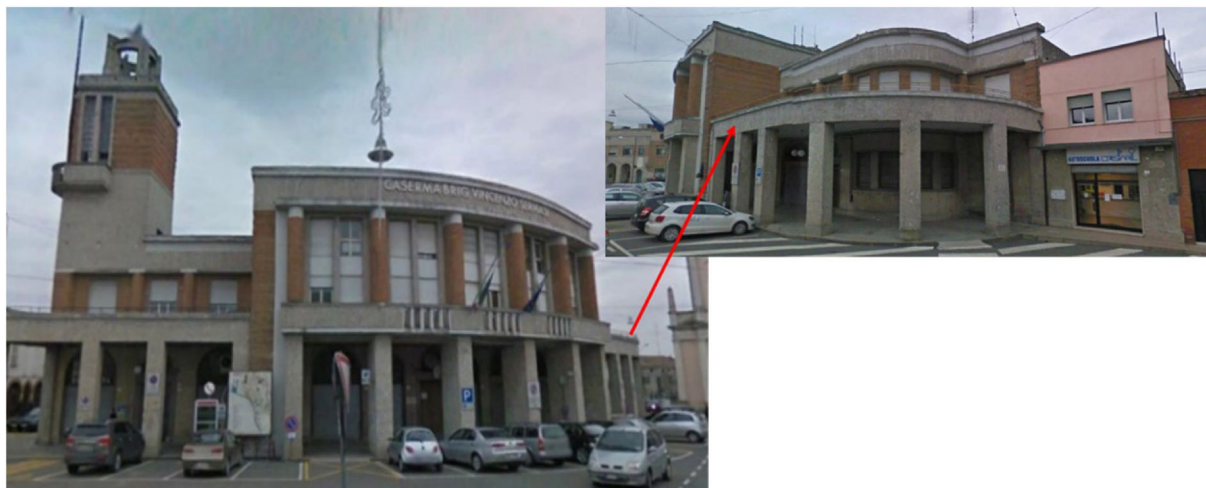
Figure 1. The Ex Casa del Fascio building façade, Codigoro, near to Ferrara, northeastern Italy.

areas. Its ground floor is clad with artificial stone slabs, used as decorative stones, built above a reinforced concrete base. These slabs were severely damaged because of dilation phenomena caused by the highly corroded reinforcements. To fix this damage, several restoration oper-

element with high symbolic value in public buildings built during the rational and neoclassical architecture periods. The Ex Casa del Fascio building follows that architectural rule. The monumental colonnade balcony in artificial stone imitating marble is one of the most relevant elements of this building (Fig. 1).

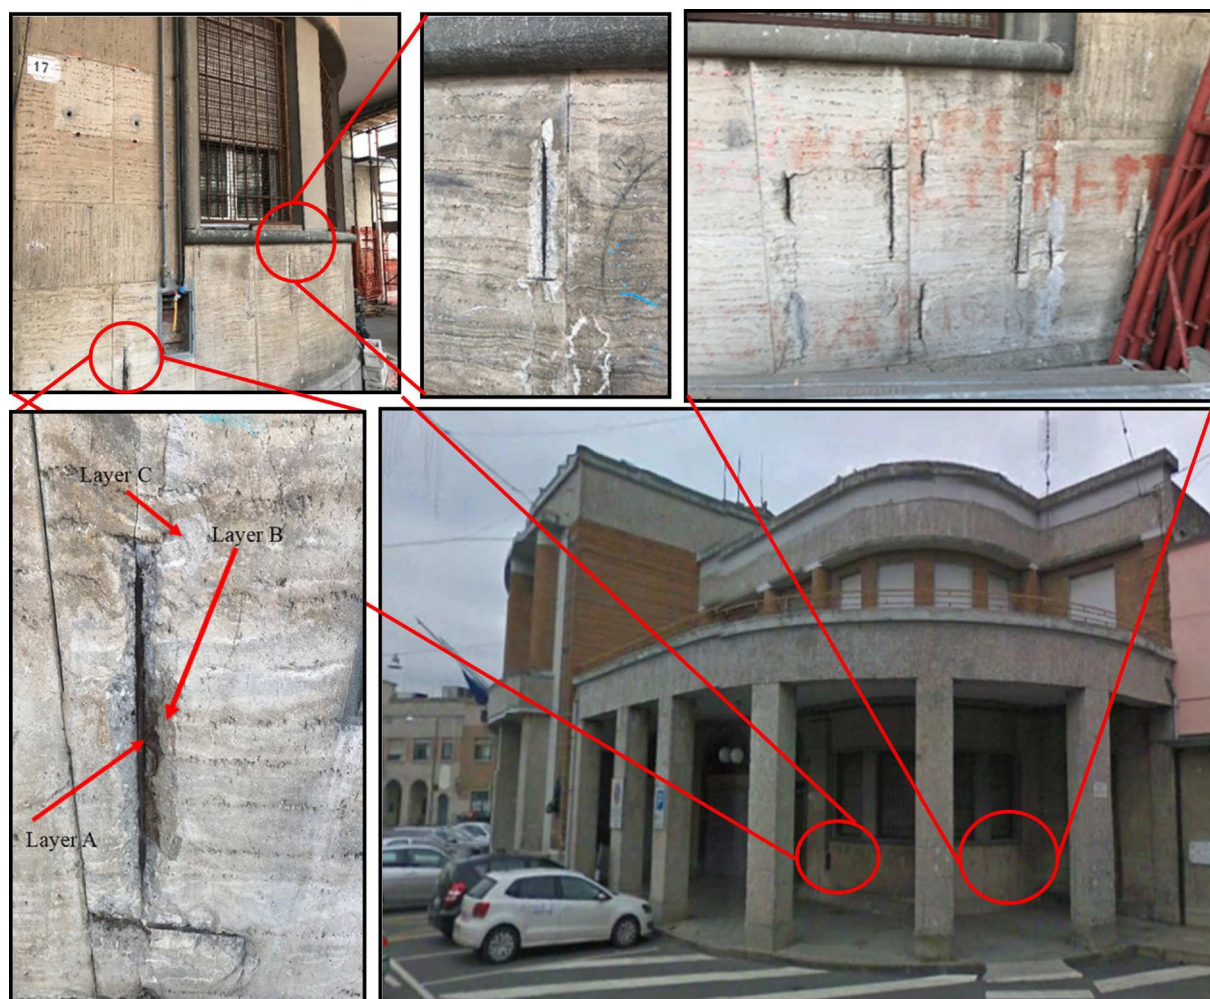
Figure 2. “Fake travertine” sample CO1. This artificial stone is present in the ground floor of the Ex Casa del Fascio building and is composed by 3 different layers: layer A (the inner), layer B (above layer A) and layer C the most superficial.

For “fake travertine” artificial stone, CO1, the sampling was mainly performed on the ground floor slabs in the areas near fractures where the reinforcement bars of the basement concrete produced expansion

phenomena due to weathering (Fig. 2).

Macroscopic observations of CO1 “fake travertine” artificial stone decoration revealed the presence of three layers.

i) Layer A represents the structural element of the decorative slabs and was composed of bar-reinforced well mixed concrete with homogeneous distribution of the aggregate. Thin section observations revealed that the aggregate fraction was mainly composed of a silico-carbonate fraction, with a higher prevalence of silicate than carbonate. The silicate fraction was mainly composed of fragments of polymineral rocks, such as gneiss, arenaceous-pelitic metamorphosed rocks, and a small amount of ultramafic rock fragments. Quartz, feldspars, a low percentage of micas (muscovite and biotite), and some serpentine crystals were the identified silica mineral phases. Few carbonate rock aggregates were also present (Fig. 6).

ii) Layer B represents the decorative layer, which was obtained by mixing a white cement type with white/pale yellow limestone rock. This decorative layer overlapped the reinforced concrete of layer A. Micrite grains and a low percentage of yellow limestone fragments was detected. OTLM observations indicated that this layer was composed primarily of a carbonate aggregate within a plaster mortar with the typical optical features of a hydraulic binder. The binder aggregate modal ratio was estimated to be approximately 1/3 with a non-homogeneous distribution of aggregate. The aggregate was mainly composed of various lithotypes of carbonate rocks, such as light white limestone, low-round foraminifera rocks, well-rounded beige micritic pebbles, and rare spathic calcite fragments. Reddish areas were present in the mixture, owing to the presence of iron oxides and hydroxides related to steel bar reinforcement alteration phenomena (Fig. 6).

iii) Layer C represents the protection strata subjected to yellowing in the altered areas. Stereomicroscopic observations of the surface revealed strong biological degradation with the presence of nests of insects and fungal hyphae, together with a black crust (Fig. 6) (Randazzo et al., 2015; Chen et al., 2017; Molina et al., 2017).

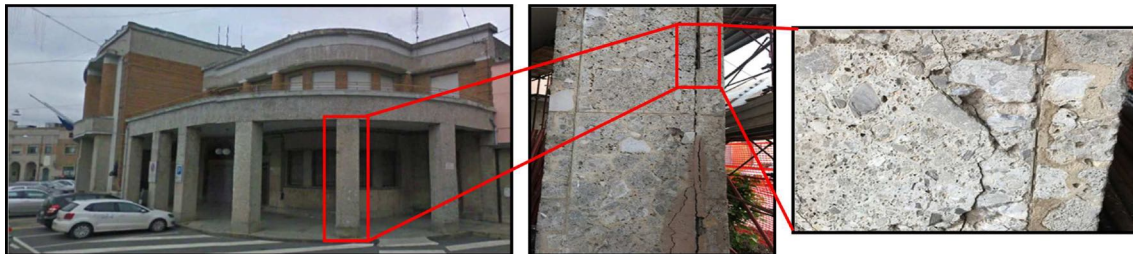
Figure 3. “Fake Ceppo di Grè” samples CO2, CO4, CO7. Big clasts of carbonate rocks (limestone and dolomite in prevalence). Damaged areas are in correspondence of emerging oxidized reinforcement bars.

Samples of “fake Ceppo di Grè” artificial stone, CO2, CO4, and CO7, were collected from the inner parts of the pillars (Fig. 3).

Macroscopic observations of “fake Ceppo di Grè” artificial stones investigated in this work (samples CO2, CO4, and CO7) showed irregular and angular fragments with a prevalence of micritic and microsparitic carbonate rocks. In “fake Ceppo di Grè,” as described for “fake travertine” slabs, regions near the damaged areas showed oxidation affecting the reinforcement bars. Because of the sizes of limestone and dolomite clasts (from 3–5 cm to 100 cm), analysis of these samples focused on the binder. Stereomicroscopic and petrographic microscopic observations of mortars showed the yellowish-gray background of the matrix, with aggregate constituted by sandy fractions. In addition to natural aggregate, some asbestos phases such as fillers (less than 1%) were observed. Thin sections showed a medium aggregate/binding ratio in mortars binding well with mixing. The binder porosity was mainly macroscopic, with low microporosity. Extensive degradation phenomena and carbonation processes corresponded to the weathering of exposed areas. The cement matrix natural aggregate was composed mostly of carbonate aggregates, with a presence of vitrophiric slag and asbestos minerals used as reinforcement fillers. Oxides and hydroxides with black (ilmenite-magnetite) and red blood color were rare (Fig. 7).

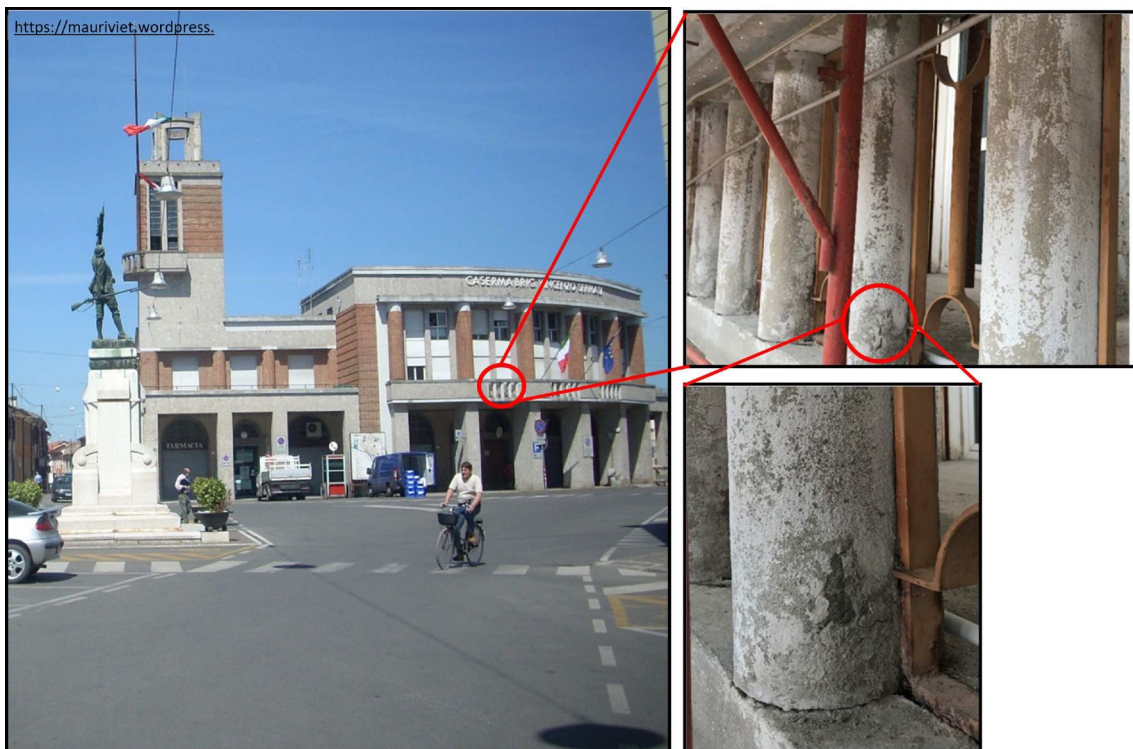
Figure 4. Fake limestone sample CO6. The first-floor colonnade. The white strata visible in the pictures is not coeval with the columns building, it has been applied on at the end of the twentieth centuries during restoration operations.

The artificial stone materials used for building the monumental colonnade balcony has been covered by successive layers of a mixture of gray cement and lime; for this reason the materials below this strata were sampled as CO6 (Fig. 4).

The observation of samples collected from the columns (CO6) showed a tenacious mortar consisting of a white cement with an amorphous structure and a well-classed medium silica sand aggregate enriched in serpentinite. The aggregate was characterized by the prevalence of serpentinite (around 70%) with a minor percentage of micritic limestones, quartz, iron hydroxides, pale yellow vitrophiric slag, and green glass fragments. Degradation phenomena were absent. The aggregate/

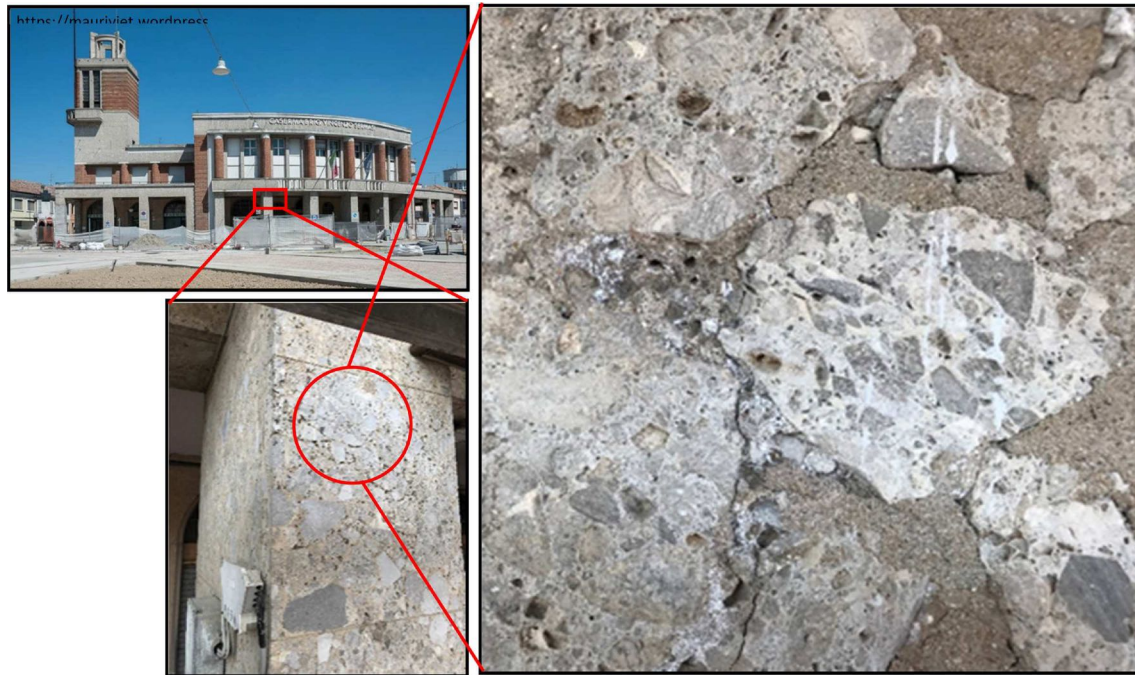
Figure 5. Concrete infilling mortar sample CO3. The Ex casa del Fascio building has been affected by damages caused by the earthquakes in May 2012, but before these events it was been subjected to restore operations not always made following the correct procedures for historical building.

Sample CO3 came from the replacement materials used to infill cracks, which was easily recognizable because of the dark gray color, relief with respect to the surfaces of the slabs, and thin appearance (Fig. 5).

Despite the high quality of these artificial stone materials, in “fake travertine” and “fake Ceppo di Grè” types, macroscopic observations revealed the decay process of the reinforced concrete base structures

with cracking fragility. The infill materials used for restoration with fibrous minerals were present in restricted and localized areas, with a maximum extension of 10 cm in diameter and thicknesses less than 4 cm. Stereomicroscopic observations of sample CO3, infilling mortar, allowed us to identify fibrous phases that favored macroporosity, which was presumably related to colonization with lithophagous fauna responsible for biodegradation decay. For these samples, thin sections were not made, to avoid the risk of fiber dispersion during the lapping and pol-

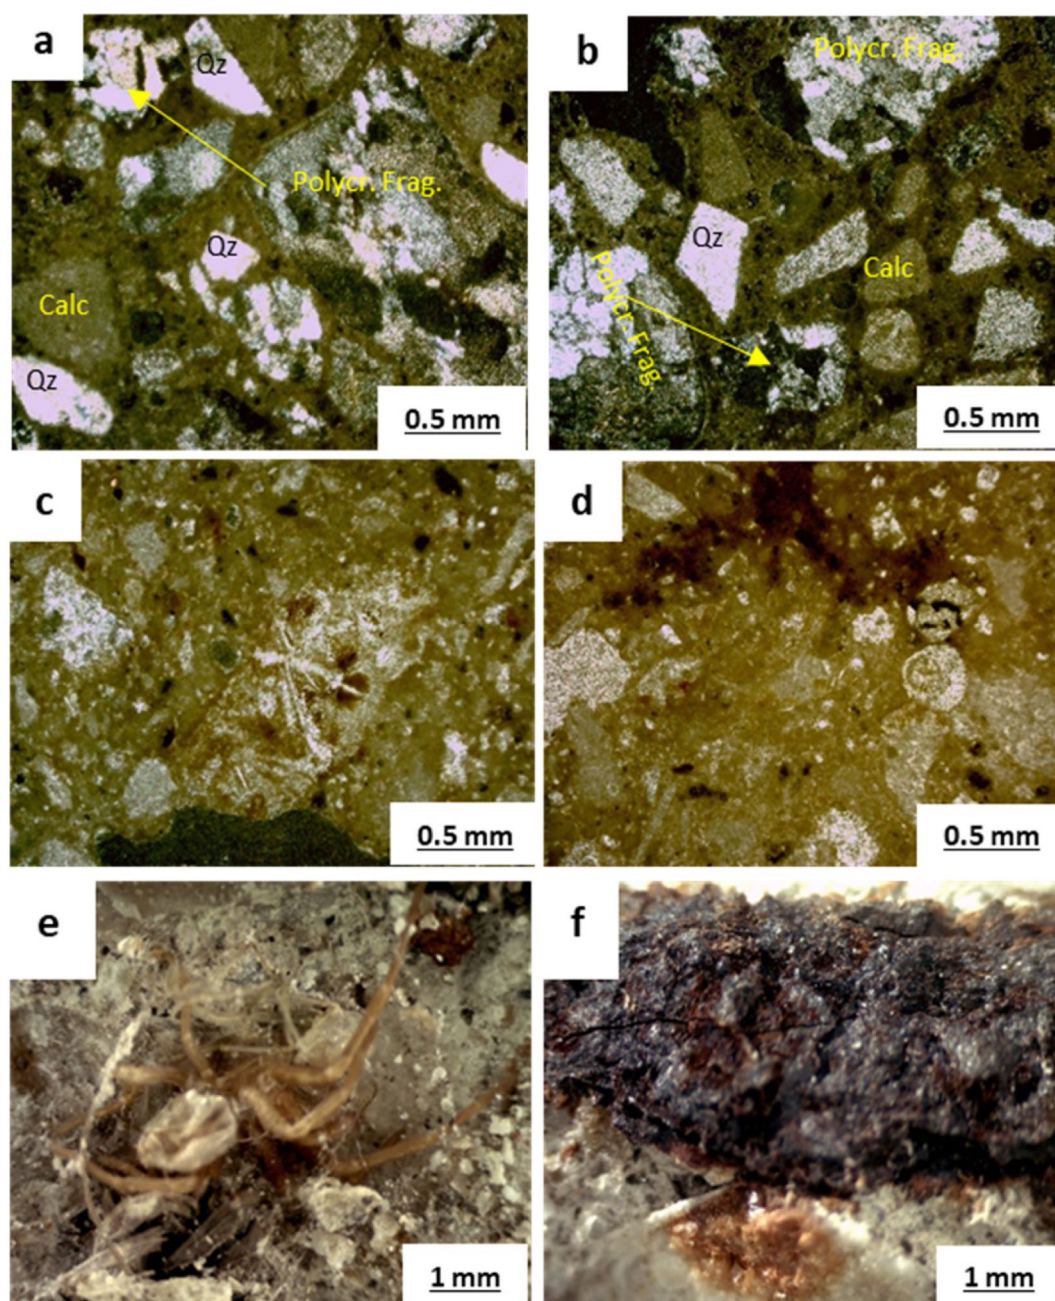
Figure 6. “Fake travertine” Sample CO1. Thin section micrographs. Layer A, examples of concrete mix with silico-carbonate aggregate a) sharp edge quartz and silicate rocks fragments; b) sharp edge quartz, silicate rocks fragment and carbonate fragments. Layer B, aggregate mainly composed by various lithotypes of carbonate rocks, such as c) light white limestone, low-round foraminifera rocks, d) well-rounded beige micritic pebbles and rare spathic calcite fragments. Reddish color should be due to presence of iron oxides and hydroxides, often deposited inside the binder in contact with the macro and micropores. Layer C stereomicroscope pictures of the outer layer e) spider; f) particular of a black crust.

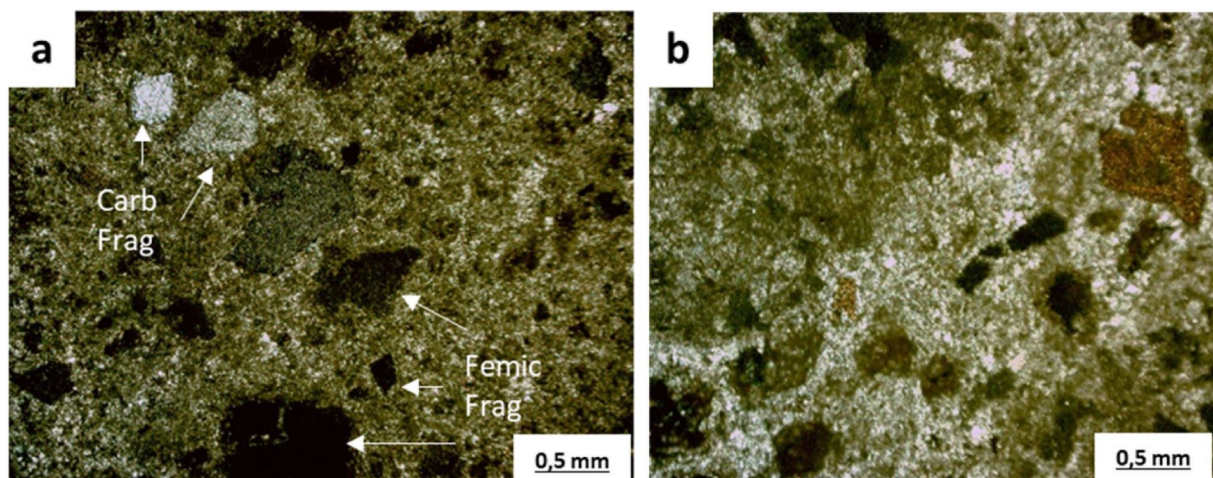
Figure 7. “Fake Ceppo di Grè” samples CO2, C74, CO7. Thin section observations: a) carbonate fragments and feldspar fragments in a greenish matrix. b) carbonation phenomena and greenish areas. Greenish color is probably due to alteration process of aggregates in the matrix.

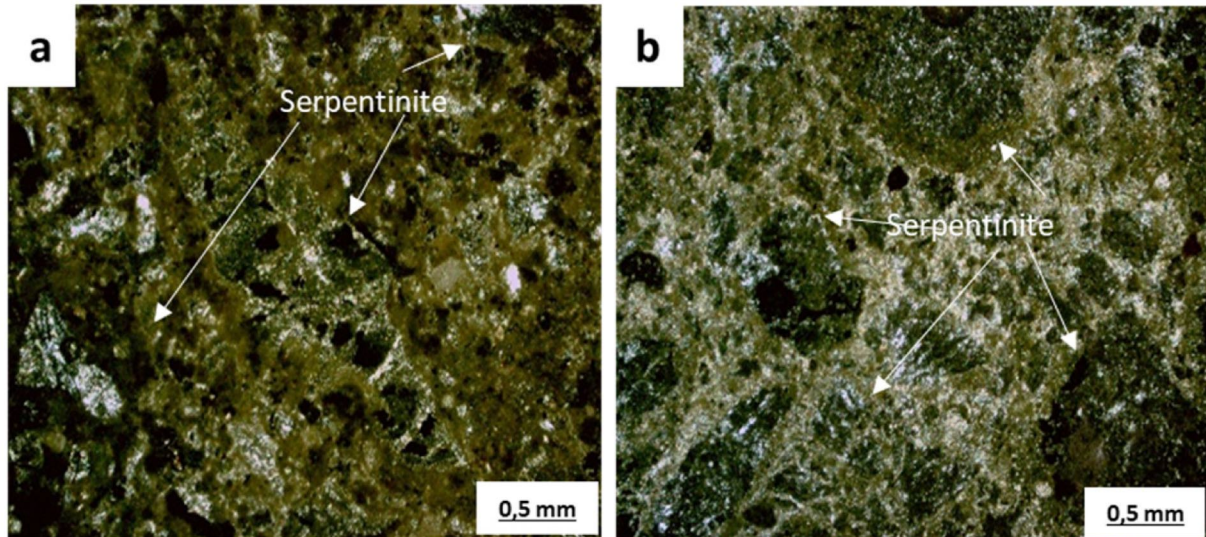
Figure 8. Fake limestone sample CO6. This section observations reveal a great Yang et al. (2019) quantity of serpentine mineral phases in the mixture.

binder modal ratio was approximately 1/3, and the mix appeared highly homogeneous (Fig. 8).

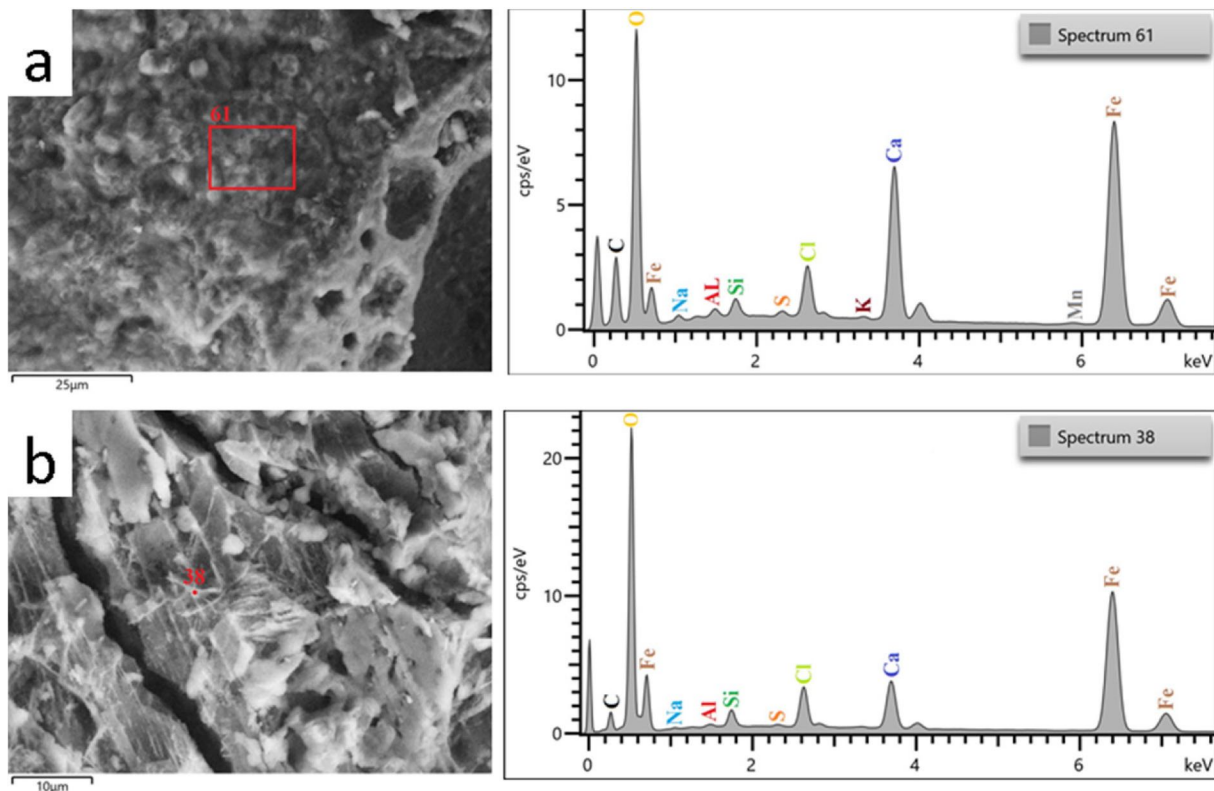
Figure 9. “Fake travertine” Layer A. a) Secondary micrograph of the matrix in the concrete substrata showing the iron oxychloride complexes around and inside a vacuolar structure with corresponding the SEM-Energy Dispersion Spectroscopy (EDS) spectra. b) Secondary micrograph showing layered two-dimensional iron oxychloride (FeOCl) husk like structured.

Layer A: the corrosion products of reinforcement steel bar were typical layered structures with red and brownish-red color (Fig. 9). This finding was consistent with the iron mobilization from reinforcement steel bars, presumably as a result of capillary action of water, that characterizes the lithological substratum where this edifice was built. These globular clusters were observed in pores of “fake travertine”

as well as in the corrosion products of steel reinforcement.

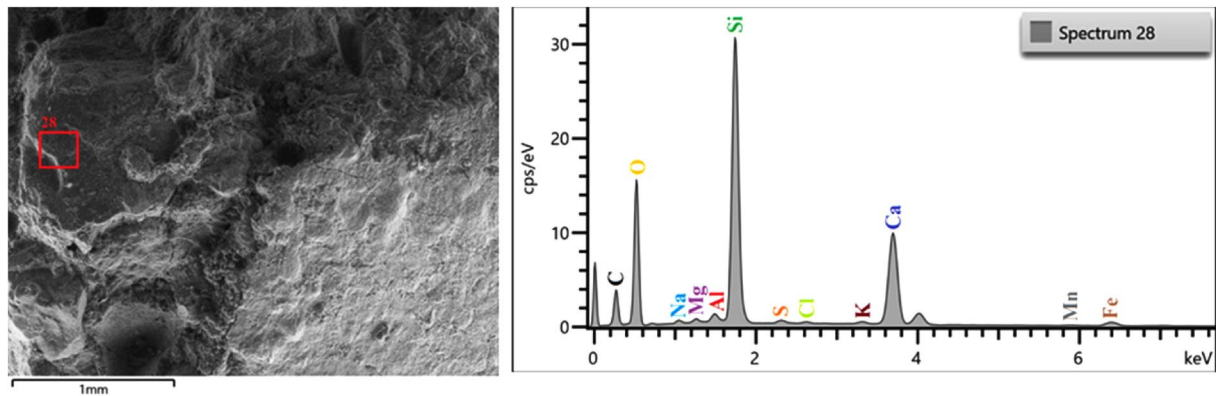
Figure 10. “Fake travertine” Layer B. Secondary micrograph showing the composition of amorphous white matrix and the corresponding the SEM-Energy Dispersion Spectroscopy (EDS) spectra.

Layer B: the components of the mix design were white cement paste, carbonate aggregate rocks, and yellow pigments, such as iron hydroxides (Fig. 10).

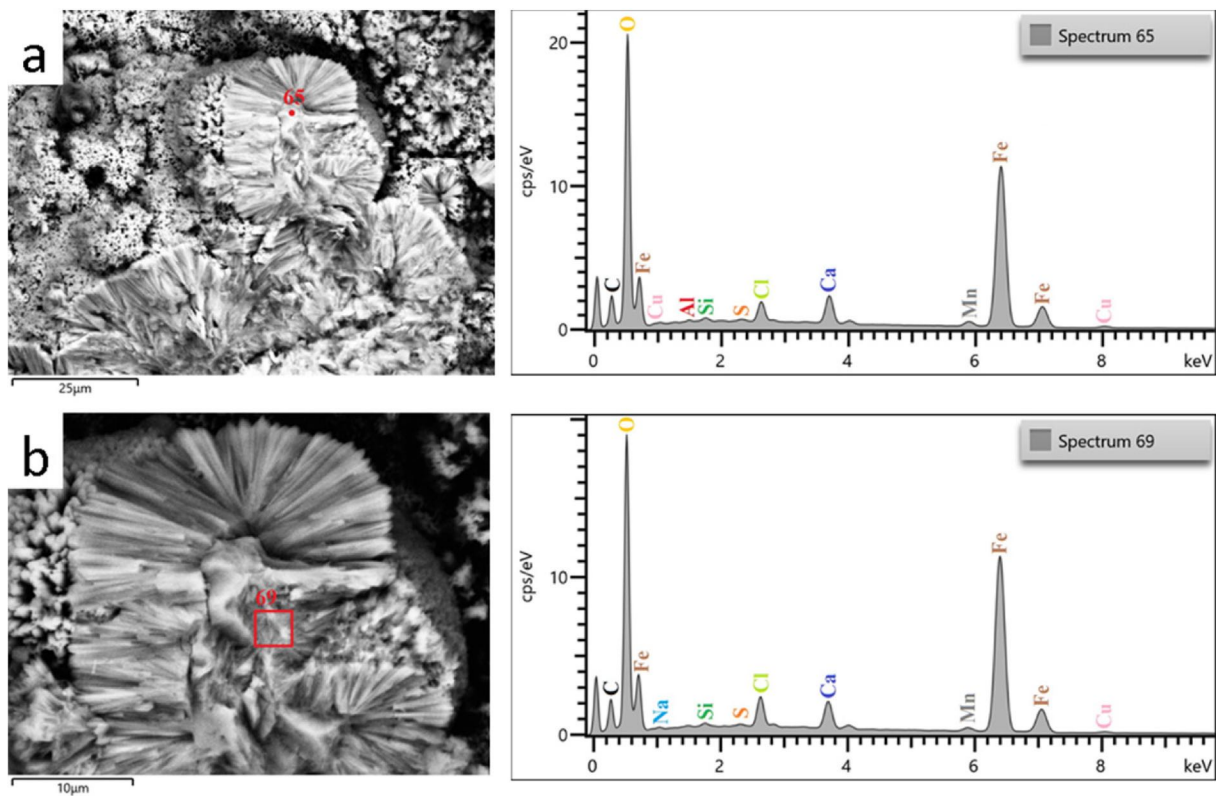
Figure 11. “Fake travertine” Layer B. a) and b) BSE micrographs showing the iron oxychloride complexes with the self-oriented flower shape with average diameter of 10–12 μm and the corresponding the SEM-Energy Dispersion Spectroscopy (EDS) spectra.

In the samples subjected to SEM observation, EDX analysis revealed iron hydration products with a self-oriented flower shape with an average diameter of 10–12 μm (Fig. 11).

SEM-EDS analyses of “fake travertine” samples indicated the presence of iron oxychloride complexes with self-oriented flower shaped markings (Fig. 13). Thus, we hypothesized that iron oxide fibers were present, as reported by Sayed and Polshettiwar (2015), in agreement with iron mobilization from reinforcement steel bars. Oxygen fugacity and pH may influence the corrosion of iron materials, and chloride might be adsorbed or might penetrate easily through the passive film,

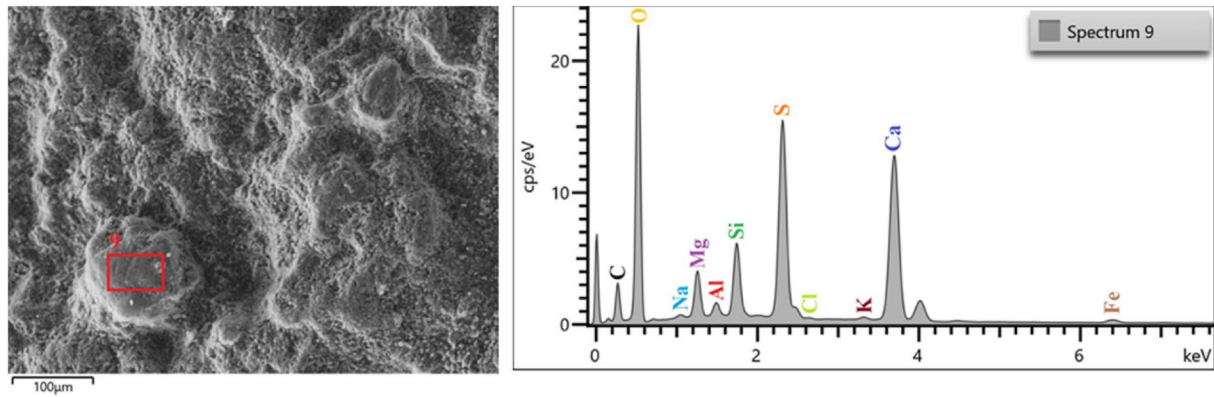
Figure 12. “Fake Ceppo di Grè”. Secondary micrograph showing calcium sulphate as indicated by SEM-Energy Dispersion Spectroscopy (EDS) spectra indicating a high-amount of sulphate for this portion of sample.

Two types of sulfates was recognized: calcium sulfate (Fig. 12) and barium sulfate (Fig. 13). The EDS spectra of these particles demonstrated a high-amount of sulfate in these black points.

SEM-EDS analyses of “fake Ceppo di Grè” highlighted unusual peaks of Ba, thus suggesting that Ba hydroxide was added to the mixture to make the concrete harder and therefore resistant to physical and mechanical stress and degradation. The same procedure might have been used for cement, in which barium may be added to help bind and enhance resistance to different types of radiation (Zezulová et al., 2016). Barium cations are a part of the raw mixture and thus can be incorporated into the crystal lattices of alite and belite, and the interstitial phase. Some authors have found neither barium nor ferrite in belite (Juel and Jøns, 2001); only tricalcium aluminate can contain barium in its structure (Katyal et al., 1999). These findings are in accordance with the high SiO₂/calcium in the Ba-rich matrix (spectrum 70–72). Zezulová et al. (2016) have observed that an excessive BaO concentration can inhibit the crystallization of alite or decompose alite in favor of belite and free lime. The free lime then produces an excess of portlandite, which, in the presence of sulfur in the mixture, justifies the high content of calcium sulfate observed with SEM analyses in this process.

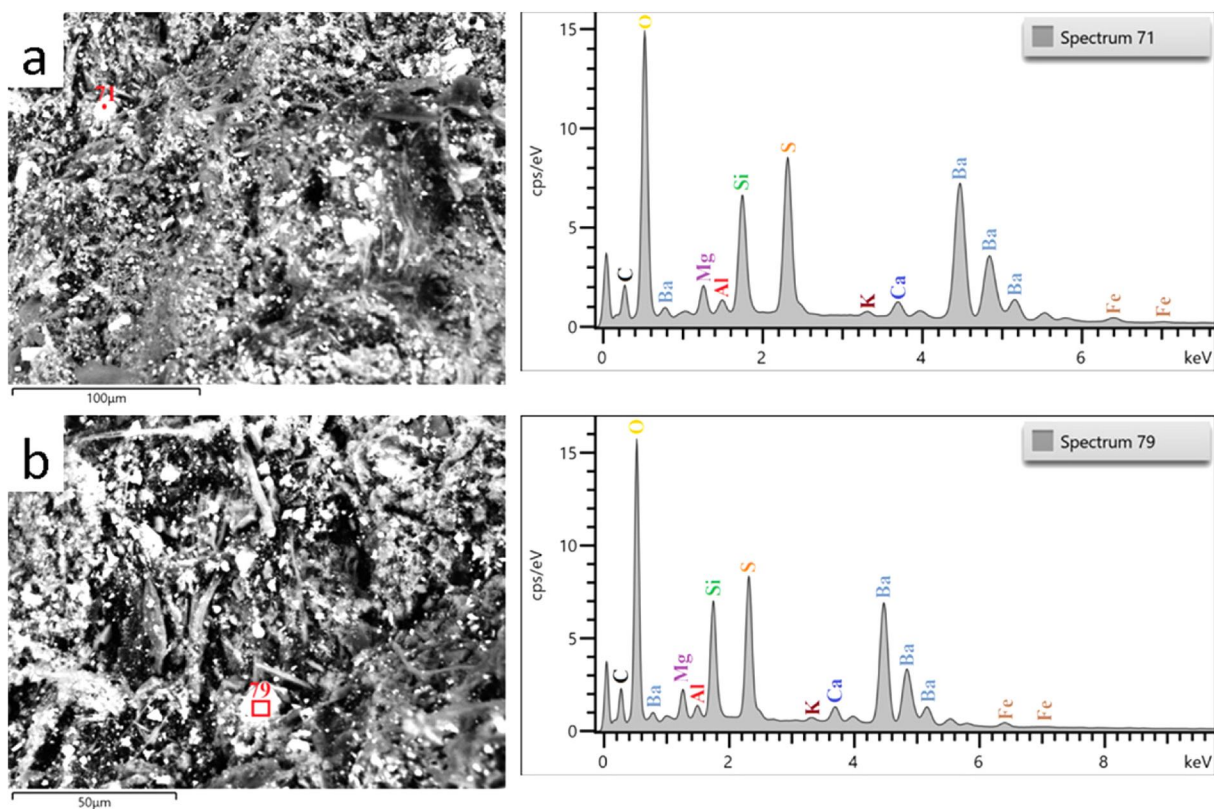
Figure 13. “Fake Ceppo di Grè”. A) and b) BSE micrographs showing presence of barium sulphate phases as confirmed by SEM-Energy Dispersion Spectroscopy (EDS) spectra. The barium hydroxide mixture has been added to make the concrete harder and therefore resistant to physical and mechanical stress and degradation.

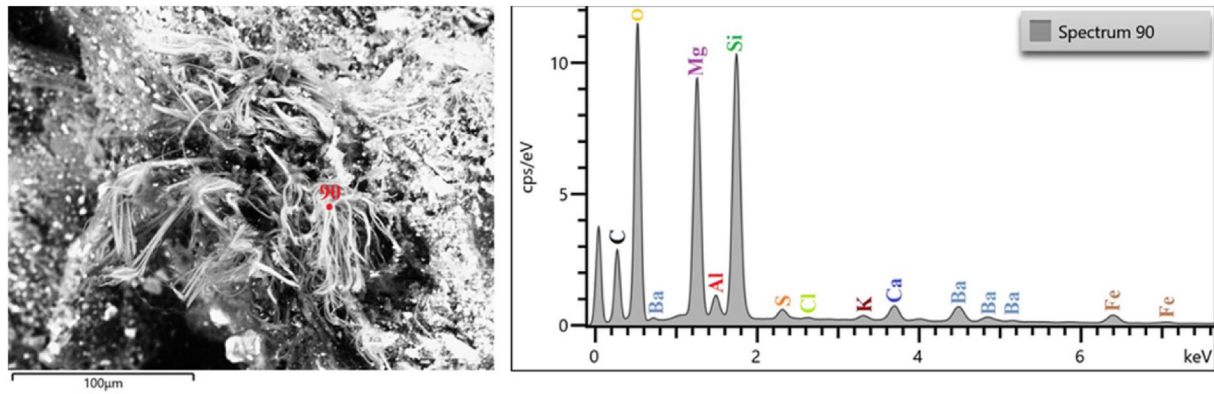
Figure 14. Concrete infilling mortar. BSE micrograph showing fibrous minerals presumably of asbestos phases, SEM-Energy Dispersion Spectroscopy (EDS) spectra revealed high peaks in Mg and Si, with minor peaks of Ti and Al coherent with phases belonging to serpentine group.

Because stereomicroscopic observation revealed the presence of fibrous phases, SEM-EDS analysis was performed to better identify the chemical. Fig. 14 shows back scattered images highlighting the presence of various fiber types and confirming the microscopic observations. In these samples, asbestos tailings mainly contained serpentine, including snakesite, antigorite and chrysotile, as well as small amounts of brucite, magnetite, quartz, talc, and chlorite. The main chemical composition of the asbestos tailings was SiO_2 , MgO , and Fe_2O_3 , with a small amount of Al_2O_3 and CaO .

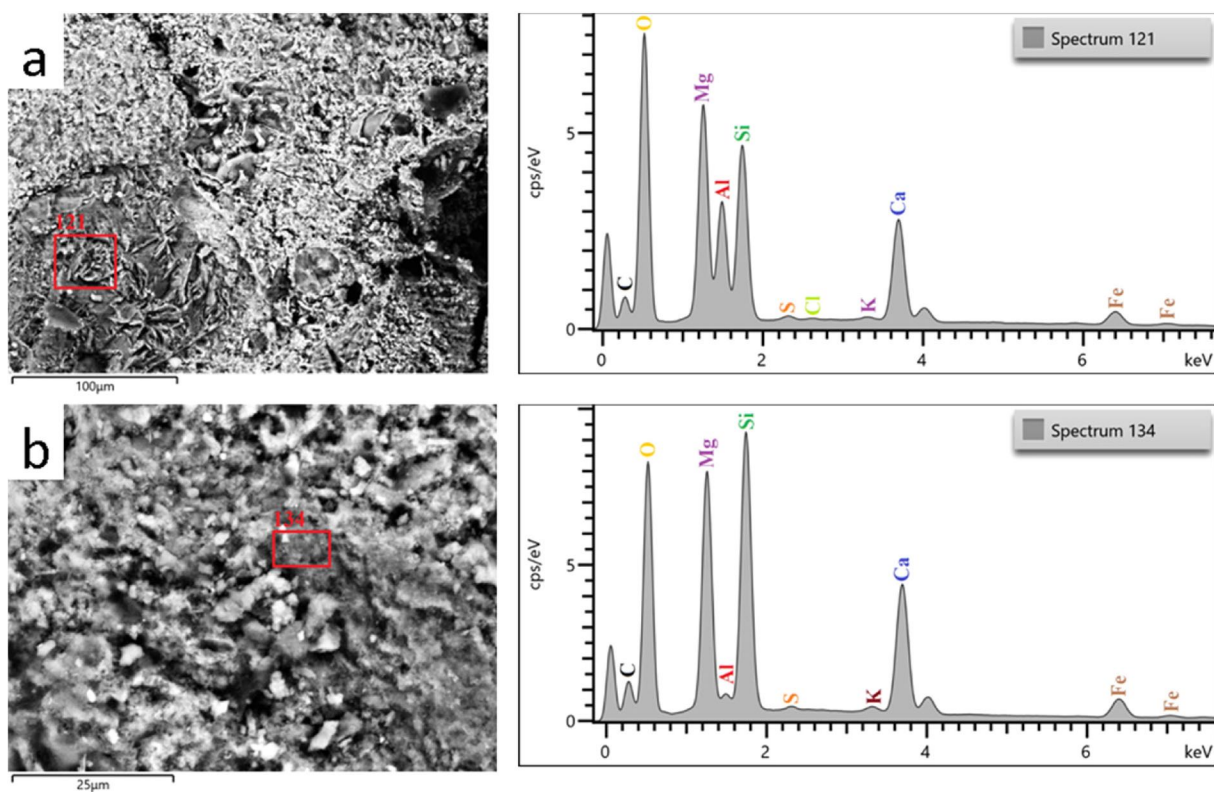
Figure 15. Fake limestone used for columns. A) and b) Secondary micrographs showing minerals presumably of asbestos phases, SEM-Energy Dispersion Spectroscopy (EDS) spectra revealed high peaks in Mg, Si and Ca, this in accordance with composition of same amphibole belonging to tremolite-actinolite group.

Thin section observations showed a white cement mortar with amorphous structure and a well-classed medium silica sand aggregate enriched in serpentinite. SEM analyses revealed a composition compatible with the presence of tremolite-actinolite amphibole group phases (Fig. 15). SEM analyses also confirmed the use of pale green and white leaded glass (Fig. 16).

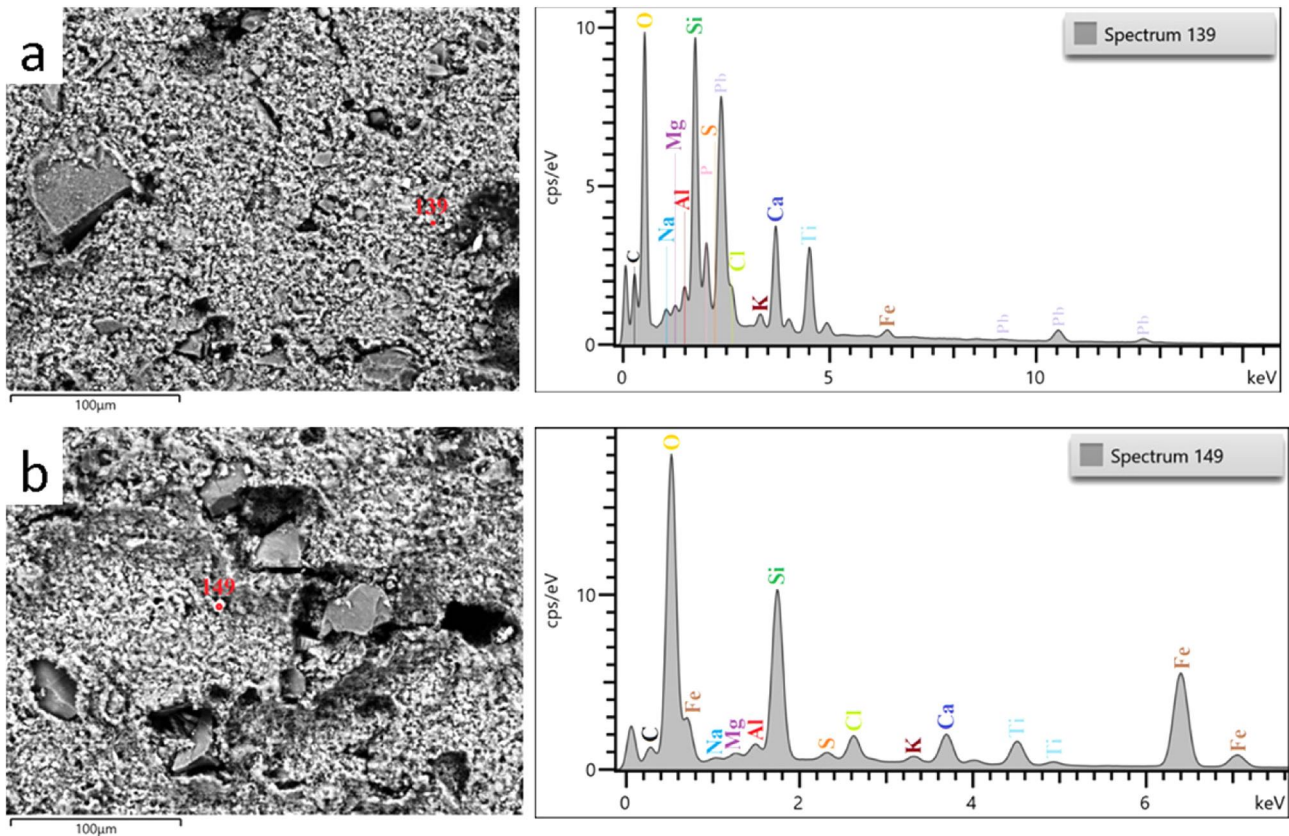
Figure 16. Fake limestone used for columns. A) and b) Secondary micrographs showing presence of glass microparticles in some cases enriched in lead.

The use of pale green and white leaded glass, as confirmed by SEM analyses, is consistent with the addition of glass fragments to mortar mixtures for aesthetic purposes and with increasing the mortar's resistance to sunlight.

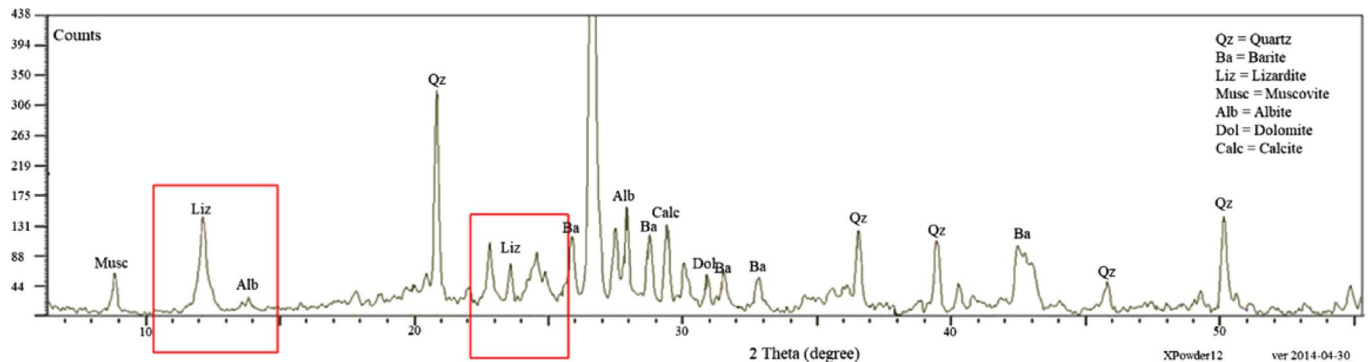
Figure 17. X Ray diffraction pattern. In the red squares are highlighted the peaks of lizardite, confirming the presence of these serpentinite mineral phases in a sample of concrete used for restoring operation.

XRD patterns of sample CO3 (Fig. 17) revealed peaks of lizardite

($\text{Mg}_3\text{Si}_2\text{O}_5(\text{OH})_4$) (2θ at 12° and 24°), a polymorph of the serpentine group minerals.

The XRD pattern of a representative sample confirmed the presence of lizardite, one of the three polymorphs of serpentine (Auzende
