# GUIDE TO IDENTIFYING AND HANDLING LOW DENSITY ASBESTOS FIBRE BOARD

This Guide provides information about identifying, managing and handling low density asbestos fibre board (LDB) in workplaces.

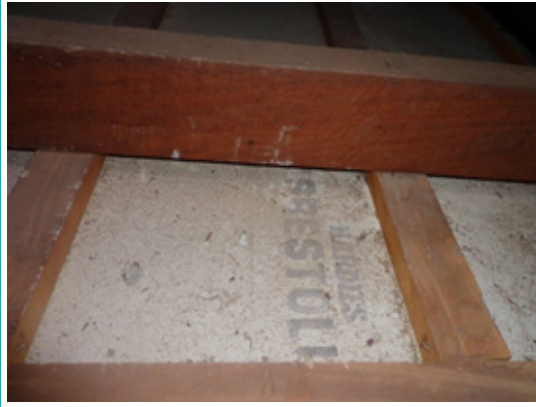
**Figure 1** Rear side of LDB ceiling sheet showing trade name

**Label:** LDB can be identified by looking at the rear side of the sheeting for the trade name Asbestolux or Duralux, as shown in Figure 1. The absence of a label does not mean the material is asbestos free.

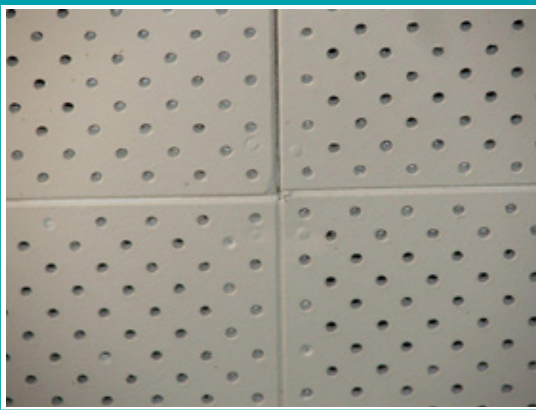
**Figure 2** Front side of perforated LDB

**Ceiling sheets/tiles:** LDB was often used as ceiling tiles/sheets and for acoustic purposes. LDB ceiling tiles were commonly perforated. Different patterns of perforated ceiling tiles were used with the difference being the number of holes per sheet as shown in Figure 2.

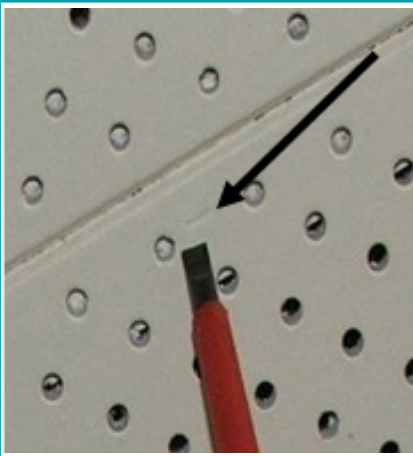
**Figure 3** Hand pressure from a screwdriver will dent the surface

**Hardness:** LDB is softer than asbestos cement sheeting because calcium silicate plaster was used to bond the asbestos fibres instead of cement. When tapped, for example with a car key, LDB will produce a dead or dull sound, indicating a soft or low density product. Using hand pressure, the head of a screwdriver will easily dent the surface as shown in Figure 3.

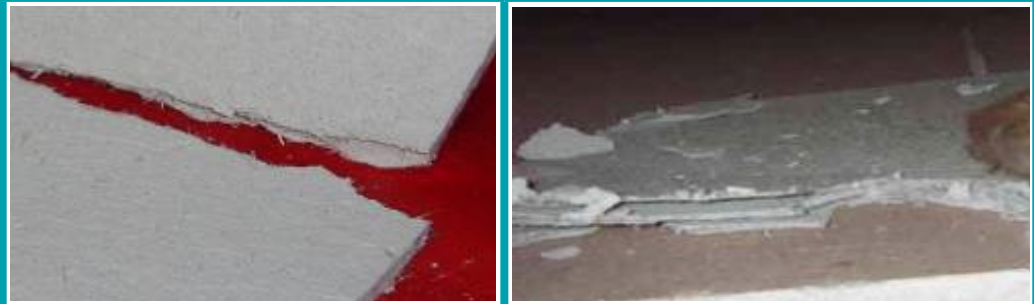
**Figure 4** Ragged or torn edges of broken LDB

When broken the edges of LDB appear ragged or torn with no sharp edges as shown in Figure 4. You can see a high percentage of asbestos fibres—the entire surface of the broken sheeting looks furry or fibrous.

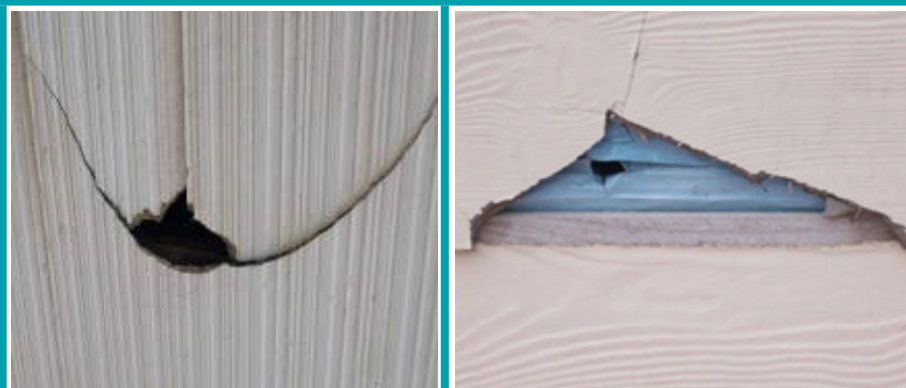
**Figure 5** Examples of sharply broken edges on asbestos cement sheeting

Asbestos cement sheeting breaks more cleanly as shown in Figure 5.

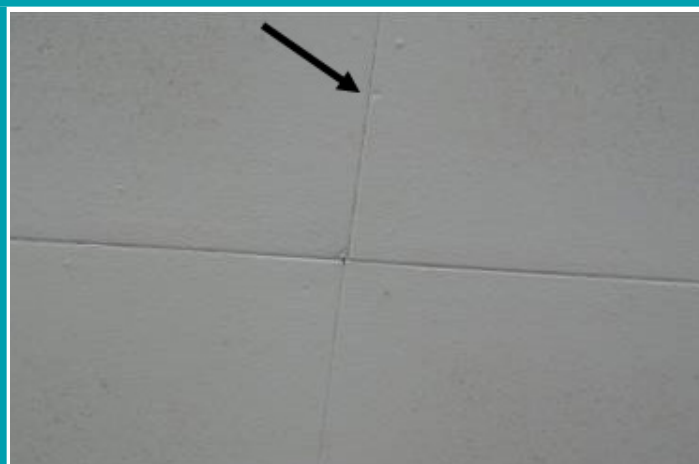
**Figure 6** Recessed fastener heads in LDB

**Finding fasteners:** The heads of fasteners, nails and clouts are often embedded or partially embedded or recessed into the surface of LDB sheeting due to the softness of the sheeting as seen in Figure 6.

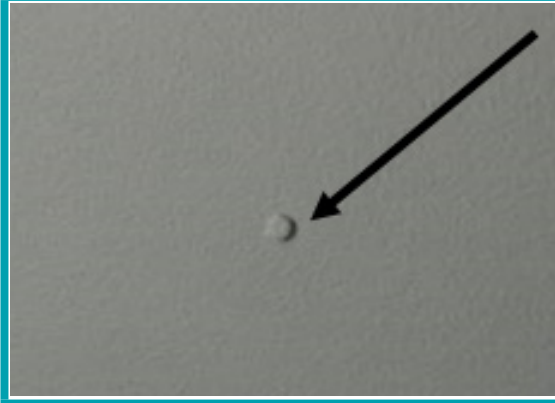
**Figure 7** Fastener in asbestos cement sheeting does not sit level with the surface

In contrast, the heads of the fasteners in asbestos cement sheeting do not sit level with the surface as seen in Figure 7.

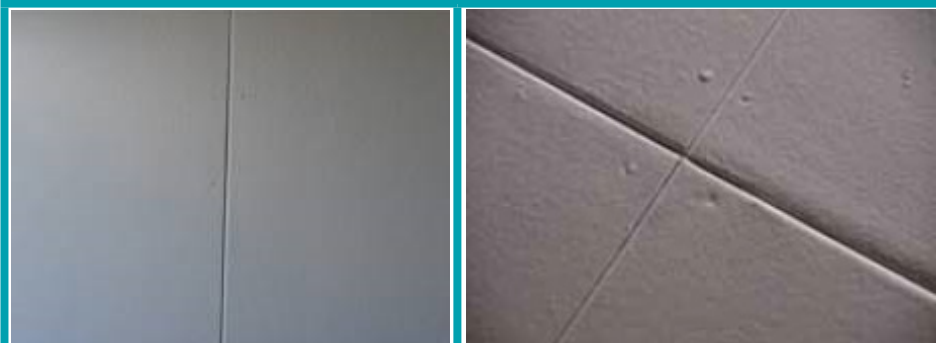
**Figure 8** Examples where fasteners are fixed into the LDB sheeting and the edges are bevelled or slanted

**Joins between sheets:** The edges of LDB products were often bevelled or slanted and hand planed so when fixed together with another sheet, a V-joint finish would be produced as shown in Figure 8.

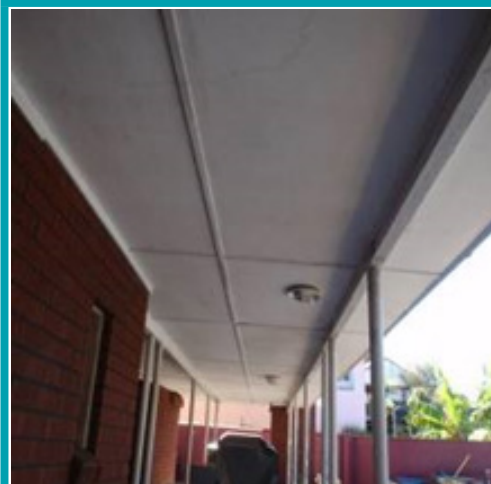
**Figure 9** Asbestos cement sheets joined with timber cover strips

Joins of asbestos cement sheeting are usually covered over with flat or moulded timber cover strips. The sheets are sometimes joined with timber cover strips as shown in Figure 9.
