GUIDE TO IDENTIFYING AND HANDLING LOW DENSITY ASBESTOS FIBRE BOARD

This Guide provides information about identifying, managing and handling low density asbestos fibre board (LDB) in workplaces.

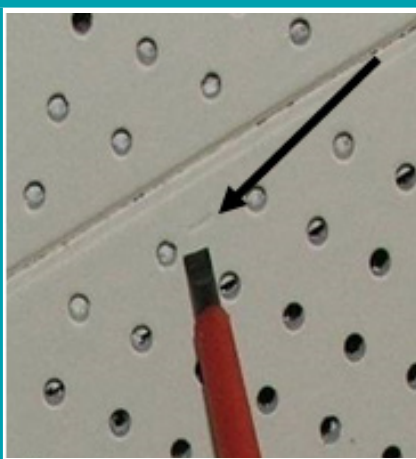
Figure 3 Hand pressure from a screwdriver will dent the surface

Hardness: LDB is softer than asbestos cement sheeting because calcium silicate plaster was used to bond the asbestos fibres instead of cement. When tapped, for example with a car key, LDB will produce a dead or dull sound, indicating a soft or low density product. Using hand pressure, the head of a screwdriver will easily dent the surface as shown in Figure 3.

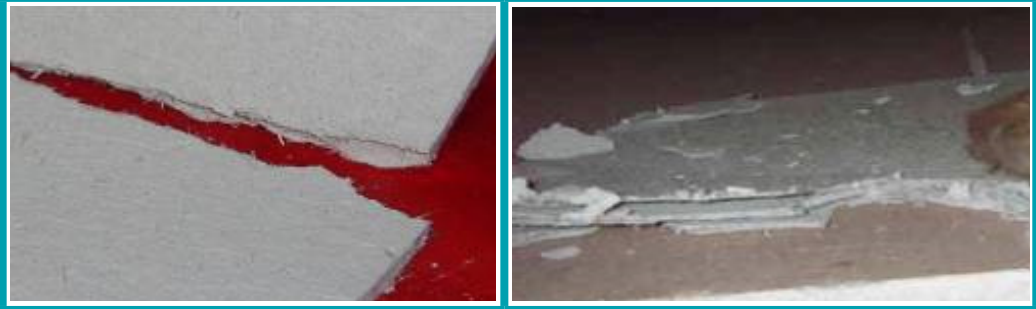
Figure 4 Ragged or torn edges of broken LDB

When broken the edges of LDB appear ragged or torn with no sharp edges as shown in Figure 4. You can see a high percentage of asbestos fibres—the entire surface of the broken sheeting looks furry or fibrous.

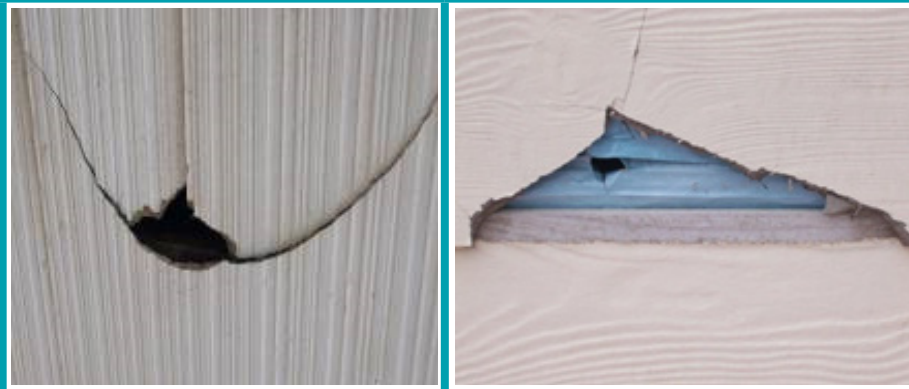
Figure 5 Examples of sharply broken edges on asbestos cement sheeting

Asbestos cement sheeting breaks more cleanly as shown in Figure 5.

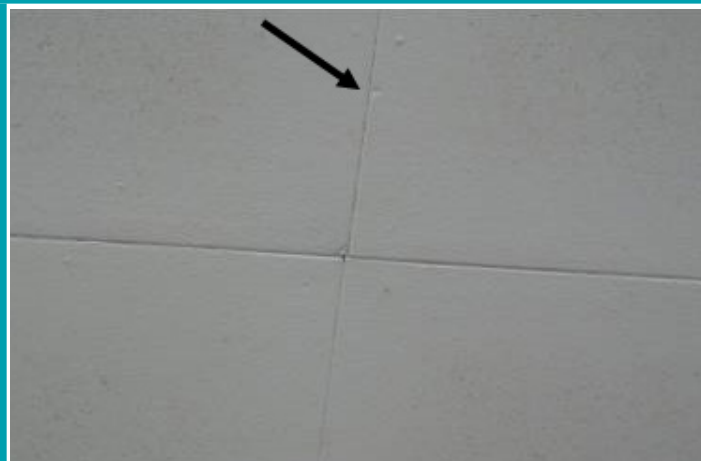
Figure 6 Recessed fastener heads in LDB

Finding fasteners: The heads of fasteners, nails and clouts are often embedded or partially embedded or recessed into the surface of LDB sheeting due to the softness of the sheeting as seen in Figure 6.

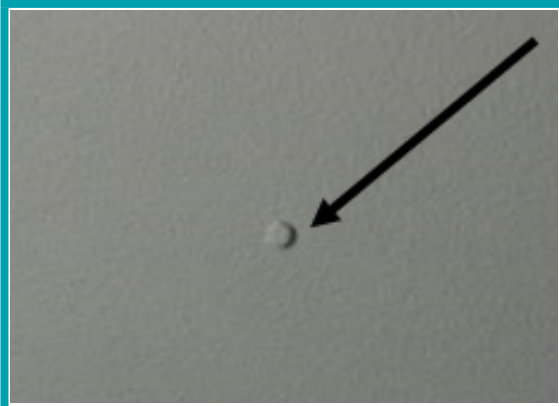
Figure 7 Fastener in asbestos cement sheeting does not sit level with the surface

In contrast, the heads of the fasteners in asbestos cement sheeting do not sit level with the surface as seen in Figure 7.

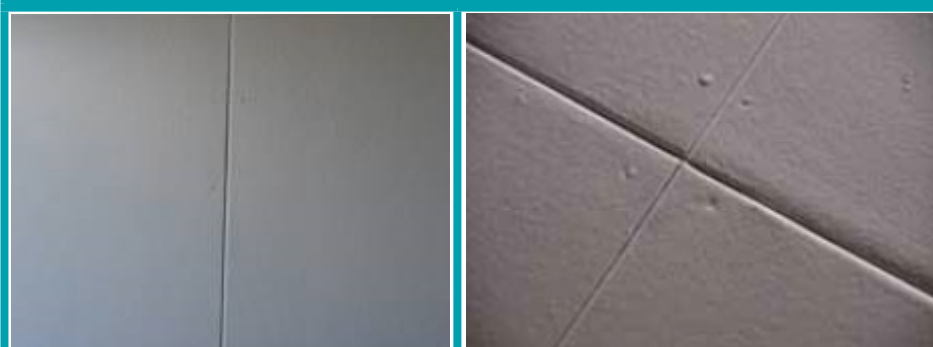
Figure 8 Examples where fasteners are fixed into the LDB sheeting and the edges are bevelled or slanted

Joins between sheets: The edges of LDB products were often bevelled or slanted and hand planed so when fixed together with another sheet, a V-joint finish would be produced as shown in Figure 8.

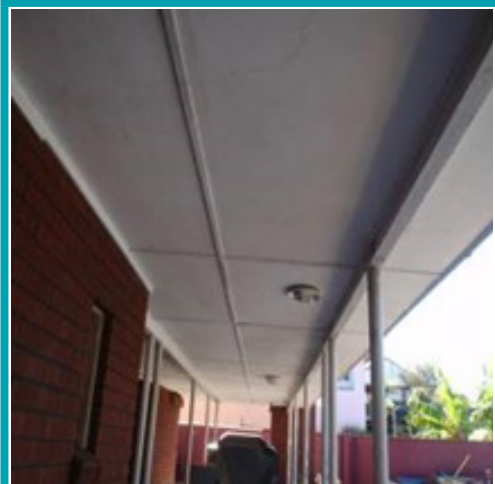
Figure 9 Asbestos cement sheets joined with timber cover strips

Joins of asbestos cement sheeting are usually covered over with flat or moulded timber cover strips. The sheets are sometimes joined with timber cover strips as shown in Figure 9.
