Working with asbestos

Where asbestos can be found

These A3 posters show where asbestos can be found in New Zealand industrial buildings and residential houses.

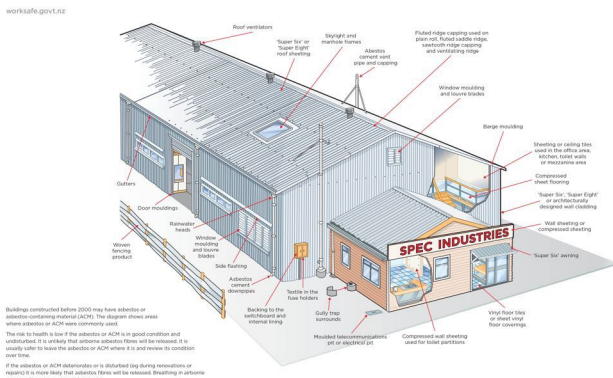
Industrial building

Buildings constructed or renovated before 2000 are likely to contain asbestos materials. The diagrams show areas where materials containing asbestos were commonly used during construction and renovation. These materials are not dangerous if they are in a good condition and remain undisturbed.

- Roof ventilators
- 'Super Six' or 'Super Eight' roof sheeting
- Skylight and manhole frames
- Asbestos cement vent pipe and capping
- Fluted ridge capping used on plain roll, fluted saddle ridge, sawtooth ridge capping and ventilating ridge

- Window moulding and louvre blades
- Barge moulding
- Sheeting or ceiling tiles used in the office area, kitchen, toilet walls or mezzanine area
- Compressed sheet flooring

- 'Super Six', 'Super Eight' or architecturally designed wall cladding
- Wall sheeting or compressed sheeting
- 'Super Six' awning
- Vinyl floor tiles or sheet vinyl floor coverings

- Compressed wall sheeting used for toilet partitions
- Moulded telecommunications pit or electrical pit
- Gully trap surrounds
- Textile in the fuse holders

- Backing to the switchboard and internal lining
- Asbestos cement downpipes
- Side flashing
- Window moulding and louvre blades
- Rainwater heads
- Door mouldings

- Gutters
- Woven fencing product

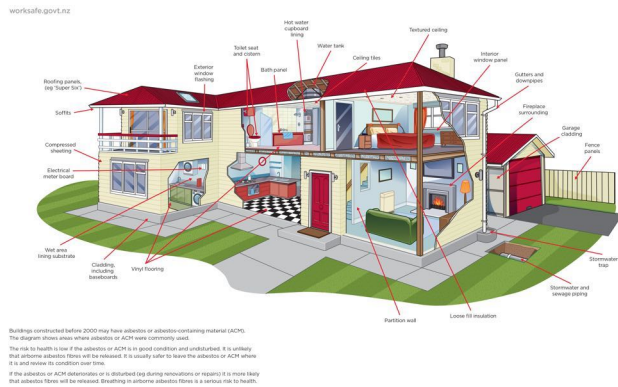
Residential house

- Vinyl flooring
- Cladding, including baseboards
- Wet area lining substrate
- Electrical meter board
- Compressed sheeting
- Soffits
- Roofing panels, eg 'Super Six'
- Exterior window flashing
- Toilet seat and cistern
- Bath panel
- Hotwater cupboard lining
- Water tank
- Ceiling tiles
- Textured ceiling
- Interior window panel
- Gutters and downpipes
- Fireplace surrounding
- Garage cladding
- Fence panels
- Stormwater trap
- Stormwater and sewage piping
- Loose fill insulation
- Partition wall
