BUILDING RESEARCH NOTE

HOUSE DEMOLITION REVEALS EARLY USE OF INSULATED SHEATHING

Division of Building Research, National Research Council of Canada

Ottawa, May 1984

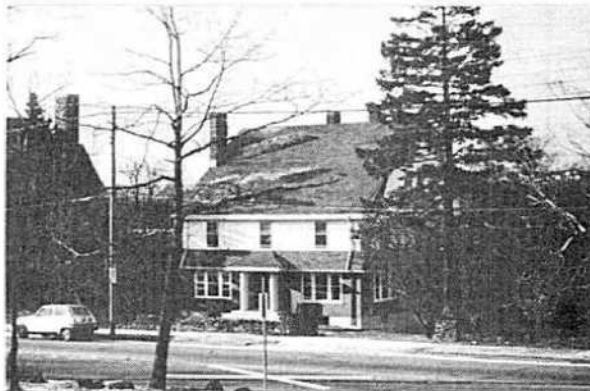
Figure 1. View of W.J. MacInnes house from east

The building was originally constructed in 1923 as a single family house for W.J. MacInnes (Fig. 1). It was later sold to Dalhousie University and served as a residence for women until it was demolished in 1983. The three-storey platform frame structure contained approximately 463 m² (5000 ft.²) of heated space over a concrete foundation that was about 12 x 13 m (40 x 44 ft.) (Fig. 2).

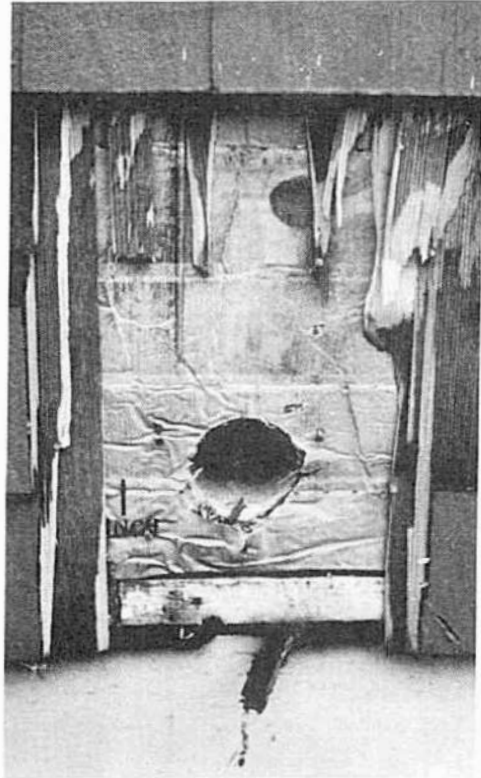
The wall-foundation junction was also carefully sealed. From the inside, bricks were layed between the top of the foundation and the subfloor and parged (Fig. 6). This remained in remarkably good condition over the 60-year life of the building and could possibly be attributed to the dry condition of the floor joists at the time of installation. Outside, the header joist was covered with a layer of Cabot's Quilt and sealed to the foundation with a material similar to plastic cement (Fig. 7).

Figure 7. Wall foundation connection

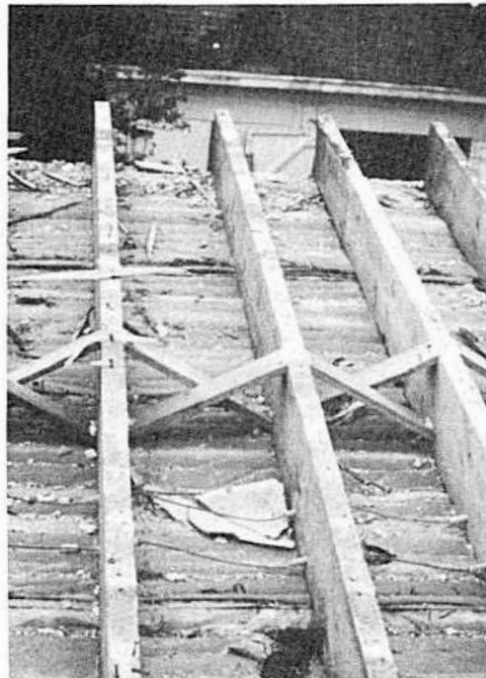
Double ply Cabot's Quilt was also applied perpendicular to the second and third floor joists. This material was carefully lapped 25 mm (1 in.) under the strapping and formed a continuous barrier at the floor line except where it was interrupted for services and at two main load bearing partitions (Figs. 9 and 10).

Figure 9. Double ply Cabot's Quilt between floors

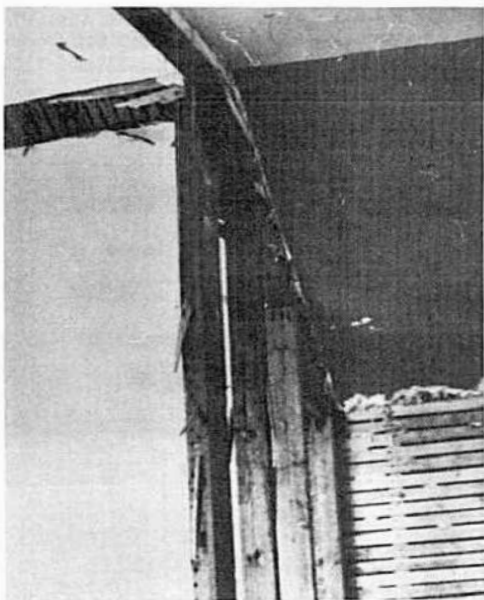
Figure 12. Continuous top plates

Interior partitions on the third floor had continuous top plates limiting the amount of air exfiltration into the attic (Fig. 12). Electrical outlets were located mainly on interior walls. Since the interior finish was lath and plaster, air leakage around any exterior electrical boxes and plumbing supply or drain pipes was minimized (Fig. 13). The three fireplaces had been closed off with masonry and parged over.
