Relationship between Density and Anatomical Structure of Different Species of *Eucalyptus* and Identification of Preservatives

The species and density of *Eucalyptus* wood poles installed in the electrical network are useful parameters which must be considered when it is necessary to establish the service life of these structures. In this work, eucalyptus poles samples were collected and analyzed by scanning electron microscopy and energy dispersive spectroscopy (SEM/EDS). SEM image analysis showed that the lumen diameter average of fiber substantially is variable between the three species studied, in line with the wood density obtained in laboratory, for poles with several years in service in the electricity network, as well as for not used poles. In addition, EDS microanalysis was utilized for identify the presence of chemical preservatives employed in the conservation these poles. The analysis method proposed proved effective for characterization for this timber.

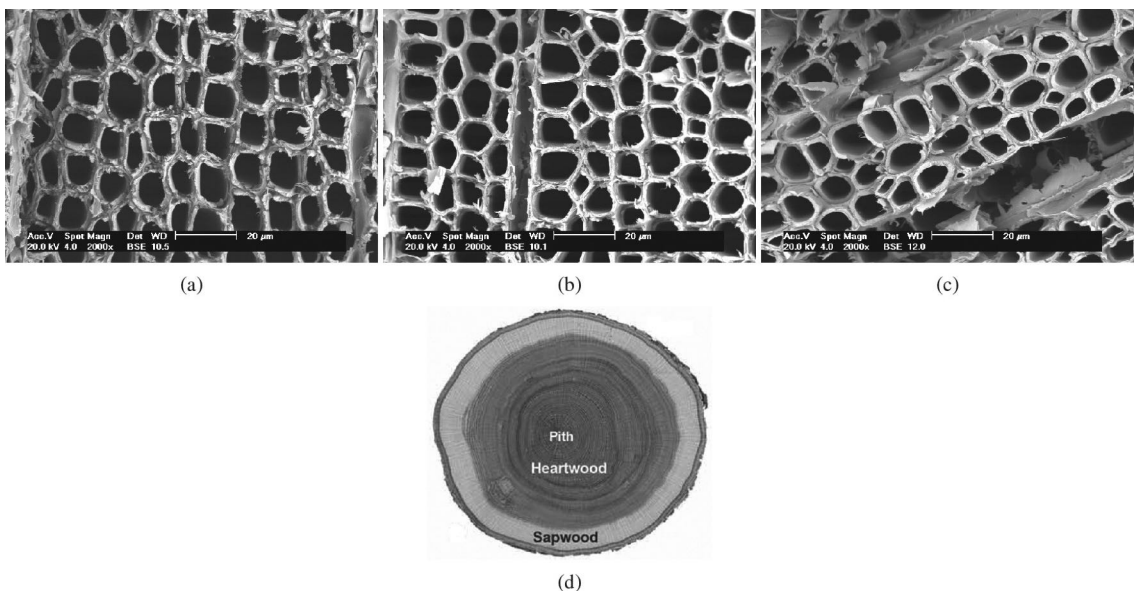
Figure 1. SEM images of *Eucalyptus grandis* samples without chemical treatment. In (a) Sapwood, (b) Heartwood, (c) Pith and (d) Typical cross-section of a trunk (Adapted from the USDA)¹³.

Microscopic analyses of cross-sections taken at random points of the pith, heartwood and sapwood were used as a parameters to relate fiber density with morphology for the species *Eucalyptus citriodora* (*Corymbia*), *Eucalyptus saligna* and *Eucalyptus grandis*. Figure 1 (from a to c) shows images of *Eucalyptus grandis* wood, indicating substantial uniformity in lumen diameter for the three regions evaluated. Similar results were found for the other species studied in new poles and those removed from the network. Average lumen diameter considering all three regions (sapwood, heartwood and pith) was used to correlate timber morphology with density.

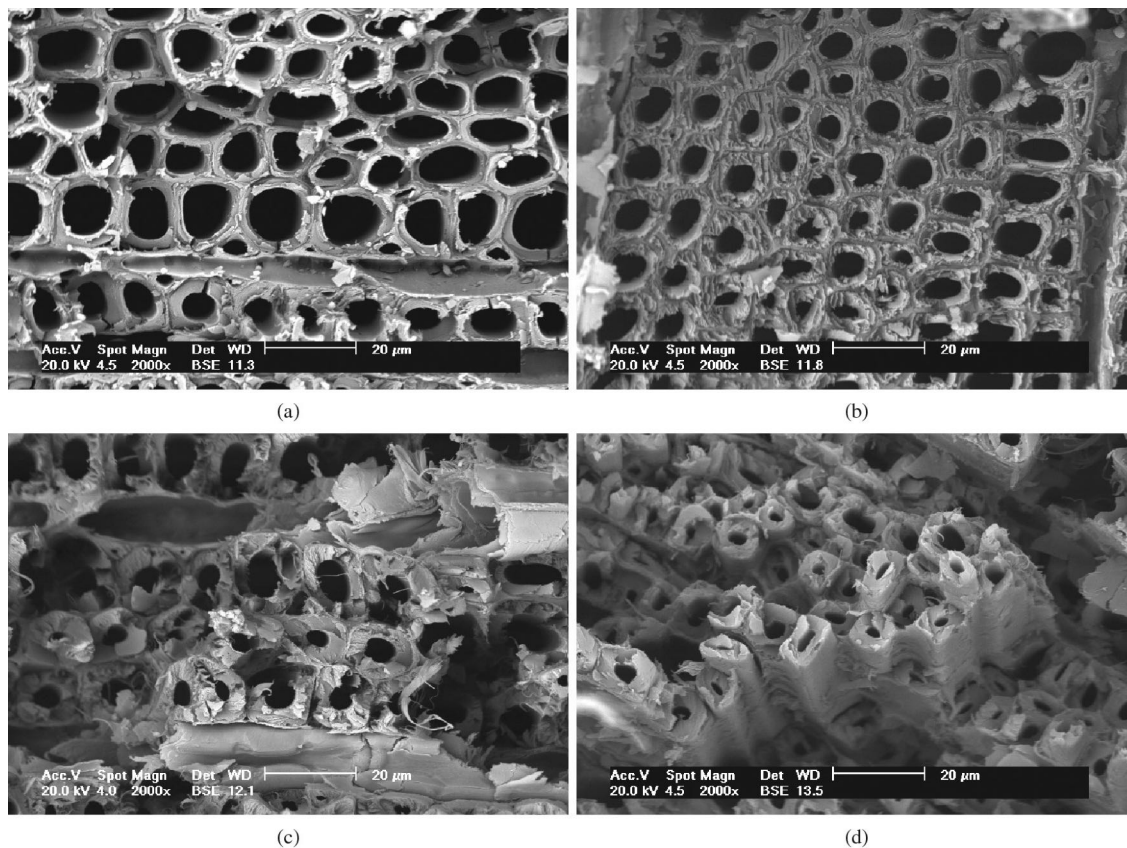
Figure 2. SEM images in cross-sections of sapwood. In (a) Pole 7, (b) Pole 6, (c) Pole 4 and (d) Pole 27.

Randomly selecting thirty poles withdrawn from the electricity network favored the occurrence of poles with varying service times and different treatments among the samples. Table 2 shows data obtained for pole number 6, 7 and 27, all CCA-treated and with different service times, and pole number 4, treated with creosote. Treatments using CCA, Creosote and CCA + Boron-Fluorine did not alter lumen diameter and variations in wood density were negligible. Service time within the electricity network also did not influence the data analyzed, likely because samples were taken from healthy areas of wood. Therefore, the data presented confirm that denser species exhibit smaller lumen diameter, regardless of the existence or type of treatment.

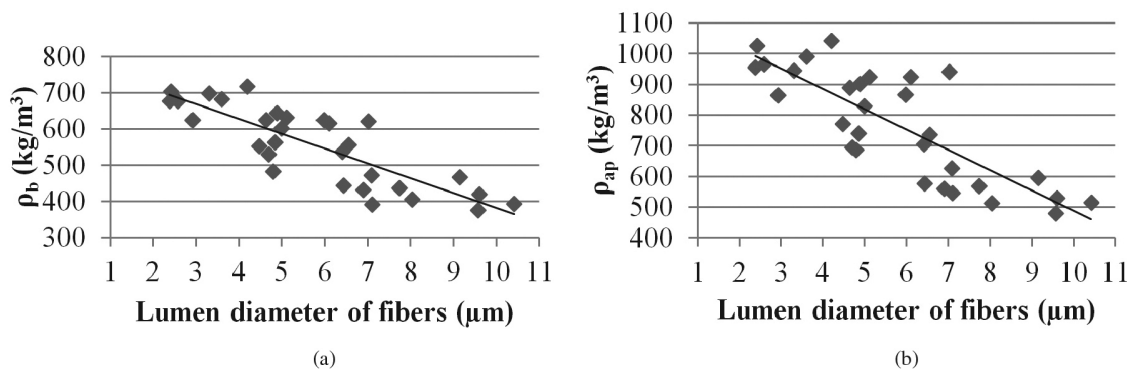
Figure 3. Density variation with the lumen diameter of fibers. (a) Basic density and (b) Apparent density.

Figure 3 demonstrates the behavior of basic and apparent density, measured in laboratory, with the lumen diameter of fibers for the thirty poles removed from service. A negative correlation was found between these two variables, evidenced by the strong Pearson correlations observed. Basic density displayed more significant correlations (0.84) and *p-value* (9.27×10^{-9}) with lumen diameter when compared to apparent density (0.81 and 4.90×10^{-8}), with a significance level less than 5% in both cases. It is important to underscore that moisture is a factor that may interfere in correlations with respect to apparent/bulk density, since the latter considers damp wood, and microscope analyses were performed on dry wood.

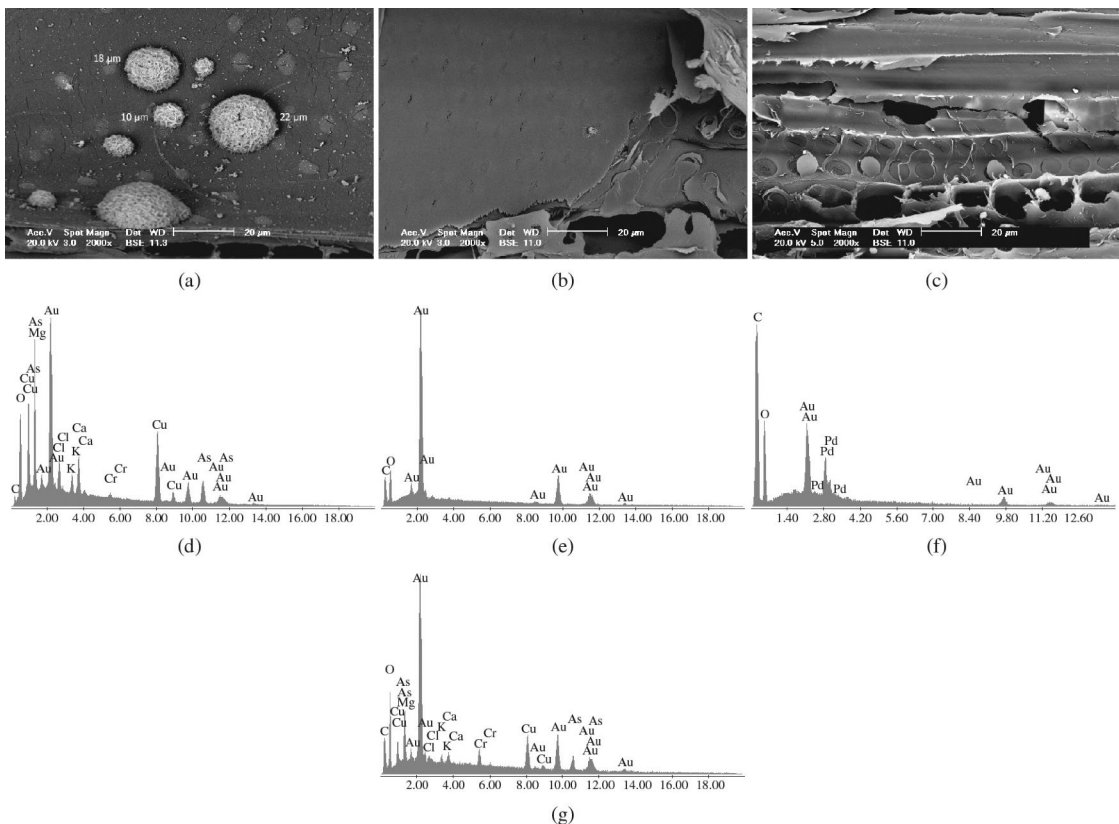
Figure 4. SEM images of a new pole (2) with CCA. In (a), (b) and (c) sapwood, heartwood and pith respectively. In (d), (e) and (f) EDS analysis of the total area in each of the images. In (g) EDS analysis of precipitate 1.

In order to locate elements of CCA in new and decommissioned poles, wood samples taken from three new poles treated with CCA and thirty poles removed from the electricity network were submitted to EDS analysis. Table 3 shows the concentrations of chromium, copper and arsenic present in the three new poles and three of those removed from service. EDS analyses conducted on three samples taken from the sapwood, heartwood and pith of a new pole (2) treated with CCA are shown in Figure 4.

EDS analyses revealed significant occurrence of chromium, copper and arsenic in only the sapwood samples for tests performed over the total area of the image, corresponding to 10 mm², and on specific regions of approximately 2 μm² over precipitates, light-colored areas and clusters. In the heartwood and pith, this technique identified none of the three CCA components. Similarly,

Figure 4a shows rounded precipitates, indicating a cluster associated to components of the preservative. Pedersen and Ottosen observed that mineral particles of chemical elements in the wood matrix may be associated or not to preservative components. Aluminum silicates and phosphates are not correlated to constituents of the preservative. Moreover, arsenic in association with calcium may form Ca-arsenate. The authors also report that a

in Figure 4g shows peaks corresponding to magnesium, potassium, chloride and calcium, suggesting that elements of the preservative are associated with wood components in the form of precipitates.

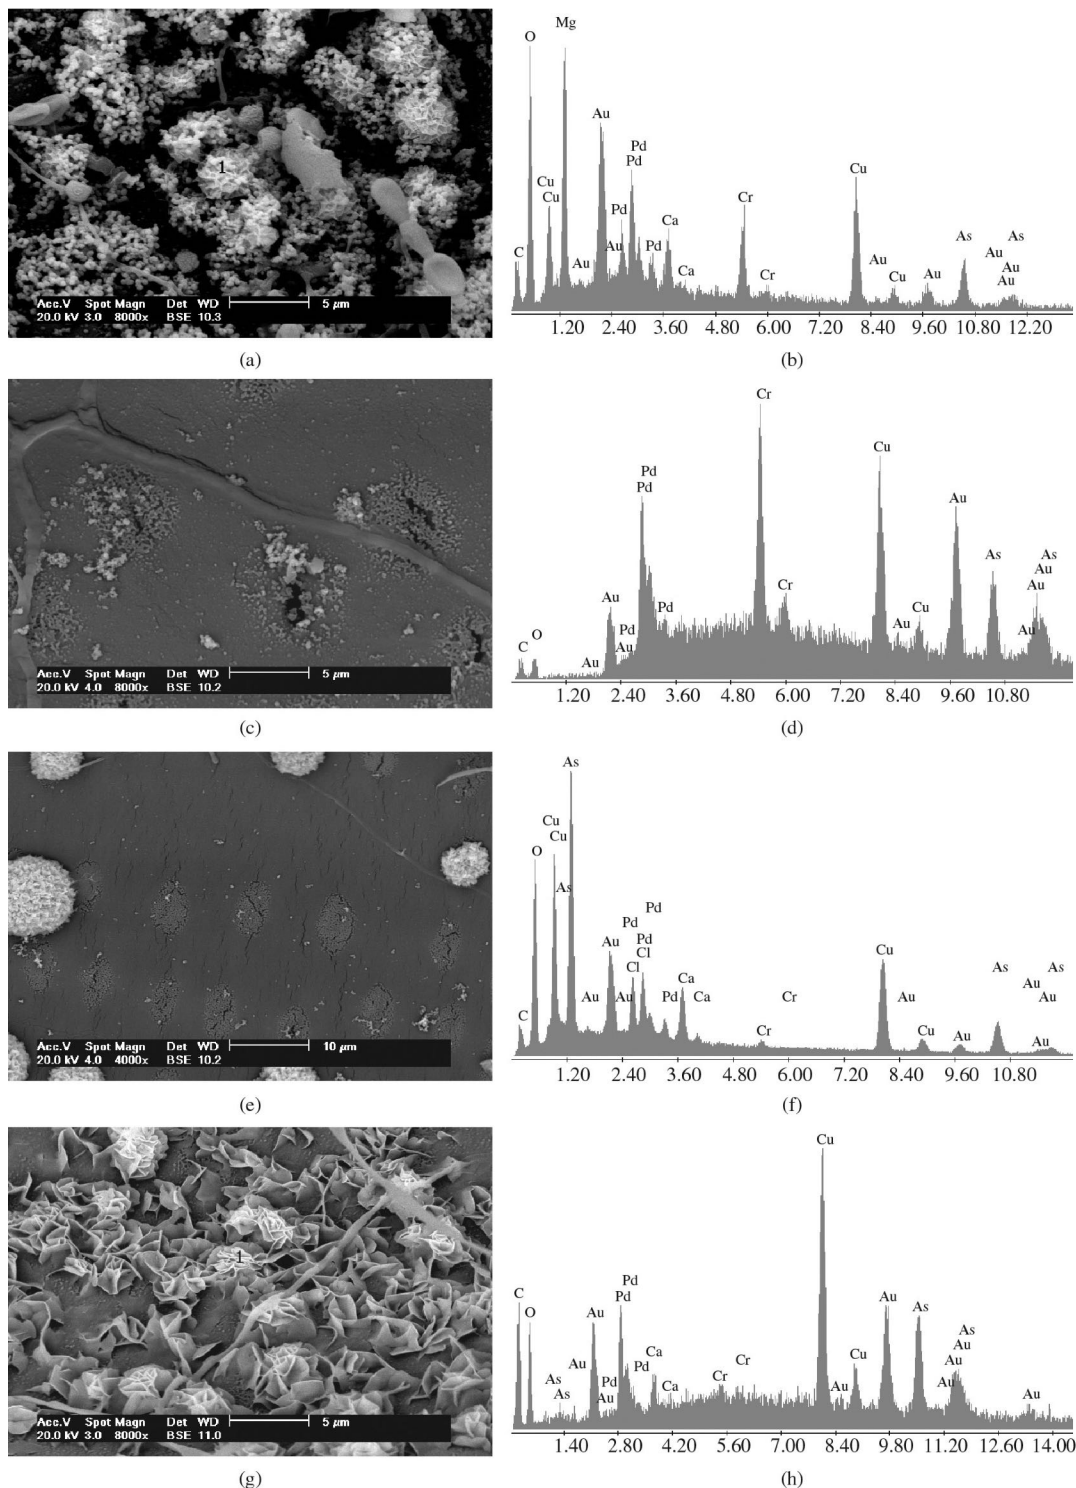
Figure 5. SEM images of the sapwood region with CCA. In (a) sample from pole (12), (b) EDS analysis of the precipitate in region 1. In (c) sample from pole (15), (d) EDS analysis of region 1. In (e) sample from pole (16), (f) EDS analysis of the total area of the image. In (g) sample from pole (27) and (h) EDS analysis of the light-colored area (1).

The methodology used in combining EDS analyses with scanning electron microscopy proved adequate in identifying CCA components in new poles and as such, was also applied to test poles removed from service. In both the new and decommissioned poles, chromium, copper and arsenic were detected only in sapwood samples, even for poles with several years of service. This confirms the effectiveness of chromium as a fixing agent for the fungicides copper and arsenic as reported by Van den Broeck⁸, partially preventing their diffusion and dispersion, since evidence of these elements was not found in the heartwood and pith, because in the heartwood according Costa⁵ formation occurs in the vessel tiles will providing a very low permeability. The sapwood exhibited several formations of preservative associated with wood components in the form of individual precipitates of varying sizes, clusters, in light-colored areas or impregnated in the timber, as shown in Figure 5.

The Figure 5 depicts a sample from the pole (12) subjected to EDS testing (Figure 5b) on a group of precipitates, in region 1. Peaks are evident corresponding to the three components of the preservative (copper, chromium and arsenic), though more intense for copper as well as magnesium and calcium peaks, predominant elements in wood.

Elements found in clusters of the pole sample (15), Figure 5c, in region 1, are also representative of the three

CCA components, as shown by the EDS spectrum in Figure 5d; however, in this case the chrome peak is more intense than the other elements in the sample. The rounded precipitates observed in the new poles treated with CCA were also present in samples of pole (16), as per Figure 5e. EDS analysis of the precipitate in Figure 5f demonstrates that, in addition to chromium, copper and arsenic, chloride and calcium are also present.

Figure 5g corresponds to the sample from pole (27), showing rosettes formed by small panels. EDS analyses of the rosettes in region 1 show greater intensity for copper peaks, followed by chromium and arsenic. A small amount of calcium, a characteristic element in wood, was also detected. Thus, there was a predominant presence of preservative in all the samples tested, irrespective of the service life of the pole. Of the twenty-three poles treated with CCA, only one did not exhibit the simultaneous occurrence of all three preservative components, with only arsenic and chromium identified in both the matrix and precipitates.

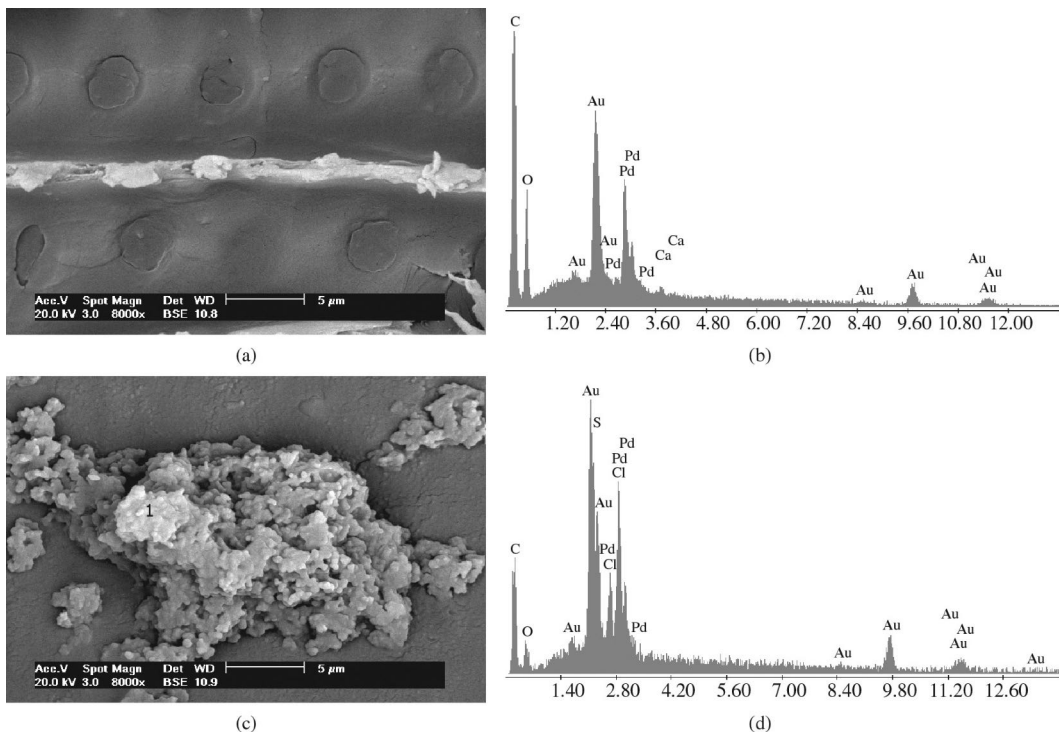
Figure 6. SEM images of the sapwood region with Creosote. In (a) SEM image of sample 4, (b) EDS on the total area for the image of sample 4, (c) SEM image of sample 29 and (d) EDS performed on the precipitate (region 1) sample 29.

calcium, chloride and sulfur were observed, as per Figure 6. Although calcium is a characteristic element of wood, sulfur is not, and has been used in conjunction with chloride to fortify phenolic substances, increasing the toxicity of creosote, which could be an indication of the presence of this preservative in wood.
