FAST Mechanical Equipment Test Results to Date - Future Plans

D.E. GRAY

Research Manager
Office of Freight Systems
Federal Railroad Administration
Washington, D.C.

OVERVIEW OF FREIGHT SYSTEMS
R&D REPORT NO FRA/ORD-77/58
OCTOBER 1977

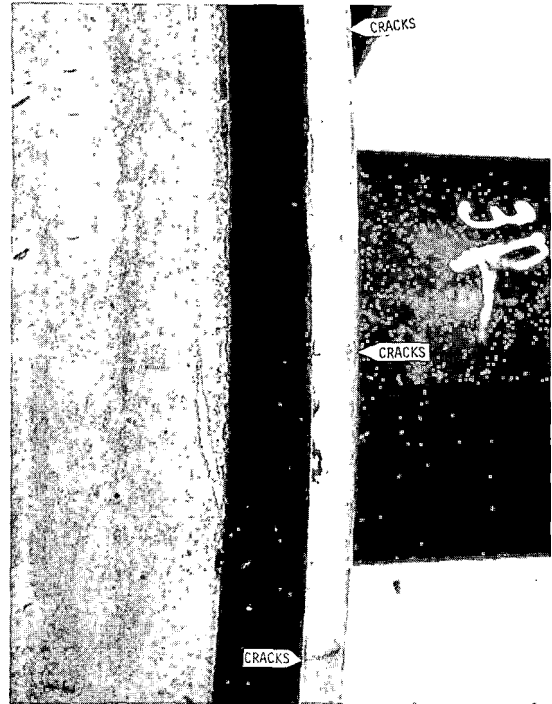
Fig. 4, Typical Wheel Flange Cracks

After approximately 40-45,000 miles a number of wheels were found to contain small cracks across the flange of the wheel. This phenomenon is depicted in Figure 4. A probable cause for this phenomenon is the unique wheel/rail wear pattern as shown in Figure 5. This pattern is due to the use of cars with the majority of wheels having uniform flange heights. Figure 6 shows an actual cracked wheel flange section mated with a worn section of high rail. An enlargement of the flange apex (Area A) is provided in Figure 7. This enlargement shows that on the gage side the flange material has plastically deformed and small subsurface cracks have been identified. This preliminary AAR study has indicated that the nucleation of the flange cracks is a subsurface phenomenon associated with the plastic deformation of the wheel steel which occurs near the apex of the flange due to wheel/rail contact in this area. As mentioned previously, such a condition has developed because of the characteristic wheel and rail wear at FAST. It is suggested that the flange

cracks nucleate from the longitudinal cracks develop due to subsurface rolling contact fatigue. The phenomenon appears to be very similar to the formation of shells and detail fractures in rails.

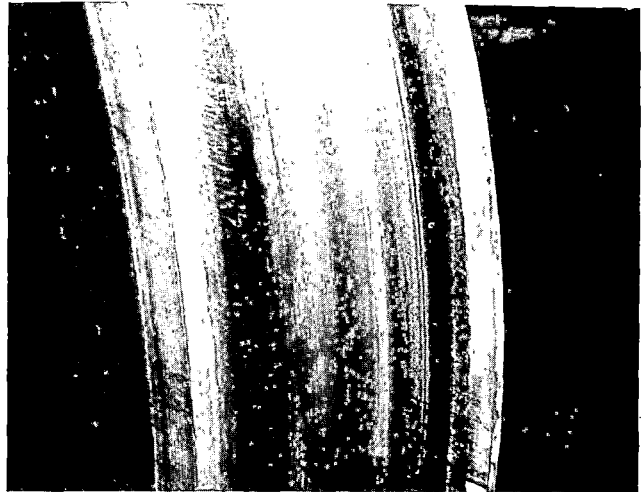
Fig. 8, Wheel Tread Cracks

The second failure mode that has been noted is comprised of tread cracks and wheel rim shelling. These phenomena are depicted in Figures 8 and 9. This condition has just recently been observed, and investigations to date have not resulted in a conclusive determination for the cause of this failure.
