49 PRESERVATION BRIEFS

Historic Decorative Metal Ceilings and Walls: Use, Repair, and Replacement

National Park Service
U.S. Department of the Interior

Technical Preservation Services

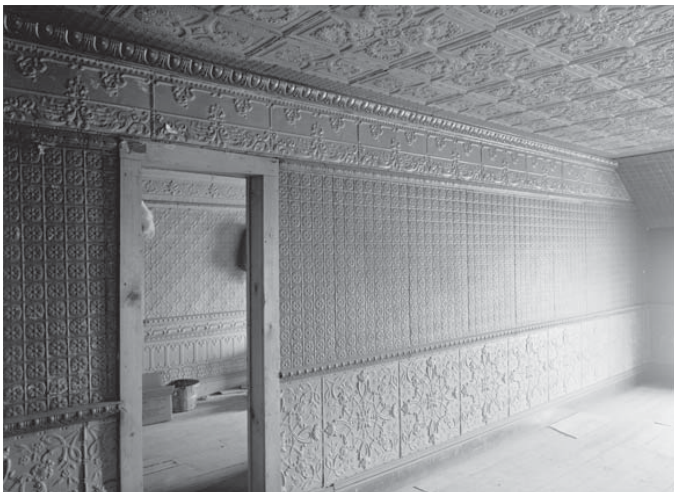
Interior of the Sig Sautelle Circus Training House, South Main Street (State Route 11), Homer, Cortland County, NY (HABS NY-5599)

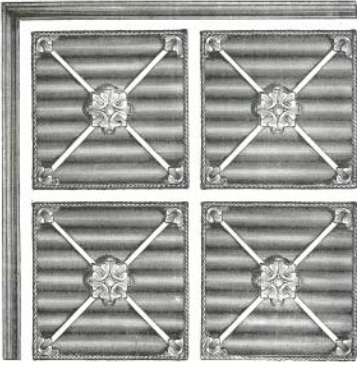
An illustration from the Philadelphia Architectural Iron Company trade catalog of 1872 showing a corrugated iron ceiling, paneled and ornamented with applied decoration.

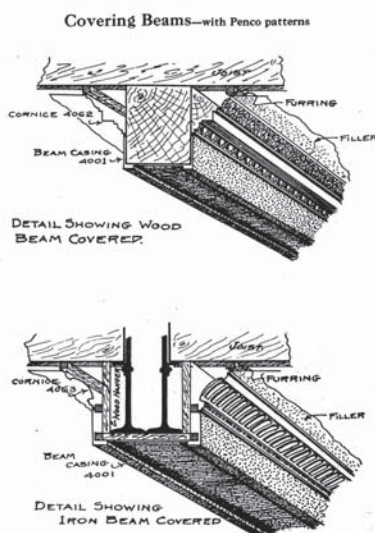
Early catalogs provide how-to instructions for “fire-proofing” beams of both metal and wood, incorporating them into decorative ceiling patterns.

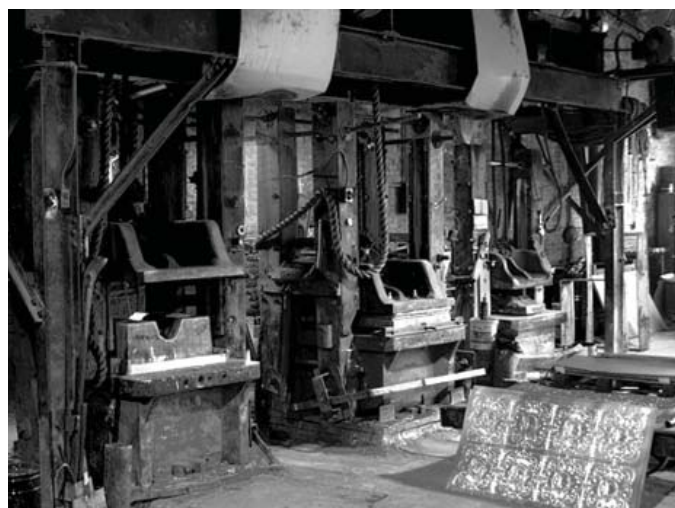
Rope drop hammers at the turn-of-the century factory in Nevada, Missouri, that W. F. Norman Corporation still uses to stamp individual panels, resulting in high quality pressed metal sheets. (Photo: W. F. Norman Corporation)

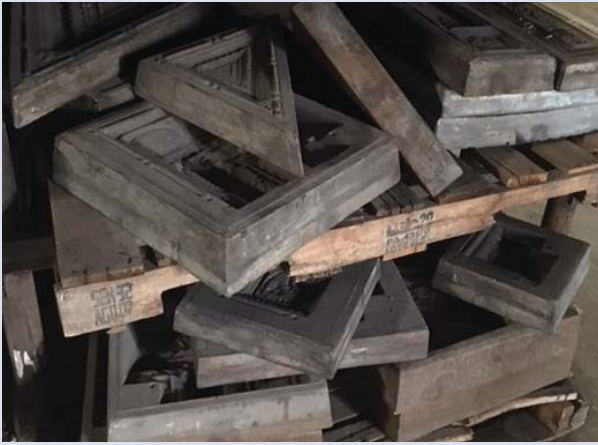
Stamping molds used in drop-hammer presses began on the artist's design table. Once a design was approved, it was transferred from a full-sized paper drawing to a slab of molding clay and sculpted into a 3-dimensional model. The artist then cast it into plaster, first in a shell cast making a negative, and from that a positive, replicating the original clay model. This last mold was carefully leveled and smoothed and coated with shellac. Molten iron was next poured over the positive plaster mold to create a negative metal die. After the iron die was cooled, milled, and smoothed, workmen poured liquid zinc over the bottom die to make a separate positive metal mold. When cooled, the 2-part die was fastened to the hammer heads of the press with the strong iron die on the bottom and the more malleable zinc die on the top. (Photo: W. F. Norman Corporation)

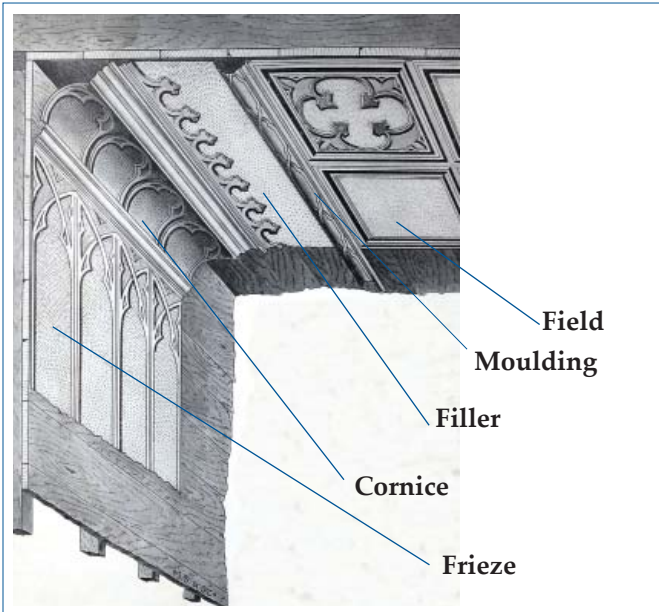
Anatomy of a decorative metal ceiling and upper wall.

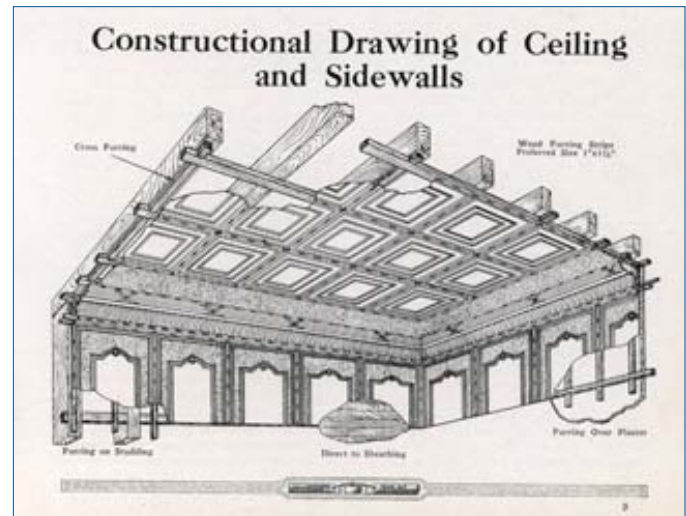
A 1928 Berger Manufacturing Company catalog shows the recommended ceiling and sidewall support structure beyond the pressed metal tiles.

Decorative pressed-steel ceilings were mostly laid over lathing strips that were nailed to joists and beams. The lathing was nailed in grids that matched the locations of the panel seams. Steel ceilings could be laid directly over existing wood ceilings and even over plaster that was attached to lathing. If the plaster was deteriorated, lathing strips for the metal ceiling could be applied directly over the plaster. For small rooms, manufacturers recommended applying 1/2” wood sheathing over the whole ceiling for ease of installation. Common lathing sizes included 7/8” x 7/8” and 7/8” x 1 1/4”, though in fact they typically ranged from 5/8” to 1 3/4” in thickness and from 1-1/4” to 1-7/8” in width.

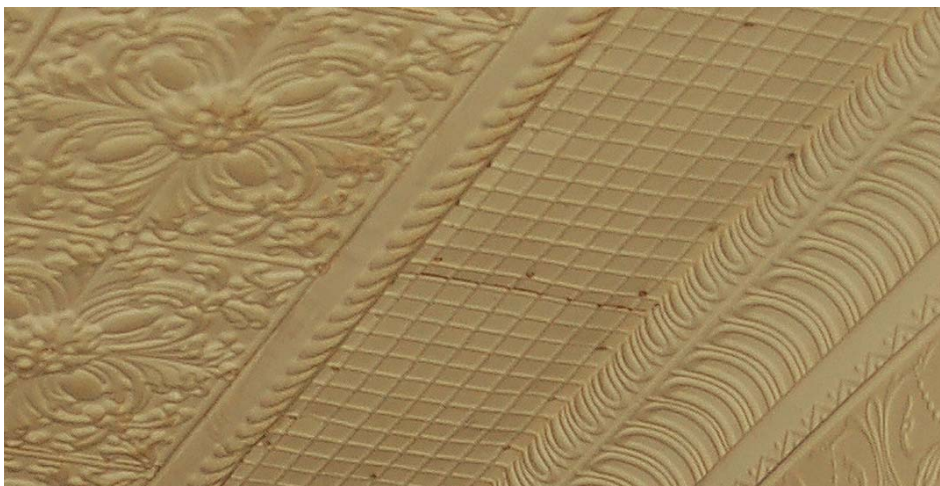
Some seams were easily disguised with interlocking patterns, whereas others, like butt joints, remained quite visible. Historic decorative metal ceiling at the LaSalle/Van Buren (CTA) station, Chicago, IL. (Photo: Kaaren Staveteig, NPS)

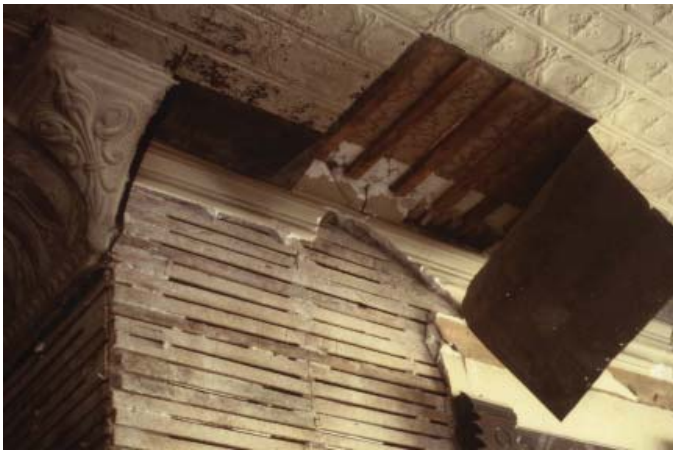
Prior to repair, a section of the pressed metal was removed to expose the condition of the plaster and lath and to document the earlier finish. (Photo: Kaaren Staveteig, NPS)

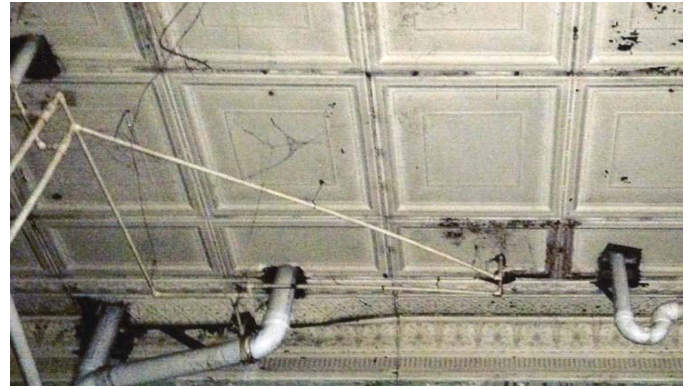
Metal ceilings can be greatly impacted by later penetrations from piping, electrical, and other such work, resulting in loose tiles and deflections in the ceiling. (Photo: Kaaren Staveteig, NPS)

Metal ceilings can be damaged by later penetrations from piping and conduit, resulting in loose and deflecting tiles. Where dissimilar metals are in direct contact with the metal ceiling, galvanic corrosion can occur in localized areas. Plumbing pipes, electrical fixtures, and other apertures over time cannot only affect the structural soundness of the ceiling, but also destroy the visual continuity of the ceiling pattern.

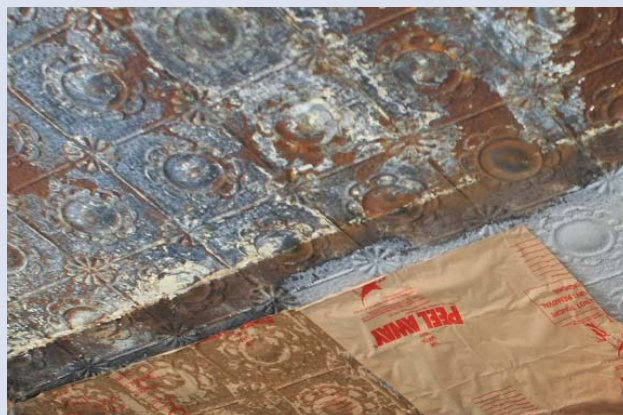
After applying a solvent-based paint to the metal, a laminated cloth/paper is applied during the chemical-peel process. (Photo: NPS)

One of the most common chemical removal processes is a chemical peel. This method typically requires application of a 1/8"- to 1/4"- thick solvent based paste with either a trowel or specialized spray equipment. The paste is then covered with a fibrous laminated cloth, polyethylene side facing out. This material is left in place up to 24 hours, as determined from the sample test findings. Remove the paint layers by sliding a tapping knife along the edges of the dried paste, easing the paint, paste, and cloth away from the surface. The remaining chemicals should be removed with a sponge and clean water before applying a neutralizing agent on the surface to return it to a neutral pH condition for best paint results. As with the chemical paint remover itself, it is important to select a neutralizer safe to use on the specific metal.

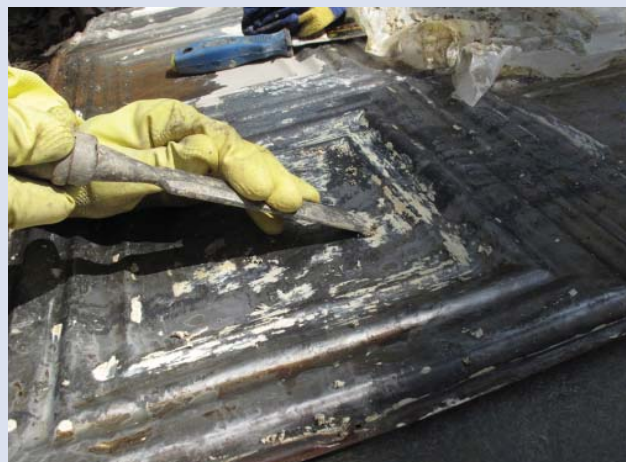
Thermal contraction—freeze/flex method

Freezing techniques have been successful in removing paint from pressed metal (see Fort Baker case study). The demounted pressed-metal panels are frozen in commercial-sized freezers. The metal contracts at a greater rate than the paint, which breaks the adhesion bond between the paint and the metal. When sufficiently frozen, the panels are removed and gently flexed by hand and tapped with brushes to flake off the paint. Hand picks, small scrapers, and other small tools then are used to remove paint remaining in deep crevices. On any project, this process must be tested on one or more panels to determine efficacy.

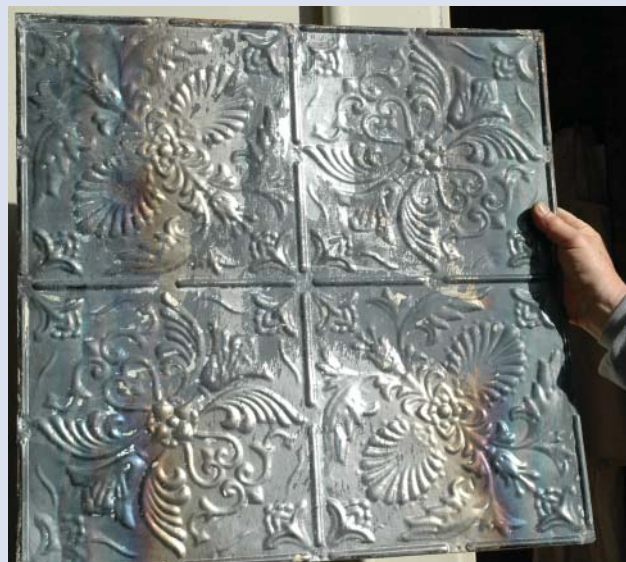
Once the metal panels are clean of previous layers of paint, it is easy to see their original decorative design. (Photo: NPS)

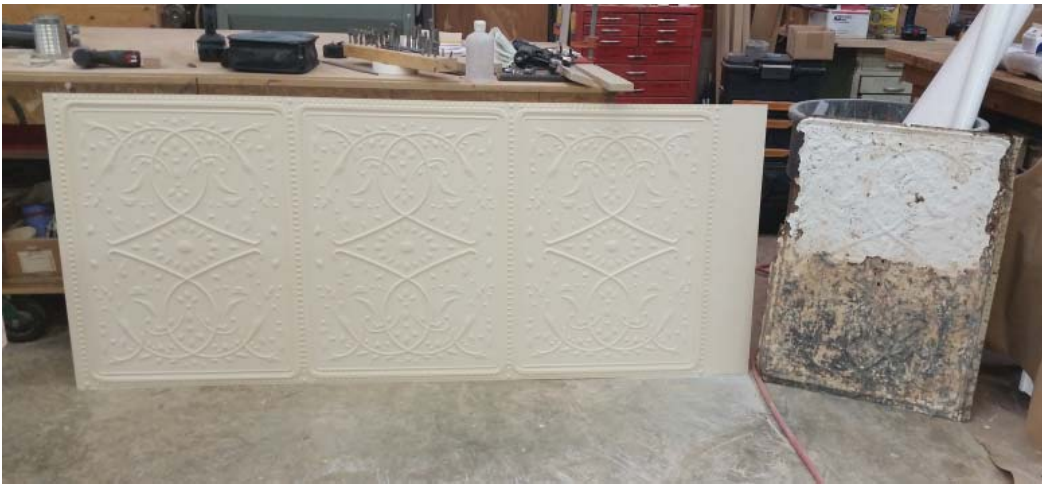
Another option for the replacement of individual tiles that may be irreparable in a field of otherwise salvageable material is digital replication. Through the careful removal of the tile, a skilled artisan can measure the exact dimensions and create a digital copy. Once an acceptable model has been created, the design can be replicated on a suitable substrate as shown. (Photo: Lonnie Coulter, La Bastille)

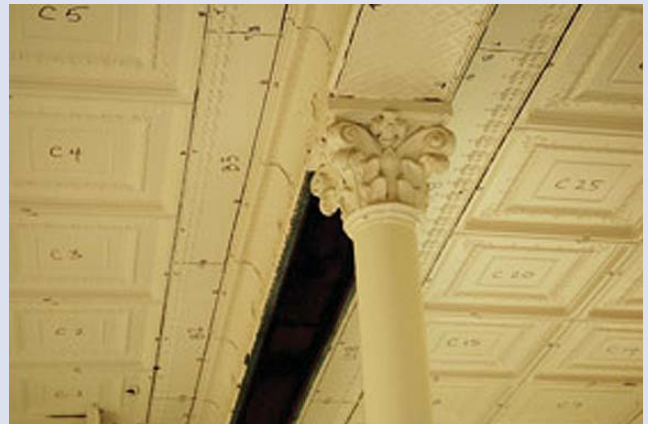
Figure a. Removal began with documenting the pieces within each room, numbering and noting their precise location on a drawing. It was important that the pieces were marked in such a way that the numbers would remain legible throughout the cleaning and reinstallation process.

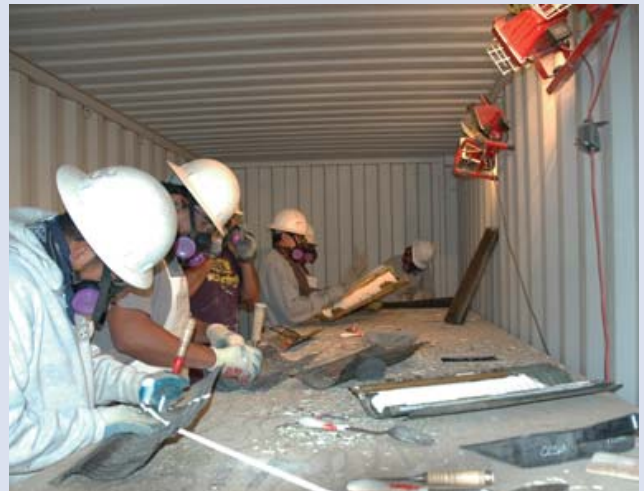
Figure b. On pieces where paint remained after the freezing/flex process, workers carefully hand scraped with chisels to finish the clean-up. Because lead paint was present, workers were required to wear NIOSH approved-respirators.

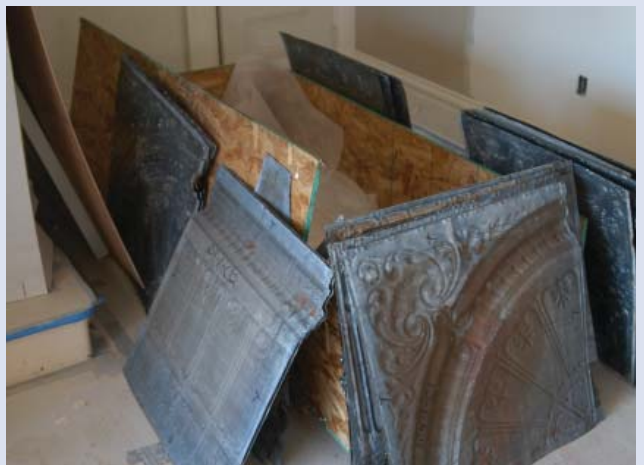
Figure c. Once the metal was cleaned of over 100 years of paint, it was easy to see the detail of the original design.

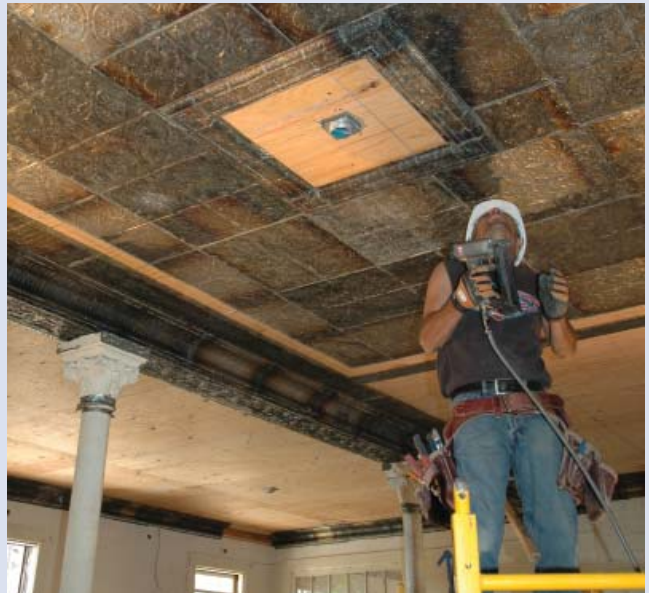
Figure d. Following the installation of the sound-proofing materials and drywall, the pressed-metal pieces were reinstalled using brads and a pneumatic gun. Matching the numbered pieces to the placement diagrams made the reinstallation easy.

Following the installation of the sound-proofing materials and drywall, the pressed-metal pieces were reinstalled using brads and a pneumatic gun. Matching

the numbered pieces to the placement diagrams made the reinstallation an easy process. New replacement pieces matching the historic Fort Baker design elements were purchased to replace any damaged or missing pieces. Once installed, the room ceilings were painted, completing the successful preservation and renewal of the historic pressed metal.

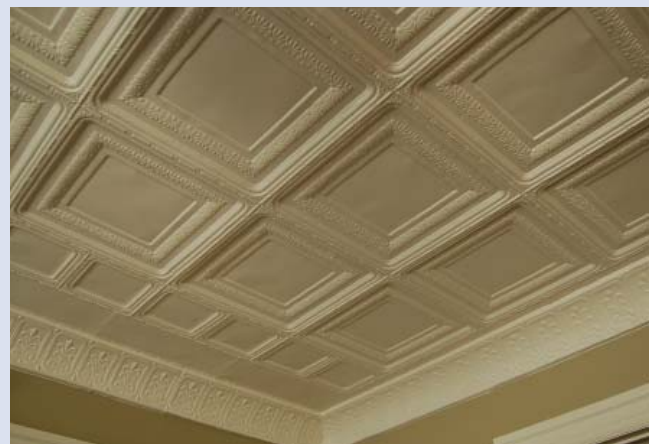
Figure e. The ceilings were finished with a fresh coat of paint. (Photos a-d courtesy of Kristin Baron, NPS; Photo e: Kaaren Staveteig, NPS)

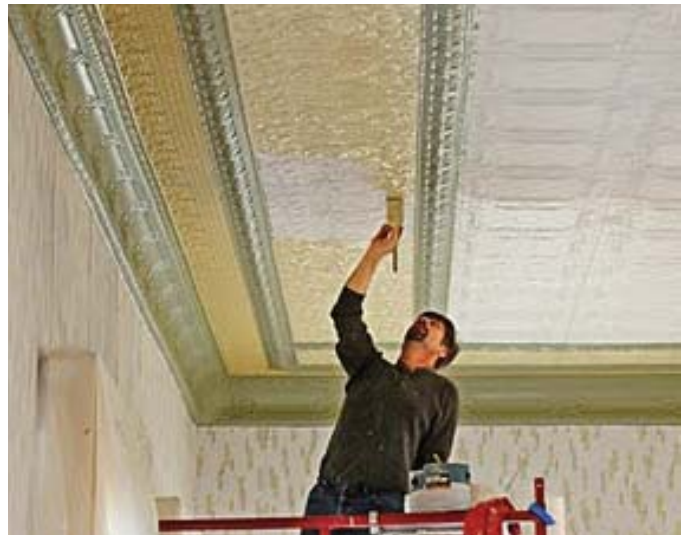
The historic polychrome appearance is being recreated and enhances the depth and complexity of the decorative metal ceiling. (Photo: The Madison Courier)
