# 22 PRESERVATION BRIEFS

## The Preservation and Repair of Historic Stucco

Anne Grimmer

U.S. Department of the Interior  
National Park Service  
Preservation Assistance Division

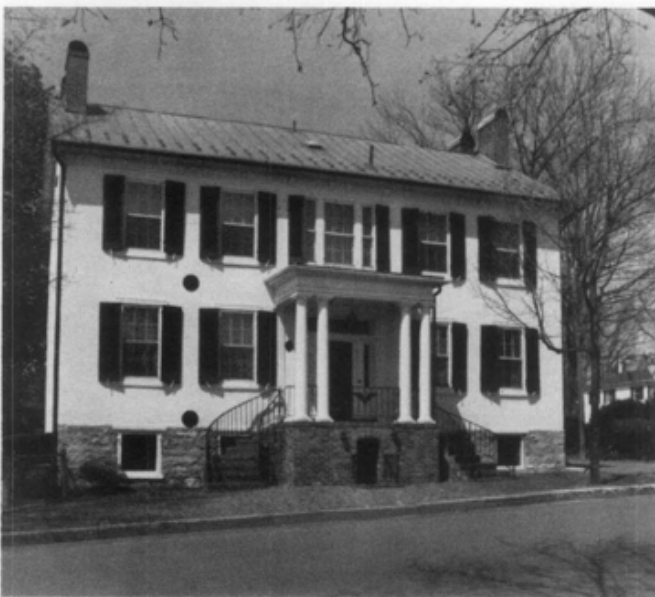
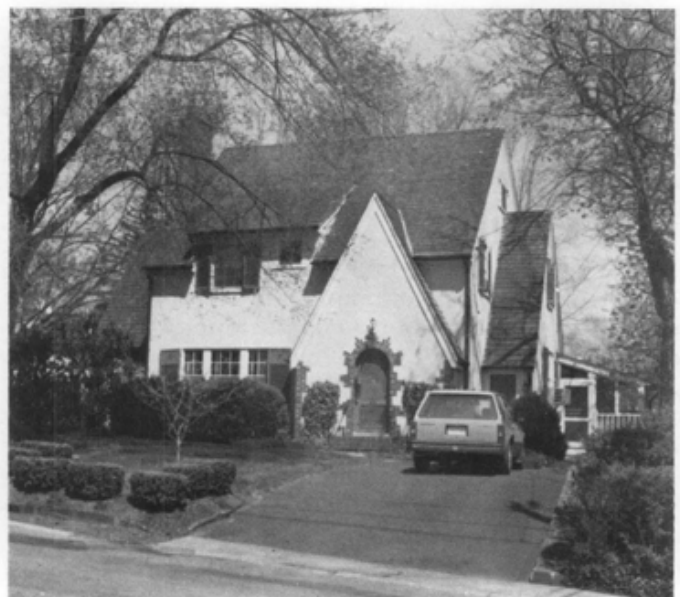
Fig. 1. These two houses in a residential section of Winchester, Virginia, illustrate the continuing popularity of stucco (a) from this early 19th century, Federal style house on the left, (b) to the English Cotswold style cottage that was built across the street in the 1930's. Photos: Anne Grimmer.

Stucco has been used since ancient times. Still widely used throughout the world, it is one of the most common of traditional building materials (Fig. 1). Up until

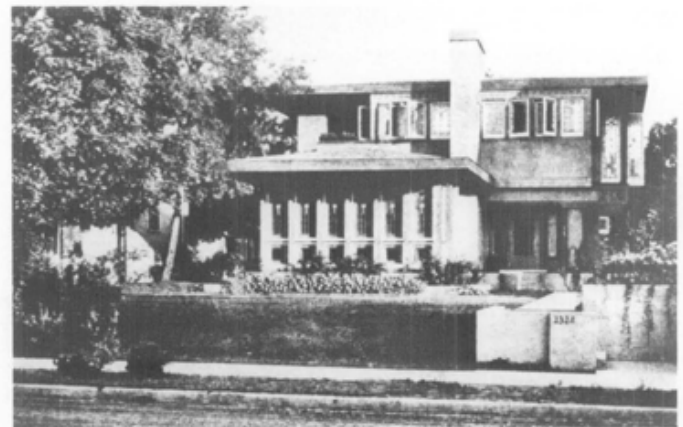
Fig. 3. The William Gray and Edna S. Purcell House, Minneapolis, Minnesota, was designed in 1913 by the architects Purcell and Elmslie in the Prairie style. Stuccoed in a salmon-pink, sand (float) finish, it is unusual in that it featured a 3-color geometric frieze stencilled below the eaves of the 2nd story. The Minneapolis Institute of Art has removed the cream-colored paint added at a later date, and restored the original color and texture of the stucco. Photo: Courtesy MacDonald and Mack Partnership.

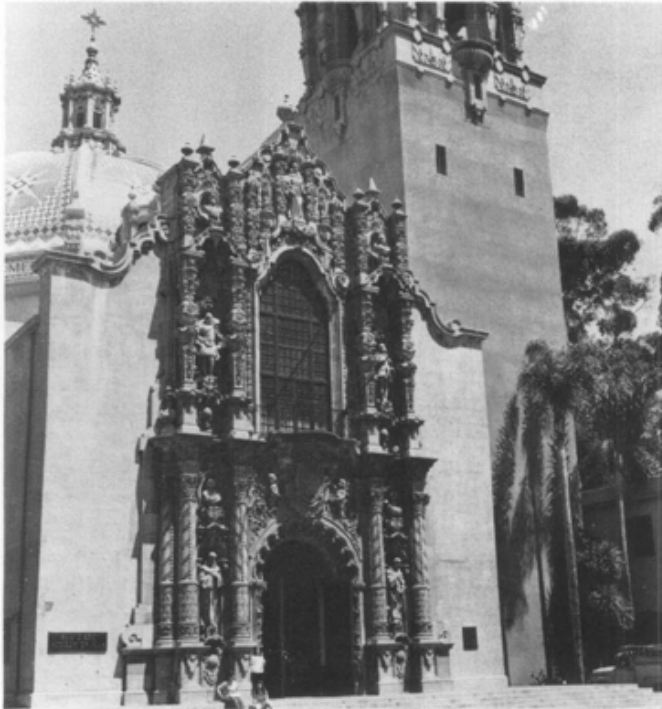
Fig. 4. The elaborate Spanish Colonial Revival style of this building designed by Bertram Goodhue for the 1915 Panama California Exposition held in San Diego's Balboa Park emphasizes the sculptural possibilities of stucco. Photo: C. W. Snell, National Historic Landmark Files.

The introduction of the many revival styles of architecture around the turn of the twentieth century, combined with the improvement and increased availability of portland cement resulted in a "craze" for stucco as a building material in the United States. Beginning about 1890 and gaining momentum into the 1930's and 1940's, stucco was associated with certain historic architectural styles, including: Prairie; Art Deco, and Art Moderne; Spanish Colonial, Mission, Pueblo, Mediterranean, English Cotswold Cottage, and Tudor Revival styles; as well as the ubiquitous bungalow and "four-square" house (Fig. 3). The fad for Spanish Colonial Revival, and other variations on this theme, was especially important in furthering stucco as a building material in the United States during this period, since stucco clearly looked like adobe (Fig. 4).

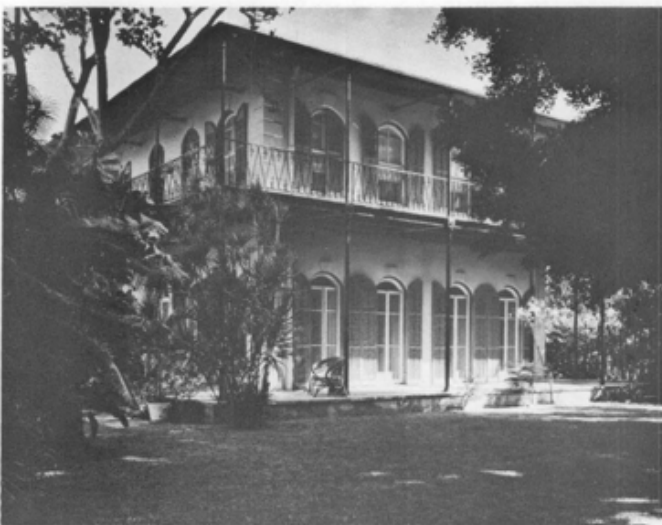
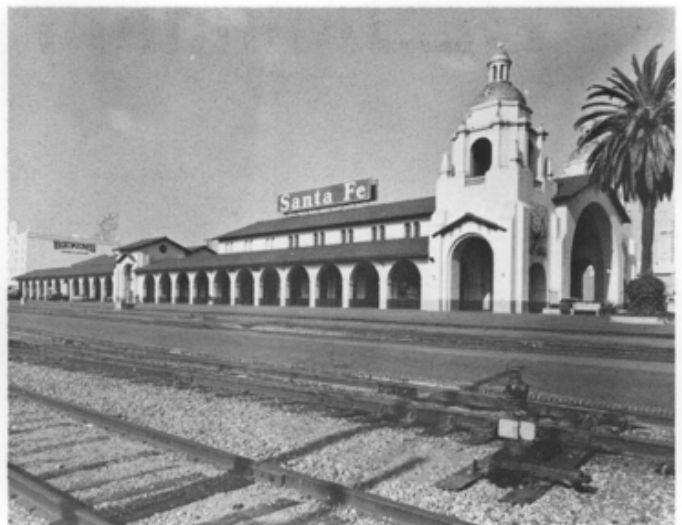
Fig. 5. During the 19th and 20th centuries stucco has been a popular material not only for residential, but also for commercial buildings in the Spanish style. Two such examples are (a) the 1851 Ernest Hemingway House, Key West, Florida, built of stuccoed limestone in a Spanish Caribbean style; and (b) the Santa Fe Depot (Union Station), San Diego, California, designed by the architects Bakewell and Brown in 1914 in a Spanish Colonial Revival style, and constructed of stucco over brick and hollow tile. Photos: (a) J.E. Brooks, HABS Collection, (b) Marvin Rand, HABS Collection.

of the "romance" of period styles, and adopted the stucco construction that had become synonymous with these styles (Fig. 5).

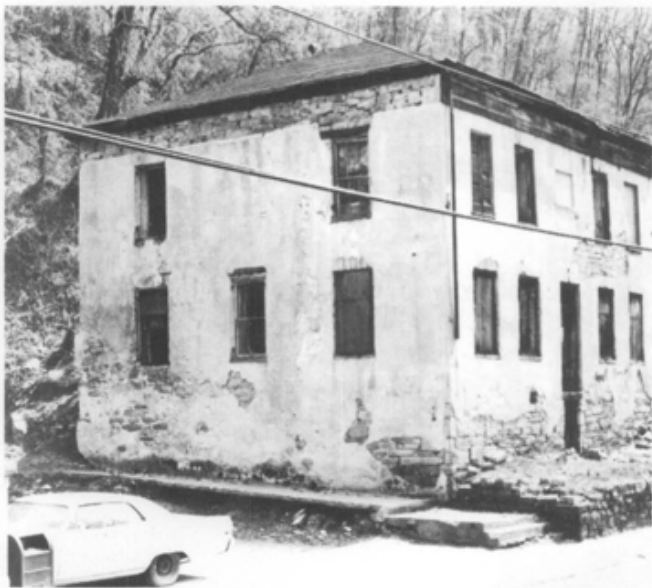
Fig. 7. Patches of stucco have fallen off this derelict 19th century structure exposing the rough-cut local stone substrate. The missing wood entablature on the side and the rough wood lintel now exposed above a second-floor window, offer clues that the building was stuccoed originally. Photo: National Park Service Files.

Stucco is applied directly, without lath, to masonry substrates such as brick, stone, concrete or hollow tile (Fig. 7). But on wood structures, stucco, like its interior counterpart plaster, must be applied over lath in order to obtain an adequate key to hold the stucco. Thus, when applied over a log structure, stucco is laid on horizontal wood lath that has been nailed on vertical wood furring strips attached to the logs (Fig. 8). If it is applied over a wood frame structure, stucco may be applied to wood or metal lath nailed directly to the wood frame; it may also be placed on lath that has been attached to furring strips. The furring strips are themselves laid over building paper covering the wood sheathing (Fig. 9). Wood lath was gradually superseded by expanded metal lath introduced in the late-nineteenth and early-twentieth century. When stuccoing over a stone or brick substrate, it was customary to cut back or rake out the mortar joints if they were not already recessed by natural weathering or

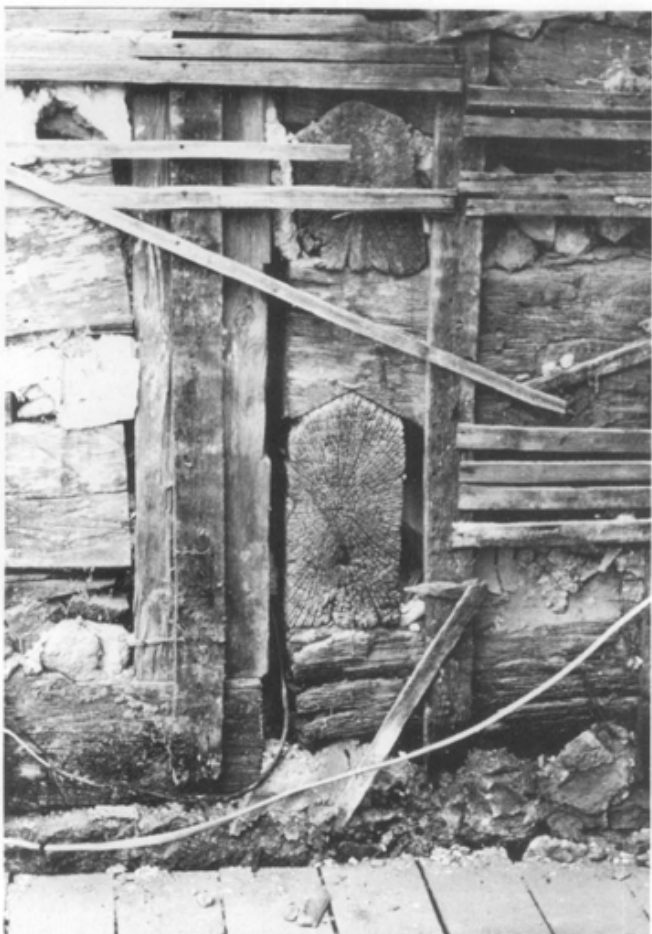
Fig. 8. Removal of deteriorated stucco in preparation for stucco repair on this late-18th century log house in Middleway, West Virginia, reveals that the stucco was applied to hand-riven wood lath nailed over vertical wood strips attached to the logs. Photo: Anne Grimmer.

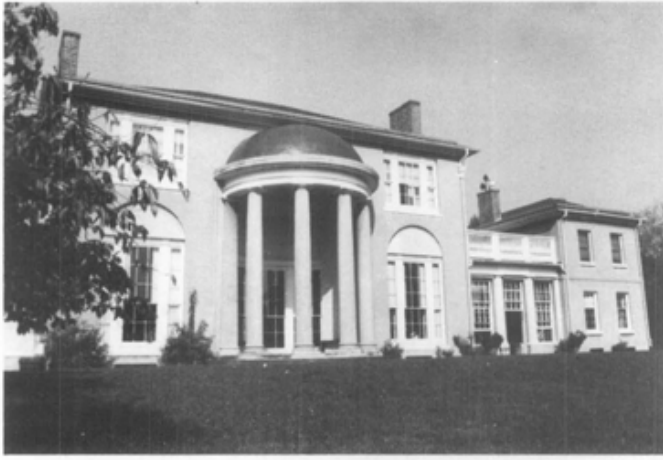
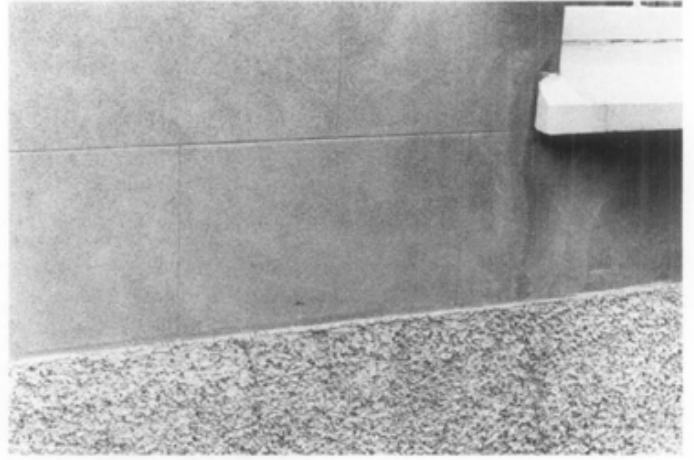
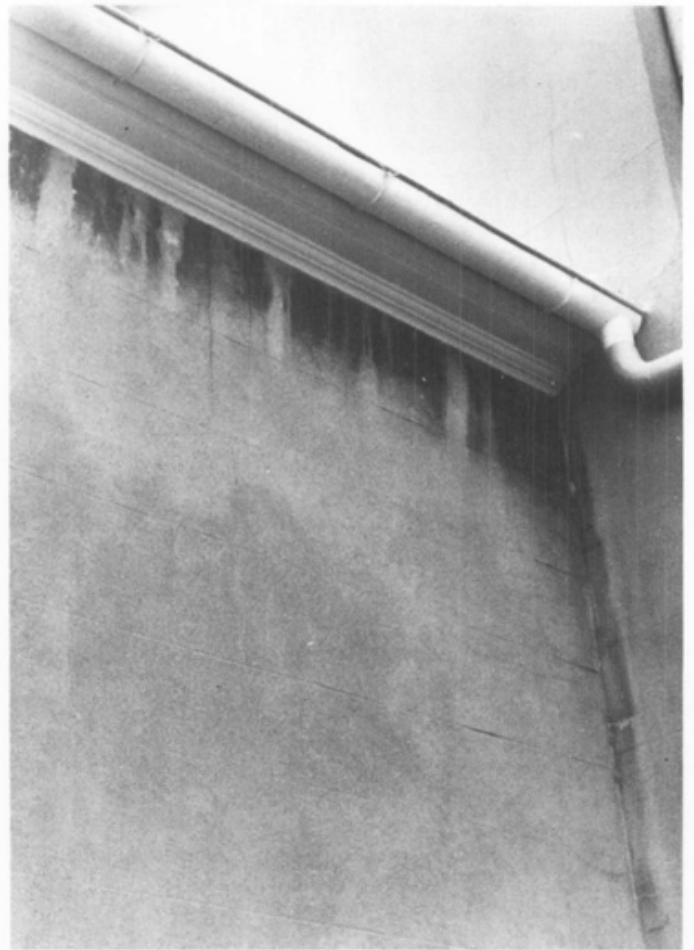
Fig. 10. (a) Tudor Place, Washington, D.C. (1805–1816), was designed by Dr. William Thornton. Like its contemporary, Arlington House, it is stuccoed and scored, with a roughcast base, but here the stucco is a monochromatic sandstone color tinted by sand and mineral pigments (b). Although the original stucco was replaced in the early-20th century with a portland cement-based stucco, the family, who retained ownership until 1984 when the house was opened to the public, left explicit instructions for future stucco repairs. The mix recommended for repairing hairline cracks (c), consists of sharp sand, cement and lime, burnt umber, burnt sienna, and a small amount of raw sienna. Preparation of numerous test samples, the size of “a thick griddle cake,” will be necessary to match the stucco color, and when the exact color has been achieved, the mixture is to be diluted to the “consistency of cream,” brushed on the wall and rubbed into the cracks with a rubber sponge or float. Note the dark color visible under the eaves intended to replicate the stronger color of the original limewashed stucco (d). Photos: Anne Grimmer.

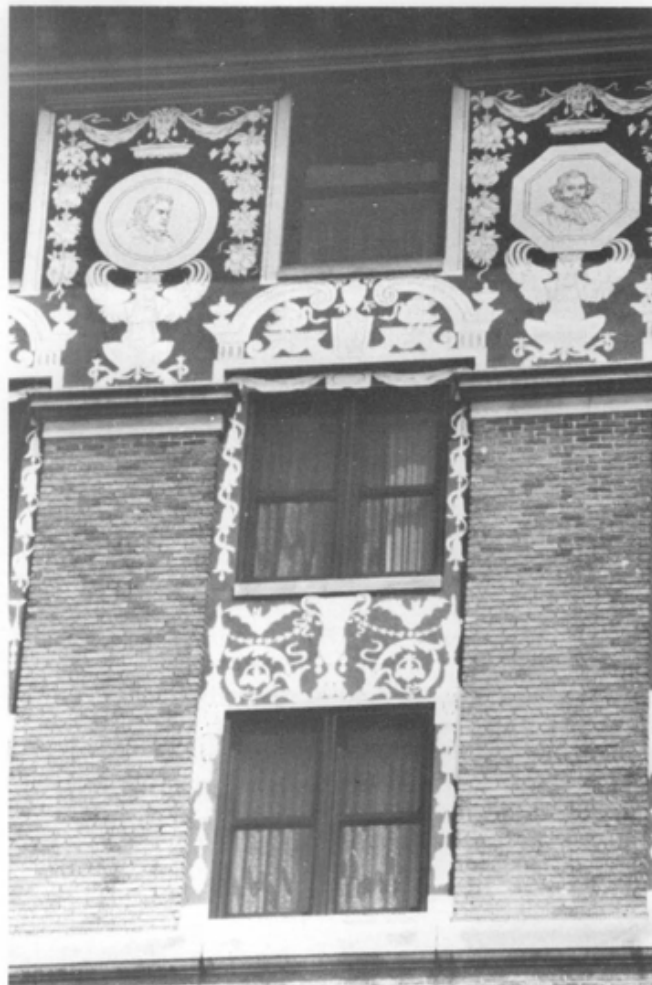
Fig. 11. The Hotel Washington, Washington, D.C. (1916–1917), is notable for its decorative *sgraffito* surfaces. Stucco panels under the cornice and around the windows feature classical designs created by artists who incised the patterns in the outer layer of red-colored stucco while still soft, thereby exposing a stucco undercoat of a contrasting color. Photo: Kaye Ellen Simonson.

Until the early-twentieth century when a variety of novelty finishes or textures were introduced, the last coat of stucco was commonly given a smooth, troweled finish, and then scored or lined in imitation of ashlar. The illusion of masonry joints was sometimes enhanced by a thin line of white lime putty, graphite, or some other pigment. Some nineteenth century buildings feature a water table or raised foundation of rough-cast stucco that differentiates it from the stucco surface above, which is smooth and scored (Fig. 10). Other novelty or textured finishes associated with the "period" or revival styles of the early-twentieth century include: the English cottage finish, adobe and Spanish, pebble-dashed or dry-dash surface, fan and sponge texture, reticulated and vermiculated, roughcast (or wet dash), and sgraffito (Fig. 11).

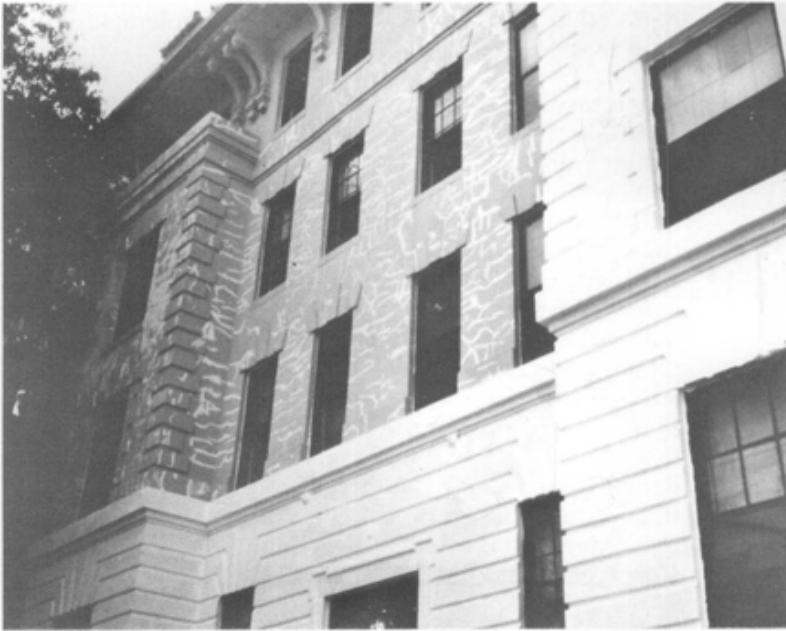
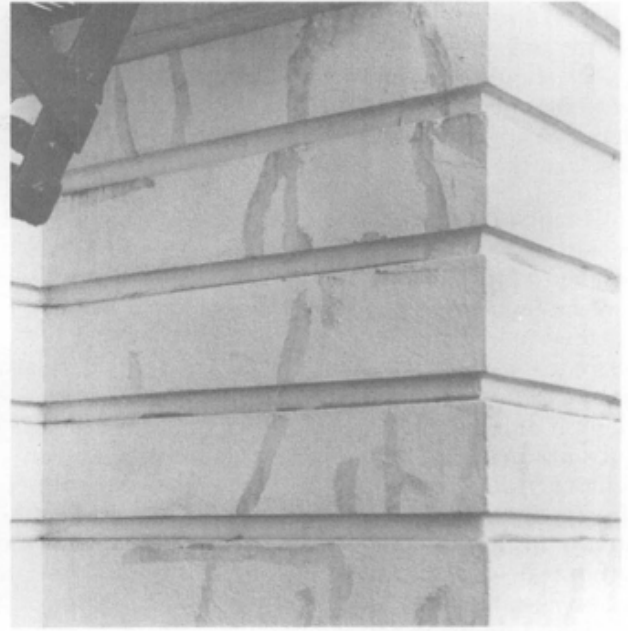
Fig. 13. (a) In preparation for repainting, hairline cracks on this Mediterranean style stucco apartment building were filled with a commercial caulking compound; (b) dirt is attracted and adheres to the texture of the caulked areas, and a year after painting, these inappropriate repairs are highly obvious. Photos: Anne Grimmer.

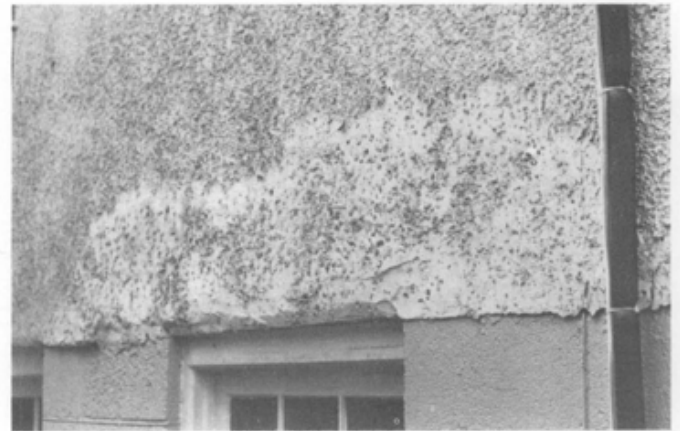
Fig. 14. This poorly executed patch is not the work of a professional plasterer. While it may serve to keep out water, it does not match the original surface, and is not an appropriate repair for historic stucco. Photo: Betsy Chittenden.

Once the extent of damage has been determined, a number of repair options may be considered. Small hairline cracks usually are not serious and may be sealed with a thin slurry coat consisting of the finish coat ingredients, or even with a coat of paint or white-wash. Commercially available caulking compounds are not suitable materials for patching hairline cracks. Because their consistency and texture is unlike that of stucco, they tend to weather differently, and attract more dirt; as a result, repairs made with caulking compounds may be highly visible, and unsightly (Fig. 13). Larger cracks will have to be cut out in preparation for more extensive repair. Most stucco repairs will require the skill and expertise of a professional plasterer (Fig. 14).

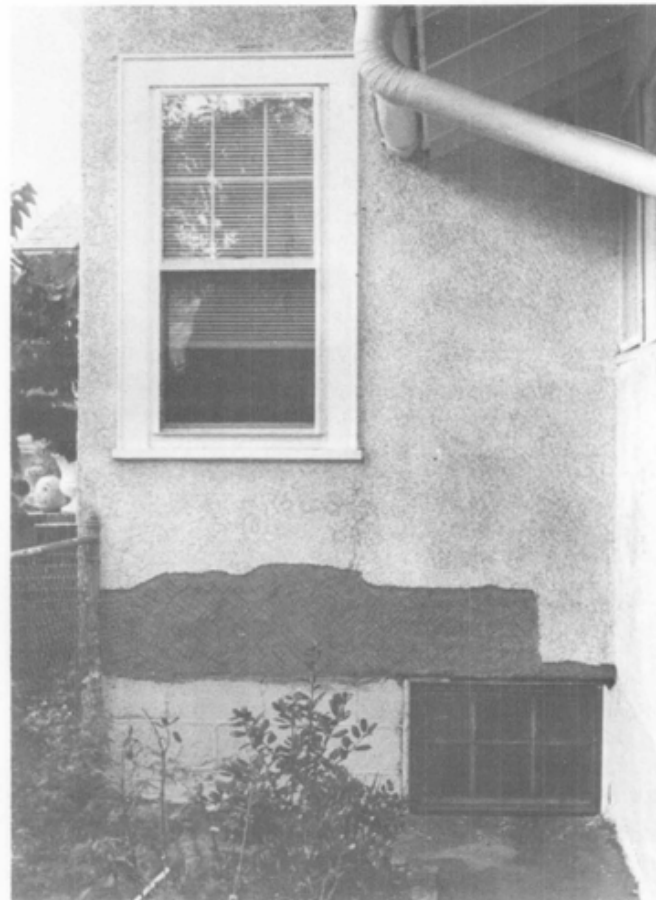
Fig. 15. (a) After reattaching any loose wood lath to the furring strips underneath, the area to be patched has been cleaned, the lath thoroughly wetted, and (b) the first coat of stucco has been applied and scratched to provide a key to hold the second layer of stucco. Photos: Betsy Chittenden.

bond between the stucco and substrate. The areas to be patched should be cleaned of all debris with a bristle brush, and all plant growth, dirt, loose paint, oil or grease should be removed (Fig. 15). If necessary, brick or stone mortar joints should then be raked out to a depth of approximately 5/8" to ensure a good bond between the substrate and the new stucco.

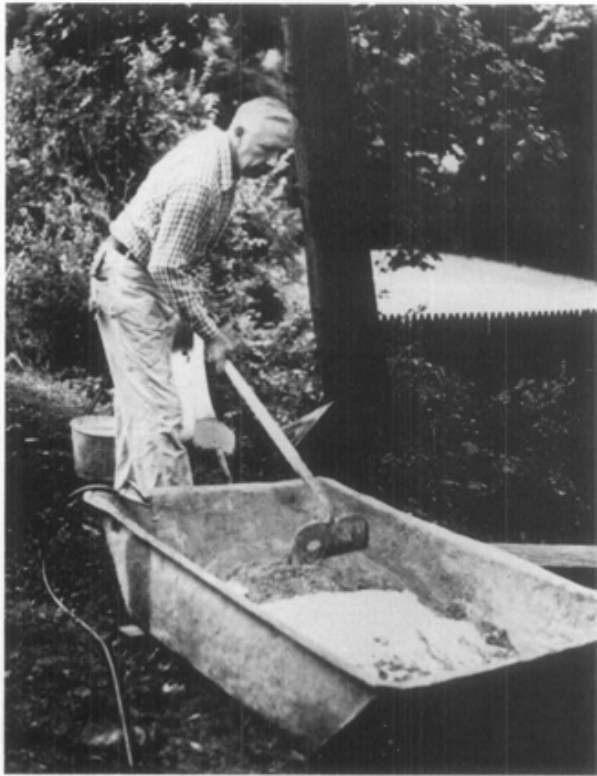
Fig. 16. (a) In preparation for stucco repair, this plasterer is mixing the dry materials in a mortar box with a mortar hoe (note the 2 holes in the blade), pulling it through the box using short choppy strokes. After the dry materials are thoroughly combined, water is added and mixed with them using the same choppy, but gradually lengthening strokes, making sure that the hoe cuts completely through the mix to the bottom of the box. (b) The deteriorated stucco has been cut away, and new metal lath has been nailed to the clapboarding in the area to be patched. (Although originally clapboarded when built in the 19th century, the house was stuccoed around the turn-of-the-century on metal lath nailed over the clapboard.) (c) The first, scratch coat and the second coat have been applied here, and await the spatterdash or rough-cast finish of the final coat (d) which was accomplished by the plasterer using a whisk broom to throw the stucco mortar against the wall surface. This well-executed patch is barely discernible, and lacks only a coat of paint to make it blend completely with the rest of the painted wall surface. Photos: Anne Grimmer.

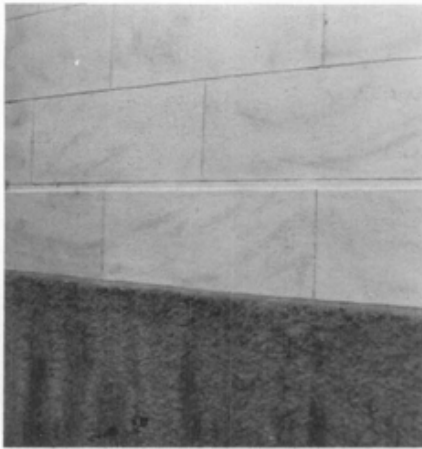
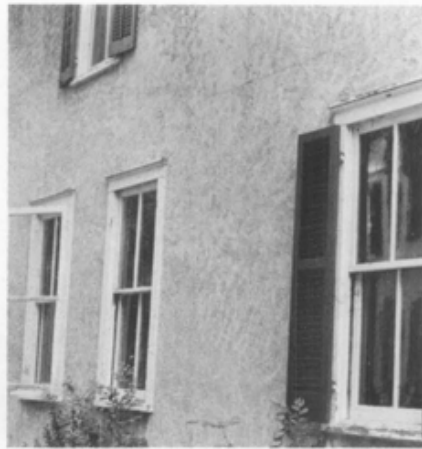
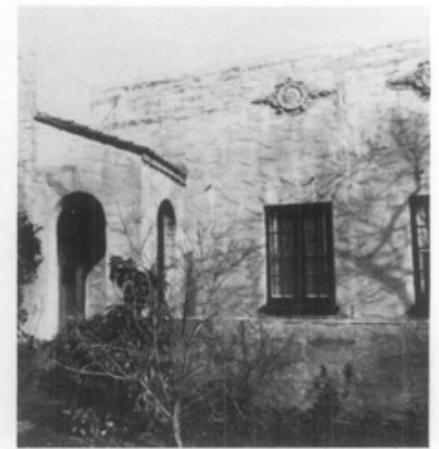
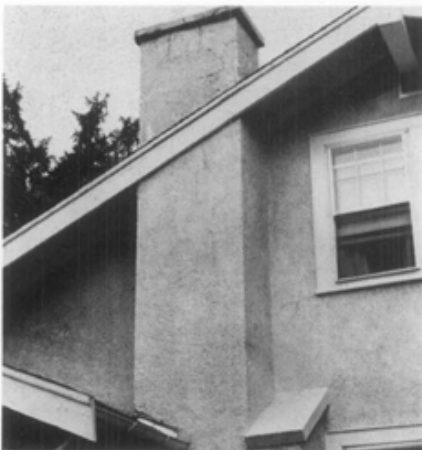
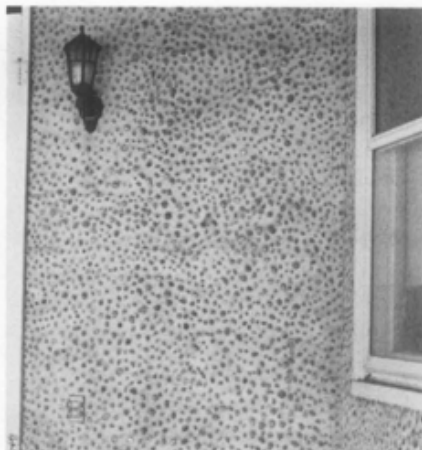
The most common early-twentieth century stucco finishes are often found on bungalow-style houses, and include: **spatter** or **spatterdash** (sometimes called **roughcast**, **harling**, or **wetdash**), and **pebbledash** or **drydash**. The **spatterdash** finish is applied by throwing the stucco mortar against the wall using a whisk broom or a stiff fiber brush, and it requires considerable skill on the part of the plasterer to achieve a consistently rough wall surface. The mortar used to obtain this texture is usually composed simply of a regular sand, lime, and cement mortar, although it may sometimes contain small pebbles or crushed stone aggregate, which replaces one-half the normal sand content. The **pebbledash** or **drydash finish** is accomplished manually by the plasterer throwing or "dashing" dry pebbles (about 1/8" to 1/4" in size), onto a coat of stucco freshly applied by another plasterer. The pebbles must be thrown at the wall with a scoop with sufficient force and skill that they will stick to the stuccoed wall. A more even or uniform surface can be achieved by patting the stones down with a wooden float. This finish may also be created using a texturing machine (Figs. d-f illustrate 3 versions of this finish. Photos: National Park Service Files).

A wide variety of decorative surface textures may be found on revival style stucco buildings, particularly residential architecture. These styles evolved in the late-nineteenth century and peaked in popularity in the early decades of the twentieth century. Frank Lloyd Wright favored a **smooth finish** stucco, which was imitated on much of the Prairie style architecture inspired by his work. Some of the more picturesque surface textures include: **English Cottage** or **English Cotswold finish**; **sponge finish** (Fig. b); **fan texture**; **adobe finish** (Fig. c), and **Spanish or Italian**
