Preserving Historic Ornamental Plaster

Preservation Briefs

23

David Flaharty

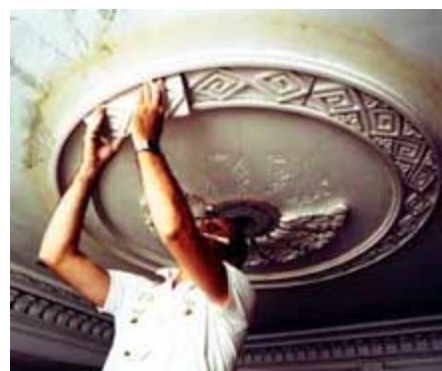
Running and enriching a ceiling medallion. Photo: Peter Sanders.

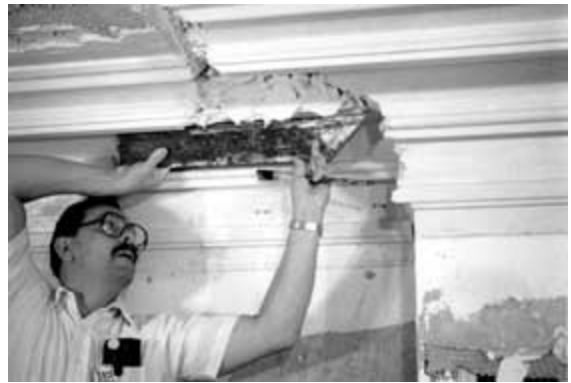
Mitering a plain-run cornice requires great dexterity using the miter rod. Photo: Old-House Journal.

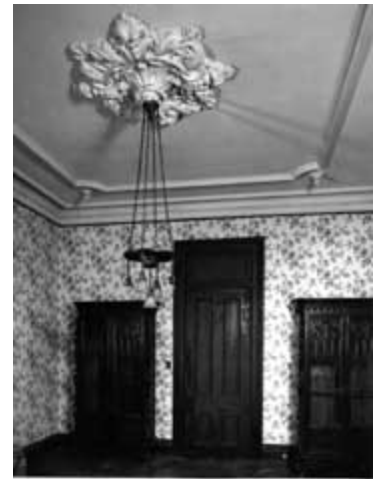
This parlor medallion and pendant drops shown in a mid-19th century house in Annapolis, Maryland, were originally ordered from a catalog. Photo: M.E. Warren.

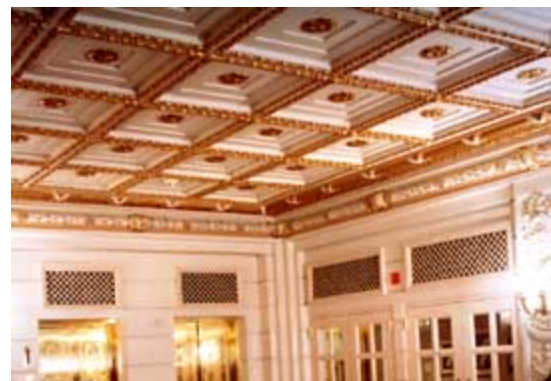
The elaborate coffered ceiling was designed for the Willard Hotel in Washington, D.C. (1902-04) by Henry Janeway Hardenbergh. It was restored as part of a rehabilitation project in the 1980s. Photo: Carol M. Highsmith.

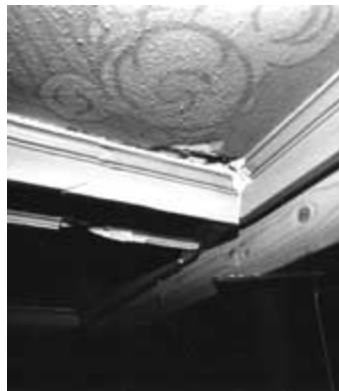
Structural settling has caused this ceiling to deflect. A structural engineer will shore-up the ceiling from below and re-attach the sagging ceiling plaster with the joists above. Photo: NPS files.

First, roof or plumbing leaks must be repaired to eliminate the problem of water intrusion. General structural repairs should be undertaken to arrest building movement, which weakens the base coat plasters to which the ornamental enrichments are attached. Ornamental plaster deflection should be corrected by shoring from below followed by re-anchoring.

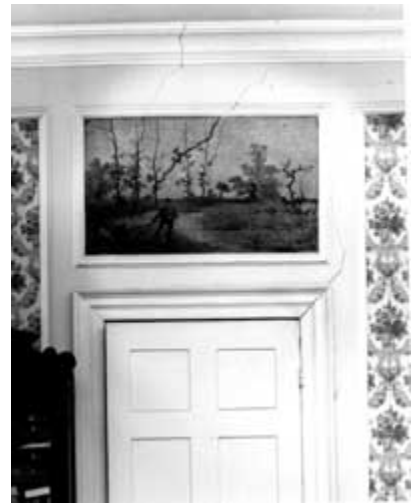
Settlement caused stress cracking through both flat wall and ornamental plaster. Repairs to the cornice molding involve chamfering the stress cracks to a "V groove," and patching with a mixture of gypsum and lime. Photo: Jack E. Boucher, HABS, NPS.

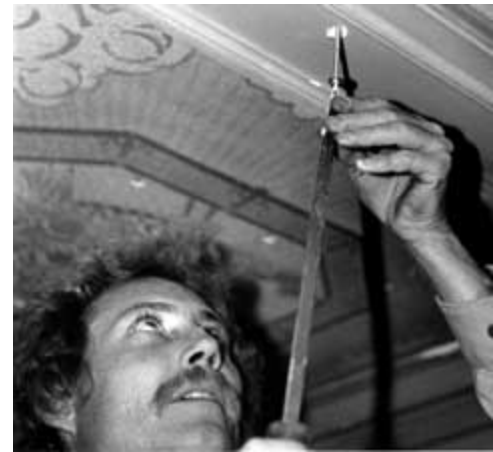
Where this ceiling was suffering from structural failure, the first step was to shore it up from below. Then, toggle bolts (seen here) were used to re-attach the plaster molding to the ceiling joists. Finally, the ceiling was patched, prior to restoring significant finishes. Photo: NPS files.

If the lath or keys have failed, plaster ceiling ornament may be saved, in whole or in part, by removing floor boards above, then drilling and injecting each lath with an elastic acrylic or epoxy material to reattach plaster to lath, and lath to the joists. This is a recently developed procedure which should only be undertaken by experienced professionals. The consolidation and reattachment process has been used successfully in period structures with dramatic results when important plaster and painted surfaces would otherwise have been lost.

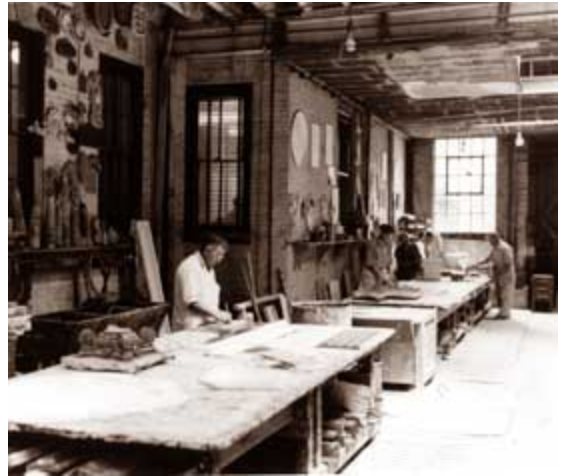
This plaster studio is well organized, with ample work space. Note the plaster casts hanging neatly on the wall. Photo: Berry and Homer, Philadelphia.

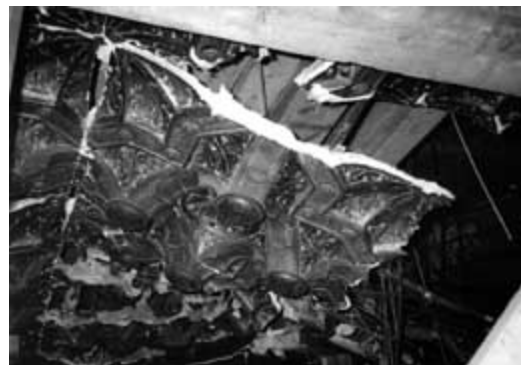
The Yiddish Arts Theater, New York City, c. 1920s. The concrete roof of this building had collapsed, damaging portions of the existing Moorish style coffered ceiling. The square coffer unit was easily identifiable and was removed to a casting shop for reproduction. Photo: David Flaharty.

But even this level of damage can usually be remedied by restoration professionals. Immediate action calls for shoring the areas adjacent to the damage, and inspecting the hanging apparatus for unforeseen detachment and deflection. New channel iron is used to stabilize the existing coffers and ties reinforced, as necessary. An intact coffering unit is then identified and carefully removed to a casting shop for molding and casting. When rehung, the units are painted to match the historic coffering.

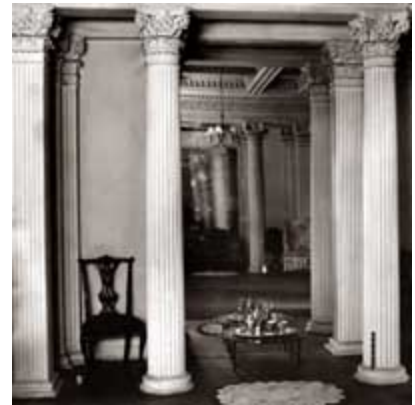
These Greek Revival columns (Gaineswood, Demopolis, Alabama, c. 1842-60) were drawn from Minard Lafever's *Beauties of Modern Architecture* of 1835. This bold new style began in New York City and quickly spread south and west. Photo: HABS Collection, NPS.
