23 PRESERVATION BRIEFS

Preserving Historic Ornamental Plaster

David Flaharty

U.S. Department of the Interior
National Park Service
Cultural Resources
Heritage Preservation Services

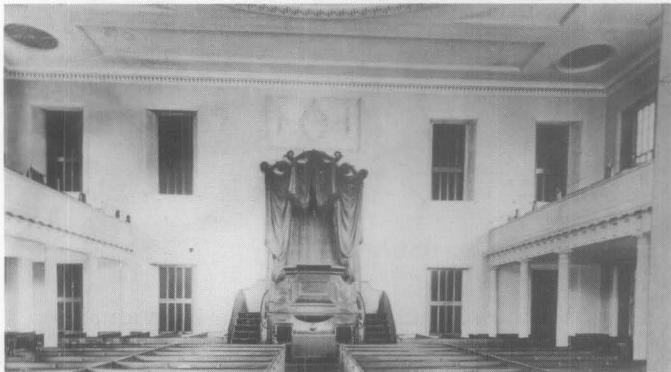
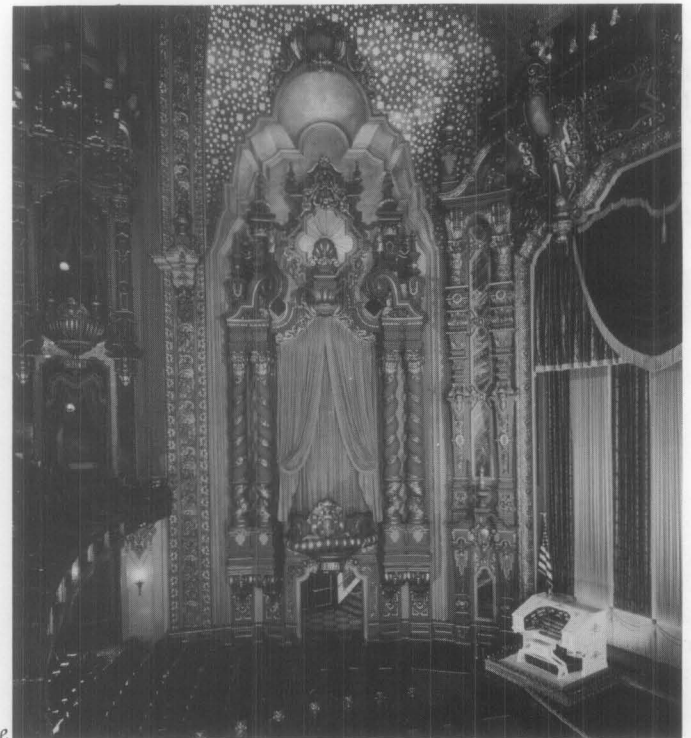
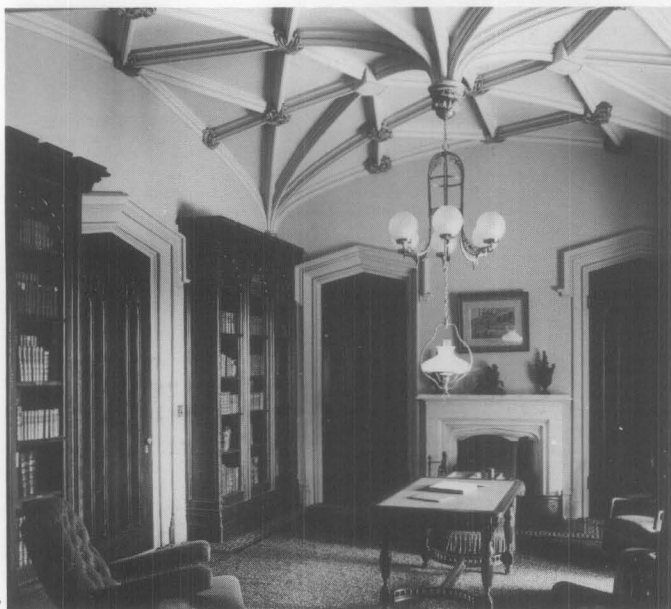
Styles of Decorative Plaster in America, 18th–20th Centuries

(a) Kenmore, Fredericksburg, Virginia, c. 1752. Georgian in style with ornamental ceilings based on Batty Langley's 1739 English style book, the plasterwork was executed by a Frenchman in the mid-1770s. This house was built by Col. Fielding Lewis and has the most elaborate ornamentation of any in the period. Photo: Historic American Buildings Survey Collection.

(b) Old West Church, Boston, Massachusetts, c. 1806. Designed by Asher Benjamin, this church in the Federal-Adamesque style became the prototype for many other New England churches through publication of plans in Benjamin's *American Builder's Companion*. Photo: Courtesy, Stanley P. Mixon (copy).

(c) Lyndhurst, Tarrytown, New York, c. 1838. This Gothic Revival villa on the Hudson River was built for financier Jay Gould by Alexander Jackson Davis. A versatile architect, Davis was simultaneously at work on Greek Revival buildings in New York City. Both styles called for elaborate ornamental plasterwork. Photo: Jack E. Boucher, Historic American Buildings Survey.

(d) Gaineswood, Demopolis, Alabama, c. 1842–60. These Greek Revival columns were drawn from Minard Lafever's *The Beauties of Modern Architecture* of 1835. This bold new style began in New York City and quickly spread south and west. Photo: Historic American Buildings Survey Collection.

(e) Ohio Theater, Columbus, Ohio, c. 1928. An example of the "Golden Age" of movie palaces, Thomas Lamb's "Spanish" style interior is a typical example of the plasterwork executed just prior to the Depression years. Ornament was site cast, often on the stage, while the orchestra was scaffolded for installation. Photo: National Park Service files.

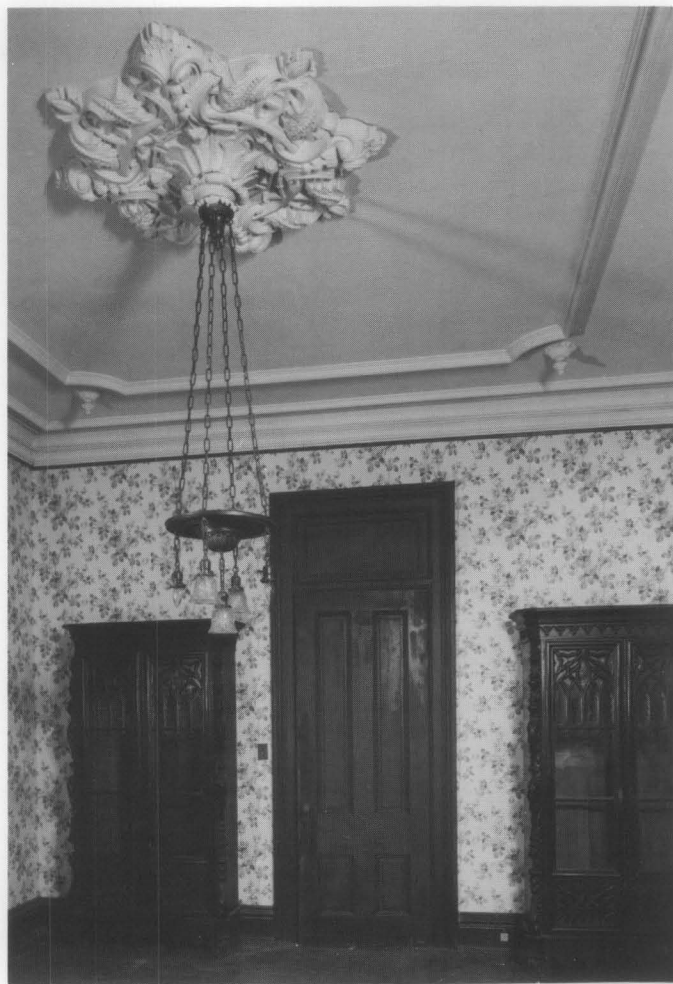
Fig. 2. This parlor medallion and pendant drops shown in a mid-19th century row house in Annapolis, Maryland were originally ordered from a catalog. A local plasterer ran the plain cornice and band ribbon, the curved corners of which were bench run, set with a plaster adhesive and pointed at the joints. Photo: M. E. Warren.

Plasterers' guilds were in existence in Philadelphia in the 1790s. In 1864, a plasterers' union was organized in the United States with members from the British Isles whose work there had been limited to palaces and churches. English and European craftsmen came to America where the demand for their skills had increased by the decade, offering them the unparalleled opportunity to open their own shops. Over the years, plaster elements became so popular in decorating interior spaces that a major industry was established. By the 1880s, catalogs were available from which property owners could select ornamentation for their splendid new buildings (see Fig. 2).

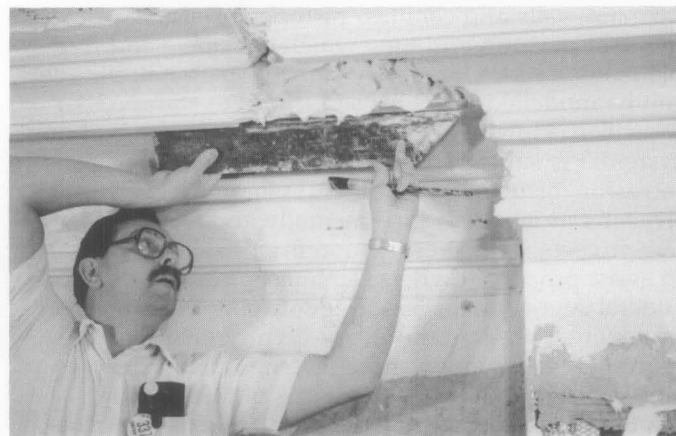
Fig. 5. Miterring a Plain-Run Cornice. Miterring requires great dexterity using the miter rod. In this case, a return at a chimney breast is tooled using an infill of gypsum and lime. Internal and external miters are required with the internal being the most difficult. Another method is to run a length of cornice (using the same blade) on a bench and set it in place, later to point the joints. Photo: Old-House Journal.

Short lengths of new cornice are best run on a bench using gypsum and lime; the reproduction molding should be somewhat longer than the required length (see Fig 18). The new footage is cut and fit in place to match the existing cornice, then securely countersunk-screwed to studs, joists and/or blocking. The resulting joints are pointed with flat mitering rods, flush with adjacent members (see Fig. 5, above).

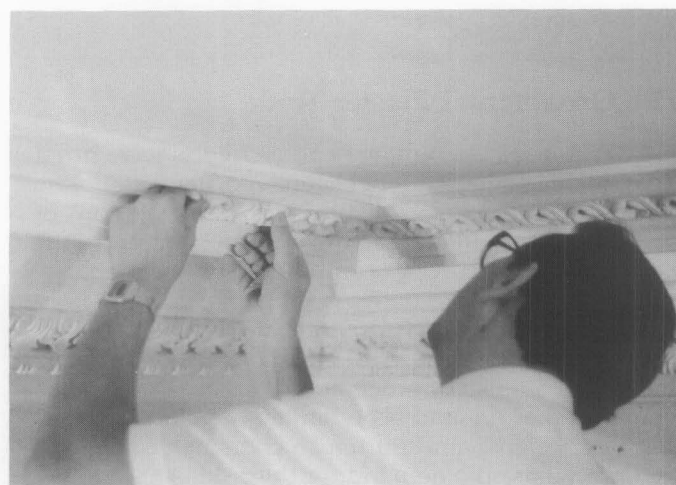
Fig. 6. Enriching a Plain-Run Cornice. After a cornice is run and mitered, cast enrichments are stuck in recessed sinkages planned to receive the casts. Ornamental models are made to engage with one another, resulting in unbroken lines or courses. A shop-cast ornament is soaked in water until saturated and pressed into its sinkage using wet plaster as an adhesive. Once the casts have been installed, they are carefully pointed at the joints and at the miters so that they appear as a continuous, repetitive design. Photo: Old-House Journal.

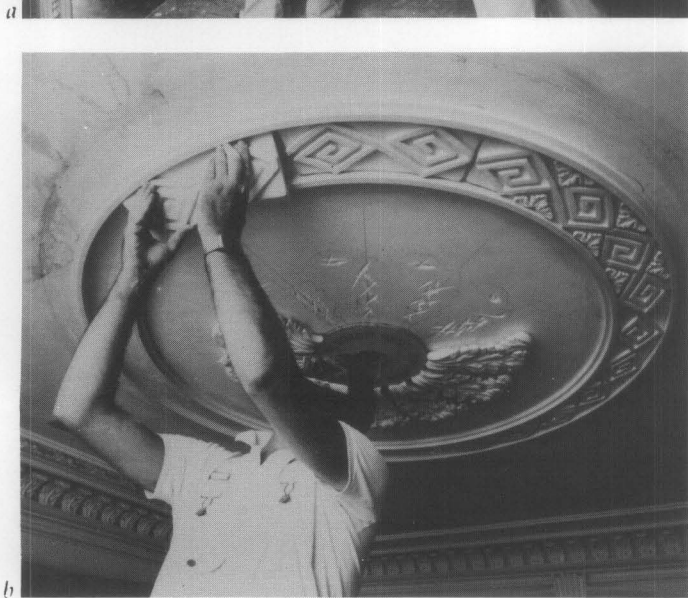
Fig. 7. Running and Enriching a Ceiling Medallion. The method of running and enriching a ceiling medallion remains the same today. (a) First, a plain-run surround is spun from a pivot point centered in the ceiling field. (b) Ornament layout is determined using plane geometric principles; segmented locations are deeply scratched to provide a rough surface for adequate bonding using plaster as an adhesive. Historically, cast enrichments could be bought from local suppliers and set individually, allowing architects to compose medallions to suit room dimensions and period motifs. Photos: Peter Sanders.

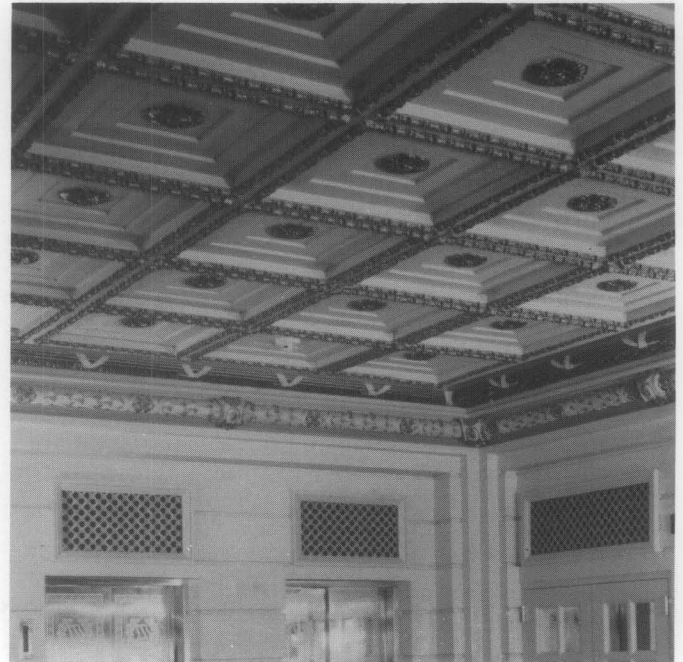
Fig. 9. The elaborate coffered ceiling was designed for the Willard Hotel in Washington, D.C. (1902–04) by Henry Janeway Hardenbergh. The coffered ceiling was restored as part of a rehabilitation project in the 1980s. Photo: Carol M. Highsmith.

identical in reflected plan; on domed or barrel ceilings, coffers differ from course to course so as to appear identical from various sight lines. The finish treatment of a coffered ceiling frequently exhibits the height of the painter's craft. Foremost examples of ceiling coffering include the United States Capitol, and Washington D. C.'s Union Station. As a popular decorative form with inherent acoustical benefits, the coffered ceiling is seen across the United States in many large public spaces such as theaters, courthouses, railroad stations, and hotels (see Fig. 9).

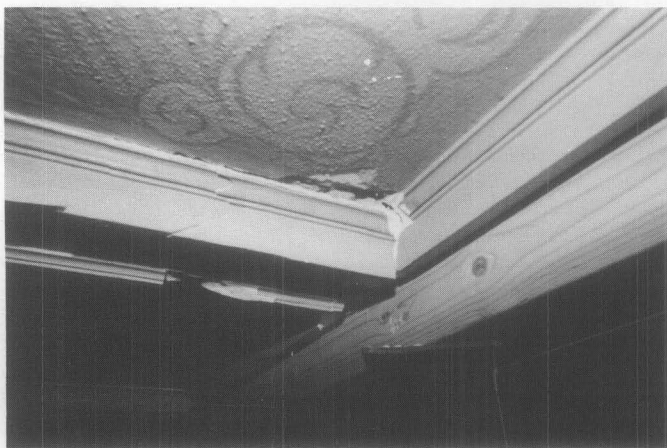
Fig. 10. Structural settling has caused this ceiling to deflect. Prior to restoring the damaged plaster and final repainting, a structural engineer experienced in historic preservation will be engaged to shore-up the ceiling from below and reattach the sagging ceiling plaster with the joists above (see also Fig. 17 under Immediate Action.) Photo: National Park Service files.

Signs of Failure. Failure of the substrate is more typical than failure of the plaster ornament itself. Among the reasons for deterioration, **structural movement** (see Fig. 10) and **water intrusion** (see Fig. 11) are the most deleterious. Buildings move and settle, causing deflection and delamination which result in stress cracking. These cracks often begin at the corners of windows and doors and extend upward at acute angles (see Fig. 12). Roof or plumbing leaks make finishes discolor and peel and cause efflorescence, especially on plain-run or enriched cornices. Unheated buildings with water intrusion are subject to **freeze-thaw cycles** which ultimately result in base coat and ornamental plaster failure (see Fig. 13).

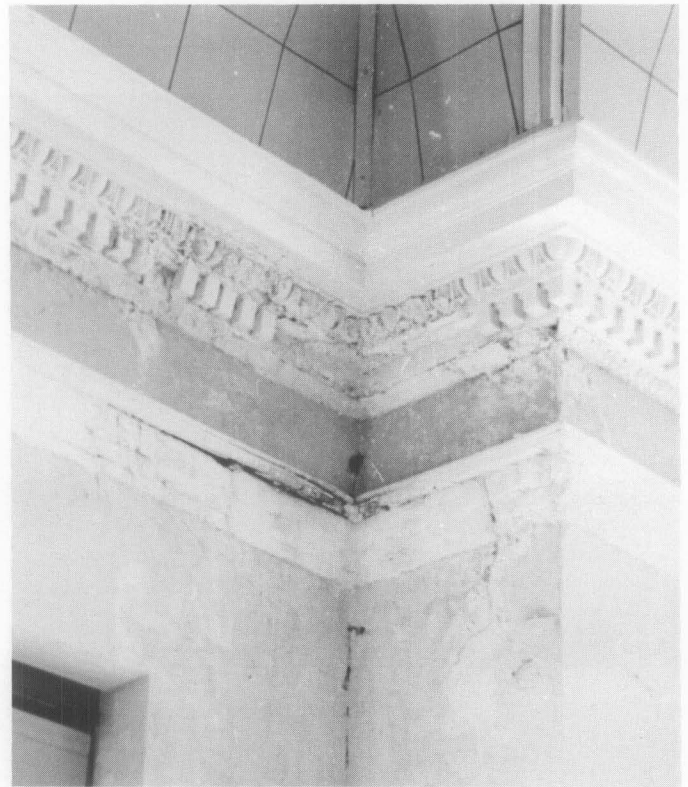
Fig. 11. The cornice of an Iowa courthouse has been severely damaged from a roof leak. In order to repair the ornamental plaster, a thixotropic rubber impression will be taken (with the paint build-up undisturbed). The efflorescence will be removed and fresh plaster casts installed so that egg and dart, dentil and leaf molding are perfectly aligned. Photo: National Park Service files.

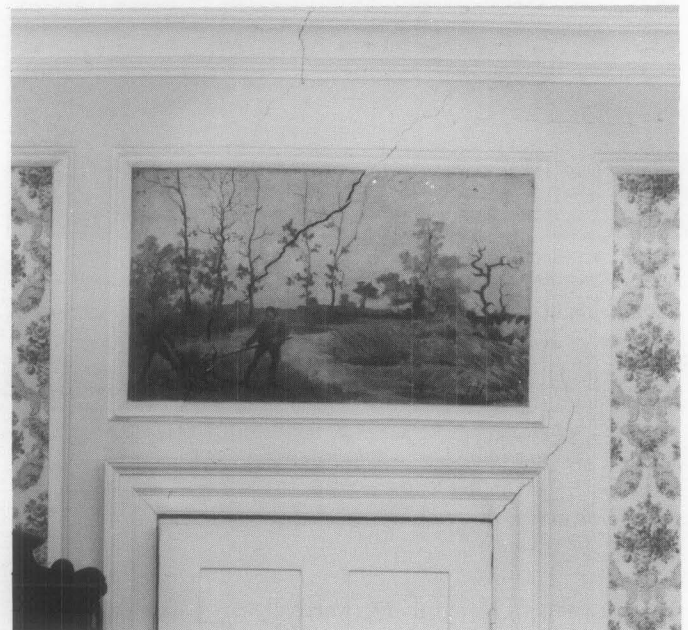
Fig. 12. Settlement caused stress cracking through both flat wall and ornamental plaster. Repairs to the cornice molding involve chamfering the stress cracks to a "V groove" and patching with a mixture of gypsum and lime. The cornice can be countersunk-screwed to its substrate to prevent further movement. Screw heads are then plastered over. The crack running through the painting will need to be filled carefully, and the painting restored by a trained conservator. Photo: Jack E. Boucher, Historic American Buildings Survey.

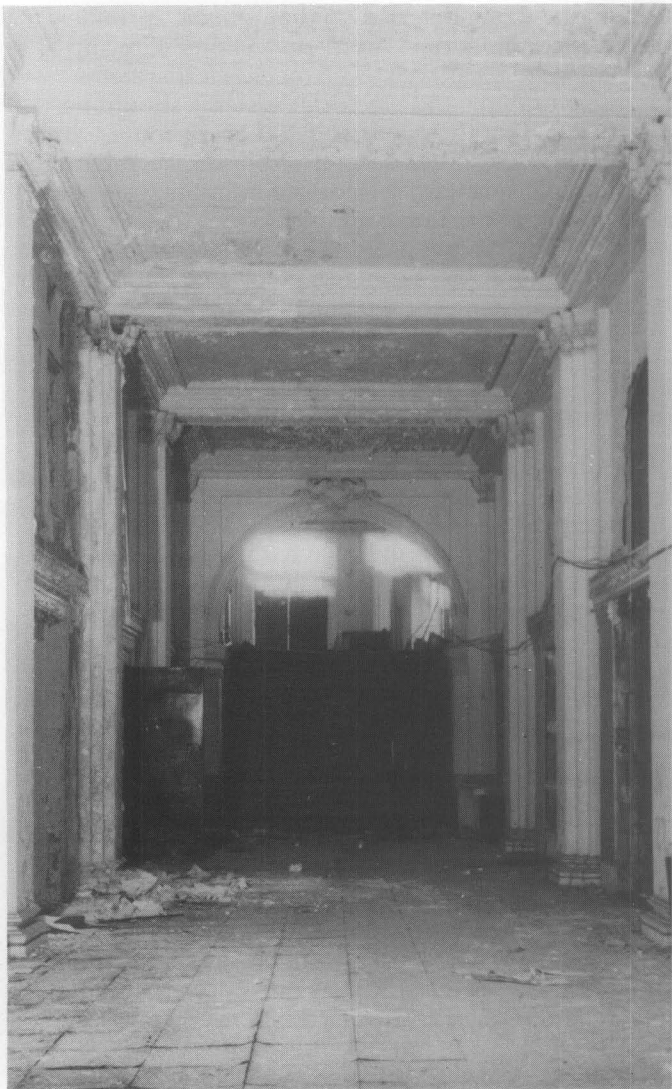
Fig. 13. Water intrusion and freeze/thaw cycles caused extensive efflorescence and ornamental plaster failure. The plaster needed almost total replacement within the rehabilitation project. Photo: Commercial Photographics.

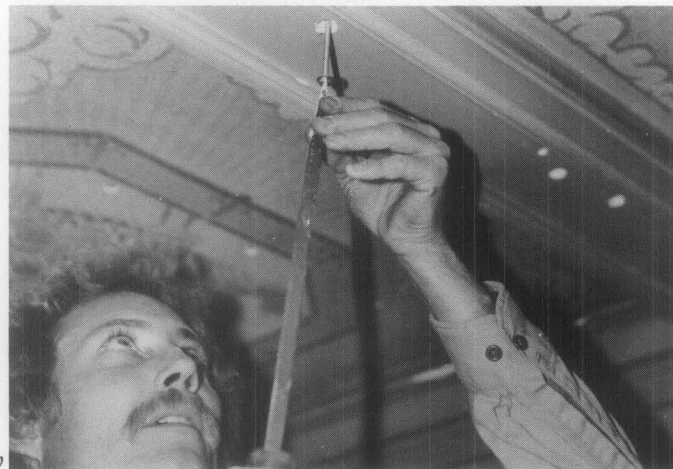
Fig. 17 (a) Where this ceiling was suffering from structural failure, the first step was to shore it up from below. (b) Toggle bolts were used to reattach the plaster molding to the ceiling joists. The ceiling was then patched with gypsum and lime, prior to restoring the significant paint finishes. Photos: National Park Service files.

First, roof or plumbing leaks must be repaired to eliminate the problem of water intrusion. General structural repairs should be undertaken to arrest building movement, which weakens the base coat plasters to which the ornamental enrichments are attached. Ornamental plaster deflection should be corrected by shoring from below followed by re-anchoring (see Fig. 17).

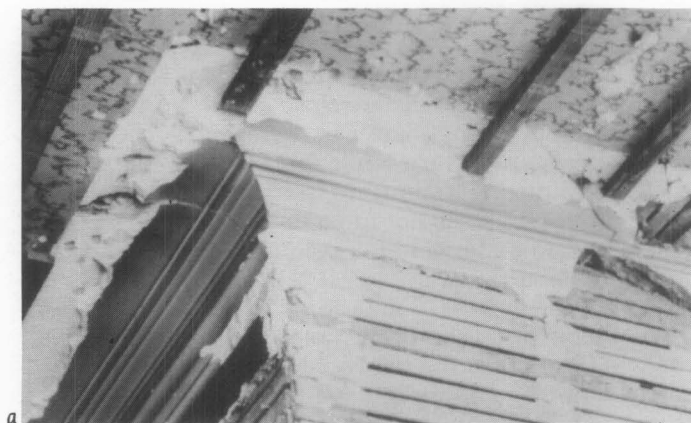
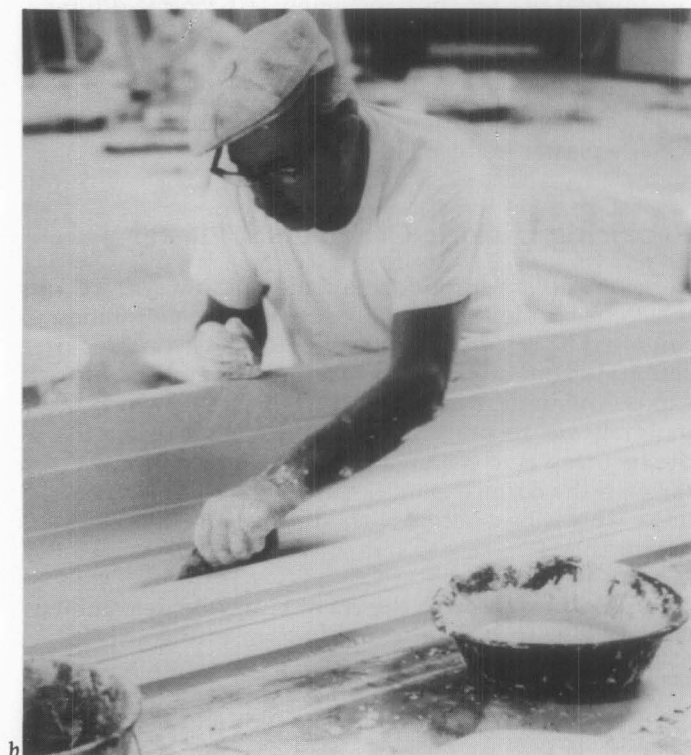
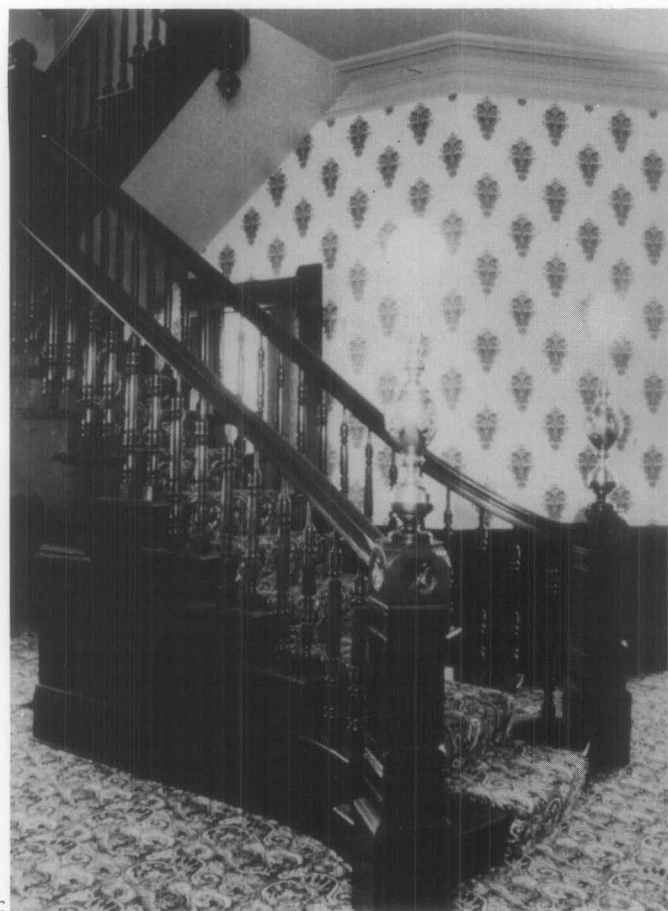
Fig. 18. Repairing a Cornice. (a) In the restoration of the Henry Hirshfeld House, a 19th century residence in Austin, Texas, removal of a tin ceiling revealed a damaged plain-run cornice. Photo: John Volz, ALA. (b) A section through the molding was taken, a template blade cut, horsed-up, and run on a bench using gypsum and lime. Photo: Charles E. Fisher. (c) The new cornice was then cut, fitted, and applied to new blocking between wall and ceiling. The external miter and returns were pointed using the miter rod. After the ceiling restoration was complete, other finishes, such as wallpaper, were applied. Photo: Candace Volz.

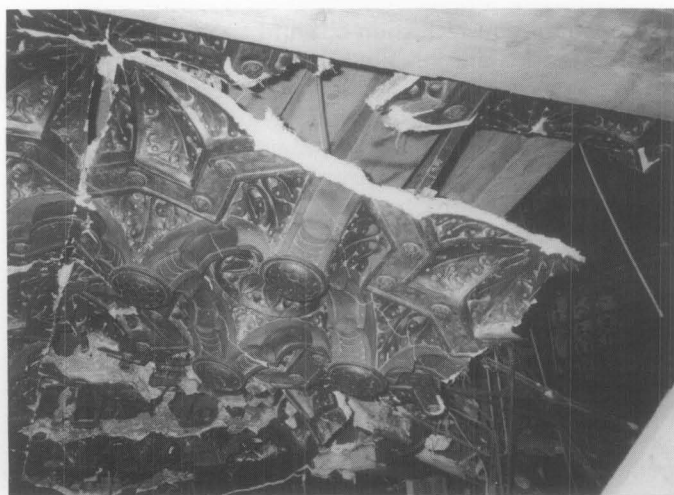
Fig. 21. The Yiddish Arts Theater, New York City, c. 1920s. The concrete roof of this building collapsed, damaging portions of the existing Moorish style coffered ceiling. The square coffer unit was easily identifiable and was removed to a casting shop for reproduction. Photo: David Flaharty.

Coffered Ceiling. Like cornices and medallions, coffered ceilings suffer from poor maintenance practices and structural problems; however, these individually cast ceiling units are particularly vulnerable when a building is being rehabilitated and great care is not taken in executing the work. In the most serious of cases, portions of a roof can collapse, dropping heavy debris through the hanging coffering panels, and demolishing large portions of the ornamentation (see Fig. 21).

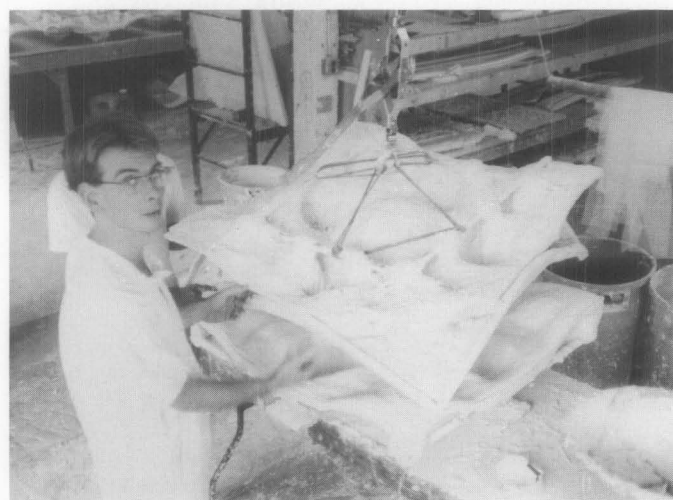
Fig. 22. Repairing a Coffered Ceiling. As part of the theater rehabilitation, the coffered ceiling panels are being reproduced in urethane rubber molds and reinforced with open weave burlap and wood fiber. Steel channel irons can be seen, attached to the backs of the casts. Later, these irons are used to hang the panels from a superstructure at the site. Photo: David Flaharty.

and deflection. New channel iron is used to stabilize the existing coffers and ties reinforced, as necessary. An intact coffering unit is then identified and carefully removed to a casting shop for molding and casting (see Fig. 22). When re-hung, the units are painted to match the historic coffering (see Fig. 23).

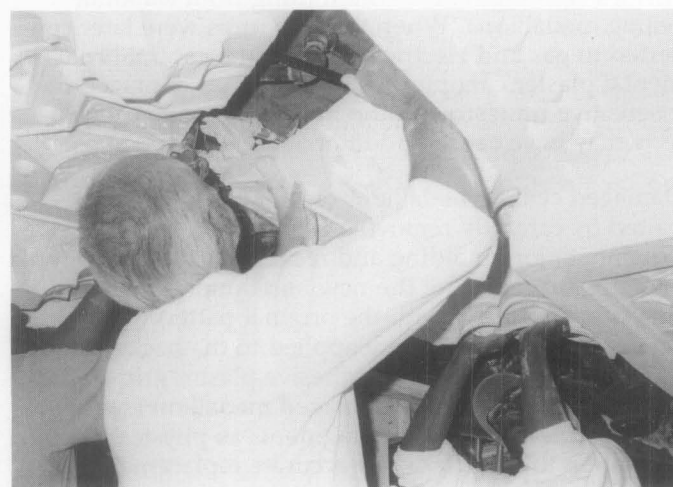
Fig. 23. A pre-cast coffer is lifted into place to abut adjacent panels. Tie wire will be fastened to the channel irons and the superstructure above, twisted to level, and finally wadded with wood fiber soaked in plaster to prevent the wire from stretching. Photo: David Flaharty.

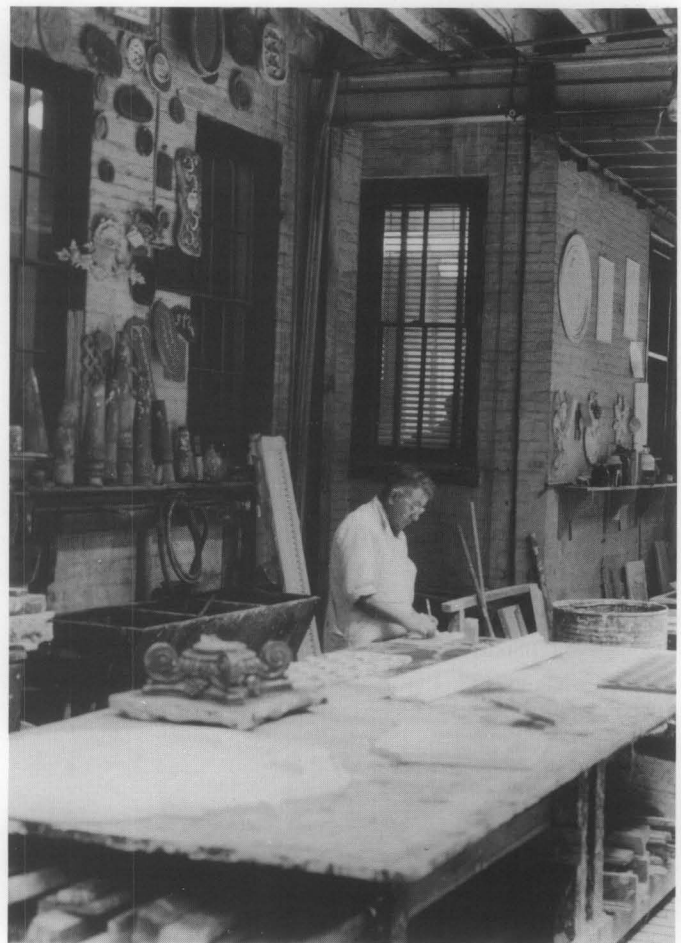
Fig. 24. This plaster studio is well organized, with ample work space. Note the plaster casts hanging neatly on the wall. Photo: Berry and Homer, Philadelphia.

or developer should secure the services of a reputable restoration contractor before proceeding further. It is clear as more and more projects are undertaken, that there is a wide disparity of skills within the trade today. This is partly due to the introduction of gypsum board as a substitute for traditional plastering. As gypsum board became popular after World War II, plasterers saw the demand for their skills decline. Plastering techniques were forgotten because they were often not passed down within shops and families. However, ornamental plaster studios have seen a resurgence in demand for their services in the last decade, particularly as more historic buildings are rehabilitated (see Fig. 24).
