18 PRESERVATION BRIEFS

Rehabilitating Interiors in Historic Buildings

Identifying and Preserving Character-defining Elements

U.S. Department of the Interior
National Park Service
Cultural Resources
Heritage Preservation Services

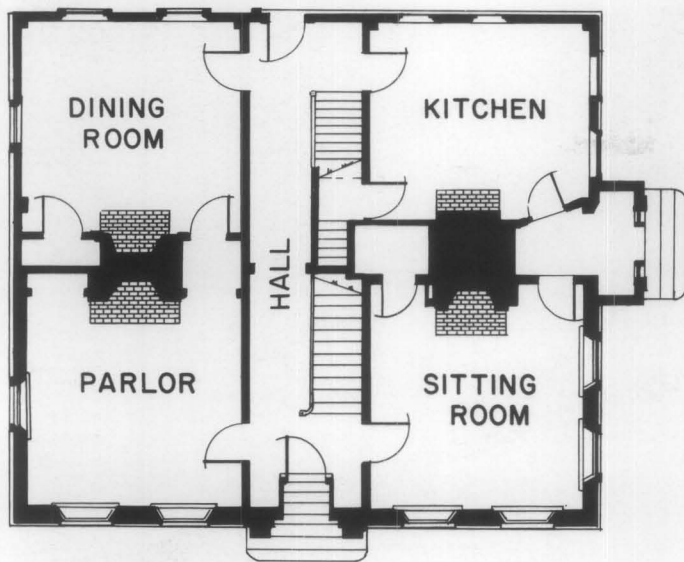
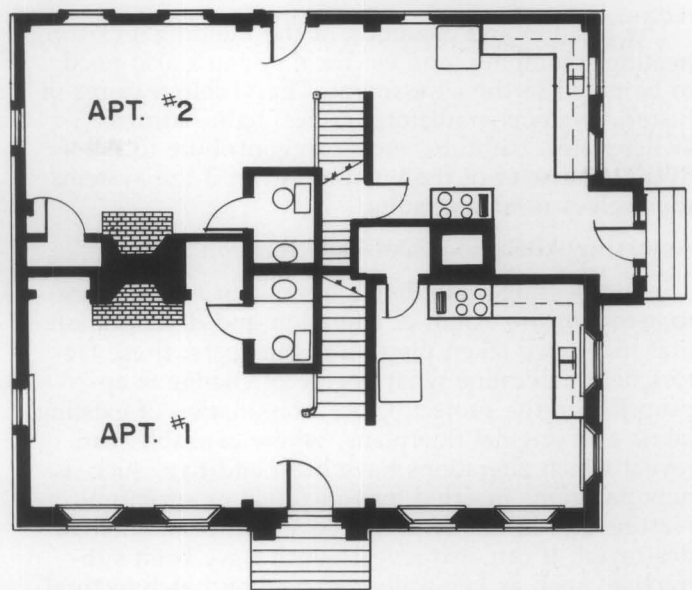
Figure 3. The floor plan at left is characteristic of many 19th century Greek Revival houses, with large rooms flanking a central hall. In the process of rehabilitation, the plan (at right) was drastically altered to accommodate two duplex apartments. The open stair was replaced with one that is enclosed, two fireplaces were eliminated, and Greek Revival trim around windows and doors was removed. The symmetry of the rooms themselves was destroyed with the insertion of bathrooms and kitchens. Few vestiges of the 19th century interior survived the rehabilitation. Drawing by Neal A. Vogel

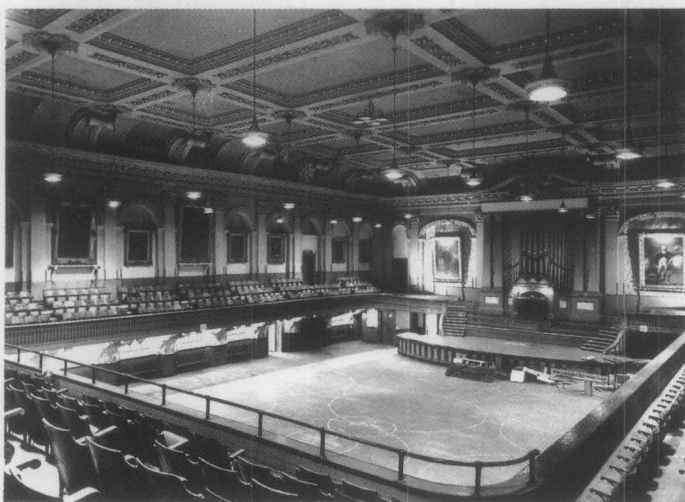
Figure 4. Many institutional buildings possess distinctive spaces or floor plans that are important in conveying the significance of the property. Finding new compatible uses for these buildings and preserving the buildings' historic character can be a difficult, if not impossible, task. One such case is Mechanics Hall in Worcester, Massachusetts, constructed between 1855 and 1857. This grand hall, which occupies the entire third floor of the building, could not be subdivided without destroying the integrity of the space.

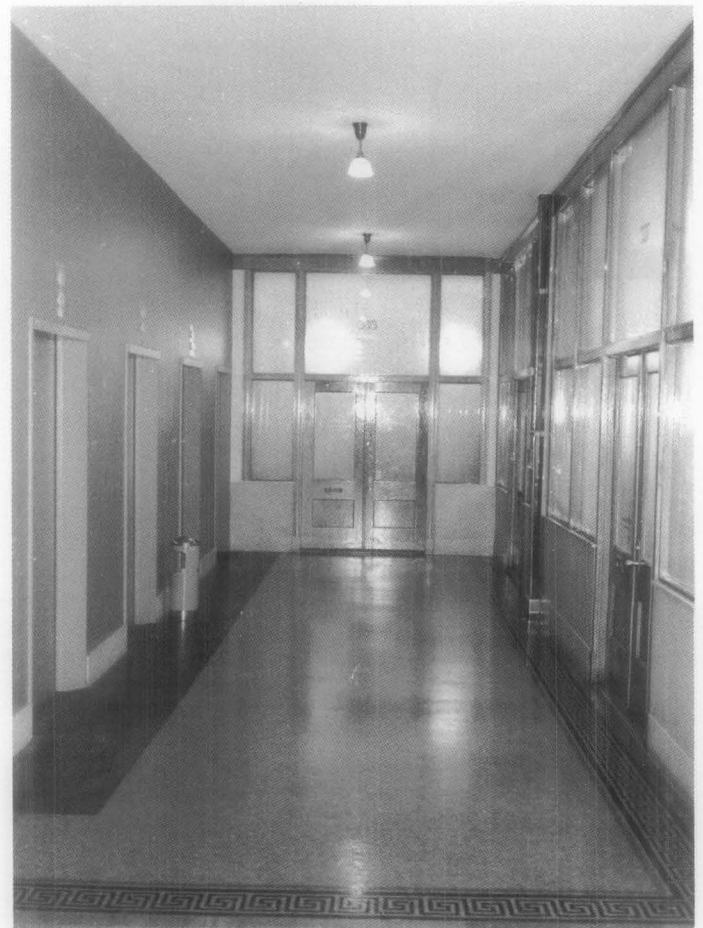
Figure 6. This corridor, located in the historic Monadnock Building in Chicago, has glazed walls, oak trim, and marble wainscoting, and is typical of those found in late 19th and early 20th century office buildings. Despite the simplicity of the features, a careful attention to detail can be noted in the patterned tile floor, bronze mail chute, and door hardware. The retention of corridors like this one should be a priority in rehabilitation projects involving commercial buildings.

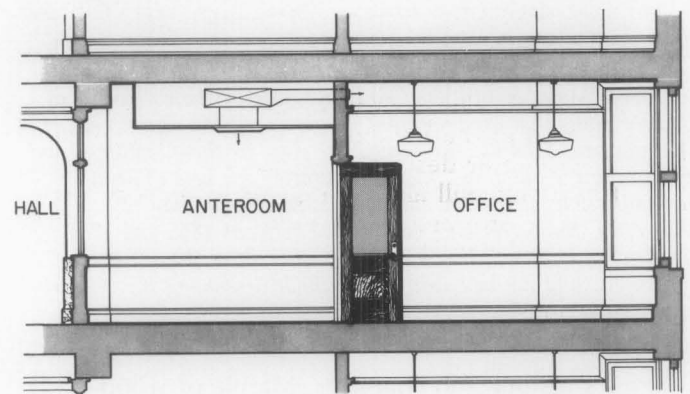
Figure 7. When the Monadnock Building was rehabilitated, architects retained the basic floor plan on the upper floors consisting of a double-loaded corridor with offices opening onto it. The original floor-to-ceiling height in the corridors and outside offices—the most important spaces—was maintained by installing needed air conditioning ductwork in the less important anterooms. In this way, the most significant interior spaces were preserved intact. Drawing by Neal A. Vogel

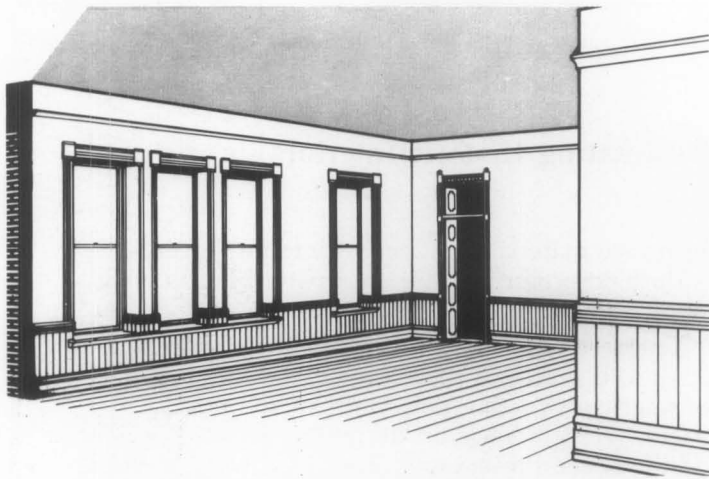
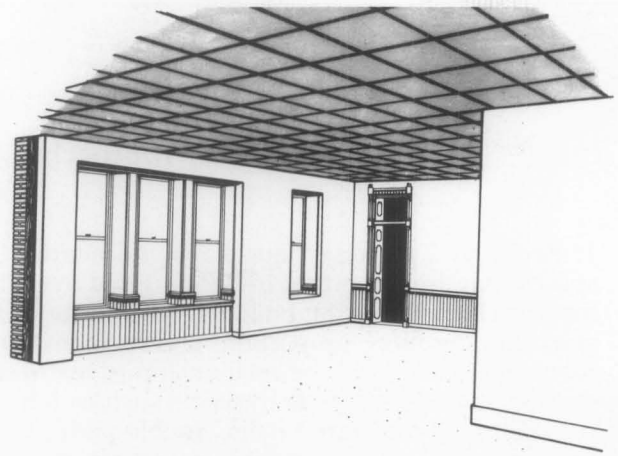
Figure 8. Furring out exterior walls to add insulation and suspending new ceilings to hide ductwork and wiring can change a room's proportions and can cause interior features to appear fragmented. In this case, a school was converted into apartments, and individual classrooms became living rooms, bedrooms, and kitchens. On the left is an illustration of a classroom prior to rehabilitation; note the generous floor-to-ceiling height, wood wainscoting, molded baseboard, picture molding, and Eastlake Style door and window trim. After rehabilitation, on the right, only fragments of the historic detailing survive: the ceiling has been dropped below the picture molding, the remaining wainscoting appears to be randomly placed, and some of the window trim has been obscured. Together with the subdivision of the classrooms, these rehabilitation treatments prevent a clear understanding of the original classroom's design and space. If thermal performance must be improved, alternatives to furring out walls and suspending new ceilings, such as installing insulation in attics and basements, should be considered. Drawings by Neal A. Vogel

8. Avoid "furring out" perimeter walls for insulation purposes. This requires unnecessary removal of window trim and can change a room's proportions. Consider alternative means of improving thermal performance, such as installing insulation in attics and basements and adding storm windows.

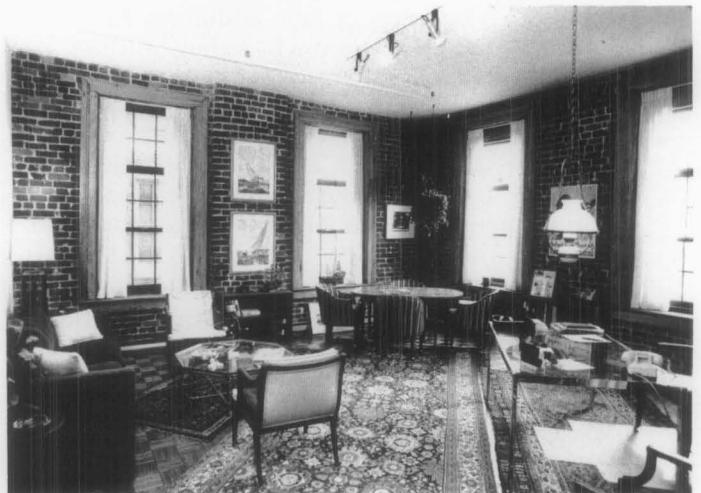
Figure 10. In this case plaster has been removed from perimeter walls, leaving brick exposed. In removing finishes from historic masonry walls, not only is there a loss of historic finish, but raw, unfinished walls are exposed, giving the interior an appearance it never had. Here, the exposed brick is of poor quality and the mortar joints are wide and badly struck. Plaster should have been retained and repaired, as necessary.

9. Avoid removing paint and plaster from traditionally finished surfaces, to expose masonry and wood. Conversely, avoid painting previously unpainted millwork. Repairing deteriorated plasterwork is encouraged. If the plaster is too deteriorated to save, and the walls and ceilings are not highly ornamented, gypsum board may be an acceptable replacement material. The use of paint colors appropriate to the period of the building's construction is encouraged.
