The Preservation and Repair of Historic Stucco

Preservation Briefs

22

Anne E. Grimmer

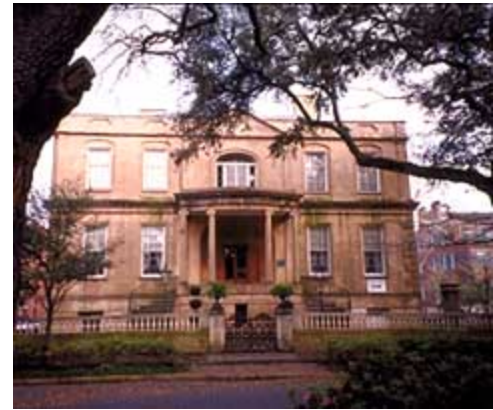
The stucco on the early-19th century Richardson-Owens-Thomas House in Savannah, Georgia, is a type of natural cement. Photo: NPS files.

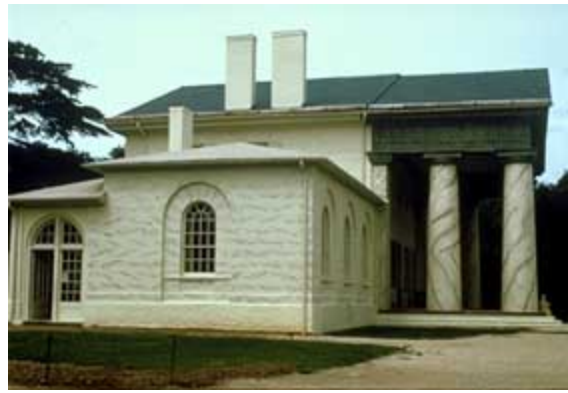
The stucco finish on Arlington House, Arlington, Virginia, was marbled in the 1850s, approximately 30 years after it was built. Photo: NPS files.

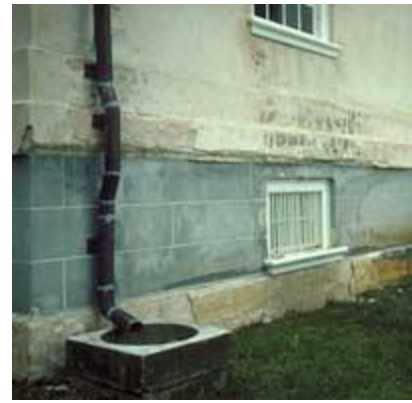
The damage to this stucco appears to be caused by moisture infiltration. Photo: NPS files.

Most stucco deterioration is the result of water infiltration into the building structure, either through the roof, around chimneys, window and door openings, or excessive ground water or moisture penetrating through, or splashing up from the foundation. Potential causes of deterioration include: ground settlement lintel and door frame settlement, inadequate or leaking gutters and downspouts, intrusive vegetation, moisture migration within walls due to interior condensation and humidity, vapor drive problems caused by furnace, bathroom and kitchen vents, and rising damp resulting from excessive ground water and poor drainage around the foundation. Water infiltration will cause wood lath to rot, and metal lath and nails to rust, which eventually will cause stucco to lose its bond and pull away from its substrate.

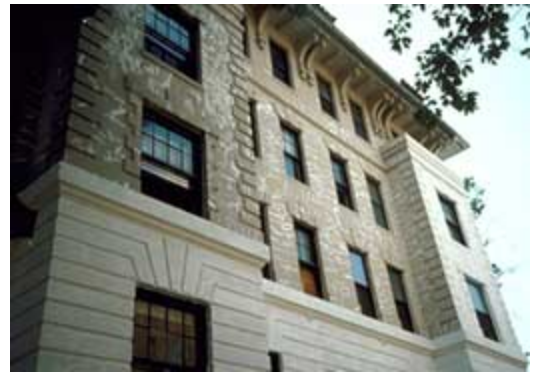
Caulking is not an appropriate method for repairing cracks in historic stucco. Photo: NPS files.

Commercially available caulking compounds are not suitable materials for patching hairline cracks. Because their consistency and texture is unlike that of stucco, they tend to weather differently, and attract more dirt; as a result, repairs made with caulking compounds may be

highly visible, and unsightly. Larger cracks will have to be cut out in preparation for more extensive repair. Most stucco repairs will require the skill and expertise of a professional plasterer.

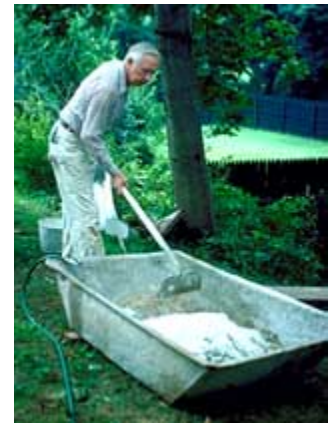
The dry materials must be mixed thoroughly before adding water to make the stucco. Photo: NPS files.

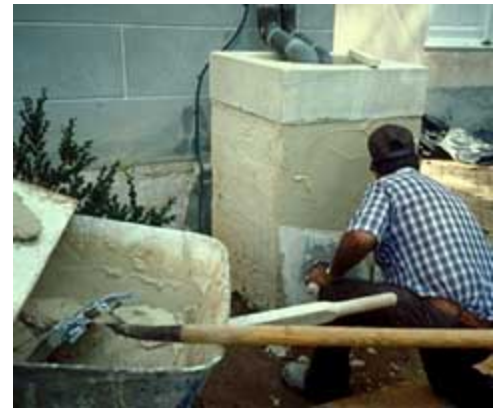
The deteriorated surface of this catch basin is being re-stuccoed. Photo: NPS files.

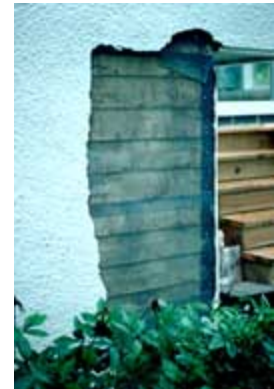
The stucco will be applied to the wire lath laid over the area to be patched.
Photo: NPS files.

To ensure a firm bond, the new patch must not overlap the old stucco. If the stucco has lost its bond or key from wood lath, or the lath has deteriorated or come loose from the substrate, a decision must be made whether to try to reattach the old lath, to replace deteriorated lath with new wood lath, or to leave the historic wood lath in place and supplement it with modern expanded metal lath. Unless authenticity is important, it is generally preferable (and

easier) to nail new metal lath over the old wood lath to support the patch. Metal lath that is no longer securely fastened to the substrate may be removed and replaced in kind, or left in place, and supplemented with new wire lath.

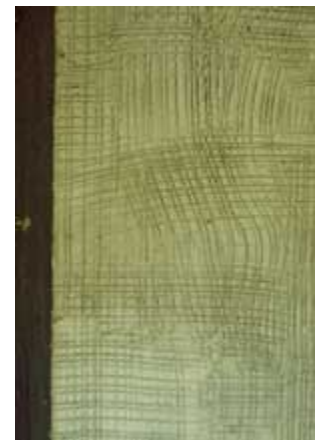
The final finish coat will be applied to this scratch coat. Photo: NPS files.

After thoroughly dampening the masonry or wood lath, the first, scratch coat should be applied to the masonry substrate, or wood or metal lath, in a thickness that corresponds to the original if extant, or generally about 1/4" to 3/8". The scratch coat should be scratched or crosshatched with a comb to provide a key to hold the second coat. It usually takes 24-72 hours, and longer in cold weather, for each coat to dry before the next coat can be applied. The second coat should be about the same thickness as the first, and the total thickness of the first two coats should generally not exceed about 5/8". This second or leveling coat should be roughened using a wood float with a nail protruding to provide a key for the final or finish coat. The finish coat, about 1/4" thick, is applied after the previous coat has initially set. If this is not feasible, the base coat should be thoroughly dampened when the finish coat is applied later. The finish coat should be worked to match the texture of the original stucco.

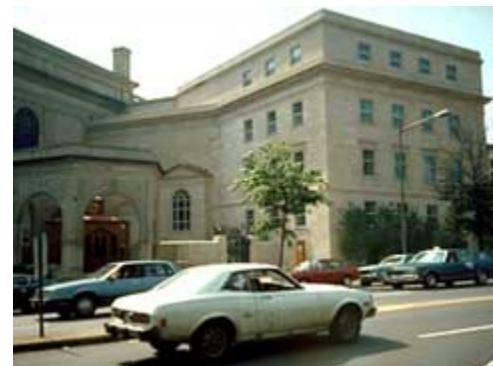
The new addition on the right is stucco scored to imitate the limestone of the historic building on the left. Photo: NPS files.

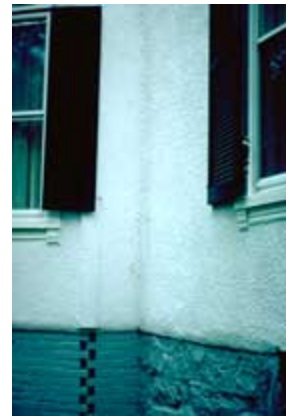
This stucco house has a rough cast finish.
Photo: NPS files.

The most common early-twentieth century stucco finishes are often found on bungalow-style houses, and include: spatter or spatterdash (sometimes called roughcast, harling, or wetdash), and pebble-dash or drydash. The spatterdash finish is applied by throwing the stucco mortar against the wall using a whisk broom or a stiff fiber brush, and it requires considerable skill on the part of the plasterer to achieve a consistently rough wall surface. The mortar used to obtain this texture is usually composed simply of a regular sand, lime, and cement mortar, although it may sometimes contain small pebbles or crushed stone aggregate, which replaces one-half the normal sand content. The pebble-dash or drydash finish is accomplished manually by the plasterer throwing or "dashing" dry pebbles (about 1/8" to 1/4" in size), onto a coat of stucco freshly applied by another plasterer. The pebbles must be thrown at the wall with a scoop with sufficient force and skill that they will stick to the stuccoed wall. A more even or uniform surface can be achieved by patting the stones down with a wooden float. This finish may also be created using a texturing machine.
