Buildera Application Note AN-14001

COLD-SHOWER MYSTERY SOLVED

Multi-Channel Data Loggers Improve Forensic Analysis of Complex Domestic Hot Water Complaints

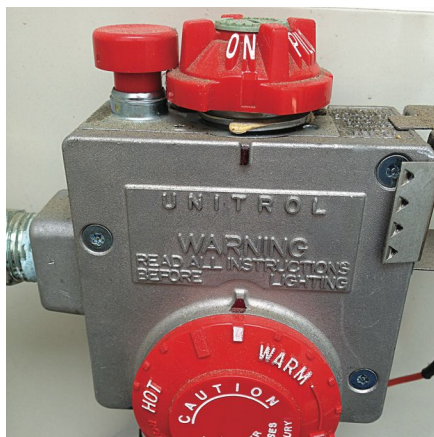
Figure 1. Residential hot-water thermostat set to 120°F temperature range.

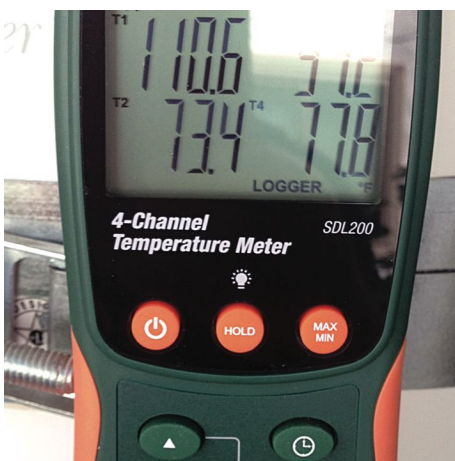
Quad-Channel Temperature Logger

Figure 4. Extech SDL200 4-Channel Temperature Meter and Data Logger. Logging interval set to 10-seconds for 48+ hours captured essential data for forensic analysis.

To assess overall temperature patterns, Buildera deployed the Extech® SDL200 4-Channel Temperature Meter in Figure 4 for its multi-channel capability and removable SD memory card, simplifying data export to an Apple® MacBook Air®. Tests were conducted over a two-day period between May 25-27, 2013 using various Type-K thermocouples optimized for the measurement

However, during the initial setup and validation, unexpected temperature offsets appeared across all thermocouple channels. A subsequent investigation revealed that, like many data loggers and acquisition systems, the SDL200 was susceptible to ground loops when measuring multiple thermocouples on a bonded system. This was due to small voltage offsets between each measurement node and non-isolated input amplifiers. True differential instrumentation input amplifiers are isolated from all other channels, including ground, helping to minimize channel interference and ground-induced noise.

To illustrate this point, Type-K thermocouples have a thermal sensitivity of 41 $\mu\text{V}/^\circ\text{C}$. Therefore, even just 100 μV of voltage offset due to ground current differentials across a finite impedance caused several degrees of error in the displayed temperature measurement. Measuring the voltage difference between thermocouples with an Agilent (Keysight) U1273A DMM, virtually all of the measured error could be correlated to the voltage differentials seen between grounded sensors. Although the hot and cold-water pipes were already bonded together, installing an additional heavy-gauge copper bonding wire between measurement points reduced the impedance and offset errors slightly, but not enough to justify a best practice.

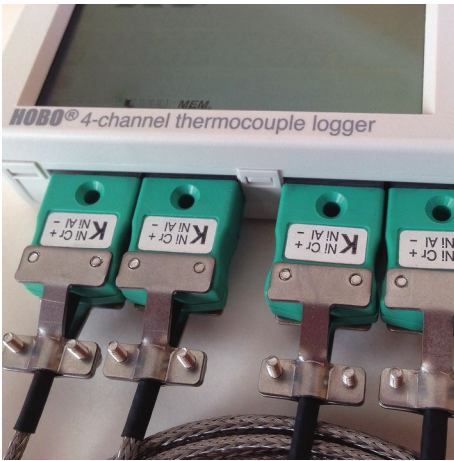
Onset® UX120-014M Quad Logger

Figure 5. The UX120-014M provides four dedicated thermocouple channels and an internal ambient temperature sensor.

In collaboration with Onset Computer Corporation, Buildera subsequently Beta tested and ultimately switched future field measurements to a production version of the Onset HOB0 UX120-014M Quad Thermocouple Data Logger (Figure 5), which offered improved measurement accuracy, as well as significantly longer battery life suitable for extended temperature studies lasting weeks or months. Regardless of logger choice, the user must always test for ground-loop errors and electrically isolate each measurement node if necessary.

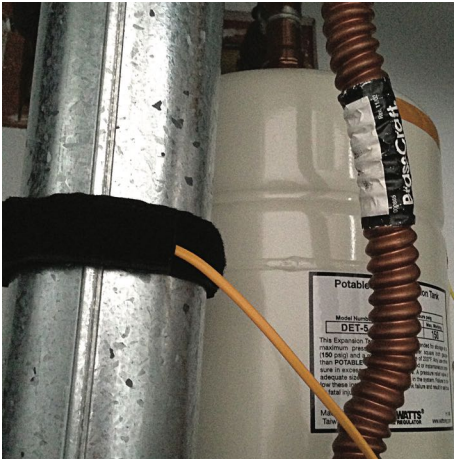
Measuring Flue Temperature

Figure 7. Measuring flue temperature $T[\text{flue}]$ with a Fluke® 80PK-11 strap-on type-K thermocouple provides an accurate indicator of thermostat on/off cycling.

Buildera deployed a Fluke® 80PK-11 Type-K Velcro® Thermocouple around the gas flue to non-invasively measure the external flue temperature. The thermocouple was placed on the water-heater vent approximately 6" above the flue outlet. This measurement provided a consistent proxy for thermostat activation. Upon firing, the flue surface temperature increased nearly instantaneously, rising to 220°F or thereabouts. Upon reaching the high trip point, the thermostat closed the gas valve. The flue temperature then dropped precipitously, providing a reliable indicator of the thermostat switch-off point. Performing low-pass filtering and thresholding of the data prior to taking the mathematical derivative of the flue temperature provided very accurate markers of step changes in temperature. The time delay between adjacent spikes indicated the duration of the heating cycle, which could be later converted into a binary on/off plot versus time.

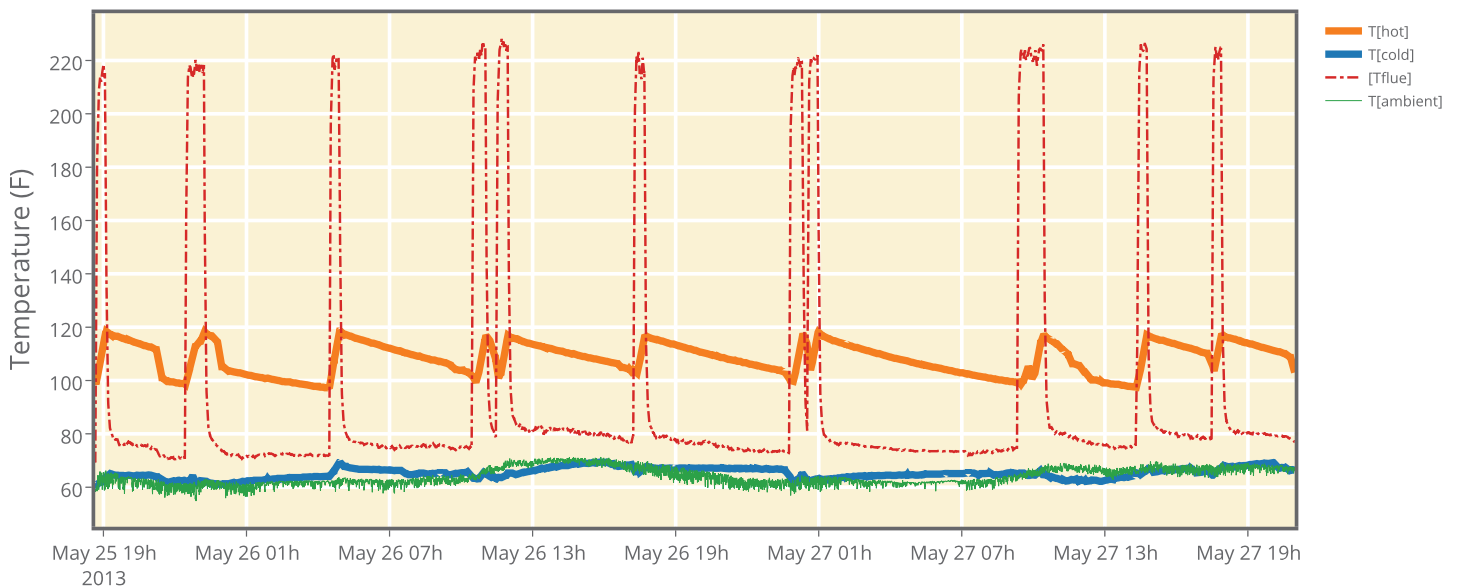
HOT-WATER THERMOSTAT HYSTERESIS ANALYSIS [BUILDERA]

Figure 8 (below). Water-heater measurements over a 48-hour period compare temperatures of hot water (orange), cold water (blue), exhaust flue (dashed red), and ambient air (green). Hot-water use during a firing cycle typically extended the heating cycle 20 to 40 minutes. Graph produced with Plotly (www.plot.ly). For interactive graph, go to website: <https://plot.ly/~glowitz/1>

As shown in the lower Plotly graph of Figure 8, temperature readings continued for two days with the following observations:

- The thermostat cycled 4-6 times/day for a duration of 20 to 60 minutes per cycle
- Ambient-air temperature inside the utility closet varied from 60°-71°F

- After periods of non-use, such as five or more hours, the hot-water temperature decayed approximately 2.3°-2.6°F/hour to 97°-103°F degrees—above the minimum threshold to trigger the thermostat before the next morning use

- Upon first use in the morning, shower temperature at the head was in the 95°-101°F range, well below acceptable minimums
- After sufficient inrush of cold water, the thermostat switched on, triggering a heating cycle with a temperature rise between 0.3°-0.8°F/minute, depending on demand during recovery

- The temperature rise was gradual, lasting from 20 to 60 minutes
- Given a typical shower duration of 8-10 minutes, there was insufficient heat rise during the first shower to provide a satisfying temperature

Armed with forensic knowledge, remedies were more evident. One solution raised the thermostat temperature, such that the low trip point was at least hot enough for a comfortable first shower. Using Figure 8 as a guide to establish the new threshold, a 10°F increase in thermostat setting to 130°F would raise the minimum hot-water output to 107-113°F—a more suitable shower temperature. Indeed, after increasing the thermostat high trip point to 130°F, the homeowner experienced comfortable showers, even during first use. However, this solution also raised the risk of scalding due to higher overall temperatures and stacking effects.

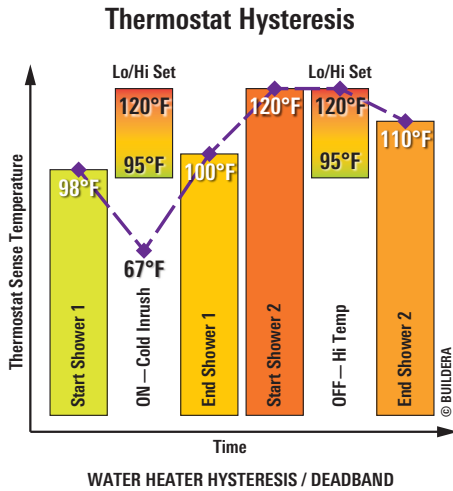
Figure 9. Water heater deadband chart illustrates the thermostat temperature profile vs. time and shower demand. Chart adapted with permission from Buell Inspections, Seattle, WA [6].

- As shown in Figure 9, at such point when a second occupant took a morning shower, there was an ample supply of hot water due to earlier thermostat activation
