ROOFING FOR HISTORIC BUILDINGS

Slate

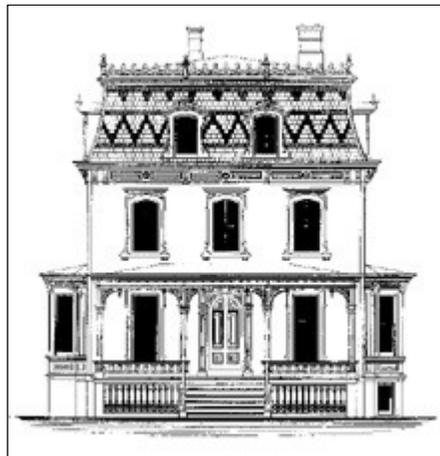
Front elevation of a dwelling published in **Supplement to Bicknell's Village Builder**. A specification for one of the designs included this direction for the French roof: "Slate the sides of the roof with slate 5 x 12 inches, cornered as shown on elevation, nailed with galvanized nails; all hips and valleys to be flashed with tin in the best manner." (Courtesy of The Athenaeum of Philadelphia)

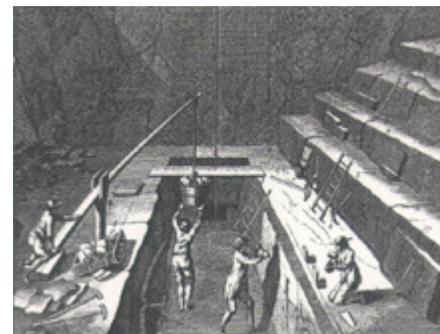
Mineralogie, Ardoises D'Anjou. Travail de la Carrière Ouverte et Outils. **Revuel de Planches, sue Les Sciences, Les Arts Liberaux, et Les Arts Mechaniques, Avec Explication**, Diderot-D'Alembert. (Courtesy of NewsBank, Inc.) [click image for larger view]

Until the 1870s the quarrying of slate changed little from what is illustrated by Diderot in the **Pictorial Encyclopedia of Science Art and Technology** of 1762. Blocks were separated from the floor of the quarry using picks, wedges, prybars and gunpowder, taking maximum advantage of the natural seams in the rock. Windlasses and simple cranes employed man or horse power to lift blocks of slate from the pit. With the Industrial Revolution came mechanical drills and steam-powered stone channeling machines and hoists. Waste associated with blasting was reduced and efficiency increased. Subsequent advances were marked by the introduction of the wire saw in 1926 and the diamond belt saw in 1988.
