The Repair, Replacement and Maintenance of Historic Slate Roofs

29

Jeffrey S. Levine

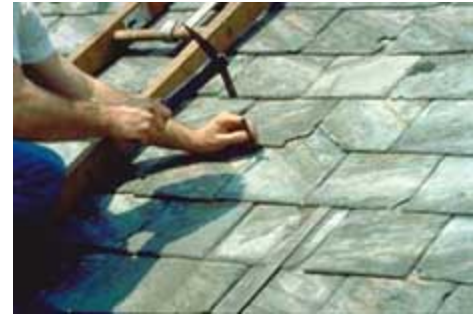
Slate roof repair. Photo: Jeffrey S. Levine.

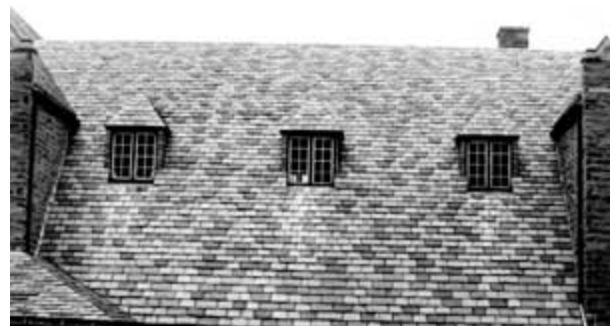
This graduated slate roof is composed of large, thick slates at the eave which are reduced in size and thickness as the slating progresses to the ridge. Photo: Jeffrey S. Levine.

Graduated slate roofs were frequently installed on large institutional and ecclesiastical structures. The slates were graduated according to thickness, size, and exposure, the thickest and largest slates being laid at the eaves and the thinnest and smallest at the ridge. Pleasing architectural effects were achieved by blending sizes and colors.

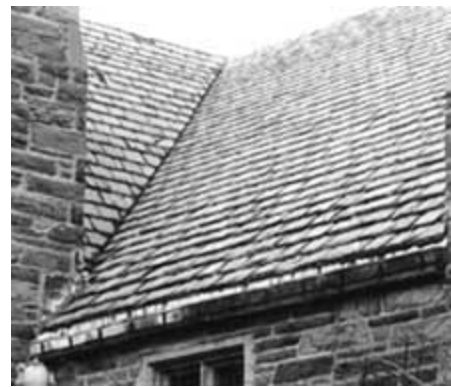
Valleys are formed at the internal angle of two roofing slopes. Flashing is often placed under the slate to increase moisture protection at this vulnerable joint.

Two types of valleys were traditionally employed, the **open valley** and the **closed valley**. The open valley is lined with metal over which slates lap only at the sides. Closed valleys are covered with slate and have either a continuous metal lining or metal flashing built in with each course. Open valleys are easier to install and maintain, and are generally more watertight than closed valleys. Round valleys are a type of closed valley with a concave rather

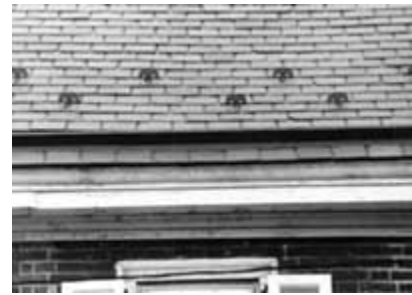
Eave details include snow guards, snow boards, and gutter treatments. Snow guards are generally used in areas where the ice and snow accumulate to avoid dangerous slides from the roof. Photo: Jeffrey S. Levine.

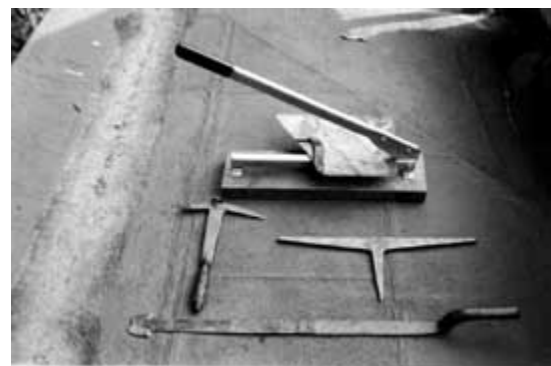
These traditional slater's tools are used to cut and trim, hammer, measure, and rip out nails. Photo: Jeffrey S. Levine.

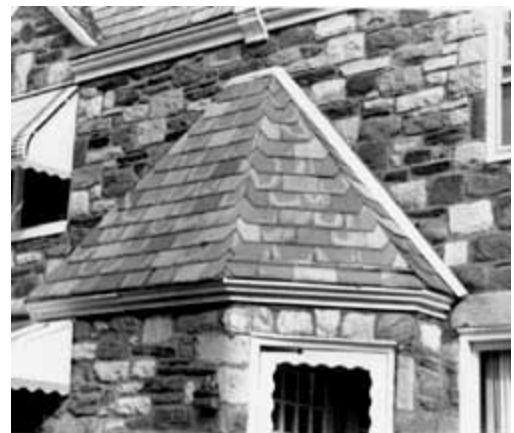
The white blotches on these Pennsylvania Soft-Vein slates indicate areas where gypsum is leaching out onto the surfaces of the slates. Photo: Jeffrey S. Levine.

The weathering of slate is chiefly due to mineral impurities (primarily calcite and iron sulfides) in the slate which, in concert with alternating wet/dry and hot/cold cycles, react to form gypsum. Because gypsum molecules take up about twice as much volume as calcite molecules, internal stresses result from the reaction, causing the slate to delaminate. This type of deterioration is as prominent on the underside of the roof as on the exposed surface due to the leaching and subsequent concentration of gypsum in this area. Consequently, deteriorated roofing slates typically cannot be flipped over and reused.

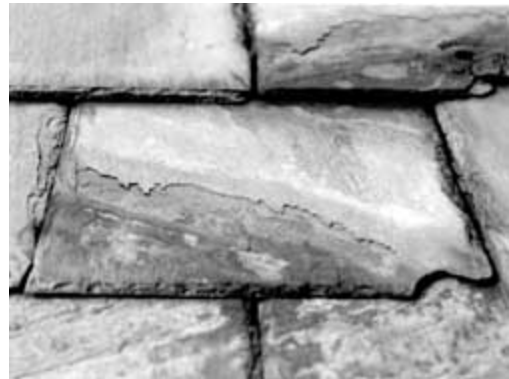
Paper thin lamination can be seen flaking off this weathered, 120 year piece of Pennsylvania Hard-Vein slate.
Photo: Jeffrey S. Levine.

The natural weathering of roofing slate manifests itself as a slow process of chipping and scaling along the cleavage planes. Paper thin laminations flake off the surface of the slate and the slate becomes soft and spongy as the inner layers begin to come apart, or delaminate. The nature of the sound given off by a slate when tapped with one's knuckles or slating hammer is a fair indication of its condition. Highgrade

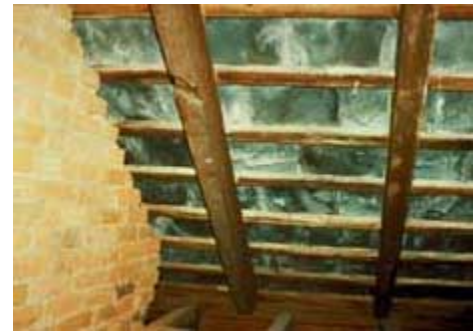
View of these slates laid on open sheathing shows that delamination and flaking are just as bad or worse on the underside of slates as on the exposed surface. This is why most slates cannot be flipped over for reuse. Photo: Jeffrey S. Levine.

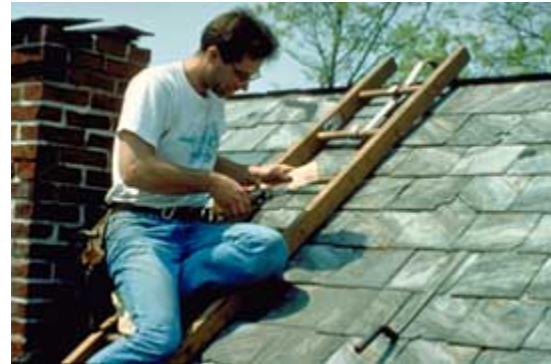
After removing the deteriorated slate and sliding the new slate into place, it is secured with a copper nail. A copper bib (shown here) is formed to protect the newly created nail hole. Finally, a slate hammer is used to push the bib in place over the nail head. Photo: Jeffrey S. Levine.

The damaged slate is first removed by cutting or pulling out its nails with a ripper. If steel cut nails, rather than copper nails, were used in laying the roof, adjacent slates may be inadvertently damaged or displaced in the ripping process, and these, too, will have to be repaired. If the slate does not slide out by itself, the pointed end of the slate hammer can be punched into the slate and the slate dragged out. A new slate, or salvaged slate, which should match the size, shape, texture, and weathered color of the old slate, is then slid into place and held in position by one nail inserted through the vertical joint between the slates in the course above and approximately one inch below the tail of the slate two courses above.

To prevent water penetration through the newly created nail hole, a piece of copper with a friction fit, measuring roughly 3" (7.5 cm) in width and 8" (20 cm) in length, is slid lengthwise under the joint between the two slates located directly above the new slate and over the nail. Alternate methods for securing the replacement slate include the use of metal hooks, clips, and straps that are bent over the tail end of the slate. The application of roofing mastic or sealants to damaged slates should not be considered a viable repair alternative because these materials, though effective at first, will eventually harden and crack, thereby allowing water to enter. Mastic also makes future repairs more difficult to execute, is unsightly, and, when applied to metal flashings, accelerates their corrosion.

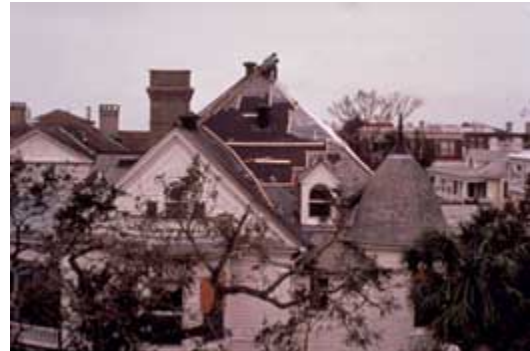
After a hurricane or other natural disaster, it may be necessary to stabilize a roof temporarily until materials can be obtained and a qualified roofing contractor hired. Significant slate roofs should not be stripped off and replaced with asphalt shingles. Photo: NPS files.

In emergency situations, such as when severe hurricanes or tornadoes blow numerous slates off the roof, a temporary roof covering should be installed immediately after the storm to prevent further water damage to the interior of the building and to permit the drying out process to begin. Heavy gauge plastic and vinyl tarpaulins are often used for this purpose, though they are difficult to secure in place and can be blown off in high winds. Roll roofing, carefully stitched in to areas of the remaining roof, is a somewhat more functional solution that will allow sufficient time to document the existing roof conditions, plan repairs, and order materials.

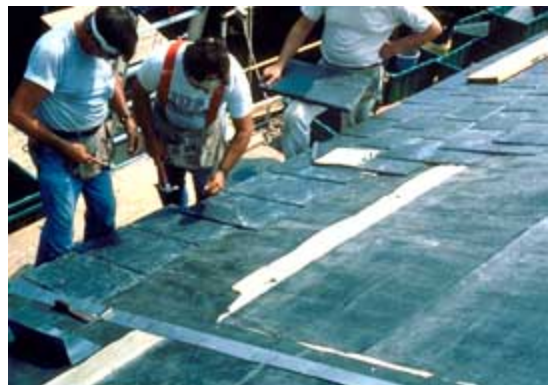
Roofing felt is being installed over the decking; a rubberized membrane is used selectively at the eaves and under some flashing. Photo: NPS files.
