## Roofing Materials Assessment

### Investigation of Toxic Chemicals in Roof Runoff

February 2014

Publication No. 14-03-003

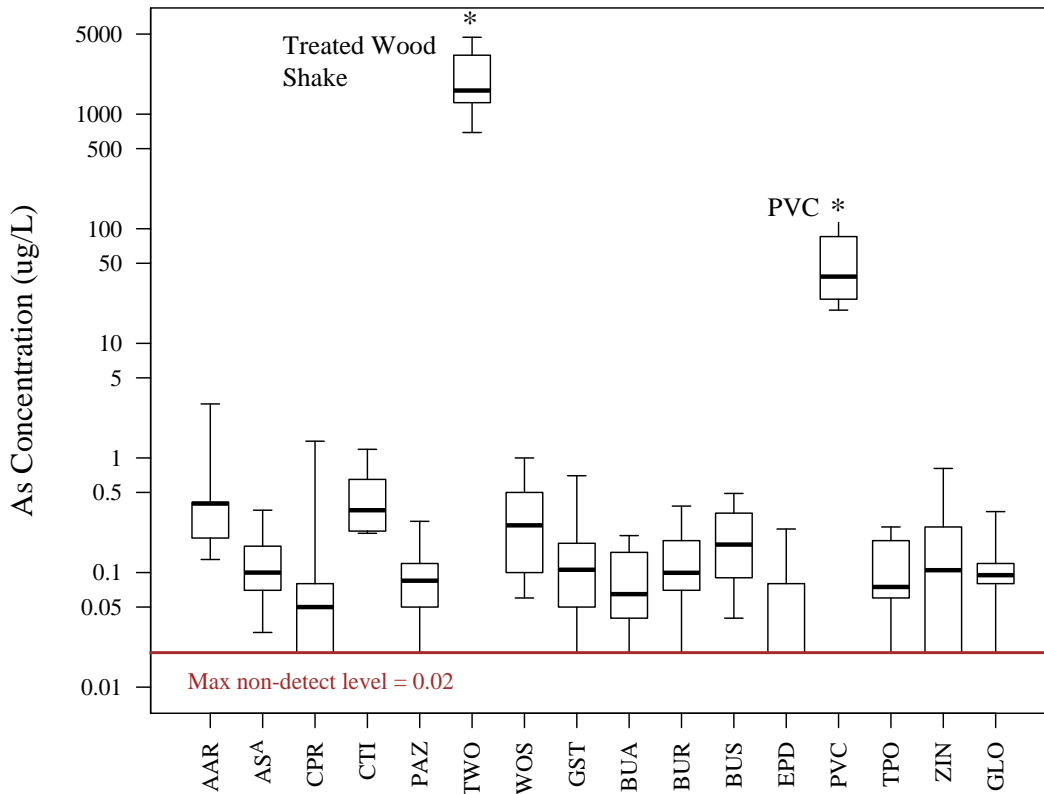
Figure 9. Box plots for total arsenic concentrations across all panels.

concentrations of arsenic. Total arsenic from this panel had a median concentration of 1,610 ug/L and ranged in concentration from 692 to 4,690 ug/L, which was significantly higher than the steep-slope glass control panel (GST).

The PVC panel released the second highest concentrations of arsenic (median value of 38 ug/L), almost two orders of magnitude lower than runoff from the treated wood shake panel (TWO). Total arsenic from the PVC panel ranged between 22 and 117 ug/L. The PVC panel was also significantly higher than the steep-slope glass control panel (GST). Arsenic was thought to be attributable to its use as a biocide in the PVC formulation (RTF, pers. comm., 2013).

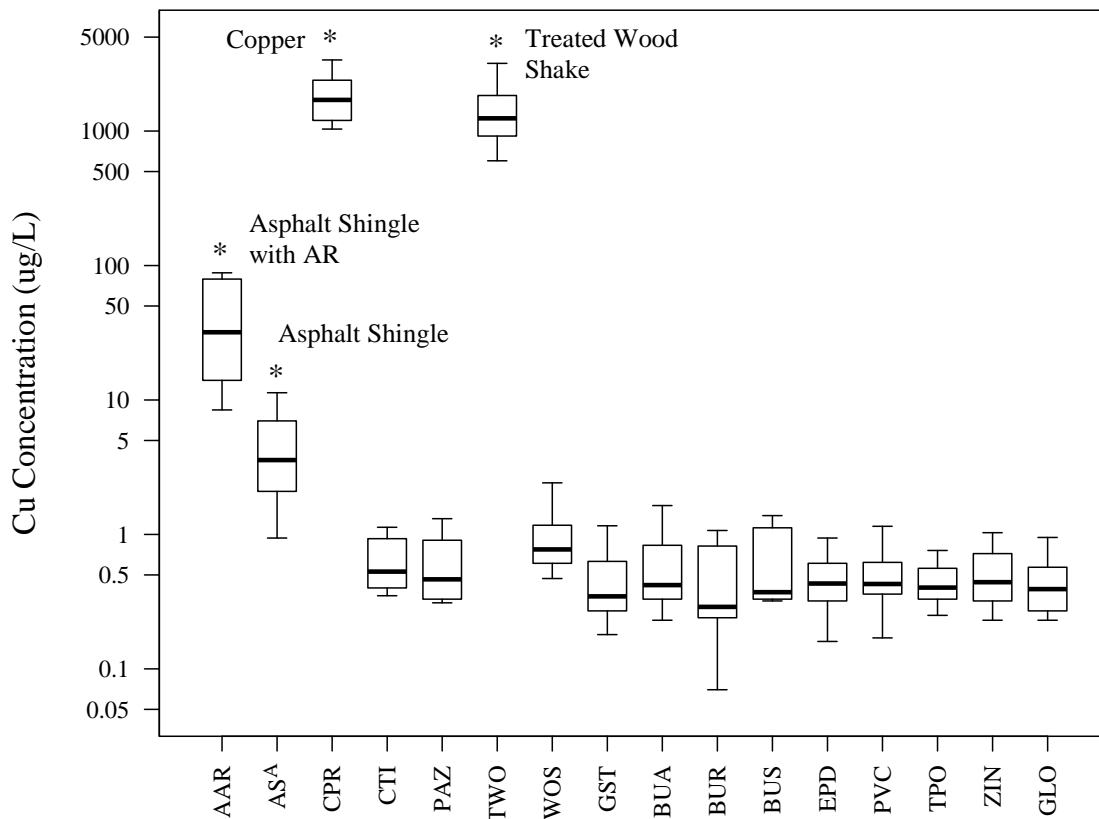
Figure 10. Box plots for total copper concentrations across all panels.

The box and whiskers plot (Figure 10) shows that the copper panel (CPR) and the treated wood shake panel (TWO) had the highest measured concentrations of copper in the runoff. Most of the other panels were two to three orders of magnitude below the concentrations on these two panels. Runoff from the treated wood shake panel (TWO) ranged five-fold from 601 to 3,190 ug/L, depending on rain event, while the copper panel released more consistent concentrations in the runoff, ranging from 1,035 to 3,380 ug/L. Both the treated wood shake (TWO) and copper (CPR) panels were significantly higher than the steep-slope glass control panel (GST).

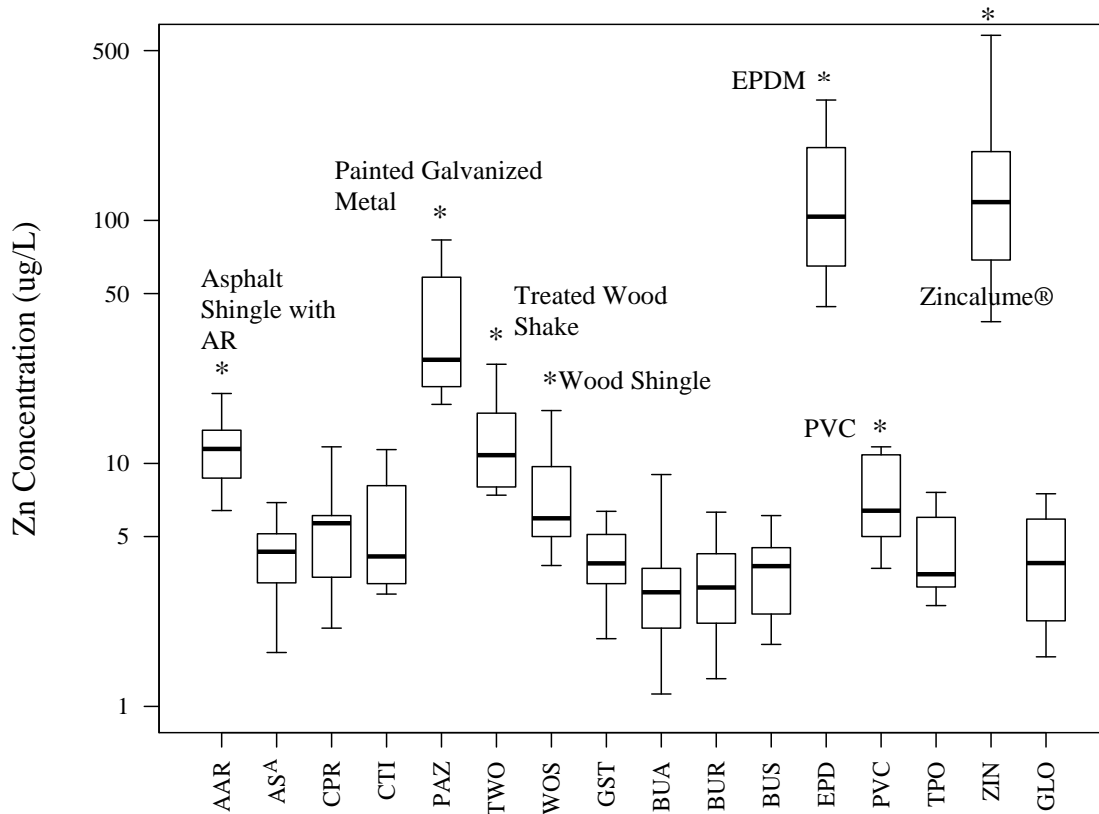
Figure 12. Box plots for total zinc concentrations across all panels.

The new EPDM roofing material (EPD) also released significantly higher concentrations of zinc than the low-slope glass control panel (GLO). EPDM runoff concentrations ranged from 44 to 313 ug/L. EPDM is a product that uses zinc as a catalyst in the manufacturing process, similar to tires (Fisler, pers. comm., 2013); therefore, and the zinc catalyst may be the source of zinc in the runoff.

The painted galvanized steel panel (PAZ) released between 18 and 83 ug/L of zinc. Runoff from the painted galvanized steel panel (PAZ) was significantly higher than the zinc concentration in runoff from the steep-slope glass control panel (GST). Zinc may have leached from the unpainted, galvanized edge of the roof material.
