4 Preservation Briefs

National Park Service
U.S. Department of the Interior

>Roofing for Historic Buildings

Sarah M. Sweetser

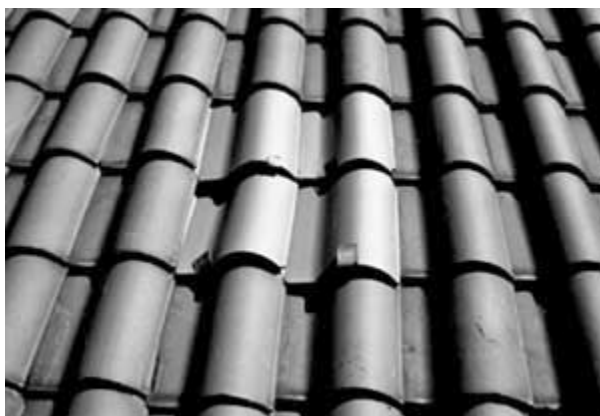
Repairs on this pantile roof were made with new tiles held in place with metal hangers. Photo: NPS files.

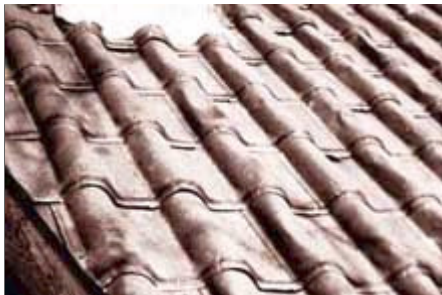
Galvanized sheet-metal shingles imitating the appearance of pantiles remained popular from the second half of the 19th century into the 20th century. Photo: NPS files.

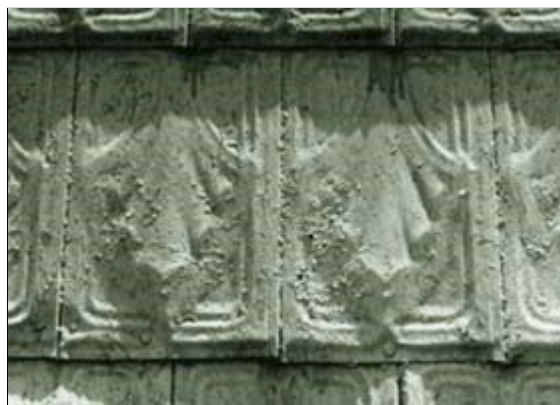
Tin shingles, commonly embossed to imitate wood or tile, or with a decorative design, were popular as an inexpensive, textured roofing material. Photo: NPS files.

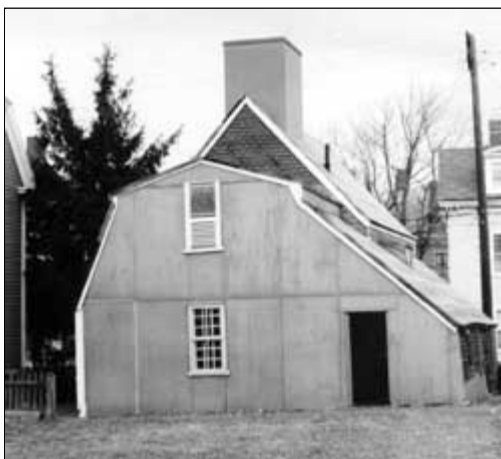
Temporary stabilization or "mothballing" with materials, such as plywood and building paper, can protect the roof of a project until it can be properly repaired or replaced. Photo: NPS files.

It may be necessary to carry out an immediate and temporary stabilization to prevent further deterioration until research can determine how the roof should be restored or rehabilitated, or until funding can be provided to do a proper job. A simple covering of exterior plywood or roll roofing might provide adequate protection, but any temporary covering should be applied with caution. One should be careful not to overload the roof structure, or to damage or destroy historic evidence or fabric that might be incorporated into a new roof at a later date. In this sense, repairs with caulking or bituminous patching compounds should be recognized as potentially harmful, since they are difficult to remove, and at their best, are very temporary.

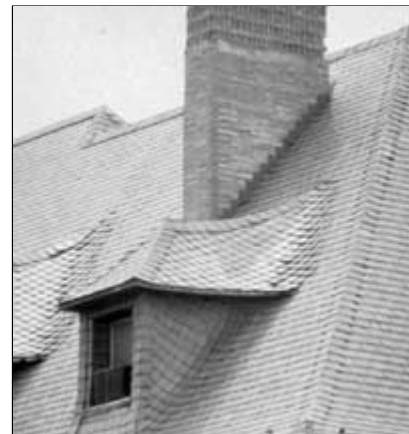
Because of the roof's visibility, the slate detailing around the dormers is important to the character of this structure. Photo: NPS files.

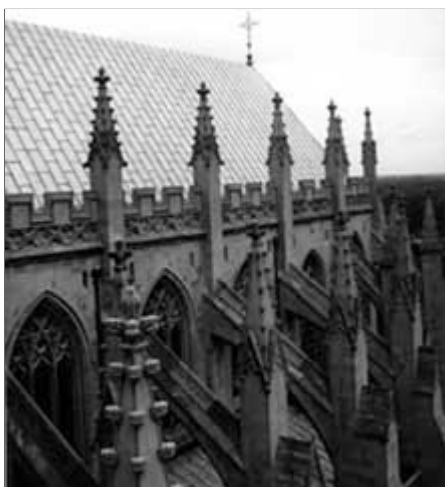
Good design and quality materials for the roof surface, fastenings, and flashing minimize failures. Photo: NPS files.

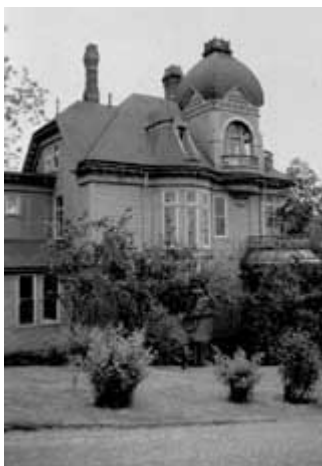
Special problems inherent in the design of an elaborate historic roof can be controlled through regular maintenance. The shape and detailing are essential elements of the building's historic character, and should not be modified, despite the use of alternative surface materials. Photo: NPS files.
