THE WIND RESISTANCE OF ASPHALT ROOFING SHINGLES

CRAIG ROBERT DIXON

A DISSERTATION PRESENTED TO THE GRADUATE SCHOOL
OF THE UNIVERSITY OF FLORIDA IN PARTIAL FULFILLMENT
OF THE REQUIREMENTS FOR THE DEGREE OF
DOCTOR OF PHILOSOPHY

2013

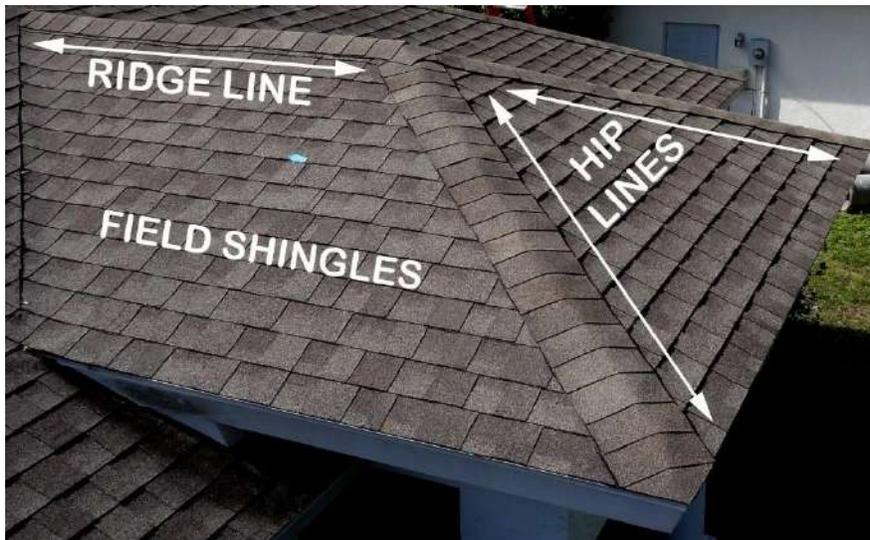
Figure 2-1. Asphalt shingles are installed in the field of the roof with additional shingles along hip and ridge lines.

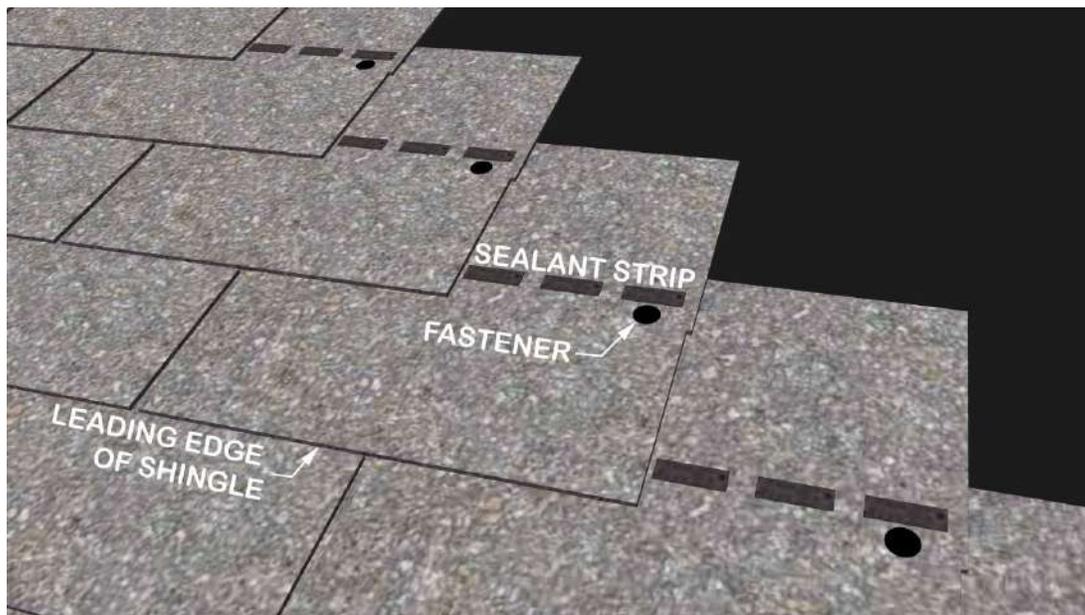
Figure 2-4. Location of sealant strip relative to the shingle's leading edge and fasteners.

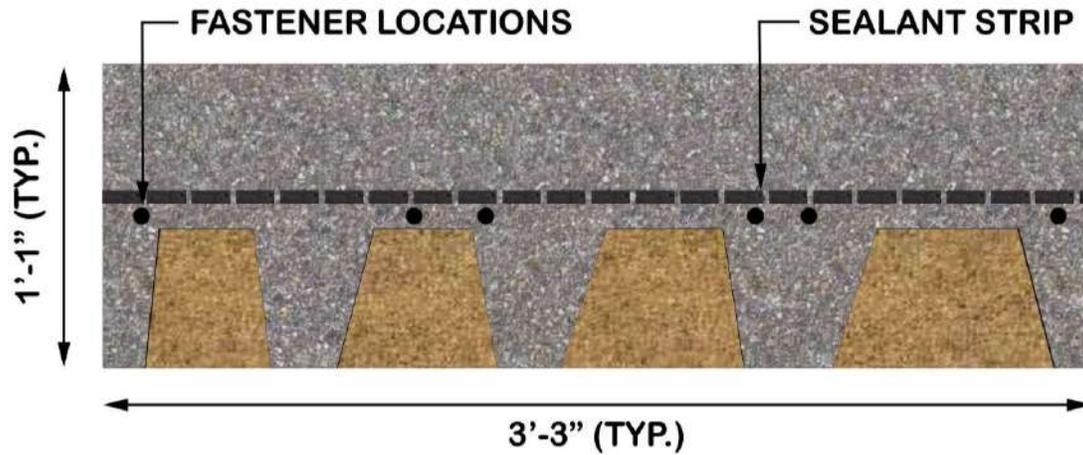
Figure 2-5. Plan view of typical laminate shingle with six-fastener pattern shown.

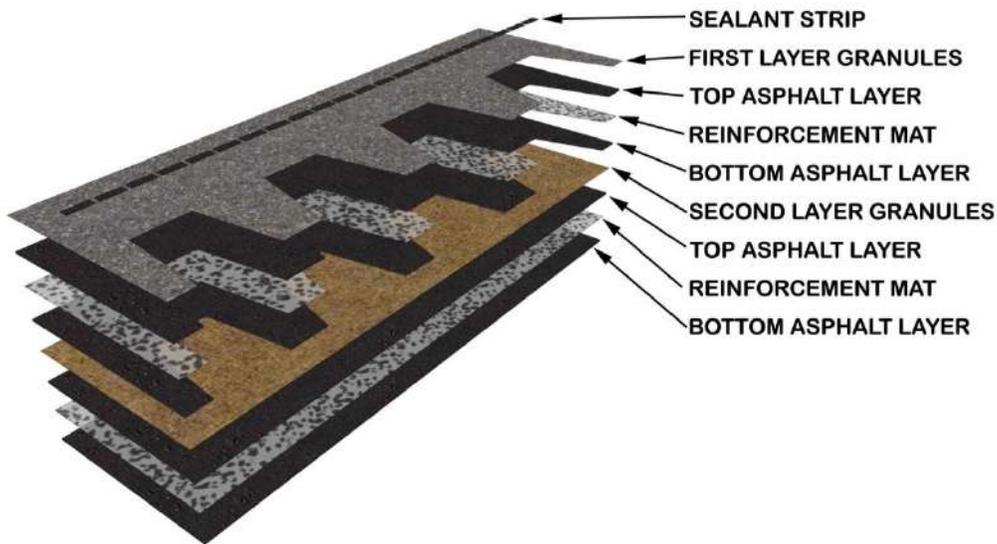
Figure 2-6. Exploded view of typical laminate shingle constitutive materials.

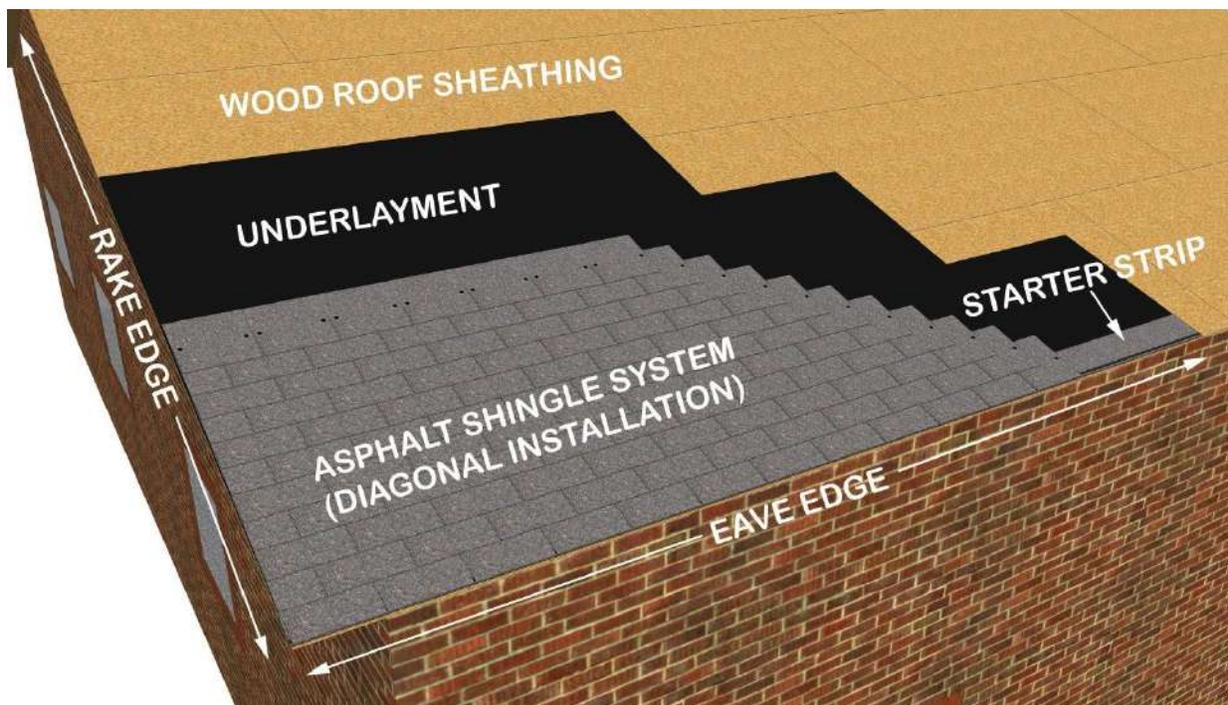
Figure 2-7. Diagonal installation of three-tab asphalt shingle system. Laminate installation produces a similar pattern.

Individual shingles are then installed over the underlayment and edge metal following one of two procedures. The first procedure is the diagonal installation method visually depicted in Figure 2-7. This is the preferred method for all shingle installations as it produces a reliable method for fastening the complete shingle strip on all locations in the field of the roof (ARMA 2006). The second method is the vertical (i.e., raked) installation procedure shown in Figure 2-8. This method is not covered and not recommended in the ARMA (2006) manual and is not allowed for laminate shingle products. However, the vertical method was used extensively on three-tab shingles in the hurricane-prone Southeast US throughout the 1980s and 90s and is a frequently cited cause of wind-related shingle failure (FEMA 2005b; FEMA 2006; RICOWI 2007). Three-tab product guidelines produced by CertainTeed (2012) present a vertical installation method; therefore, the vertical installation method will be detailed here as well.

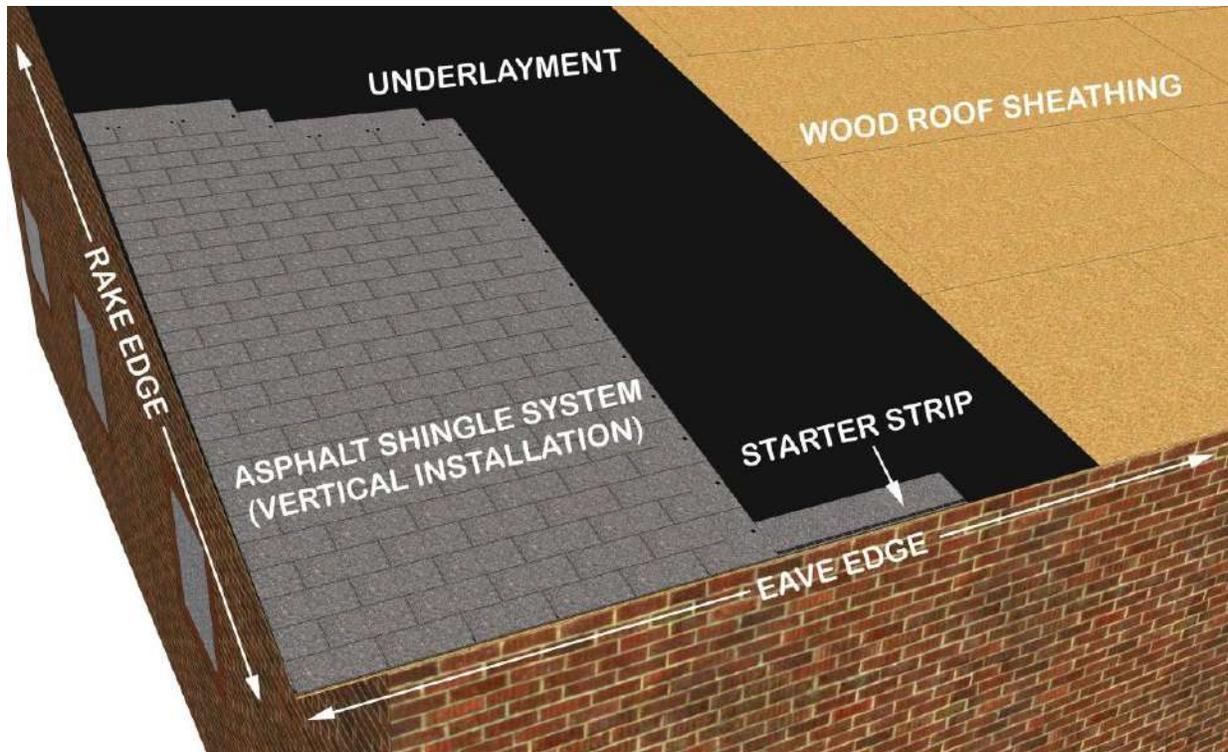
Figure 2-8. Vertical (racked) installation of three-tab asphalt shingle system. Laminate shingles are not installed with this pattern.

For the vertical installation, the first course begins with one full width three-tab strip. Then, in contrast to the diagonal method, the installation proceeds vertically to the next course with a strip that is cut one-half tab width on the left side leftmost tab. Next, a full width three-tab shingle strip is fastened to the roof decking. This proceeds vertically along the rake end switching between full width shingles and shingles with one-half tab width missing. Once the installation reaches the roof's ridge or other horizontal termination point, the installation proceeds to right and continues vertically for one full width shingle then again to the right (Figure 2-8). As with the diagonal, this continues until the roof slope is completely shingled.

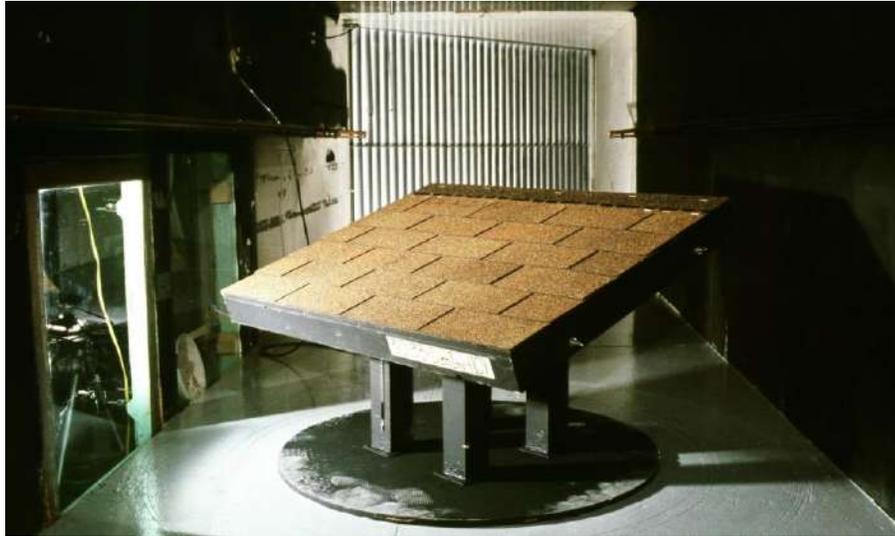
Figure 3-1. Pre-wind test asphalt shingle test deck inside the Colorado State University Meteorological Boundary-Layer Wind Tunnel (Figure courtesy of Jon Peterka)

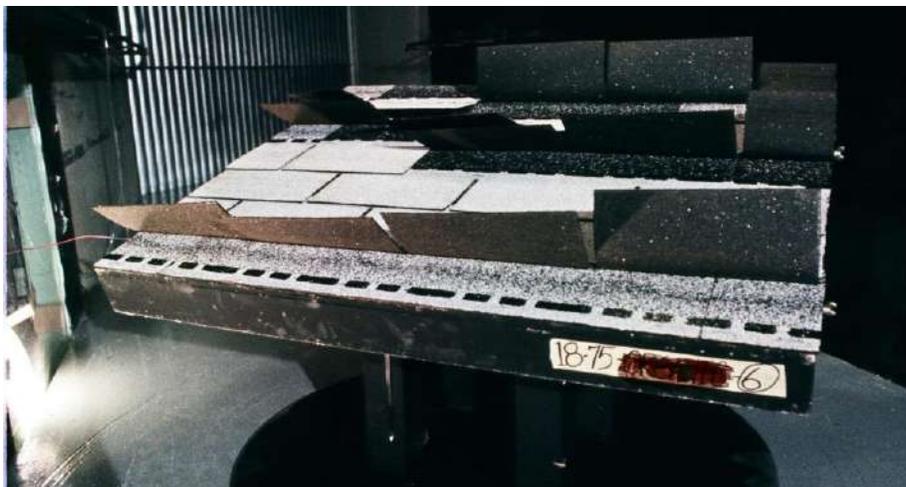
Figure 3-2. Post-wind test asphalt shingle test deck inside the Colorado State University Meteorological Boundary-Layer Wind Tunnel (Figure courtesy of Jon Peterka)

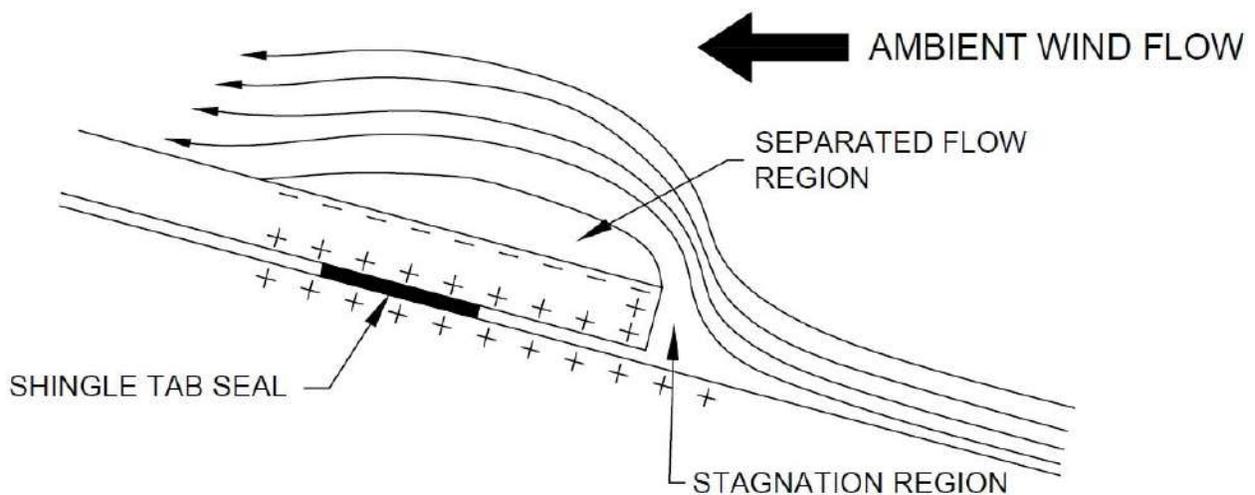
Figure 3-3. Wind load model proposed by Peterka et al. (1983).

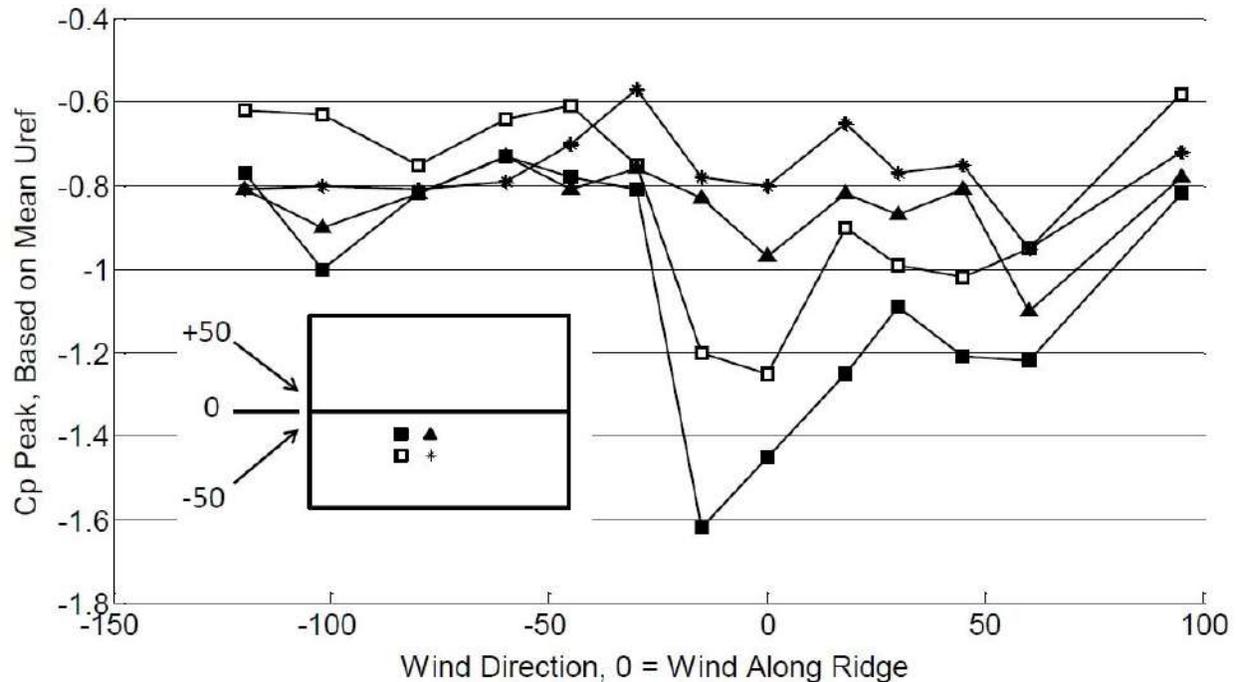
Figure 3-5. Peak pressure coefficients measured on a full-scale asphalt shingle subjected to wind flow from varying directions.

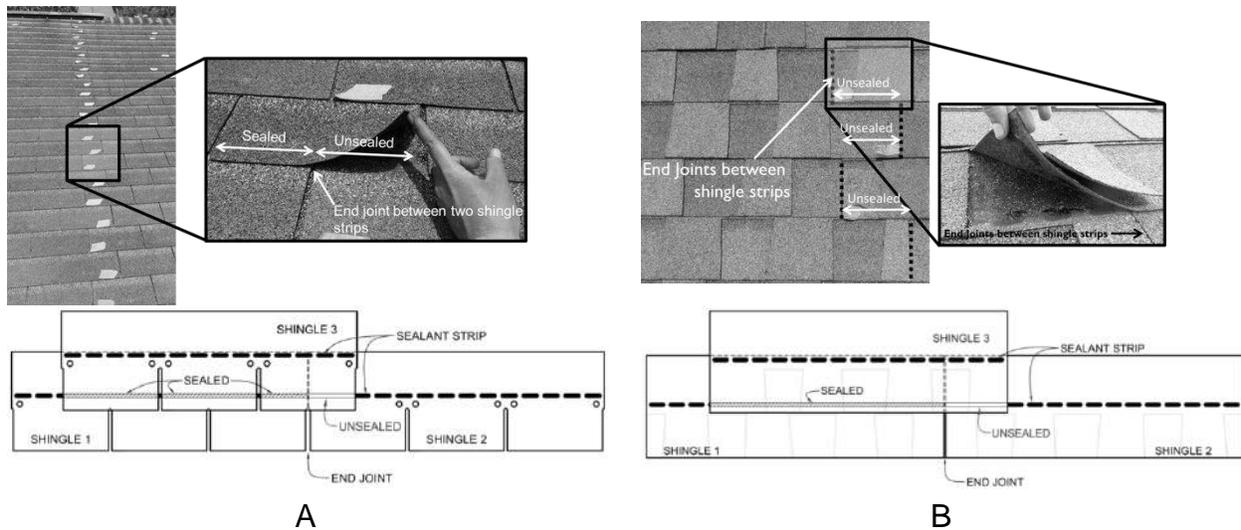
Figure 4-2. Location of partial unsealing. A) three-tab and B) laminate shingle systems.

damage pattern, and it is not conclusive that the damaged shingles in Figure 4-7 were unsealed prior to the wind event. However, the shingle tabs blown off from Hurricane Ike in Figure 4-7B were located above the end joint of the shingle course below, identical to the observed location of partially unsealed shingles (Figure 4-2A).

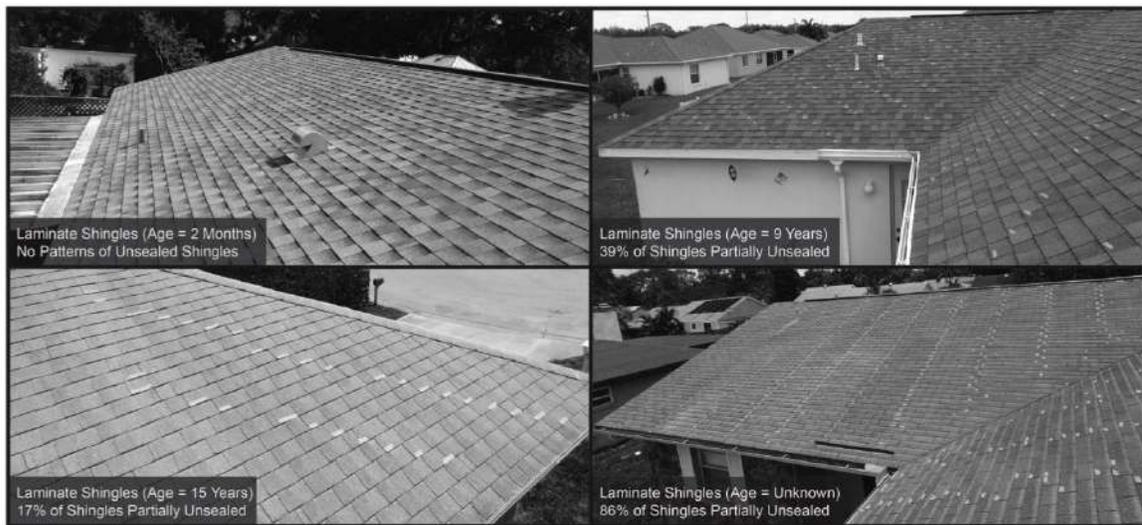
Figure 4-3. Location of partially/fully unsealed three-tab and laminate shingles (tape marks).

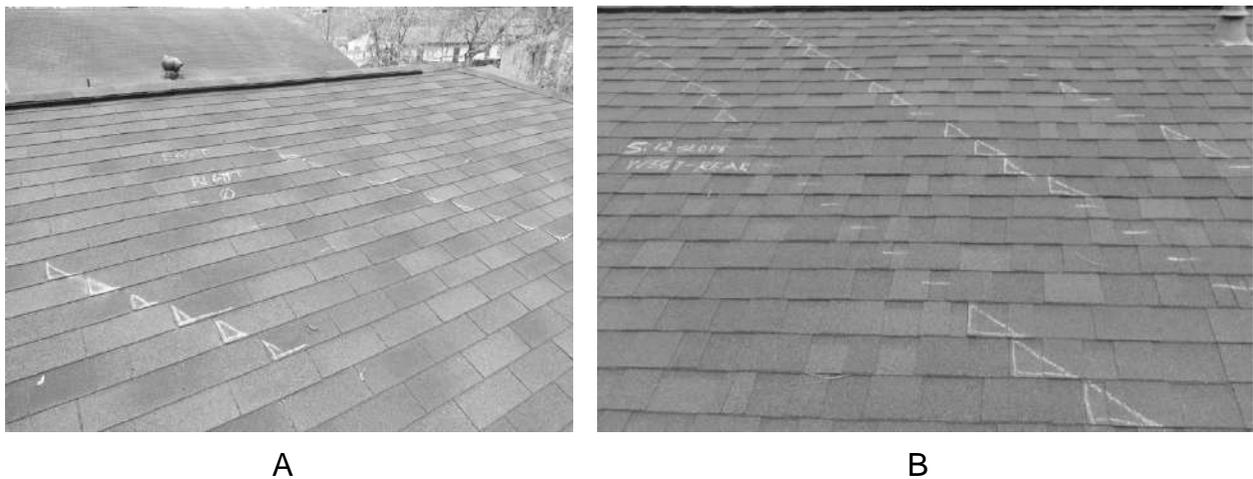
Figure 4-4. Shingle roofs located in Houston, TX with partially unsealed shingles located by triangular chalk marks and fully sealed shingles located by dash marks. A) Three-tab shingles and B) laminate shingles.

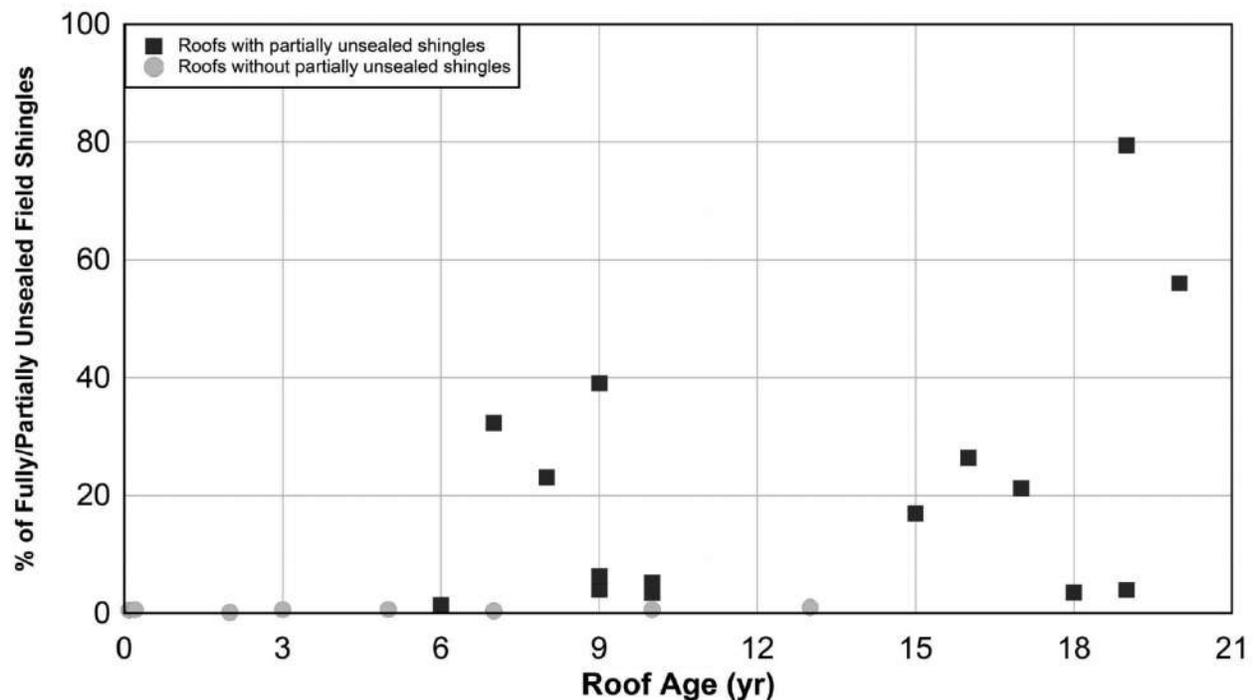
Figure 4-5. Percent of unsealed shingle strips located in the field of the roof verses roof age.

Every roof that containing unsealed strips with no discernible pattern had less than 1% of their shingle strips unsealed. Figure 4-5 also shows that the percentage of unsealed shingles for all roofs less than six years old is less than 1%, while 14 of 17 roofs older than six years had more than 1% of their shingles partially or fully unsealed.

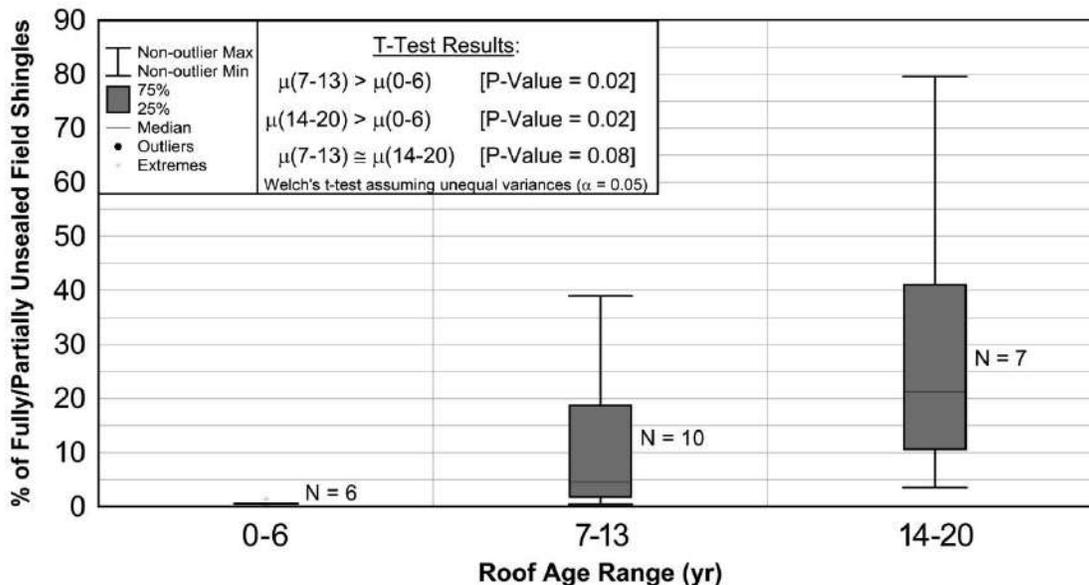
Figure 4-6. Boxplot of unsealed shingle strips located in the field of the roof versus roof age at the time of investigation.

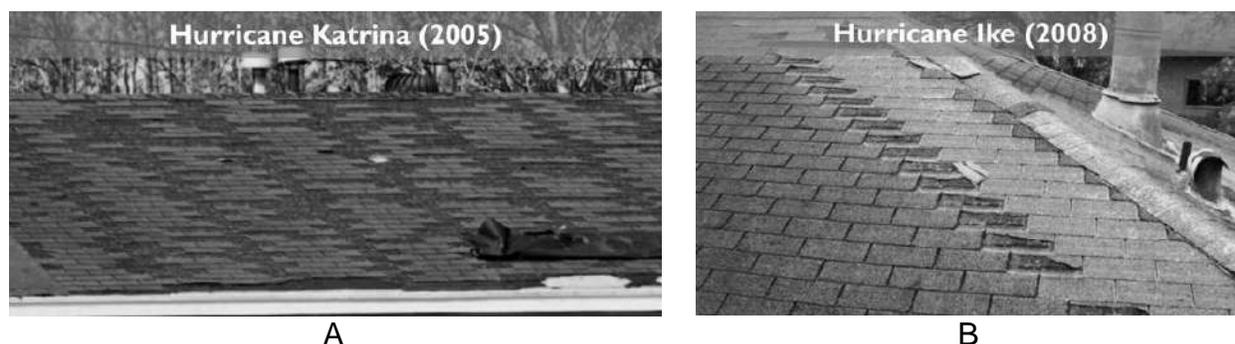
Figure 4-7. Blown off three-tab asphalt shingles. A) Hurricane Katrina in 2005 and B) Hurricane Ike in 2008.

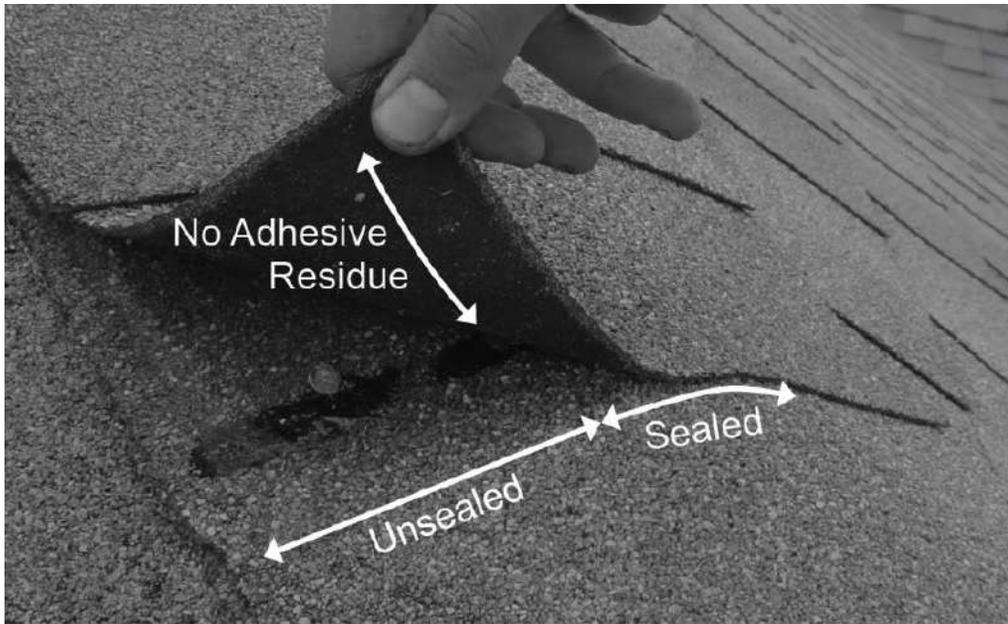
Figure 4-8. Typical condition for partially unsealed ridge and hip shingle with an adhesive failure mode between the top shingle and sealant strip indicated by the lack of sealant residue on the underside of the shingle.

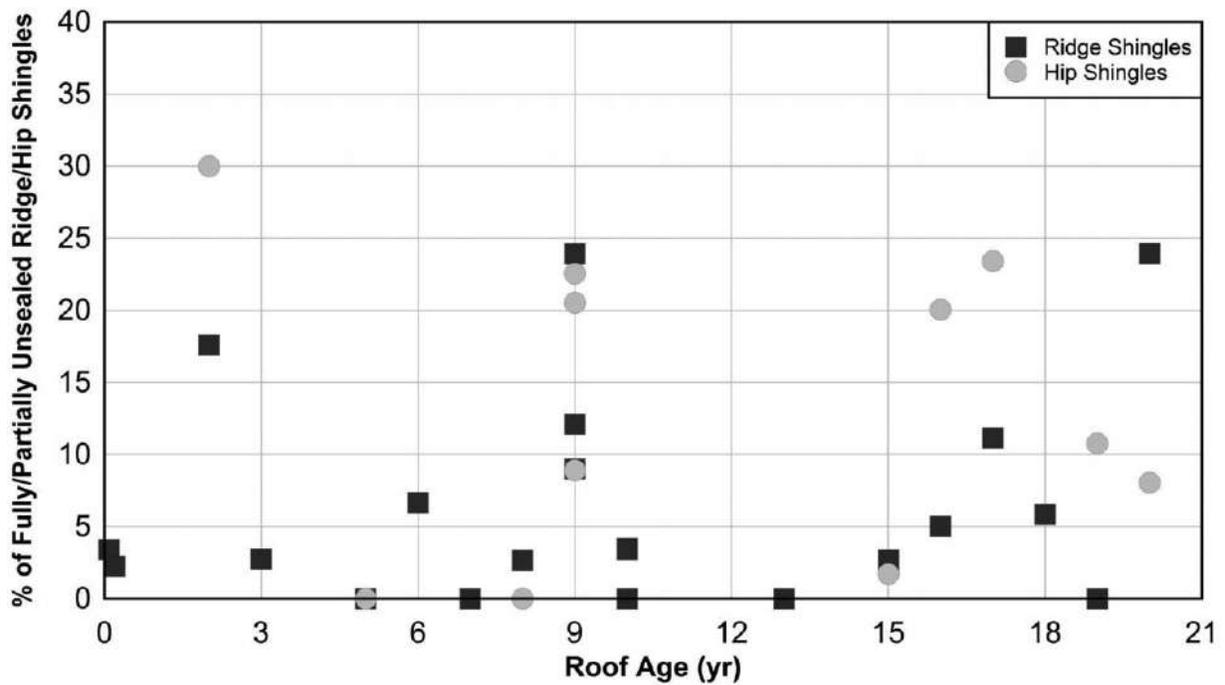
Figure 4-9. Percent of fully and partially unsealed hip and ridge shingles verses roof age. Two roofs contained hip and ridge shingles without sealant strips and are not shown in figure.

Partially and fully unsealed ridge and hip shingles were found on 20 of the 27 surveyed roofs. Observations of unsealing were concentrated at the downslope edges of both hip and ridge shingles. Full adhesion was observed elsewhere. Two findings indicate that these unsealed shingles never properly sealed. First, in contrast to field shingles, the unsealed strip on hip and ridge shingles did not show a transfer of sealant from the top surface of the sealant strip and bottom surface of top shingle (Figure 4-8), which is consistent with FEMA (2005a) post-hurricane damage observations. Second, the percentage of unsealed ridge and hip shingles shows no observable trend with age (Figure 4-9).

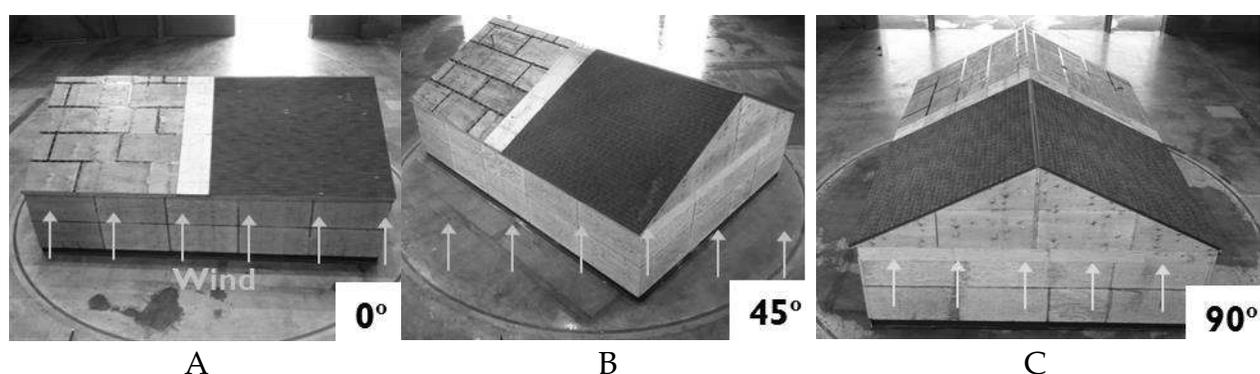
Figure 4-10. Wind directions for gable and hip roof specimens.

shingle roof systems in conformance to the 2010 Florida Residential Building Code Section R905.2 and manufacturers' guidelines. Shingle fasteners were pneumatically driven 12 gauge electroplate galvanized nails with a 9.5 mm (3/8 in) diameter head and 31 mm (1.25 in) shaft length. Three-tab specimens were secured with four nails per strip, while laminates were secured with six nails per strip. The roof specimens were placed on a base structure (9.1 m W x 12.2 m L x 2.4 m H) with a permanent half-roof on one end (Figure 4-10) to form an enclosed test structure.

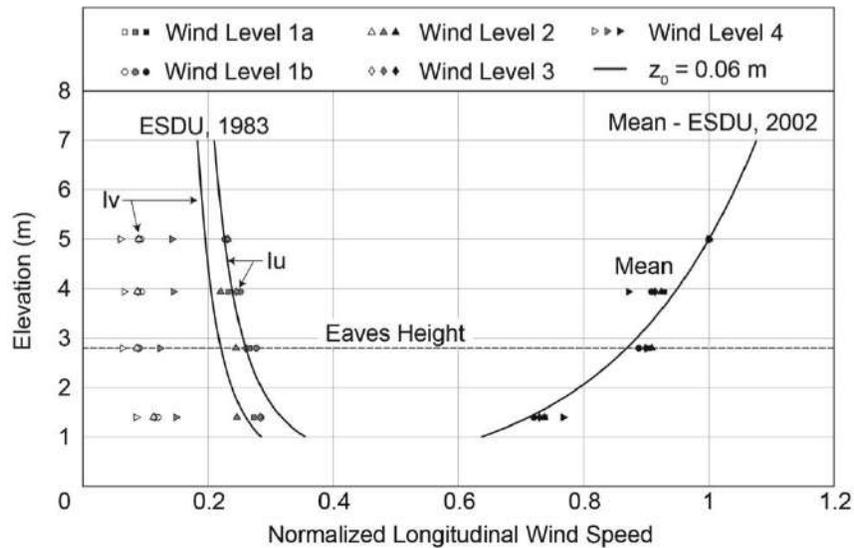
Figure 4-11. Measured and best-fit theoretical normalized mean velocity, longitudinal turbulence intensity, and lateral turbulence intensity.

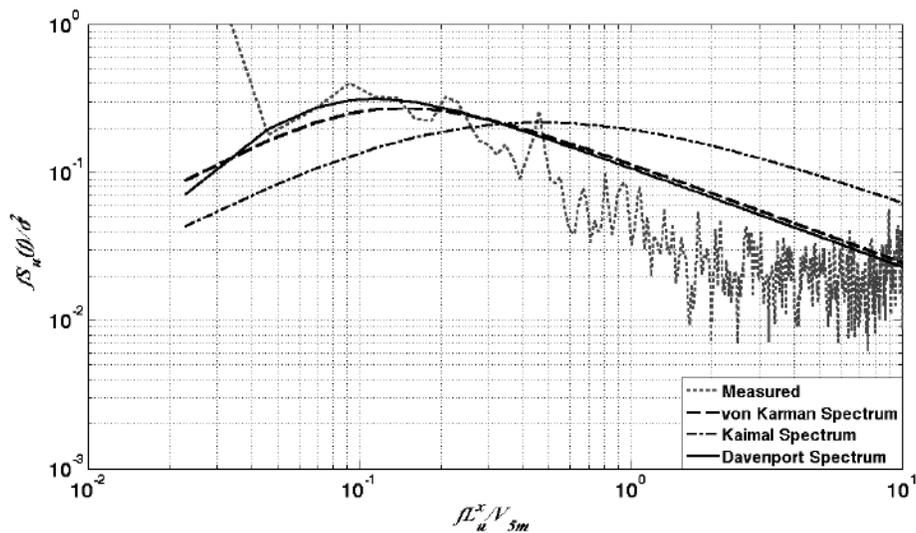
Figure 4-12. Normalized wind spectrum of Wind Level 3 (measured at 5 m).

($z_0 = 0.06$ m). Figure 4-12 shows the normalized longitudinal wind spectrum measured at 5 m (16.4 ft) during the highest wind speed level (3). Comparisons to von Karmin (1948), Kaimal (1972), and Davenport (1961) model spectra are also shown. Reasonable agreement between the data and model was found except for the lateral turbulence intensity, which was attributed to the limited range (~30 degrees) of the rotational vanes.

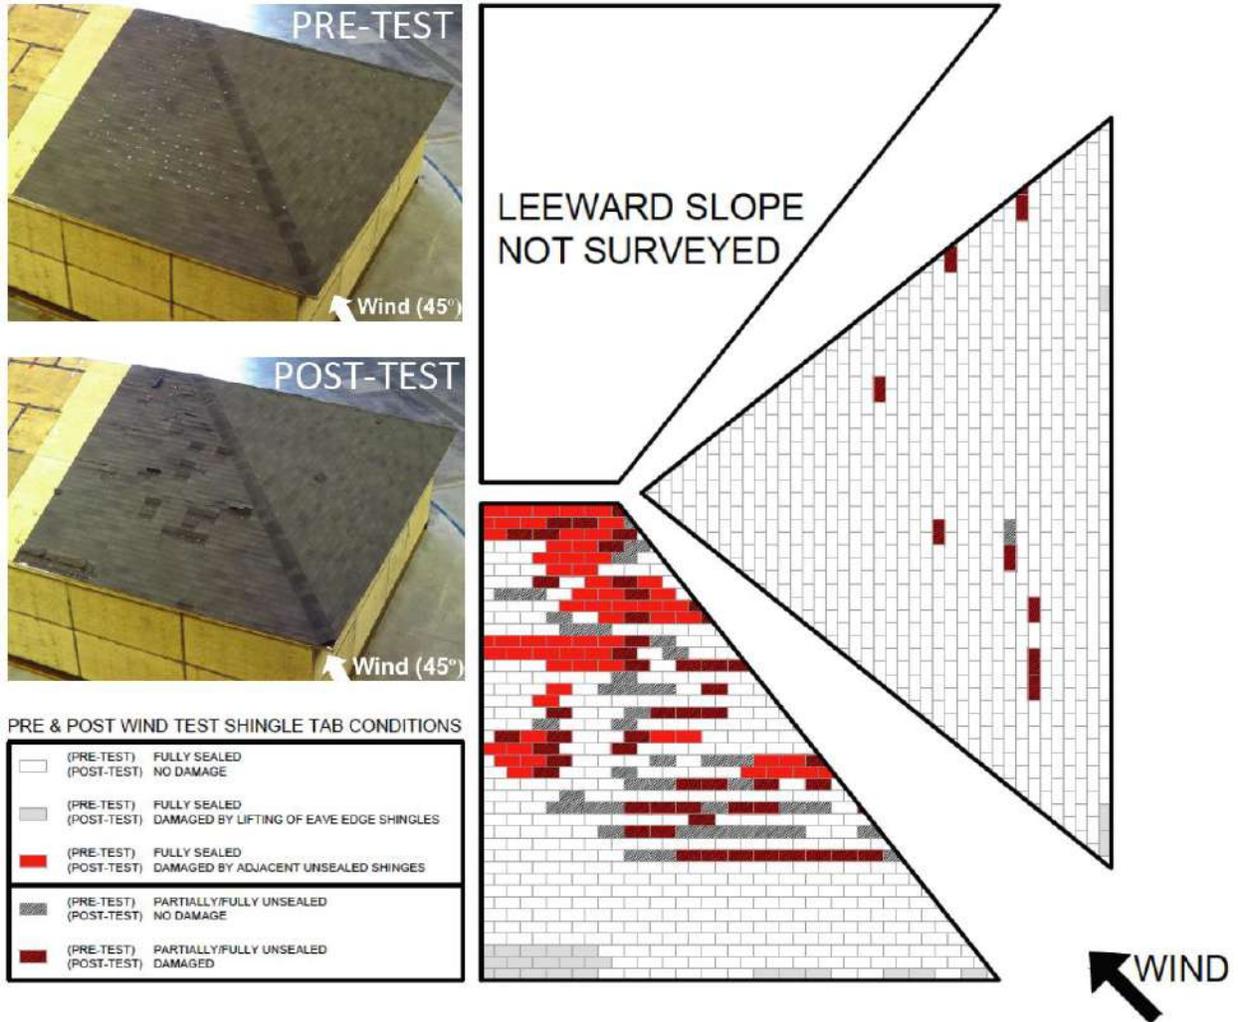
Figure 4-13. Hip roof three-tab shingle specimen pre- and post-test conditions with pre-wind test unsealed shingles denoted by blue tape in the top left photo and the post-test condition summarized in the roof plan at right.

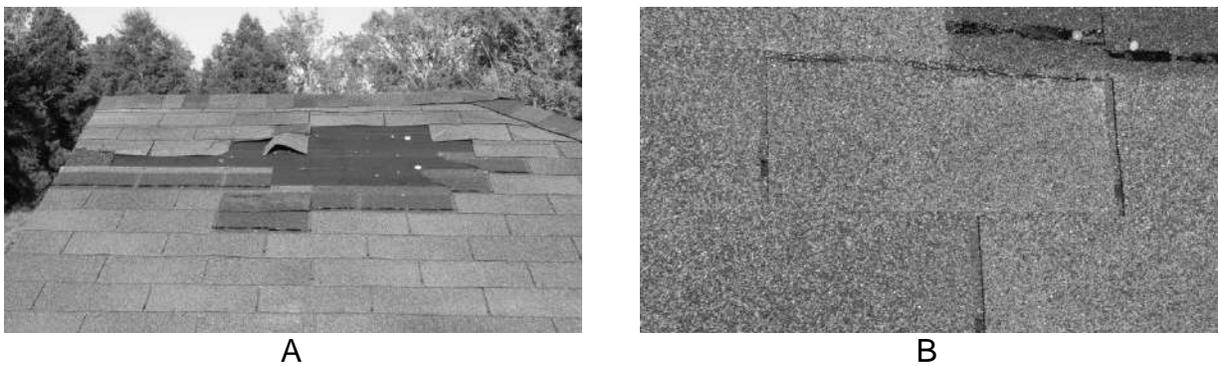
Figure 4-14. Shingle roof damage initiated by pre-wind test unsealed shingles. A) Blow off and B) cracking of shingles.

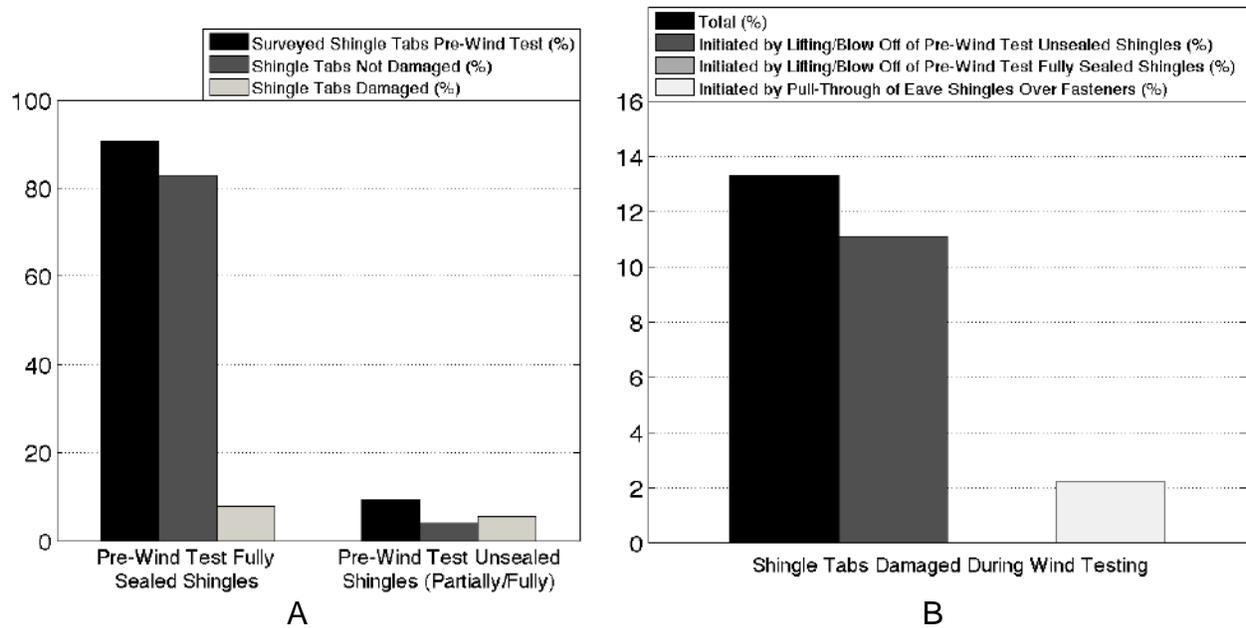
Figure 4-15. Statistical comparison of roof damage for the roof specimen shown in Figure 4-13. A) Comparison of the post-wind test condition of windward shingle tabs stratified by pre-wind test sealed/unsealed condition. B) Contribution of each potential initiator of shingle wind damage on the overall damage rate.

In summary, among the shingle tabs that were wind damaged during testing, none of the damage was initiated by pre-wind test fully sealed field shingle tabs (Figure 4-15b). The results of this roof test demonstrates that pre-existing unsealed shingles in the field of the roof pose a significant threat to both those unsealed shingles and the adjacent sealed shingles, dramatically increasing the roof's overall wind damage vulnerability.

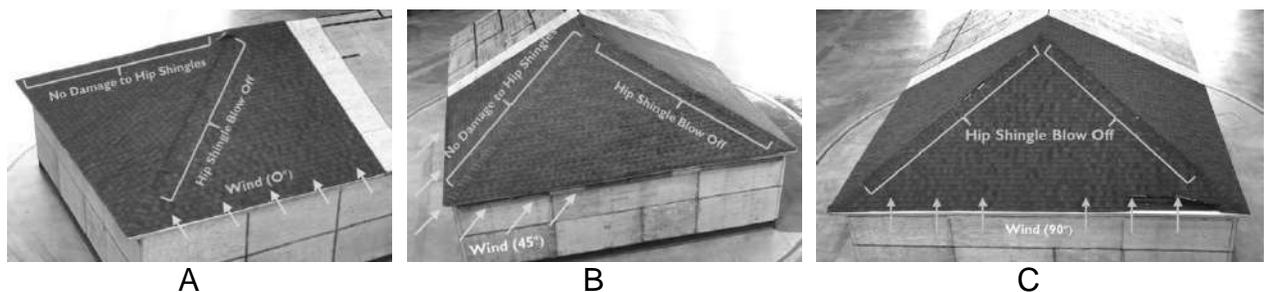
Figure 4-16. Characteristic hip shingle blow off patterns. A) 0°, B) 45°, and C) 90° wind directions.

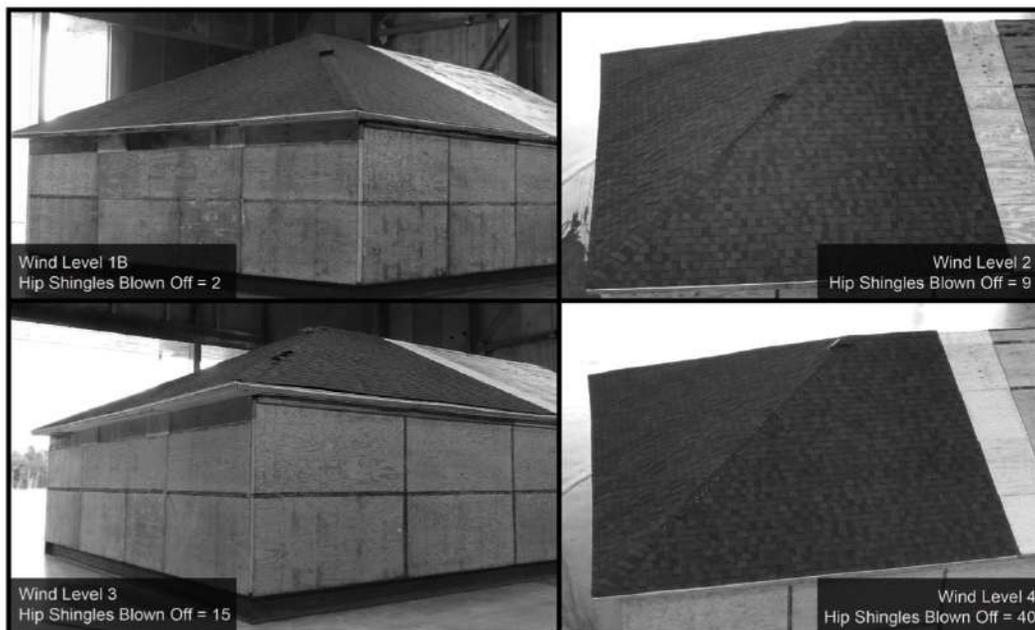
Figure 4-17. Progression of hip shingle blow off through the wind test sequence for specimen oriented at the 0° wind direction.

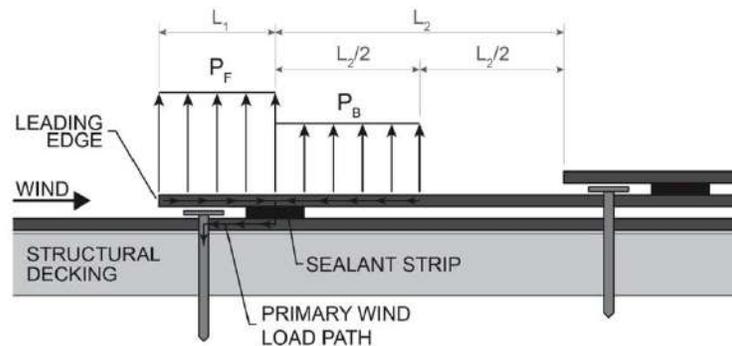
Figure 5-1. Wind pressures on shingle roofing.

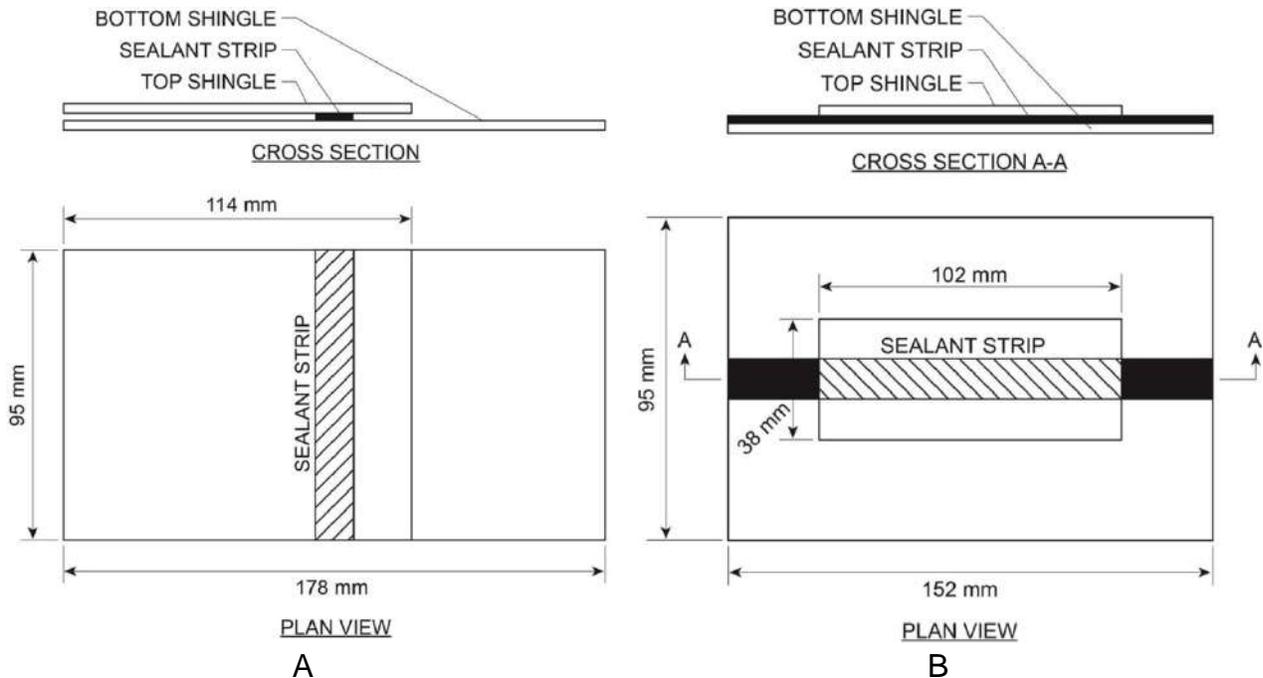
Figure 5-3. ASTM D6381 specimens. A) Procedure A specimen and B) Procedure B specimen.

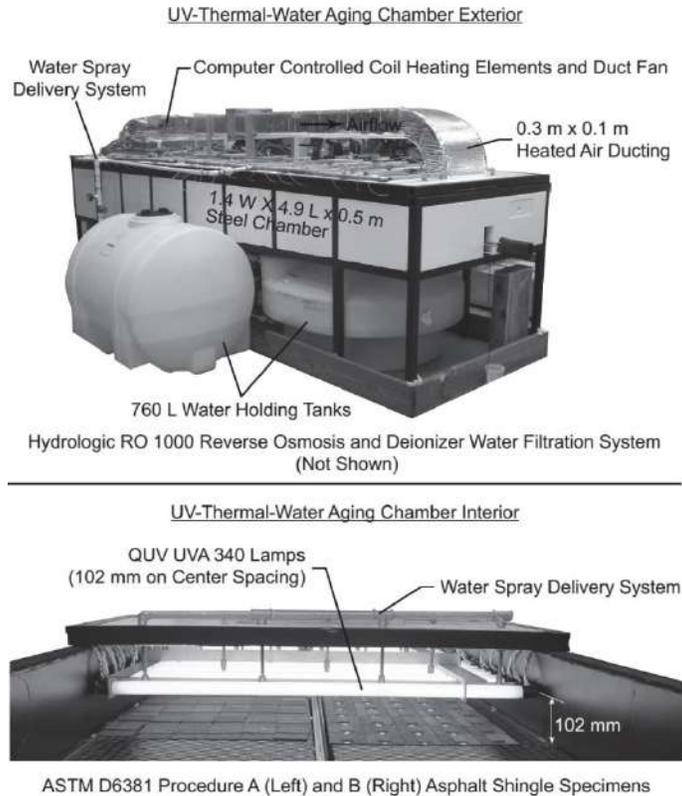
Figure 5-4. UV-Thermal-Aging chamber components.

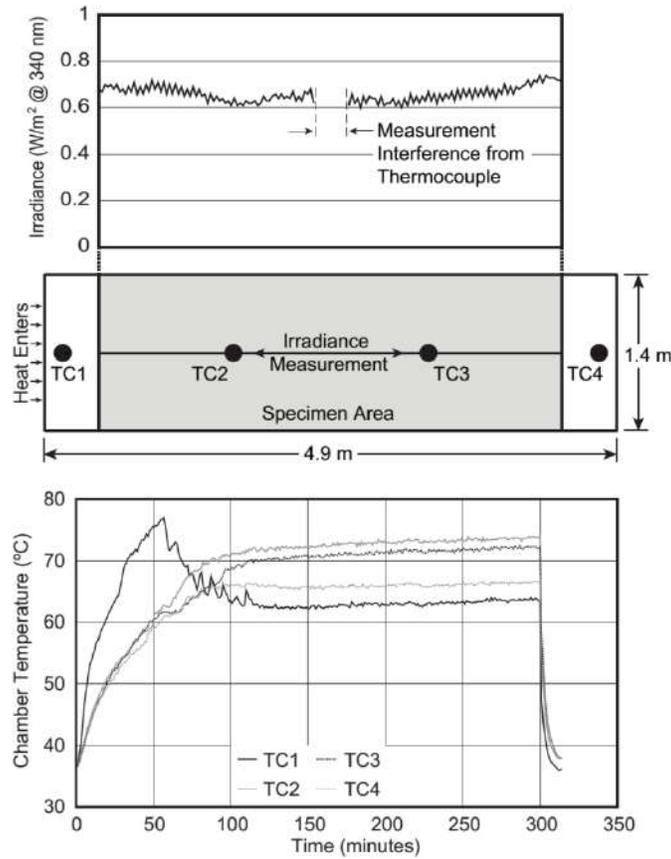
Figure 5-5. Measured irradiance, plan view, and temperature time-history of one cycle.

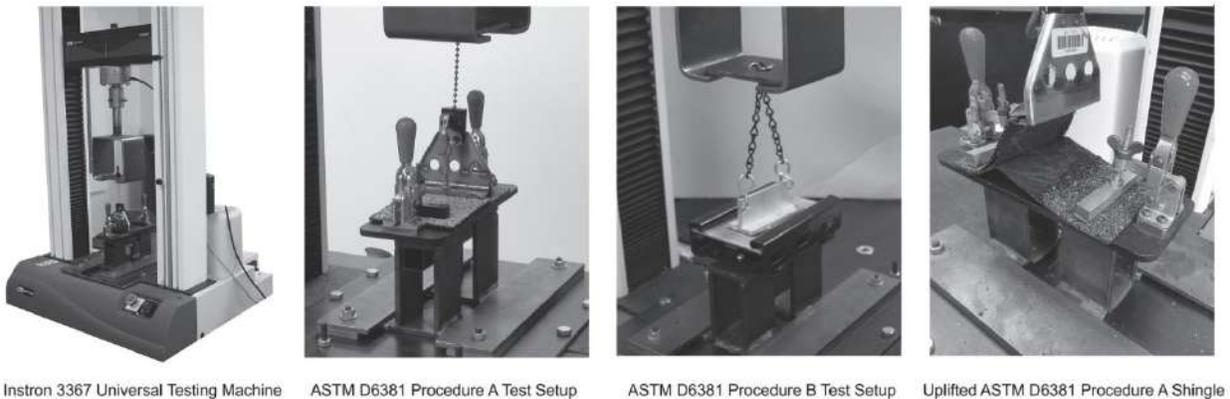
Figure 5-6. ASTM D6381 test apparatus, setup, and uplifted specimen.

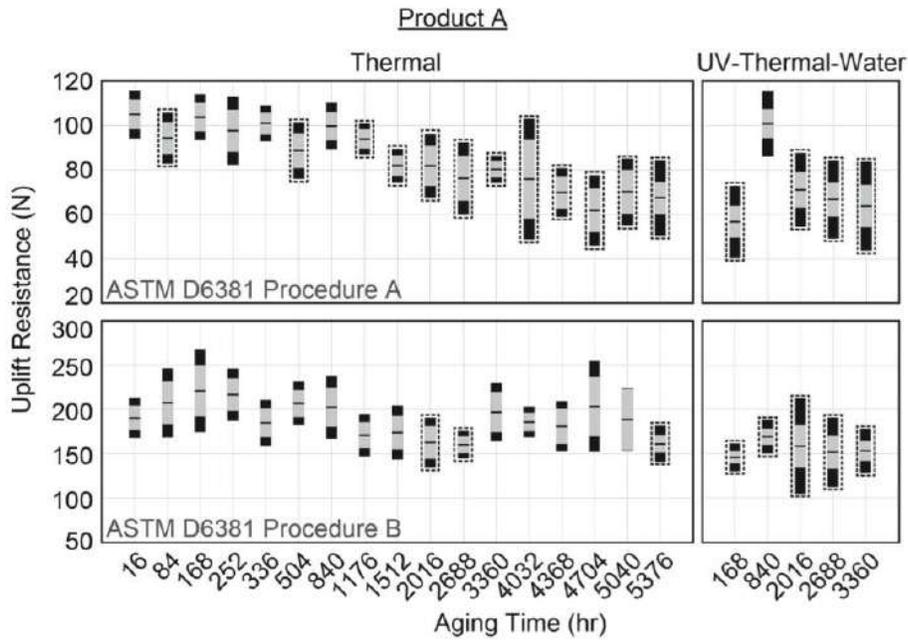
Figure 5-7. ASTM D6381 test results for Product A.

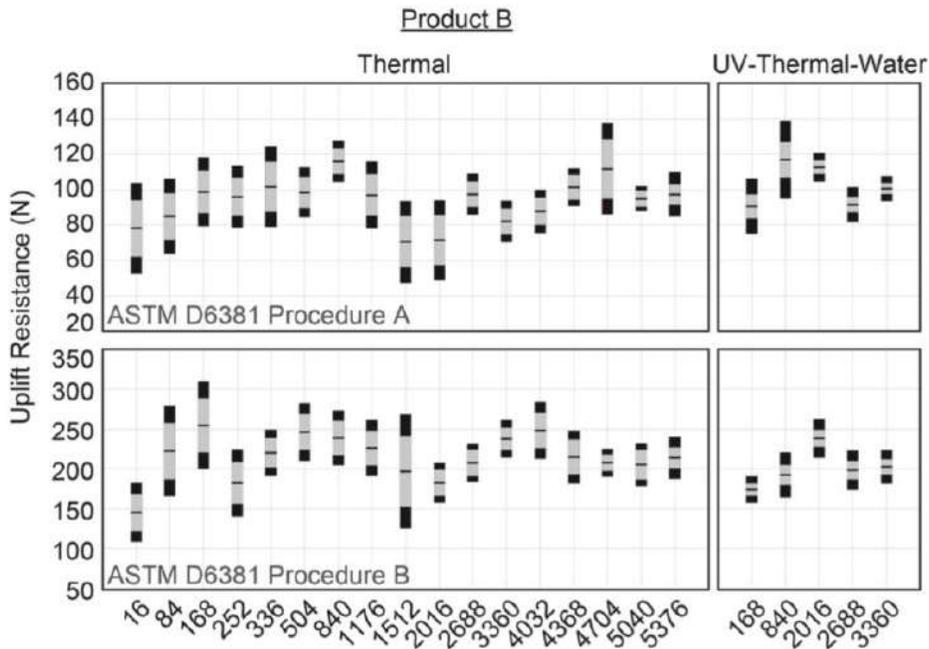
Figure 5-8. ASTM D6381 test results for Product B.
