THE WIND RESISTANCE OF ASPHALT ROOFING SHINGLES

CRAIG ROBERT DIXON

A DISSERTATION PRESENTED TO THE GRADUATE SCHOOL
OF THE UNIVERSITY OF FLORIDA IN PARTIAL FULFILLMENT
OF THE REQUIREMENTS FOR THE DEGREE OF
DOCTOR OF PHILOSOPHY

2013

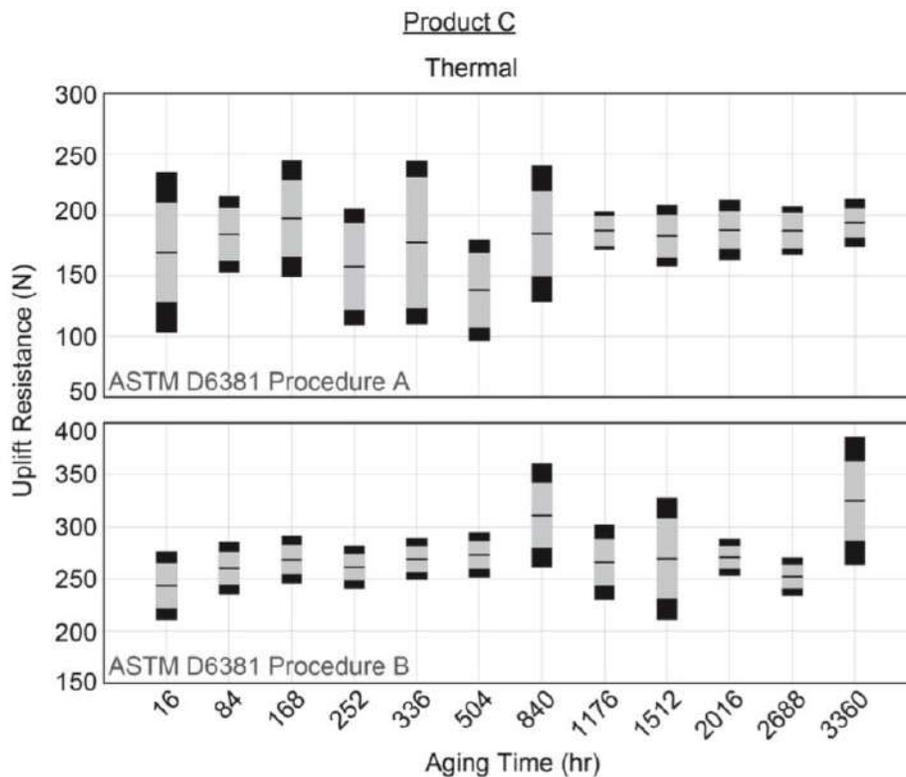
Figure 5-9. ASTM D6381 test results for Product C.

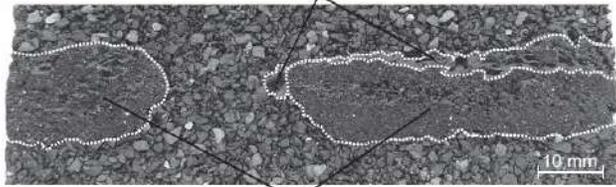
Top Shingle Asphalt Coating Cohesive Failure

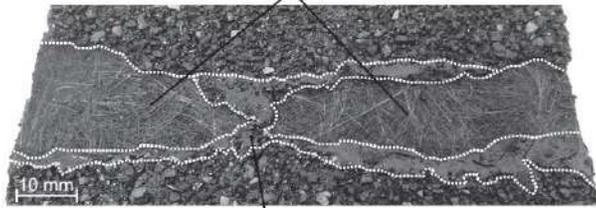
Sealant Strip-to-Top Shingle Adhesive Failure

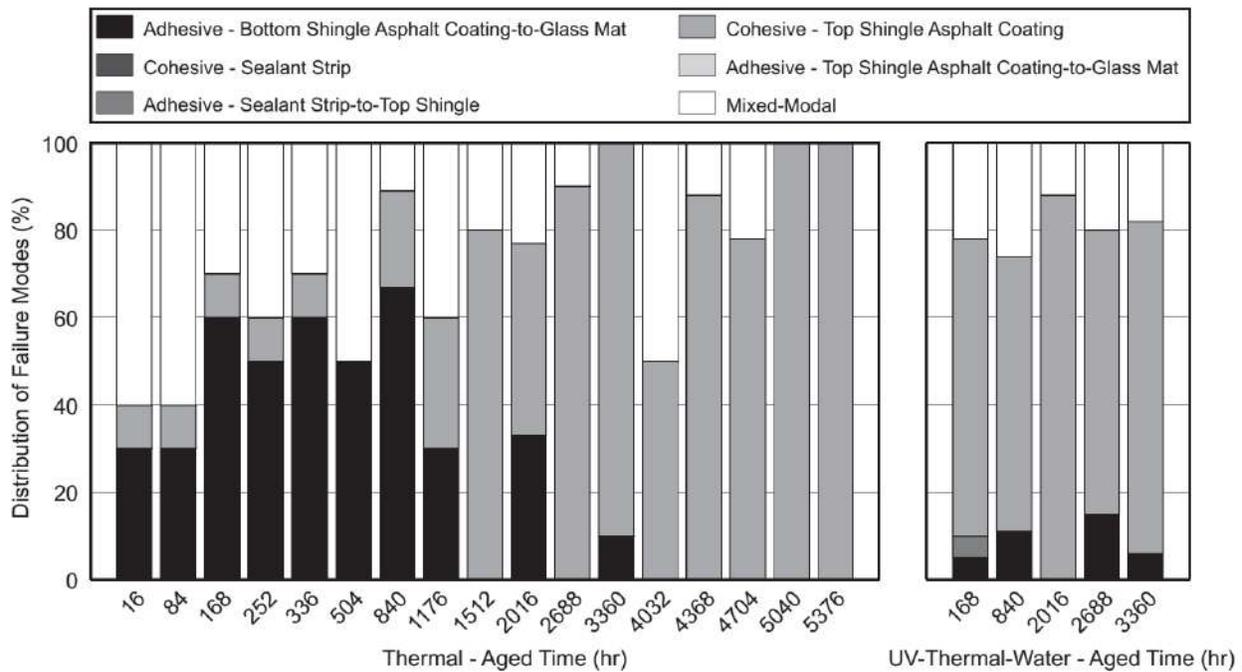
Figure 5-11. Distribution of failure modes on Product A-Procedure A.

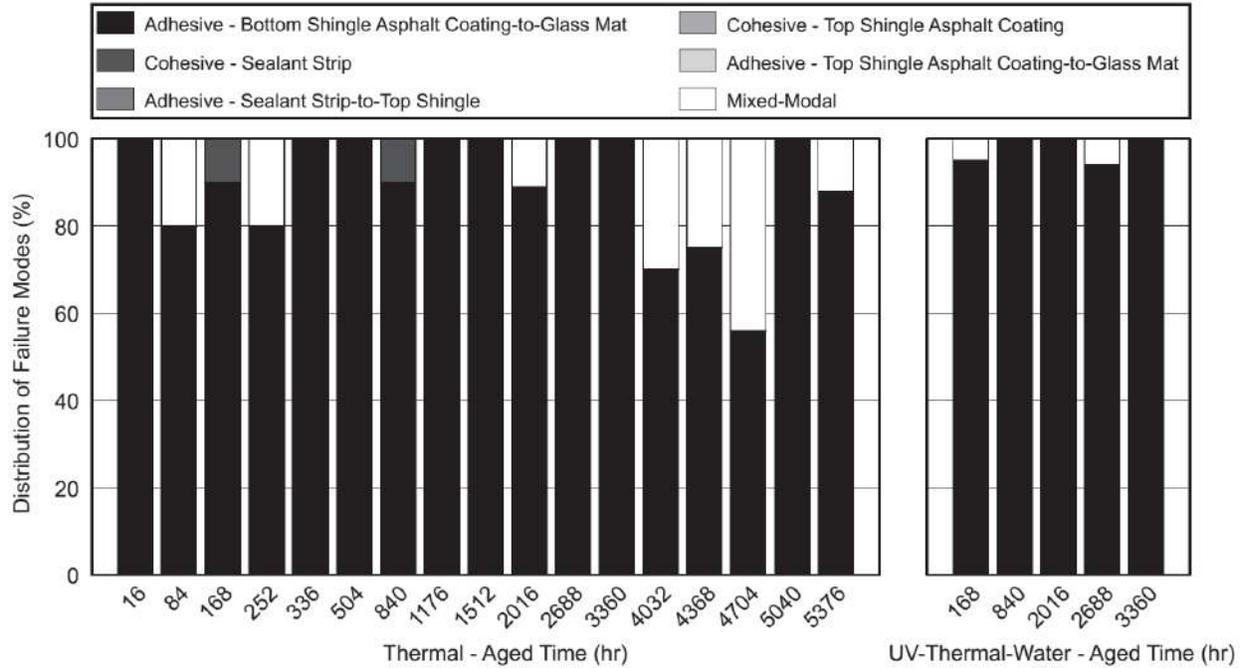
Figure 5-12. Distribution of failure modes on Product A-Procedure B.

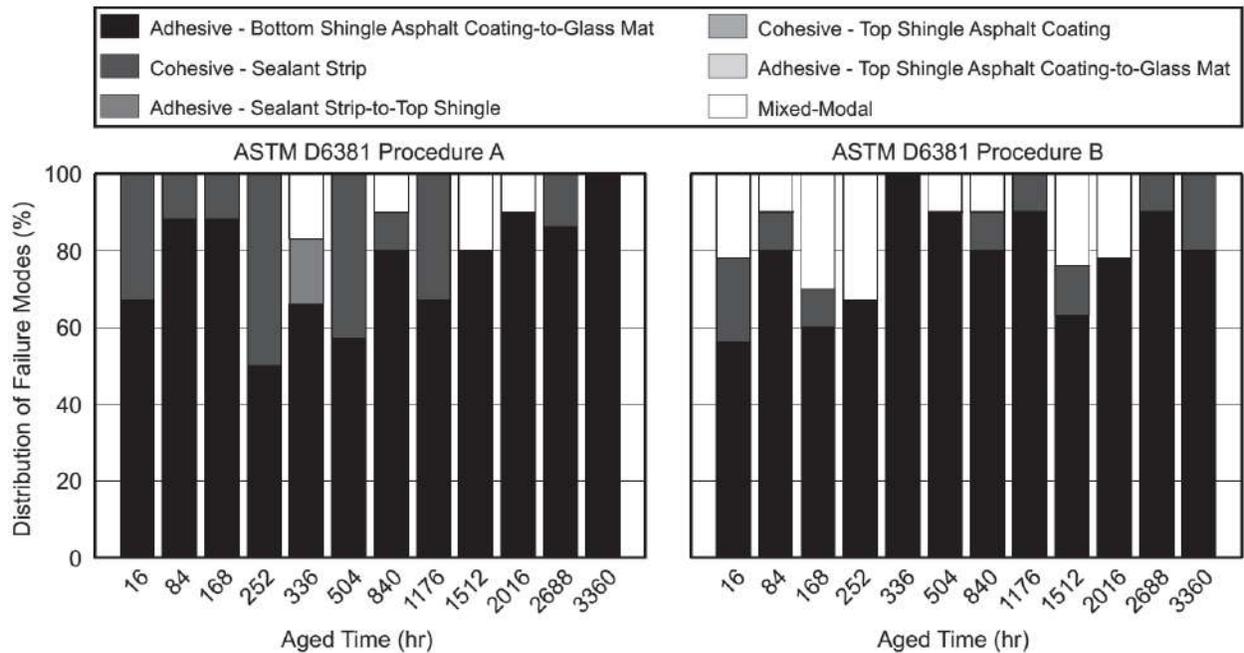
Figure 5-13. Distribution of failure modes on Product C.

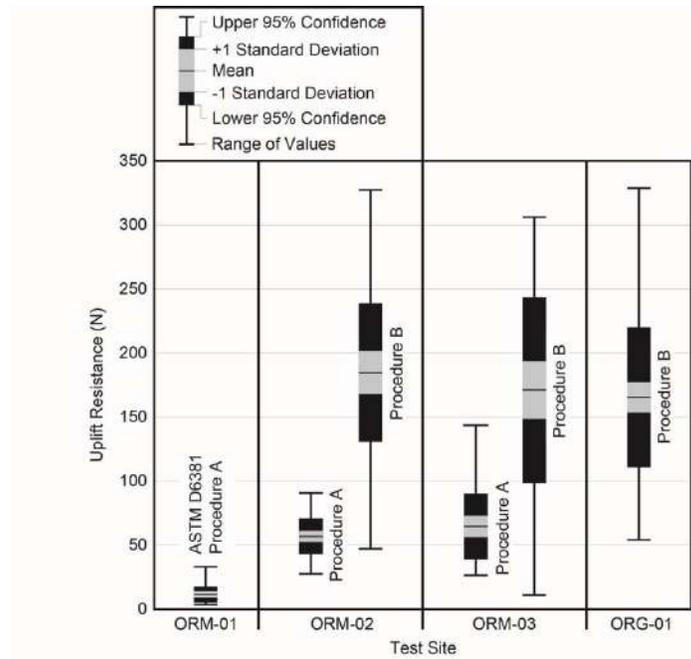
Figure 5-15. In situ ASTM D6381 test results.

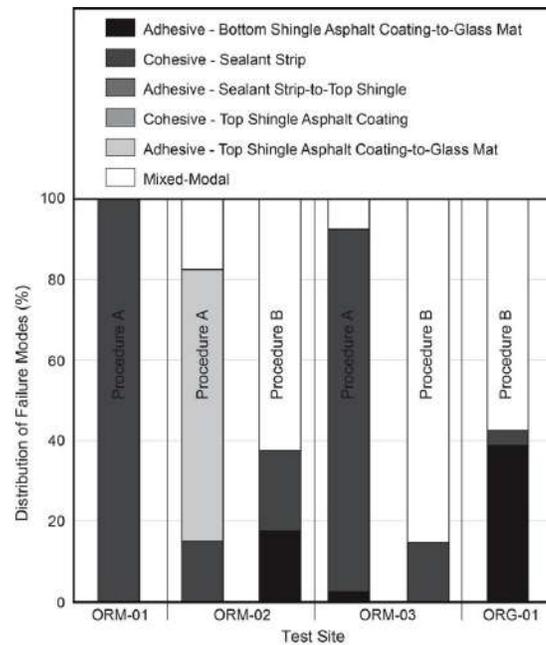
Figure 5-16. Distribution of failure modes for in situ ASTM D6381 tests.

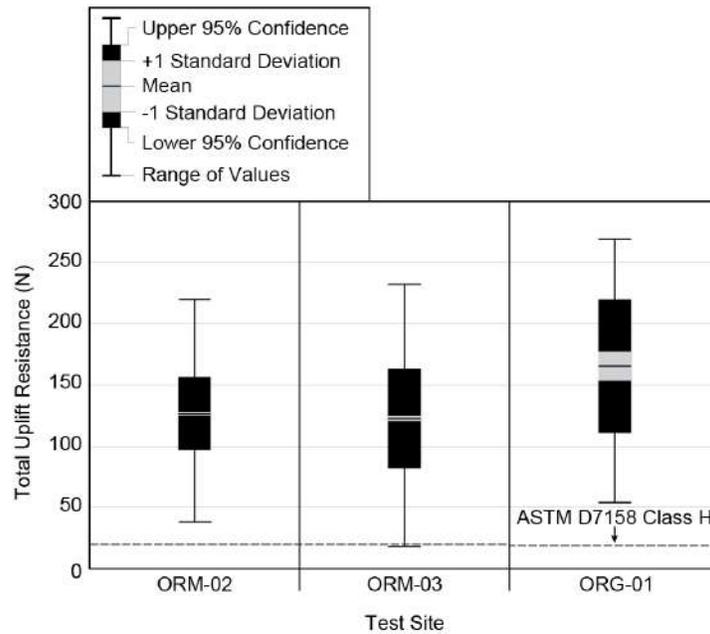
Figure 5-17. Wind resistance of naturally aged shingles vs. ASTM D7158 Class H required resistance.

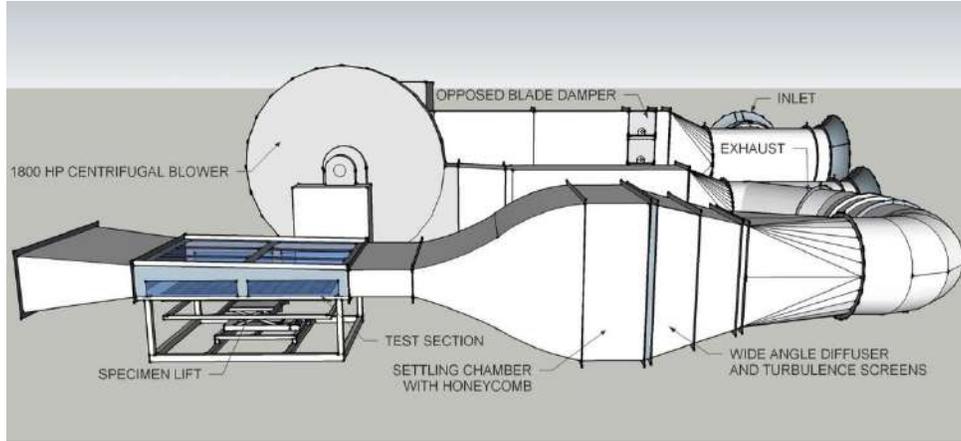
Figure 6-2. Rendering of the Dynamic Flow Simulator componentry.

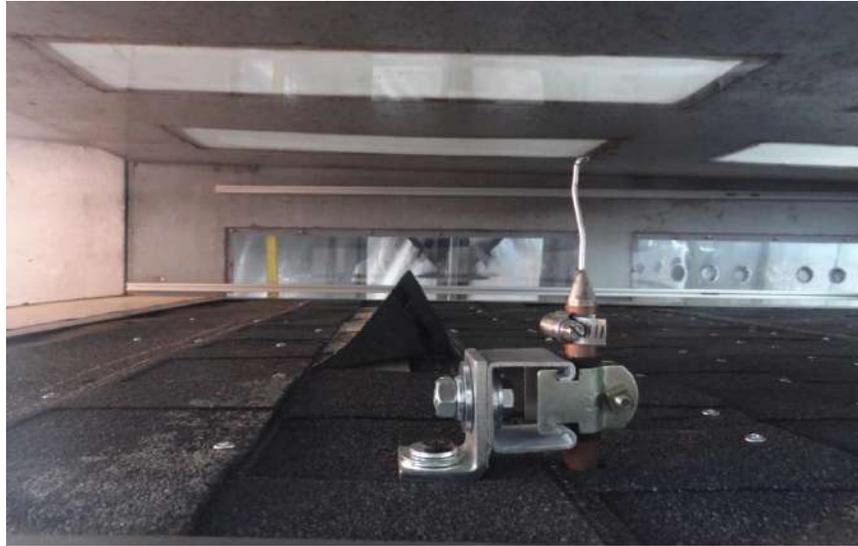
Figure 6-7. Interior view of the DFS during this study's wind test. A partially unsealed laminate shingle instrumented with load cells is shown.

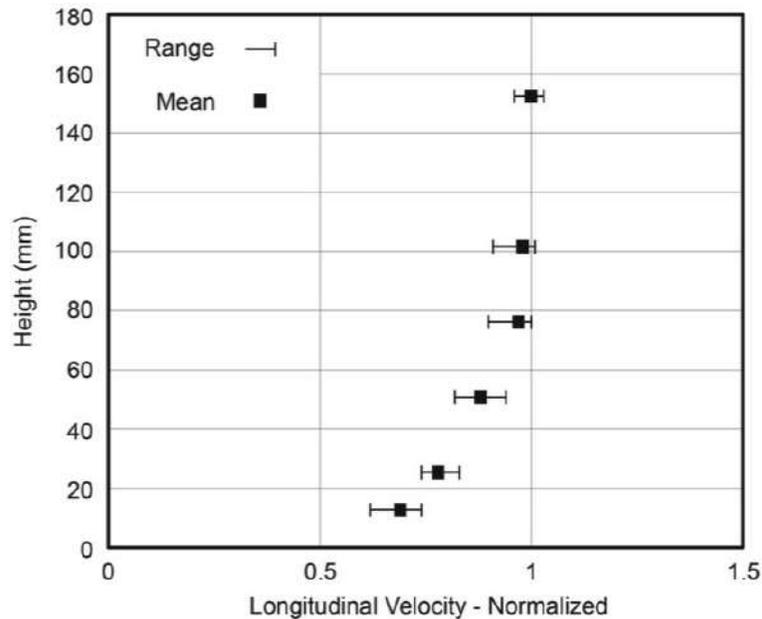
Figure 6-8. Mean longitudinal velocity across the width of a shingle test specimen located 1.9 m (6.2 ft) downwind of the windward edge of a shingle roof test deck.

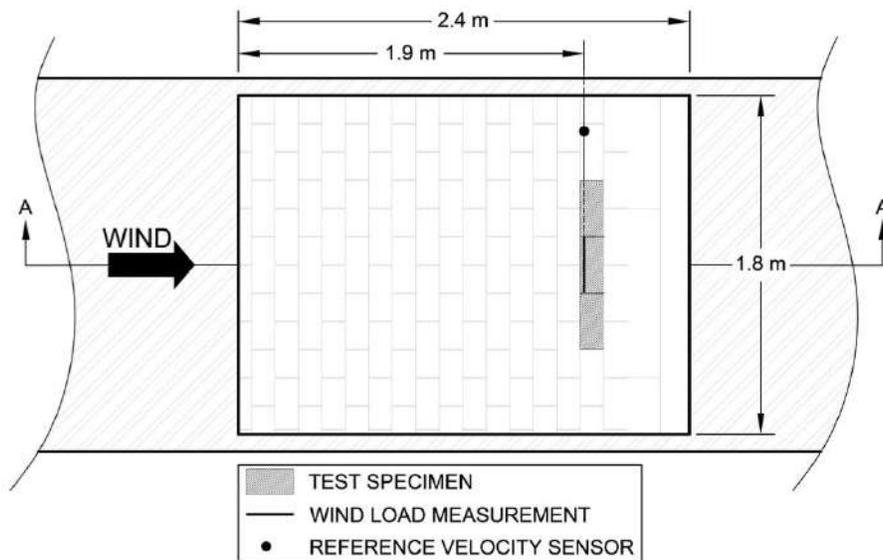
Figure 6-9. Plan view of Three-Tab test deck.

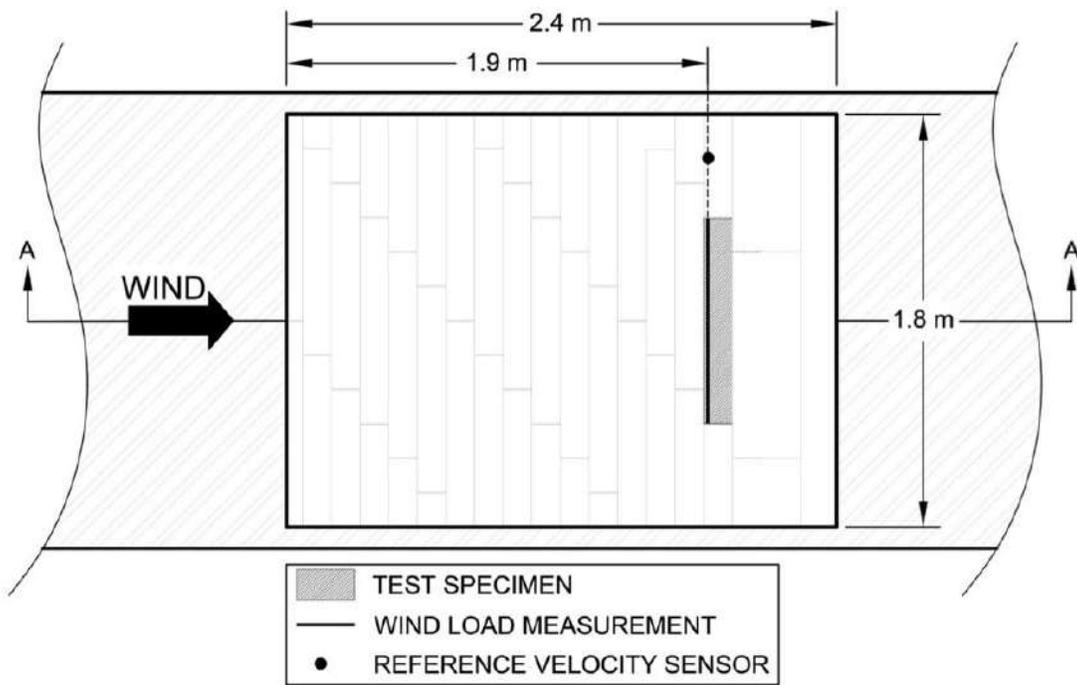
Figure 6-10. Plan view Laminate test deck.

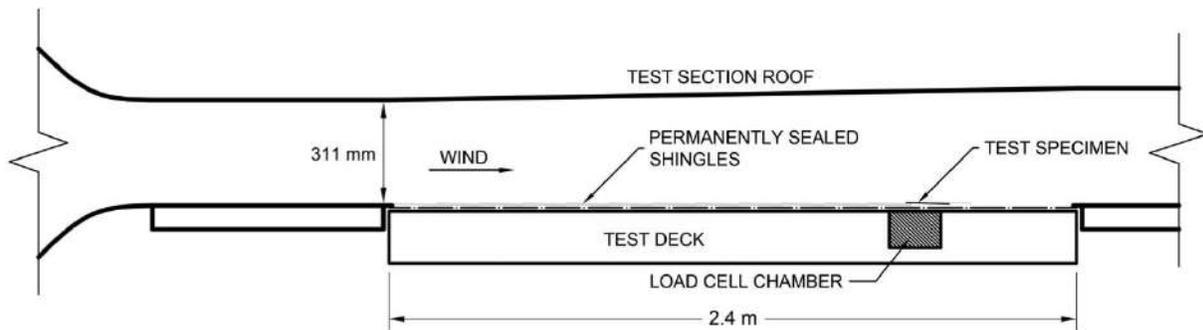
Figure 6-11. Cross-section of DFS with test deck.

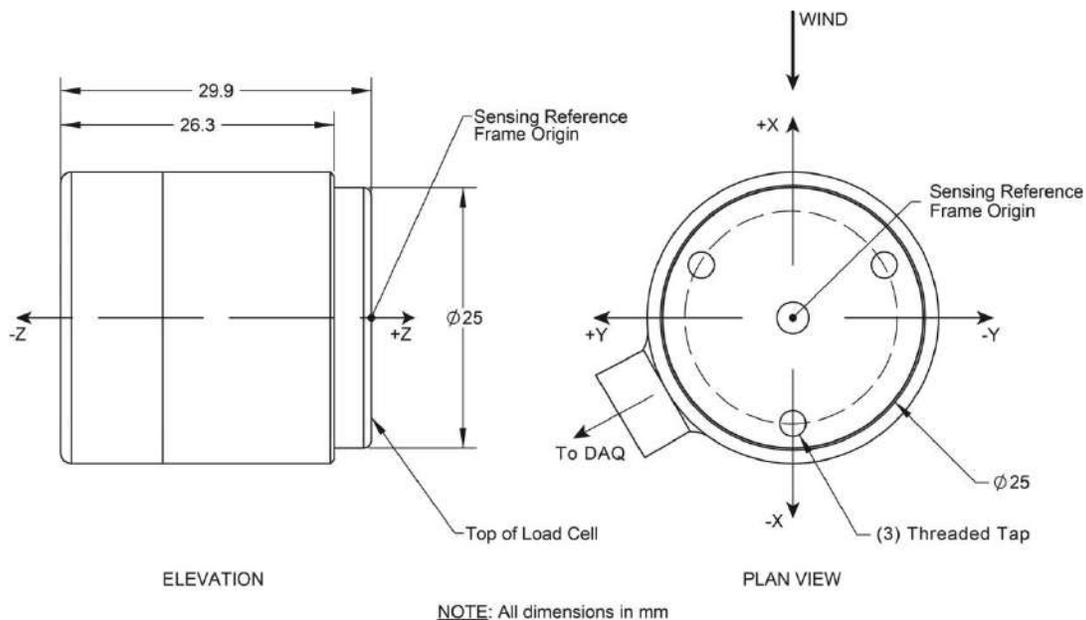
Figure 6-12. Multi-axis load cell elevation and plane view.

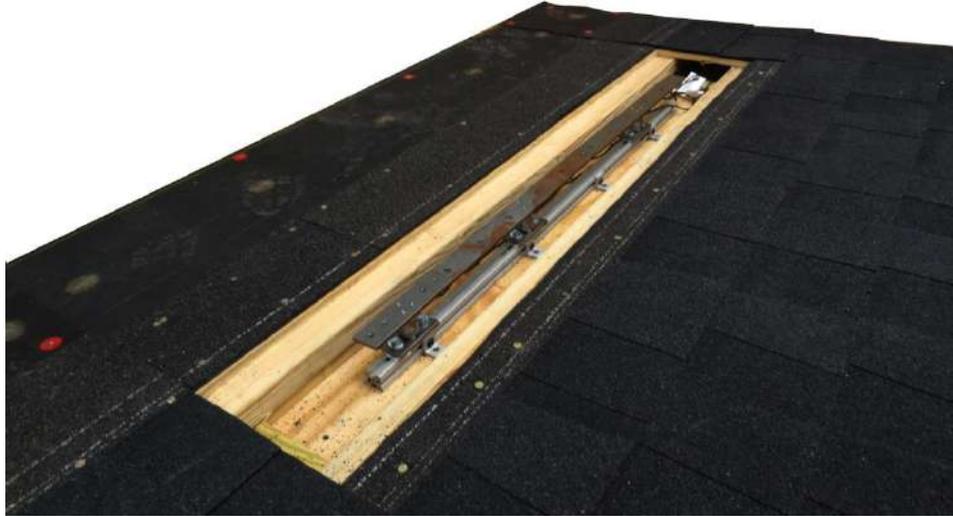
Figure 6-14. Part 1: load cell arrangement for Laminate specimen showing load cell base connection.

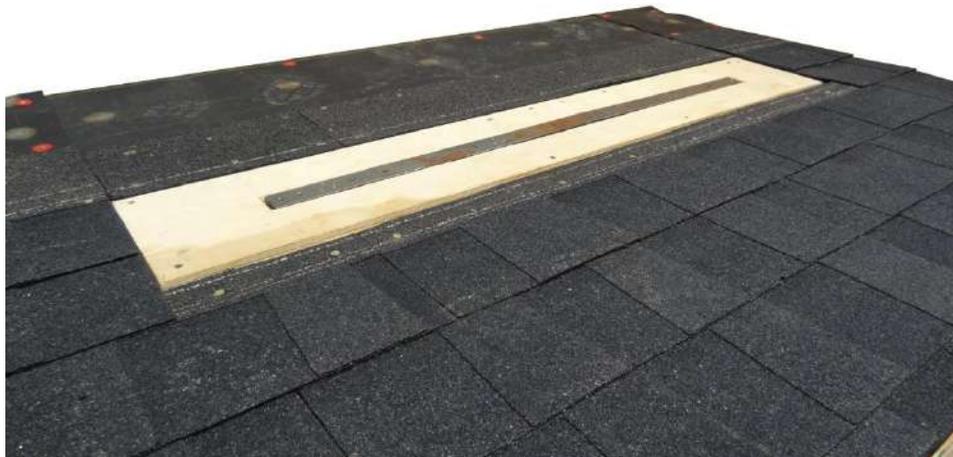
Figure 6-15. Part 2: load cell arrangement for Laminate specimen showing wood decking surrounding top plates.

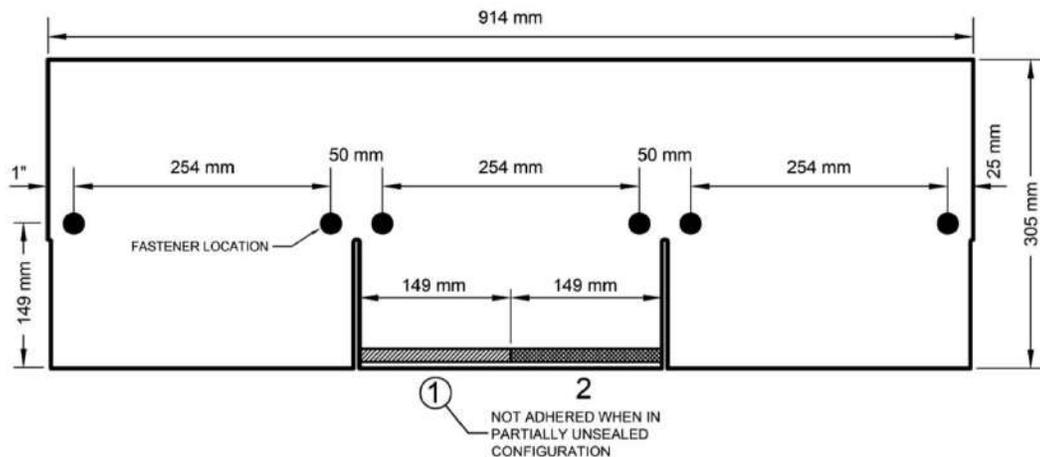
Figure 6-16. Three-Tab specimen.

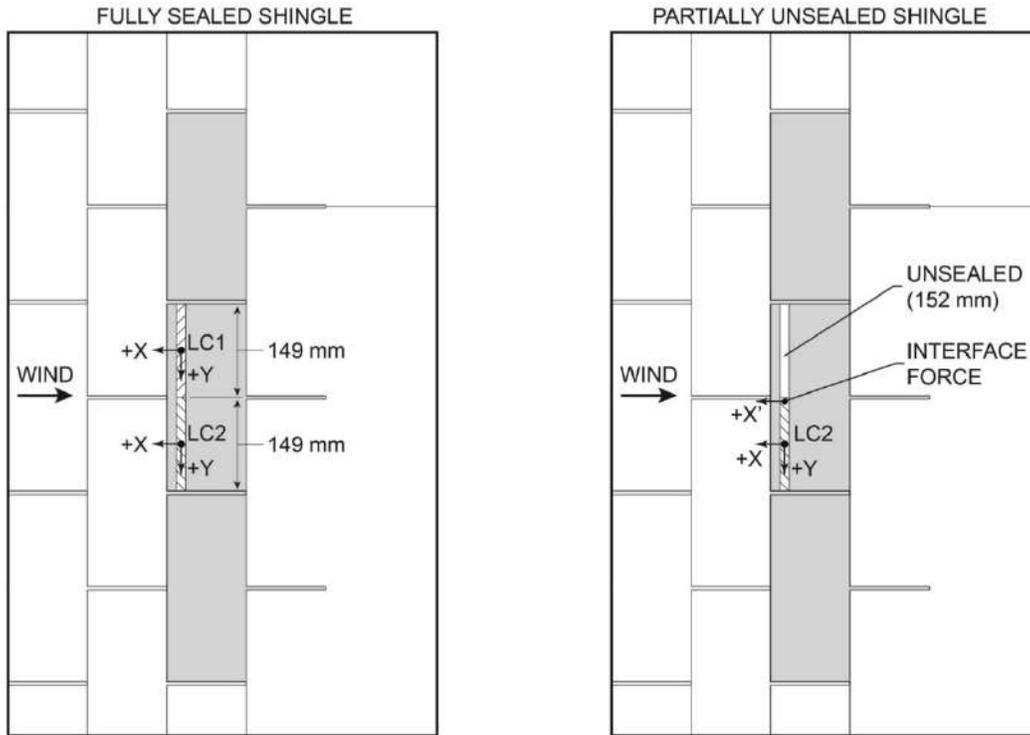
Figure 6-17. Plan views for Three-Tab fully sealed and partially unsealed arrangements.

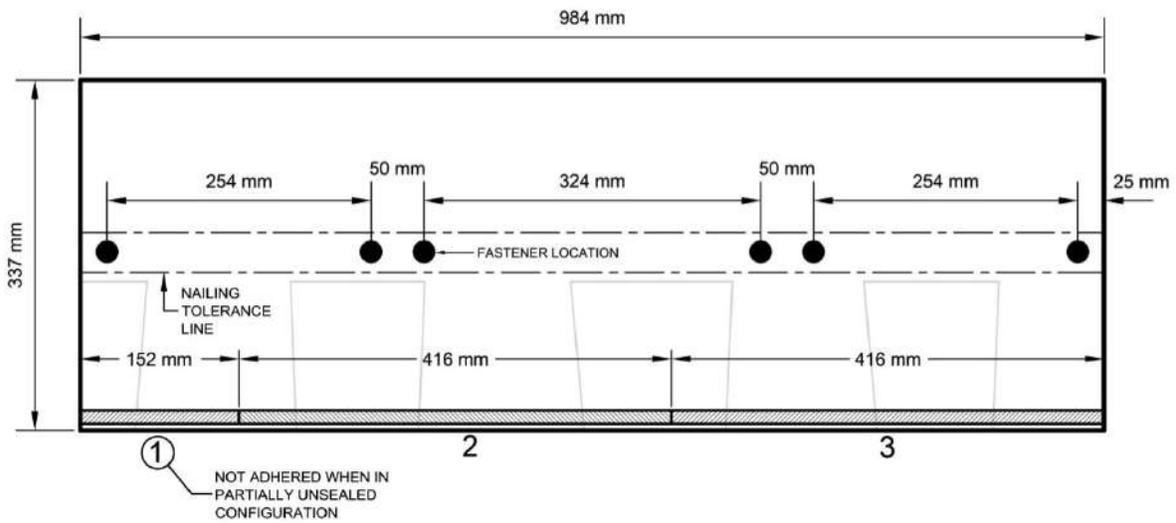
Figure 6-18. Laminate specimen.

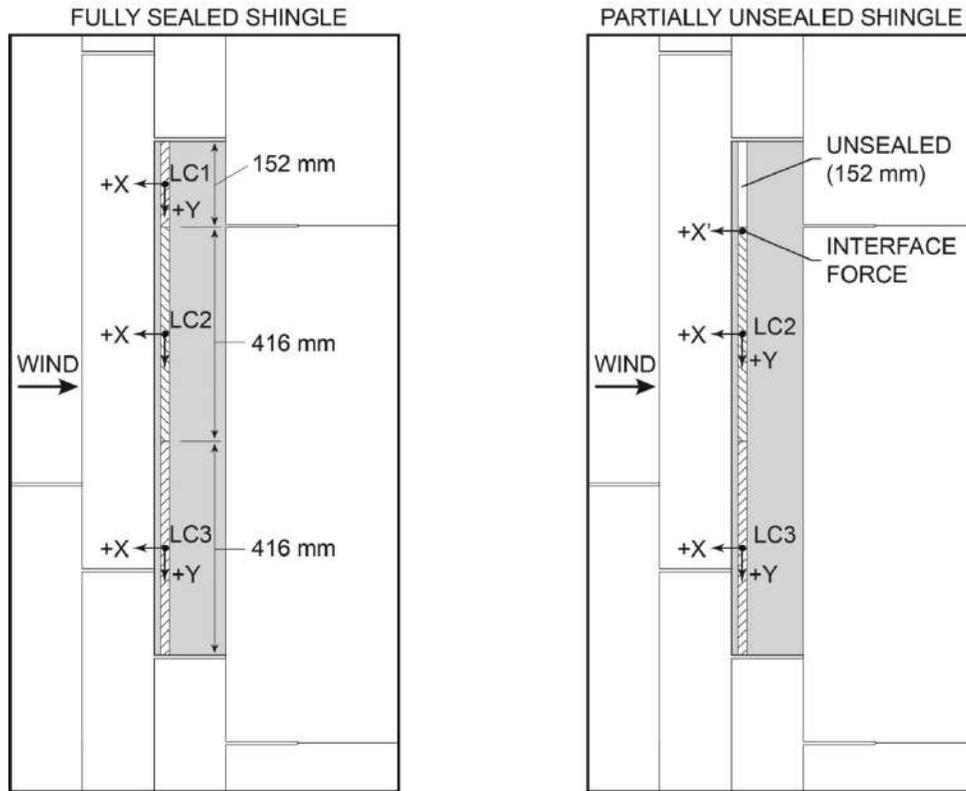
Figure 6-19. Plan views for Three-Tab fully sealed and partially unsealed arrangements.

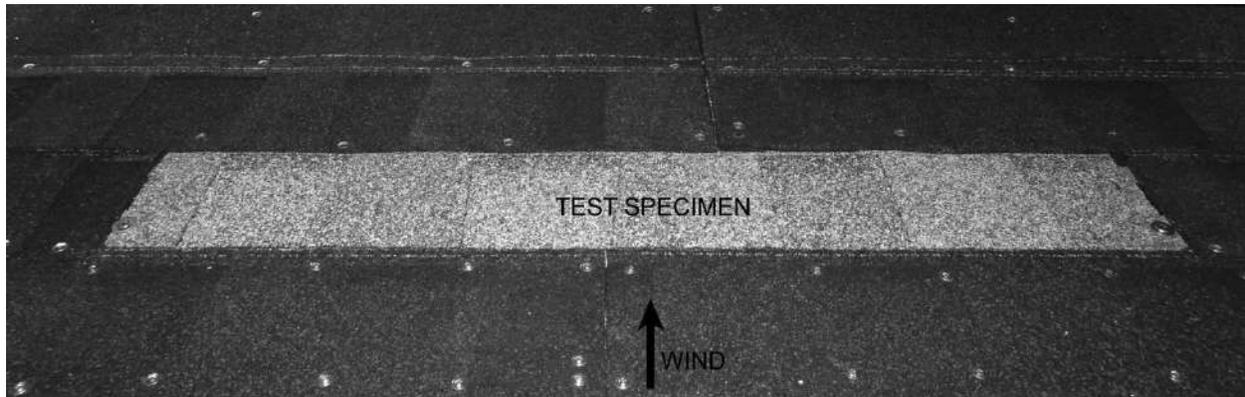
Figure 6-20. Fully sealed laminate test specimen installed on the test deck.

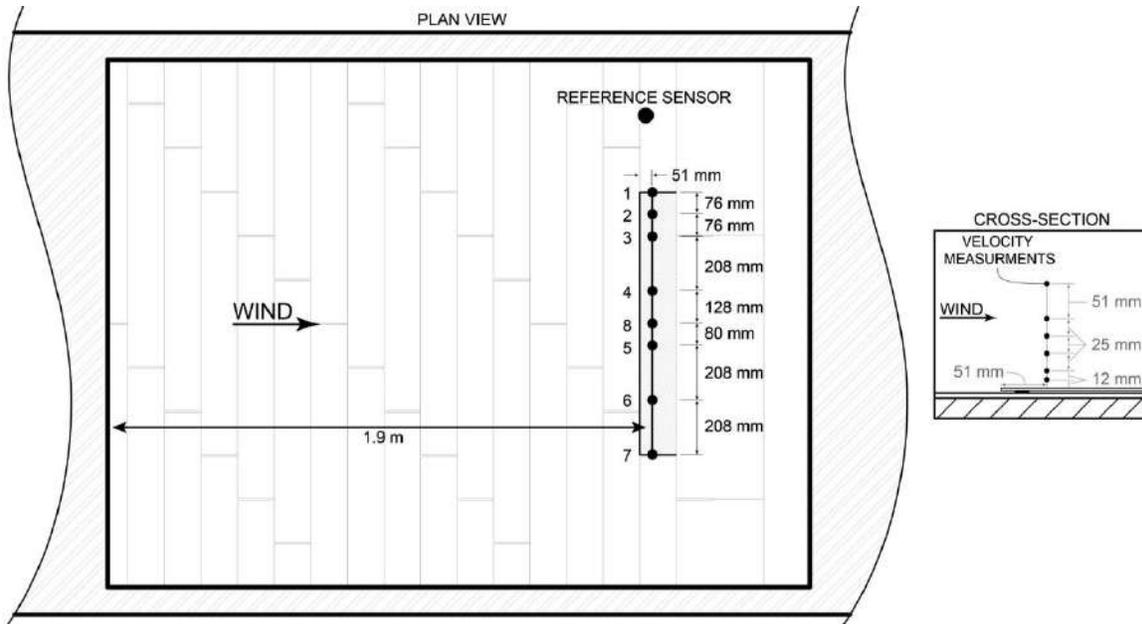
Figure 6-21. Plan view and cross section of velocity measurement locations.

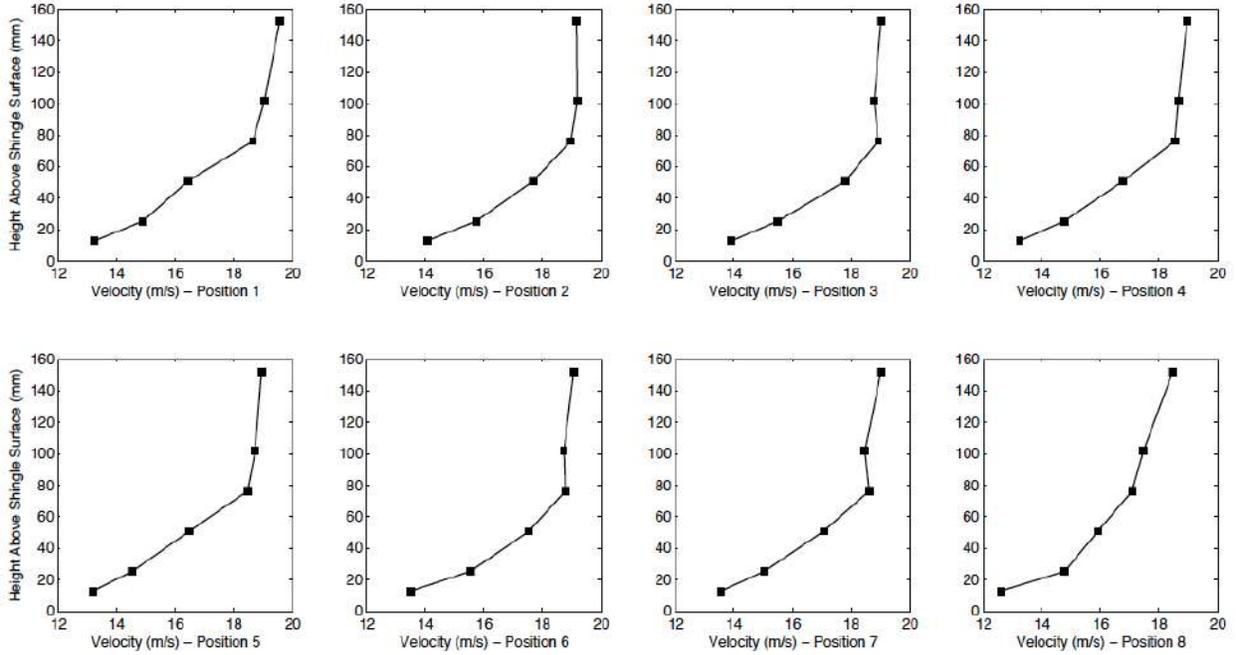
Figure 6-23. Mean longitudinal velocity profiles – Low wind speed.

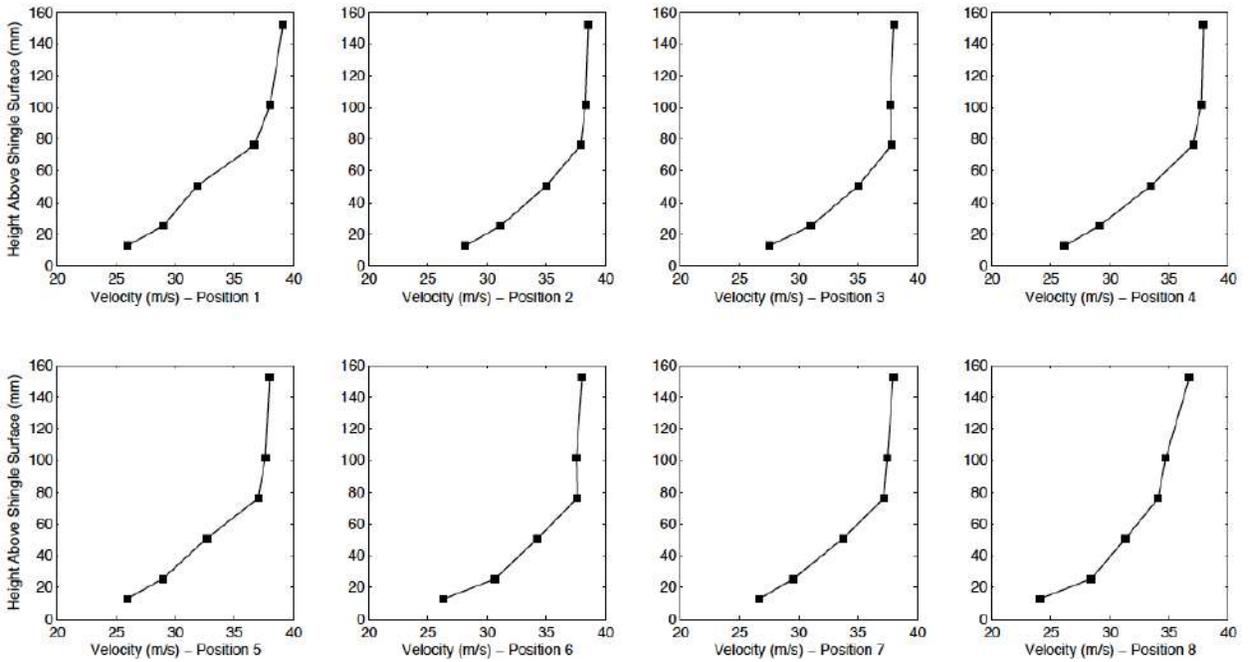
Figure 6-24. Mean longitudinal velocity profiles – Medium wind speed.

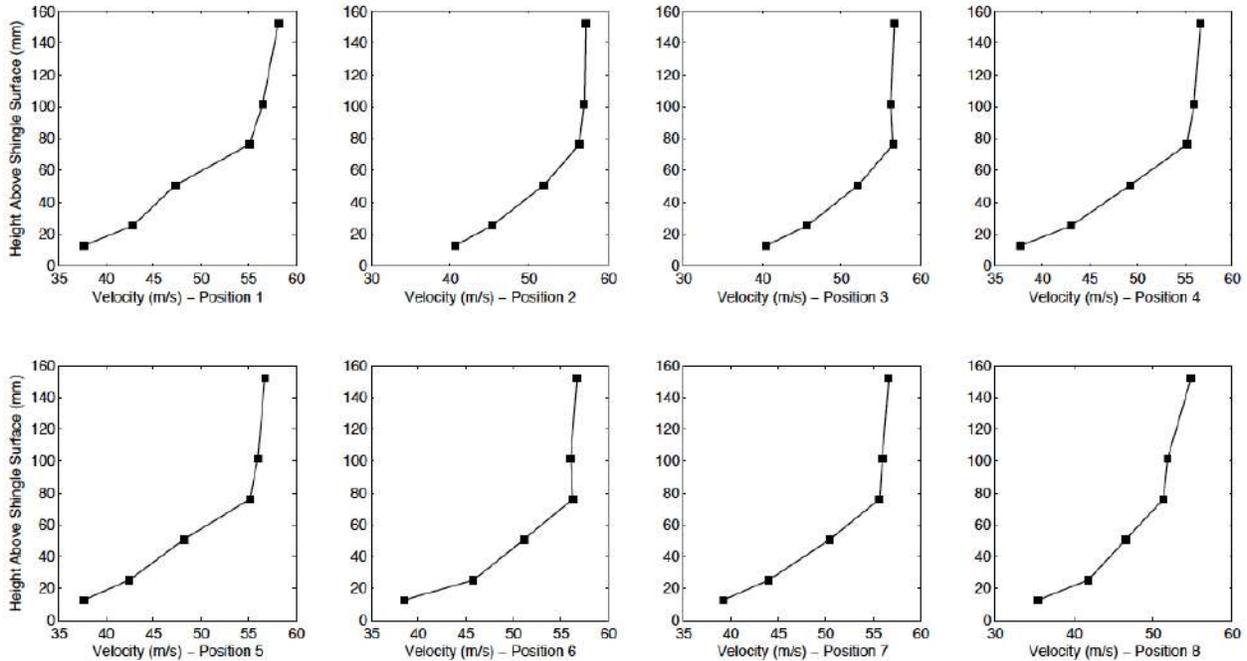
Figure 6-25. Mean longitudinal velocity profiles – High wind speed.

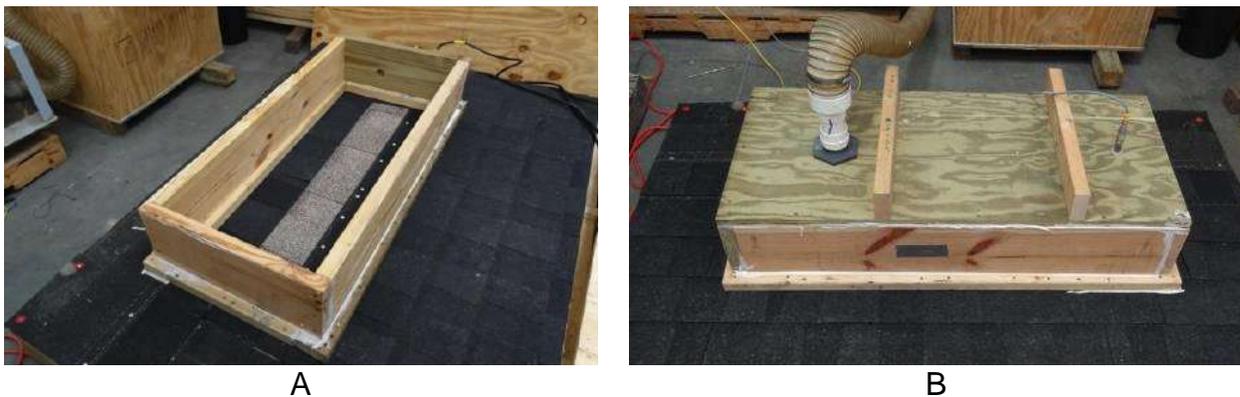
Figure 6-28. Phase II experimental setup. A) Laminate specimen with pressure box. B) Sealed box with air hose and pressure sensor attached.

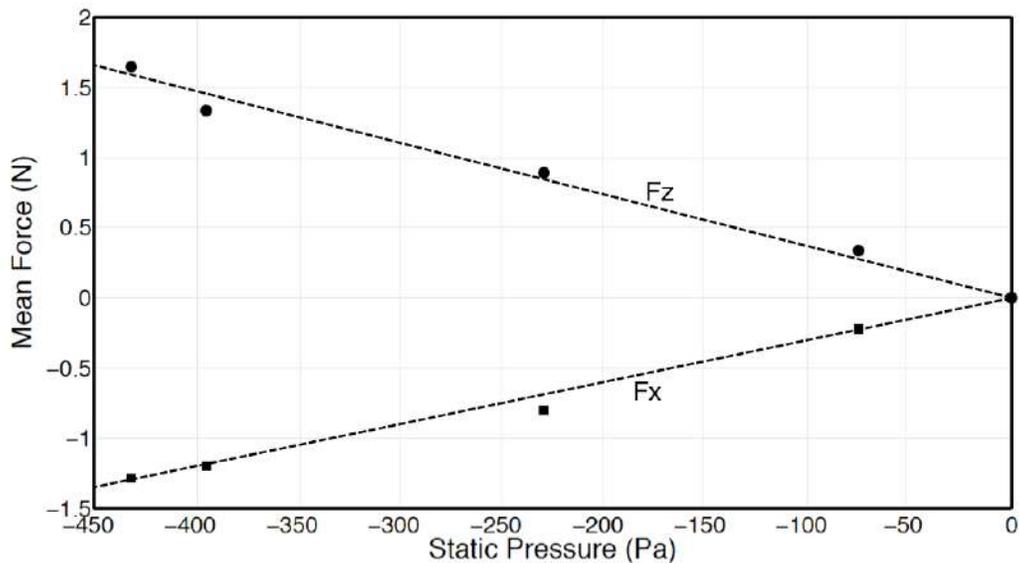
Figure 6-29. Relationship between static pressure and mean force. X- and Z- axes component force are shown for 416 mm (16.375 in) length of sealant strip.

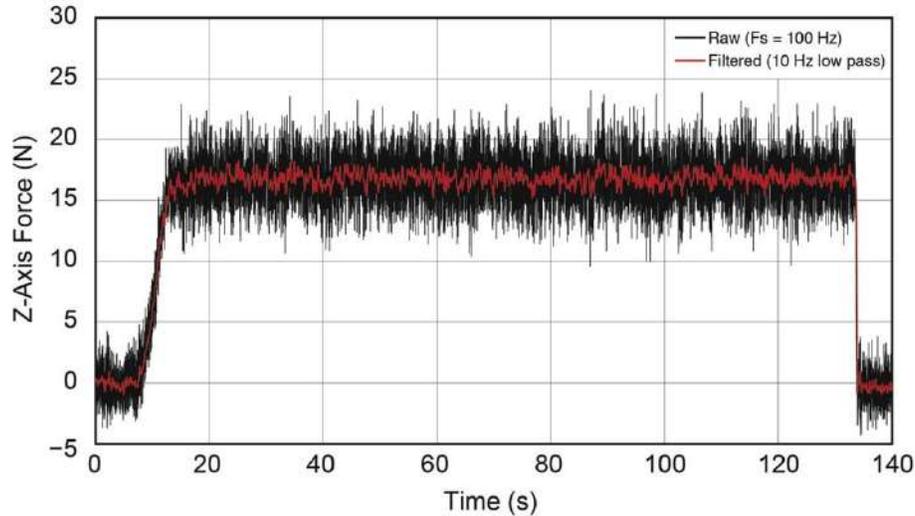
Figure 6-30. Representative time-history plot of z-axis force between raw and filtered signals and not affected by temperature.

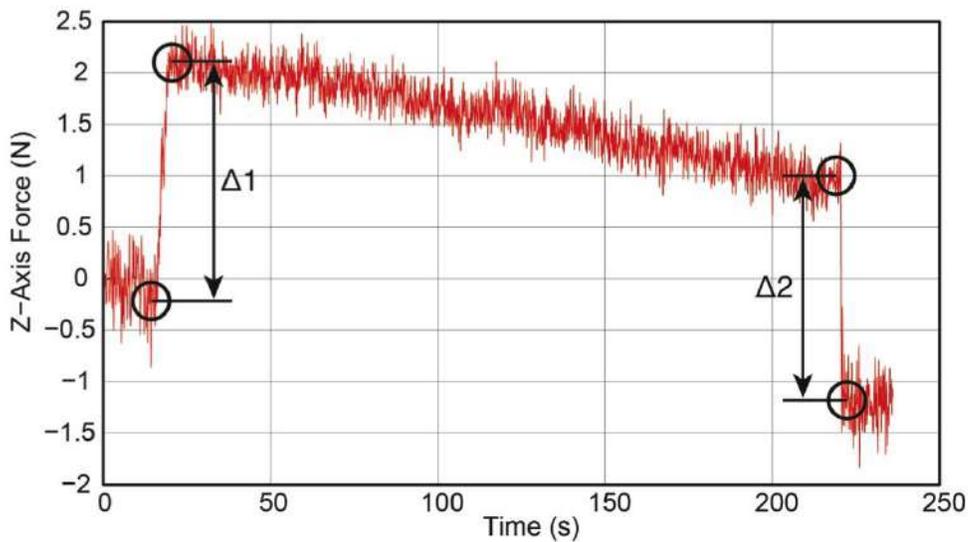
Figure 6-31. Time-history plot of z-axis force affected by temperature change on the load cell's body.

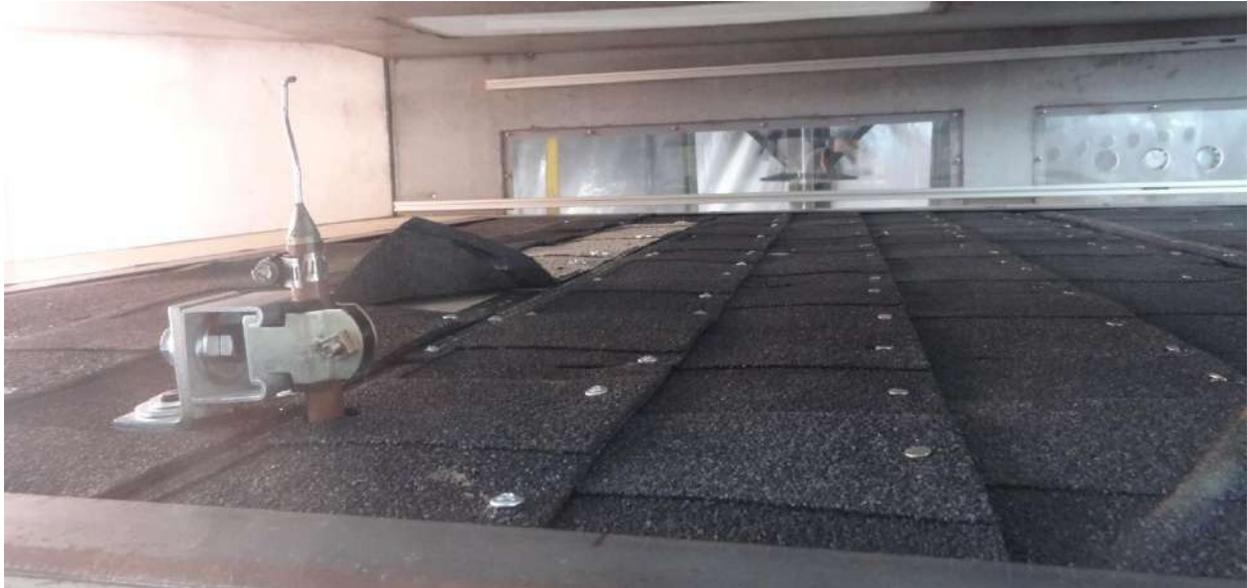
Figure 6-33. Partially unsealed Laminate Specimen 3 lifting in 44 m/s (98 mph) mean wind velocity.

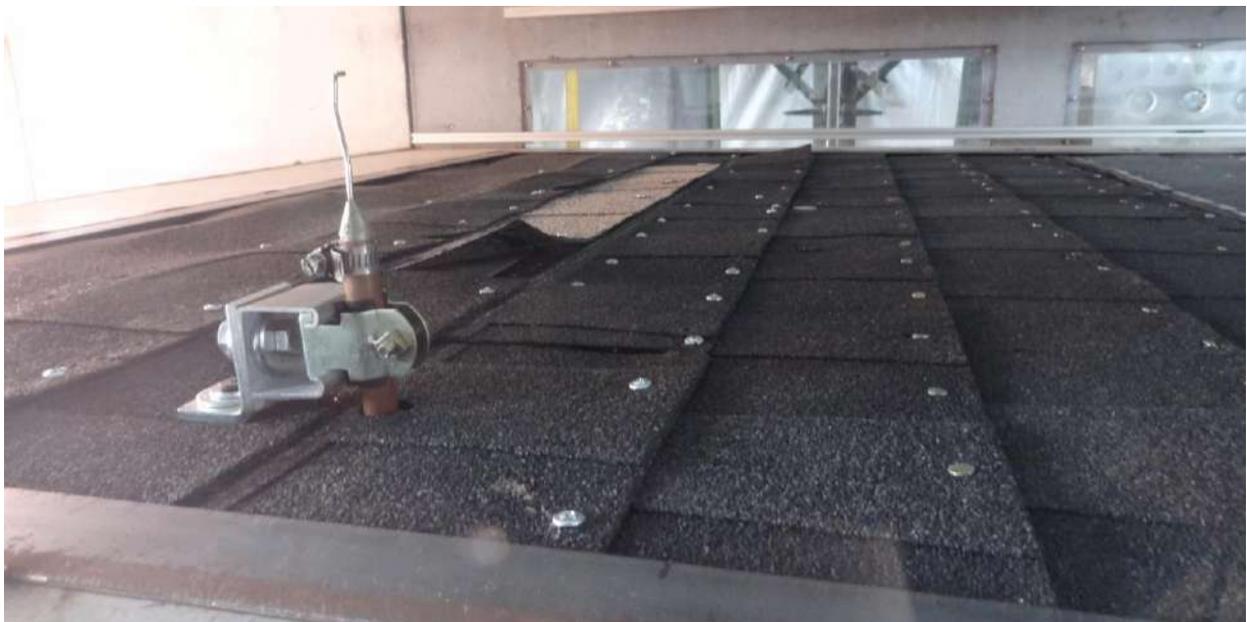
Figure 6-34. Partially unsealed Laminate Specimen 4 lifting in 44 m/s (98 mph) mean wind velocity.

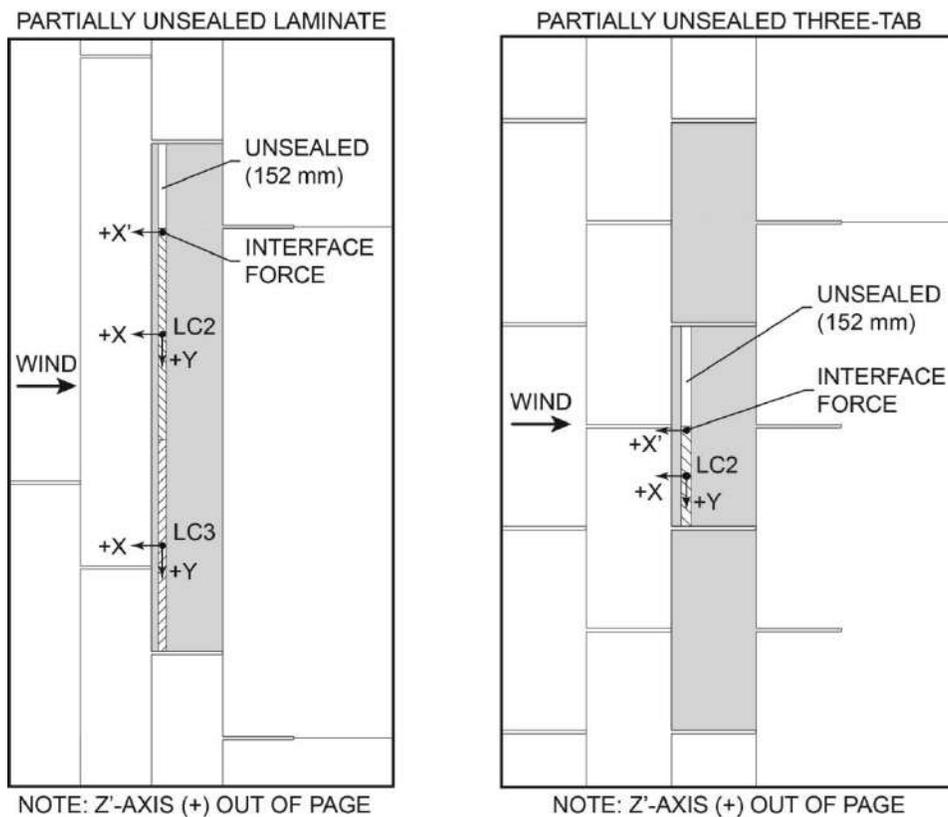
Figure 6-35. Reference frame for partially unsealed Laminated and Three-Tab specimens showing interfacial force location.
