General
Technical
Report
FPL-GTR-159

Condition Assessment of Timber Bridges

1. Evaluation of a Micro-Drilling Resistance Tool

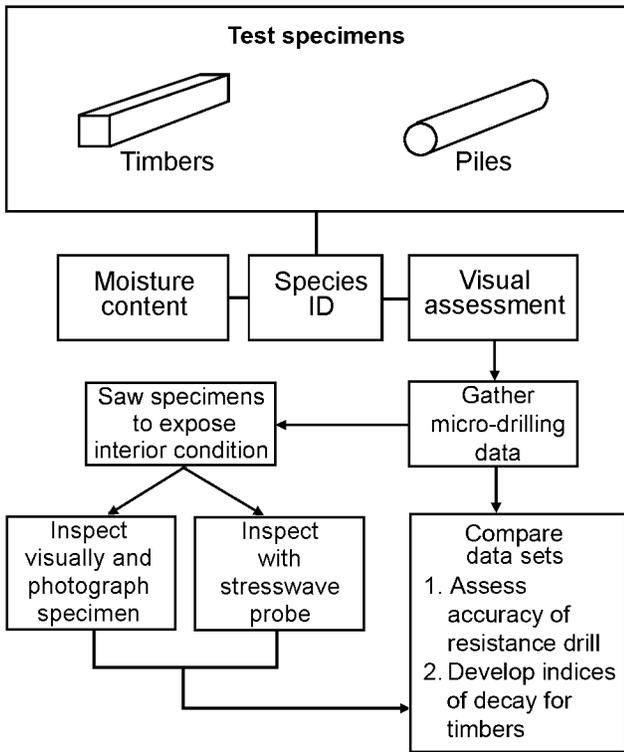
Figure 1—Stages of this study

This study was accomplished in several stages (Fig. 1). Several types of data were collected on the timber specimens in their original (unsawn) condition. First, the timber specimens were tested to determine moisture content and wood species. Second, the bridge timbers were visually inspected to locate deteriorated areas. Last, micro-drilling resistance measurements were collected from each of the timber bridge specimens.

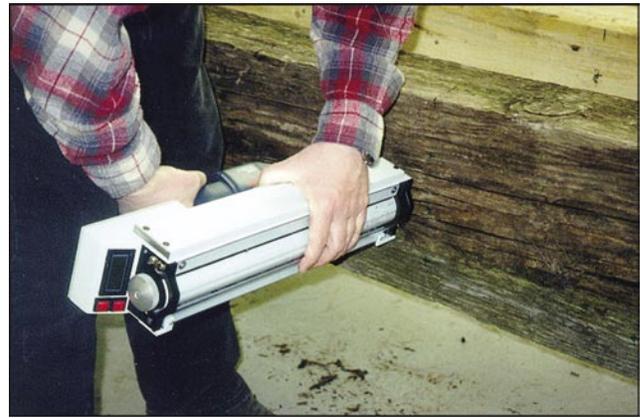
Figure 2—IML RESI F300-S in use.

The IML RESI F300-S micro-drilling device was used in this study to assess decay in the timber specimens (Fig. 2). The IML RESI F300-S performance is based on a micro-drilling resistance measuring method. A steel drilling bit 12 in. (305 mm) long with a diameter of 0.06 to 0.12 in. (1.5 mm to 3.0 mm) penetrates the wooden structure at a uniform speed while drilling resistance is measured. The measured resistance data (recorded on a relative 0–100% scale) is recorded on a wax paper strip at a scale of 1:1, printed, or captured electronically for downloading to a personal computer. The small-diameter drilling bit results in minimal damage to bridge components.

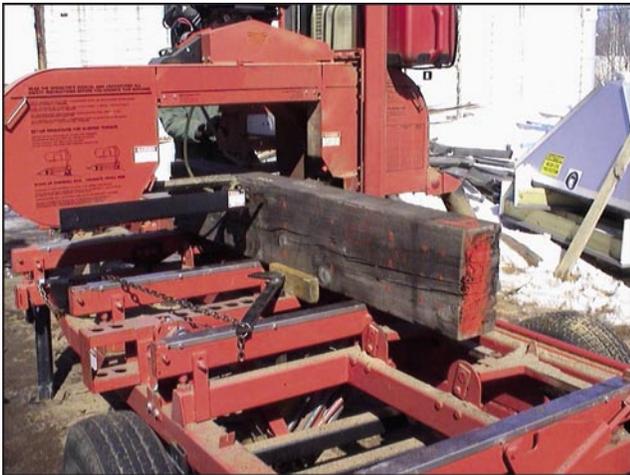
Figure 4—Portable band saw cutting timbers lengthwise along measurement lines.

Following the micro-drilling testing, each specimen was cut into slices using a portable band saw (Fig. 4). Each timber was cut along the measurement lines A, B, and C. Each section was then laid out so that interior faces could be visually assessed and documented with digital photographs. In addition, each sawn piece was evaluated using a stress-wave probe to determine the presence and extent of internal decay, checks, and splits.

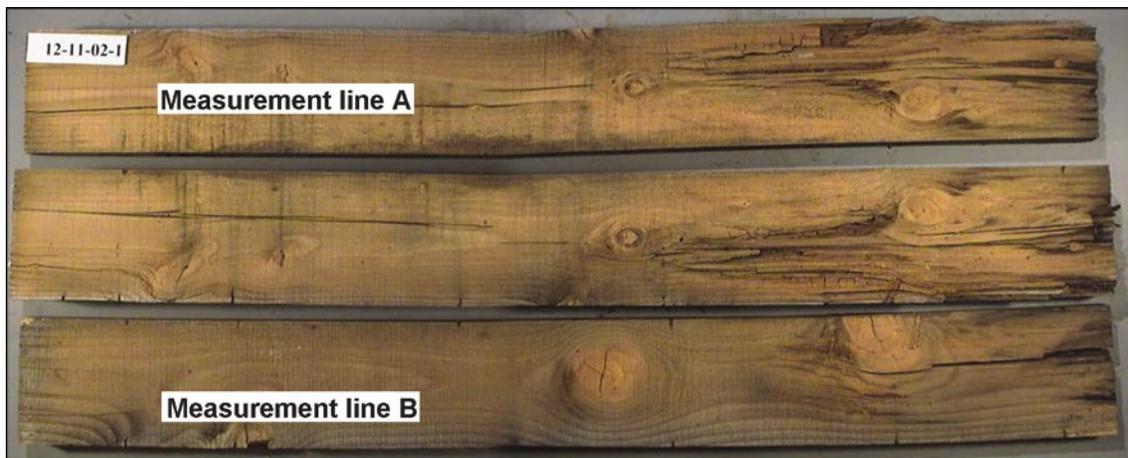
Figure 5—Typical sawn timber specimen layout for photographic documentation.

Figure 5 demonstrates how the samples were typically laid out for visual assessment and documentation. The top board corresponds with data collected along measurement line A. The bottom board corresponds with data collected along measurement line B.

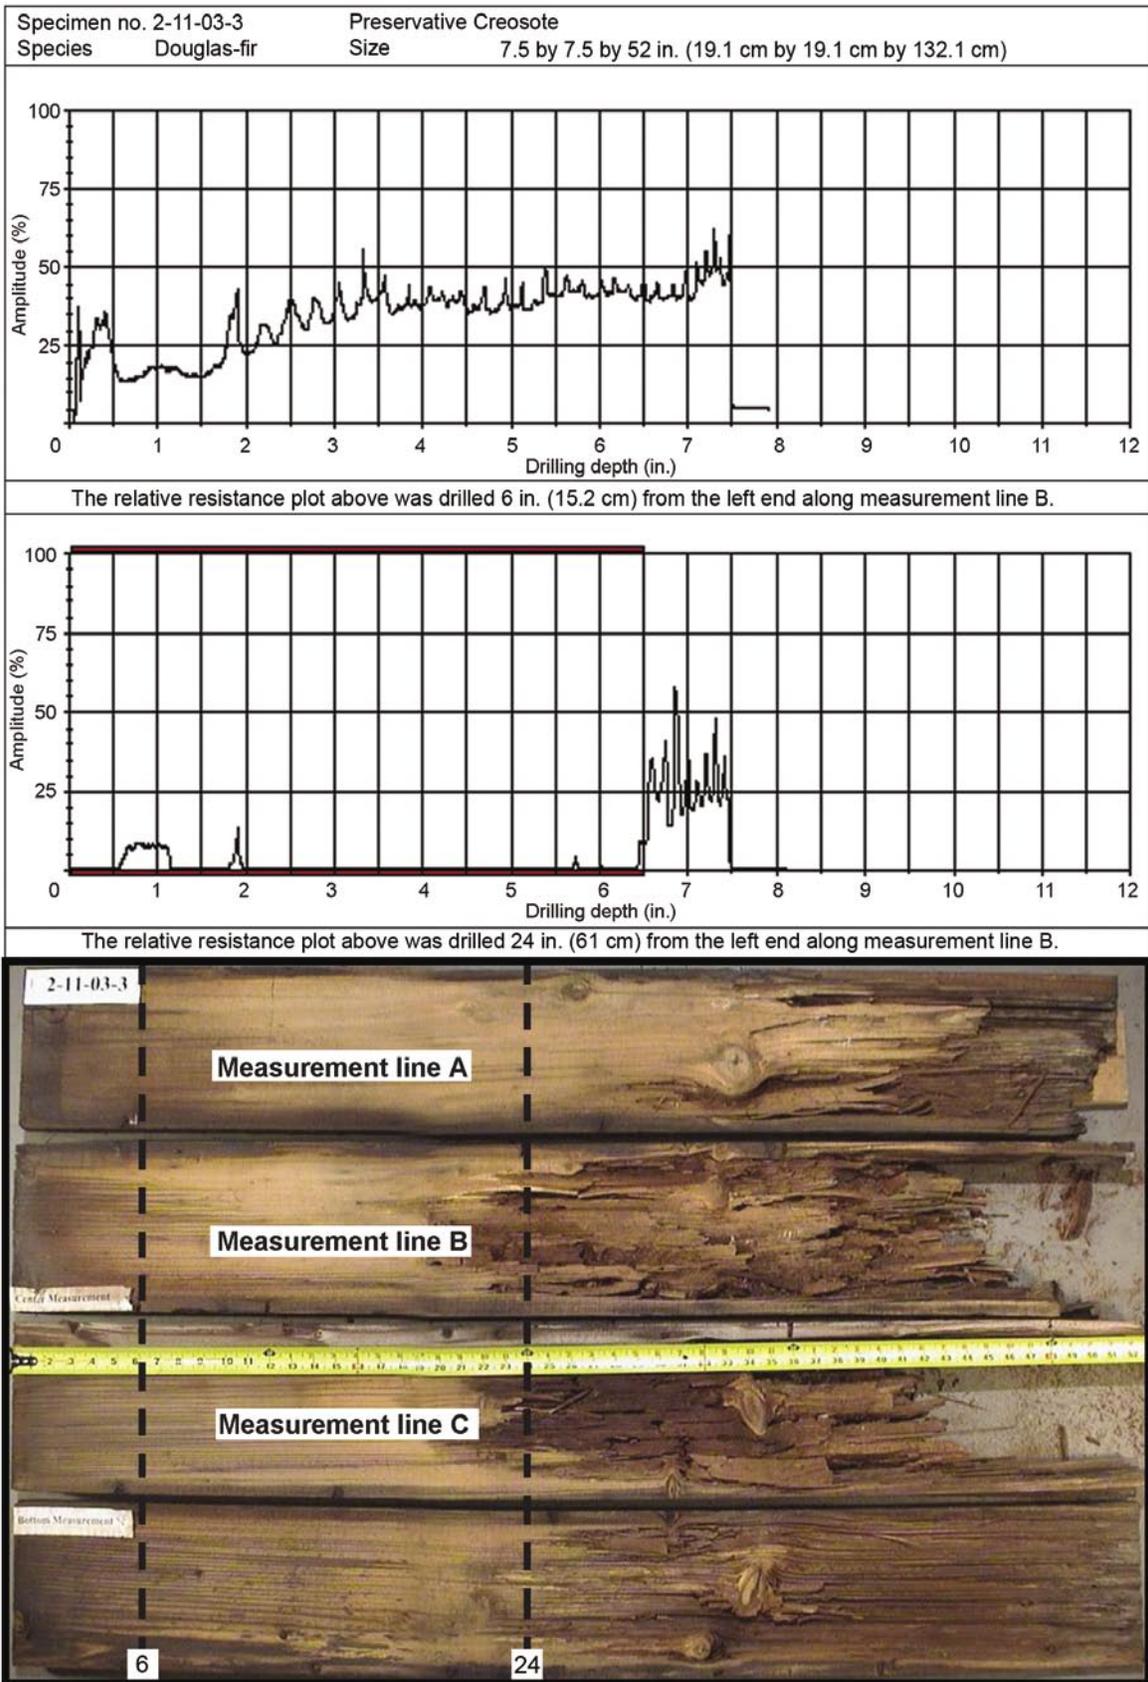
Figure 6—Comparison of resistance micro-drilling plots and interior photographs of bridge timber 2-11-03-3 reveals an example of severe deterioration. (Dashed lines denote drilling lines. Red bars at top and bottom of plots denote deterioration zones.)

Figure 6 illustrates typical results obtained from a test specimen that was severely deteriorated. Resistance plot data collected at the 4-in. (10.2-cm) drilling location along measurement line B shows severe deterioration for the first 6.5-in. (16.5-cm) drilling depth and has been marked with red bars at the top and bottom. Figure 7 illustrates typical results obtained from a test specimen that was moderately deteriorated. Resistance plot data collected at the 12-in. (30.5-cm) drilling location along measurement line B shows the effects of an internal check at nearly 6-in. (16.5-cm) drilling depth and has been marked with red bars at the top and bottom. Also, resistance plot data collected at the 24-in. (61-cm) drilling location along measurement line B shows moderate deterioration from 6.5-in. (16.5-cm) to 9.5-in. (24.1-cm) drilling depth and has been marked with red bars at the top and bottom. In contrast, Figure 8 illustrates typical results obtained from a test specimen that was sound wood, with no deterioration. An overall analysis of data from all 36 timber specimens led to the development indices of decay for the test specimens, as follows:

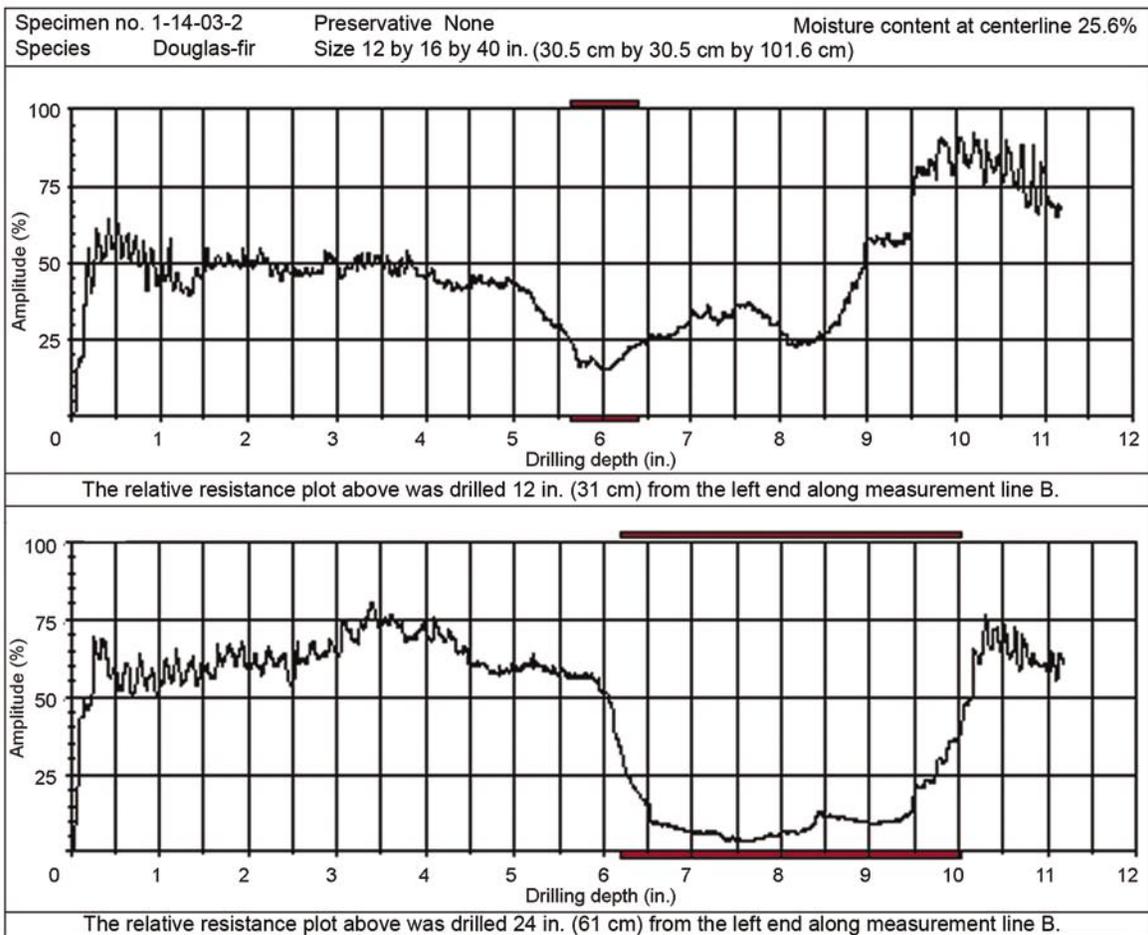
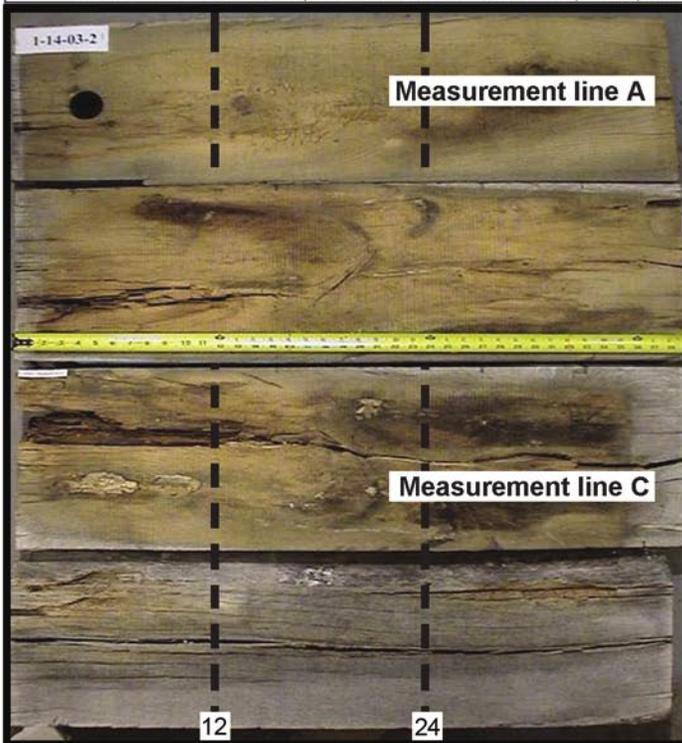
Figure 7—Comparison of resistance micro-drilling plots and interior photographs of bridge timber 1-14-03-2 reveals an example of deteriorated zones and sound wood zones. (Dashed lines denote drilling lines. Red bars at top and bottom of plots denote deterioration zones.)

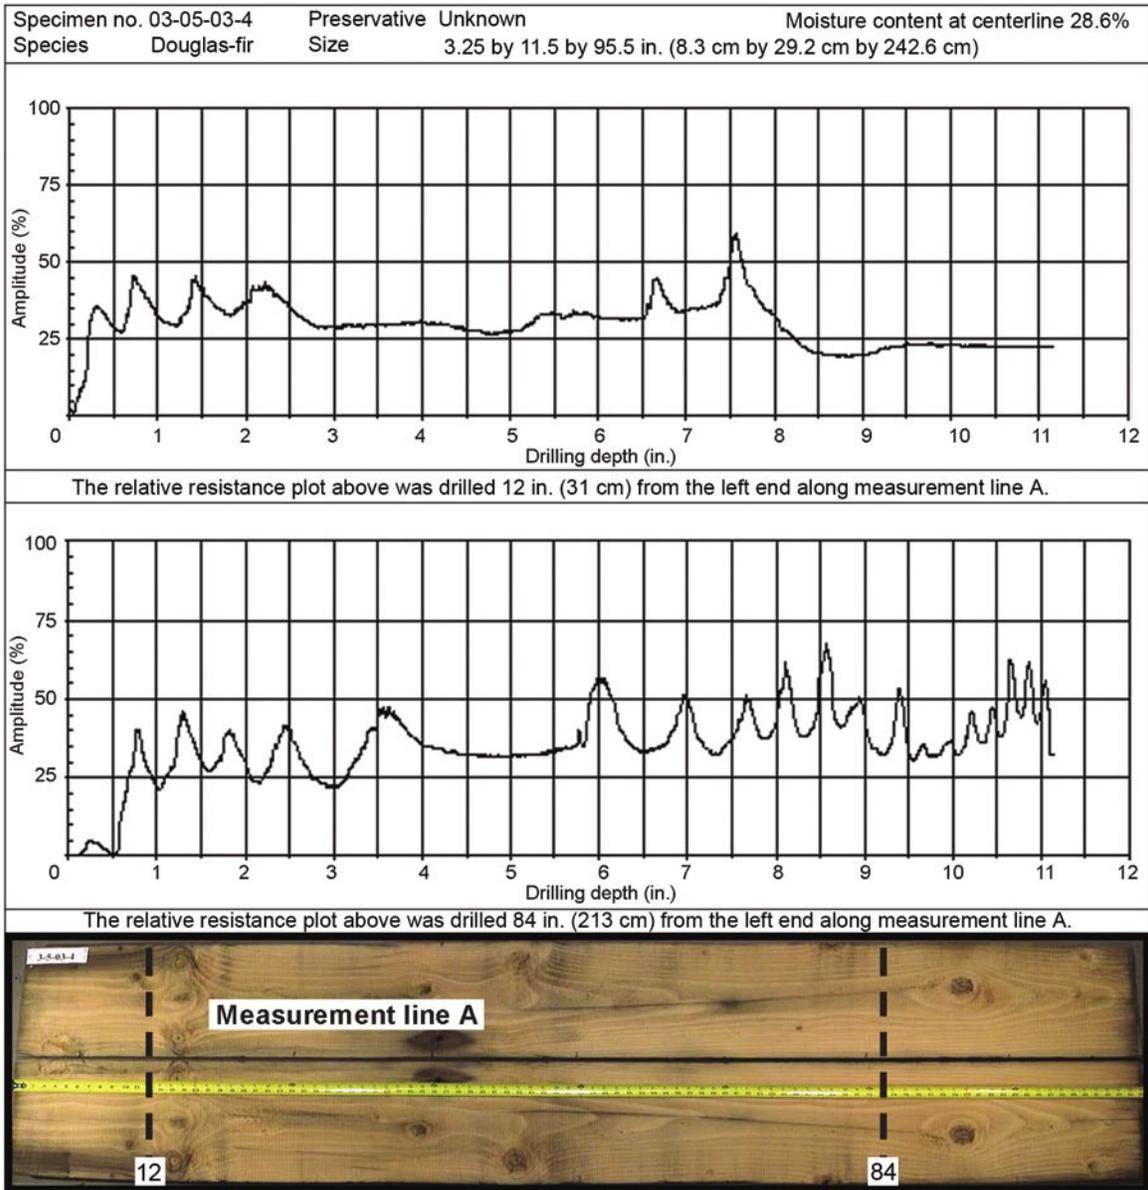
Figure 8—Comparison of resistance micro-drilling plots and interior photographs of bridge timber 03-05-03-4 reveals an example of sound wood. (Dashed lines denote drilling lines.)
