# Roof-Snow Behavior and Ice-Dam Prevention in Residential Housing

HOWARD L. GRANGE  
and LEWIS T. HENDRICKS

Agricultural Extension Service  
University of Minnesota

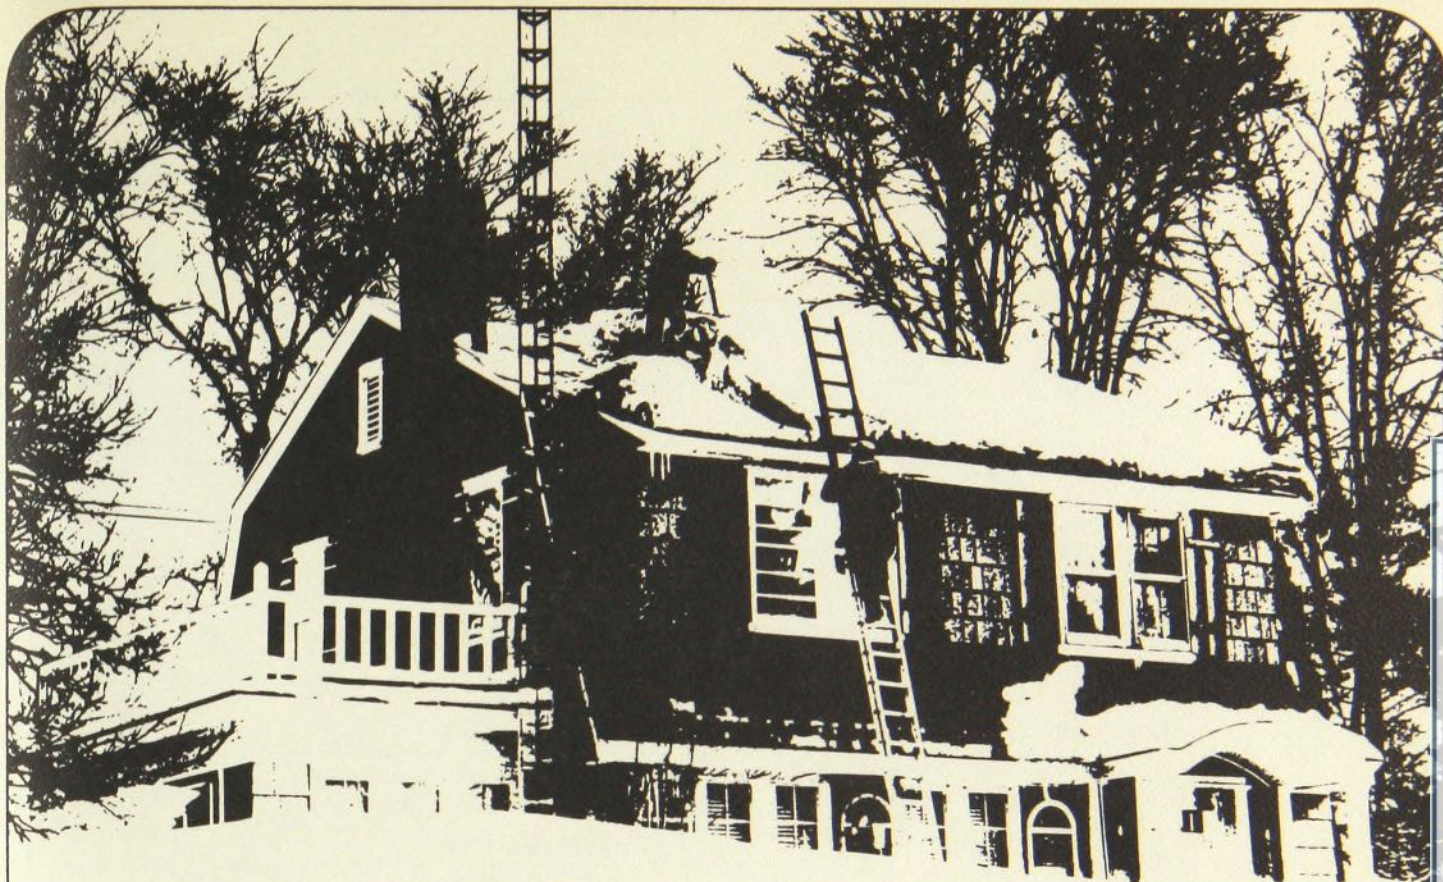
Figure 1 shows late winter snow on a roof, a bulge of ice attached to the eave, with numerous icicles that may drip from it on warmer days, and stained siding that may be optimistically written off as "a bit of rust stain from the overloaded rain gutters." Similarly, a wetted interior ceiling and wall are hopefully nothing more than a "bad place in the shingles that we will fix next spring." Perhaps this is true, but the attacks are more likely to be as indicated in figure 2 revealing the "actions" inside the cornices and attic spaces.

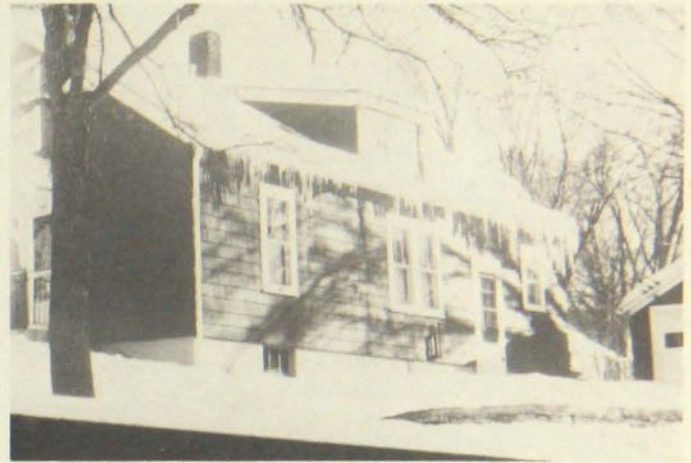
Figure 1. Typical snow-country eave in late winter.

The ice-loaded eave, the puffed snow-blanket, and the dangling icicles of figure 1 may be all that is apparent; but inside the cornices, within the attic spaces, and within the wall cavity, the destructive actions – seldom detected by direct observation – are illustrated for easy recognition in figure 2. The existence of these hidden actions is occasionally betrayed on the exterior by wetted walls, by massive wall ice formations, by wall stains, and subsequently – usually later in the spring – by blistered and peeling paint.

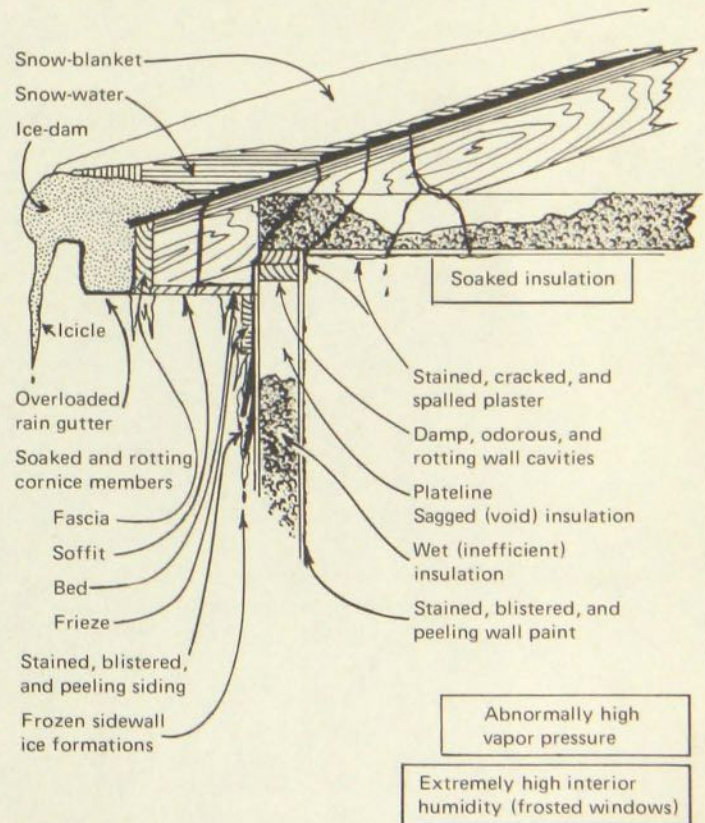
Figure 2. This sketch of the ice-dam problem identifies both the ice-dam and its damages. Of course, all the damages illustrated may (or may not) occur at any one instance. The damages illustrated here are far more common and costly than is generally acknowledged.

A re-examination of the damaging effects shown in figure 2 will identify and explain the damages of ice-dammed snow-water far better than words. All damages illustrated have been observed and recorded in a series of private audio-visual reports (2). These audio-visual reports form much of the data substantiating these comments. The authors will be pleased to arrange for private or group examination and discussion of these reports as compiled from field observations. The dank and rotting odor of some of the soaked structures is the one feature that cannot be described nor sensed with the audio-visual data.

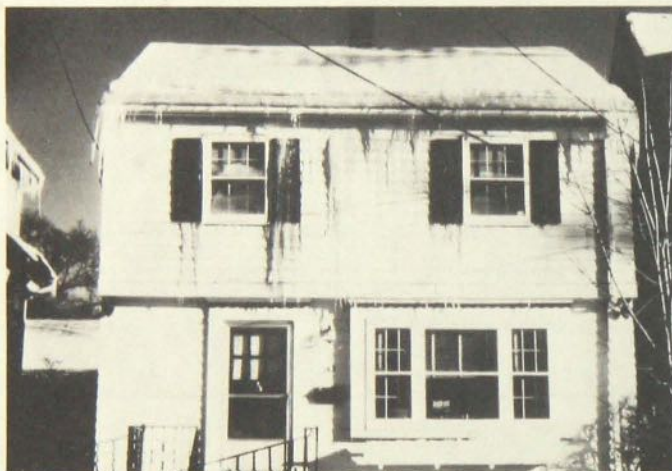
Figure 4. Frozen sidewall leaks emanating from ice-blocked eave.

Visible evidence of the penetration of ice-dammed snow-water into attic-warmed cornices is not rare in the upper mid-west in December through March. Intensely cold weather may freeze the cornice leaks in a stop-action sidewall ice-formation, as displayed in figure 4. The visible ice may be apparent for only a few days. With even slight warming, the frozen action may melt to an almost invisible flow. Similarly, ice-blocked snow-water undoubtedly also flows on the interior of the wall cavity where its detection is difficult; evidence of its presence may subsequently develop as stain, blistering, and peeling of the painted siding.

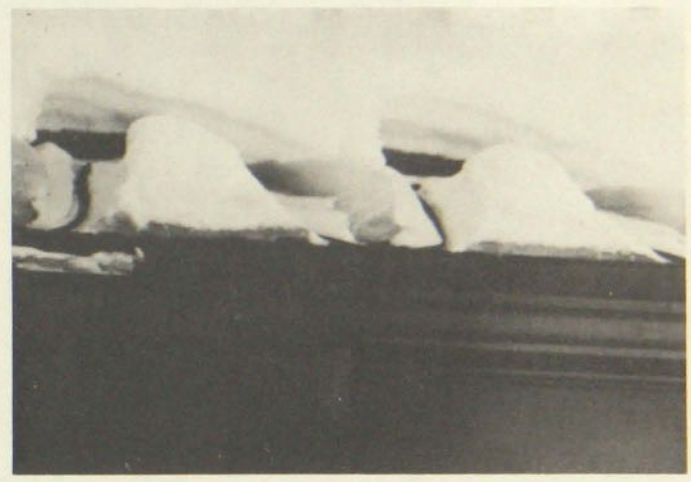
Figure 8. Secondary ice-dam developing uproof above heat zone of electric cable.

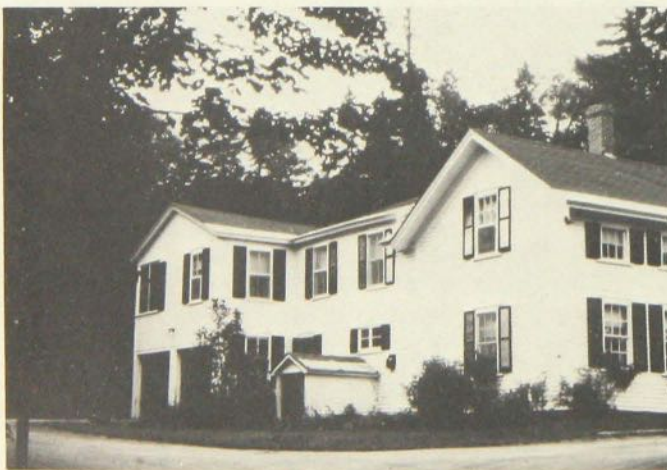
Figure 9. Eave flashings of aluminum.

Flashings of smooth metal (or roll roofing) serve as leak protection devices along the leak-vulnerable eaves. The smooth (usually aluminum) edge-band eases the slough-off of eave snow and ice along the eave projections where attic heat is insufficient to sustain further down-roof flows of snow-water. With the lowest edge of the snow-blanket a few feet above the eave, *secondary ice-dams will form and build above the metallic flashed eave.*

In the snow-country near the Canadian border from Maine to British Columbia, many houses can be observed with eave flashings of metal. The 2 to 3-foot widths of eave flashing seldom improve the appearance of the house, but distressed people living in deep snow-country seem willing to forego the esthetics of appearance for some measure of protection from snow-water penetrations.

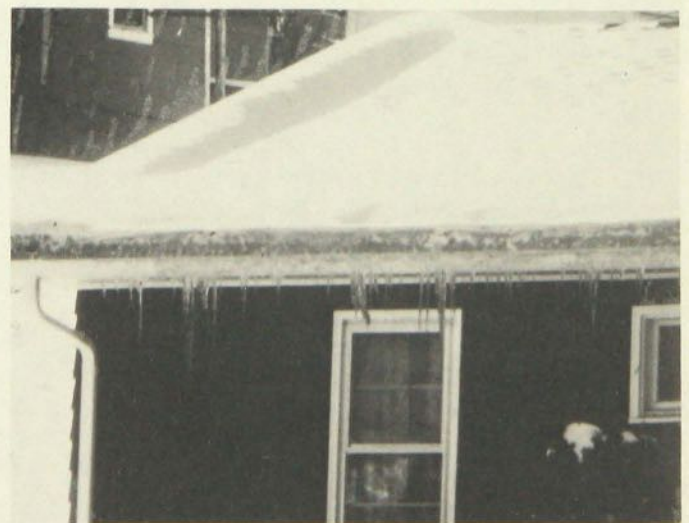
The sagging roof-snow pattern of figure 15 demonstrates the effects and locations of thermal gradients on this 1962 house. Differences in melting actions as delicate as the shingle pattern are evident. The deeper snow along the rake and eave cornices is a result of cool roof projections beyond the attic heat supply. The eave ice-dam, with its probable snow-water pool immediately uproof, is topped and protected with an insulative snow-cover along the 24-inch eave projection.

Figure 15. Telescopic lens photo of shrinking and sagging roof-snow on a modern (1962) roof.

Thermal patterns on this roof are somewhat more pronounced than are many contemporaries, but the roof-heat pattern is characteristic for houses built under minimum standards.

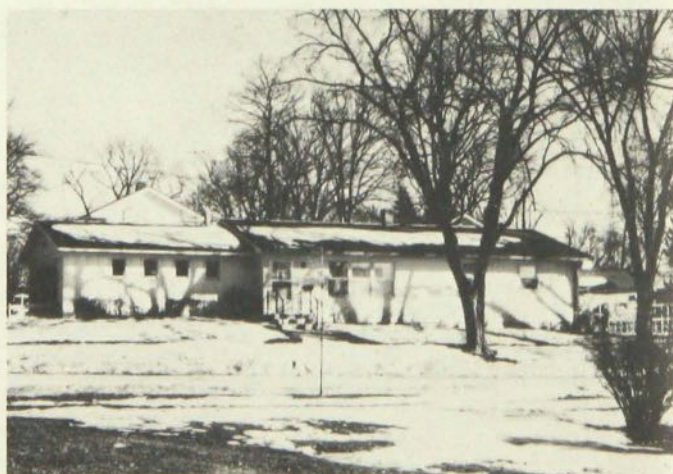
Figure 17. Residual snow pattern on a cold-roof house specifically designed for ice-dam immunity.

The snow on the roof of the cold-roof house of figure 17 is in a midroof pattern that is in sharp contrast with most (occupied) residential buildings. Notice the rake areas have

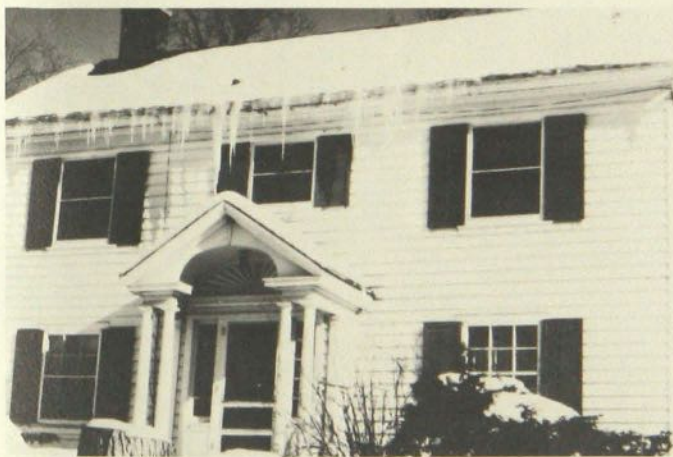
Figure 25. Well-insulated house built in 1933 with its almost annual eave-ice-dam.

Figure 25 is a photo of a Colonial-type house constructed in 1933; it was generously insulated (even by today's standards). It has no vapor barriers; it had a thirty-nine year history of blistered and peeling paint; it has also been decorated with eave ice-dams almost every winter until 1972.

In the summer of 1971, the house in figure 25 was converted (with the materials and methods described in this publication) into a cold-roof house. Since the correction was made, the house has had no eave ice-dams.

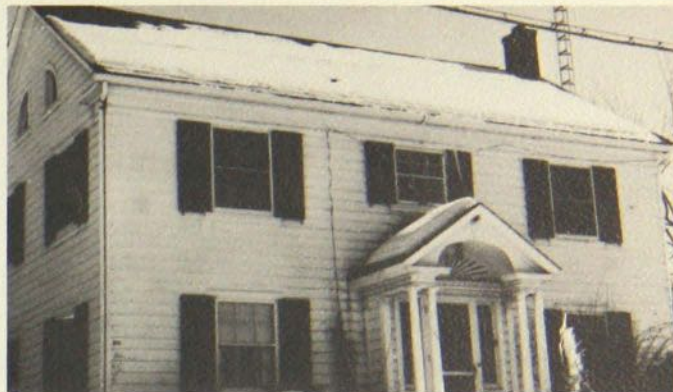
Figure 26. The house of figure 25 after its modifications into a cold deck performer.

Converting the house of figure 25 into a cold-roof performer not only eliminated the eave ice-dams, but altered the roof-snow melting pattern, as may be seen in figure 26. Notice the roof-snow edges at both rake and eave exhibit a ruffled concavity where wind actions have initiated roof-snow dissipation and removal. This house now sheds both rain *and snow-water* in an orderly drainage.

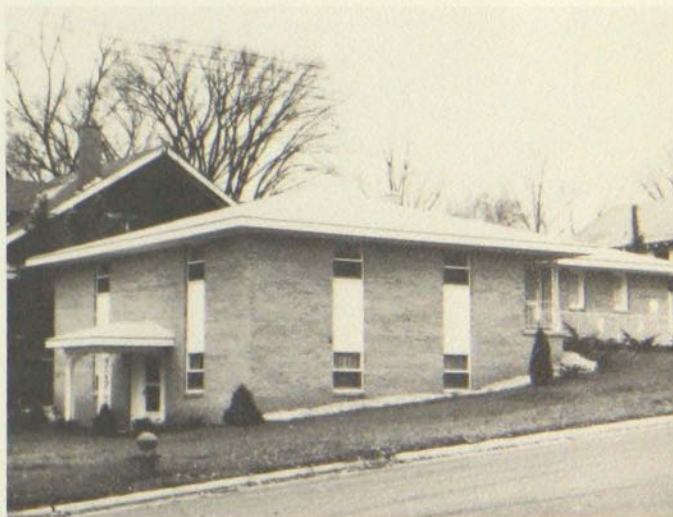
Figure 27. A house planned and constructed for cold-roof performance, but without the expense of the double roof structure.
