Minimizing Water Intrusion Through Roof Vents in High-Wind Regions

HURRICANE IKE RECOVERY ADVISORY

Purpose: To recommend practices for minimizing water intrusion through roof vent systems that can lead to interior damage and mold growth in high-wind regions (i.e., greater than 90-miles per hour [mph] gust design wind speed).

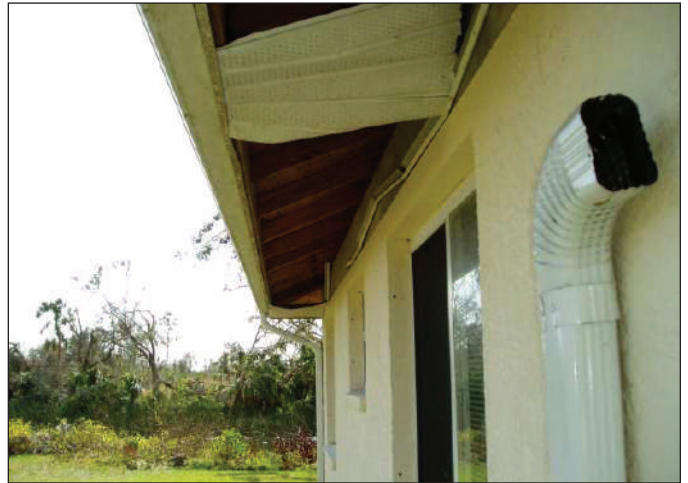
Figure 1. Missing soffit material.

- First and foremost, it is important to keep the soffit material in place. While some water can be blown into the attic through almost any type of soffit vent, the amount of water intrusion increases dramatically when the soffit material is missing (Figure 1).
- Plywood or wood soffits are generally adequately anchored to wood framing attached to the roof structure and/or the walls. However, it has been common practice for vinyl and aluminum soffit panels to be installed in tracks that are frequently very poorly connected to the walls and fascia at the edge of the roof overhang. When these poorly anchored soffits are blown off, water intrusion increases significantly. Properly installed vinyl and aluminum soffit panels are fastened to the building structure or to nailing strips placed at intervals specified by the manufacturer.

If the inspection indicates a poorly attached soffit, the best way to ensure that the soffit material is adequately anchored in place is to remove it and install adequate wood blocking to allow solid anchorage of the soffit material. In some cases, it may be possible to remove the soffit material and reinstall it. However, it is also likely that some or all of the material will need to be replaced, so make sure that it can be matched before it is removed. Short of removing and properly reinstalling the soffit material, testing has shown that the anchorage can be greatly improved by applying a bead of sealant (Figure 3) along the bottom edge of the wall channel to adhere it to the wall surface below followed by applying large dabs of sealant in indentations between the soffit panels and the wall channel at one end (Figure 4) and the fascia flashing at the other end. Surfaces receiving sealant should be cleaned in order to facilitate bonding. Extra resistance can be gained by installing screws that mechanically tie the soffit panels to both the fascia flashing and to the wall channel (Figure 5). Note that use of sealant is a remedial measure only and is not a substitute for proper installation and fastening of soffits in a new installation.

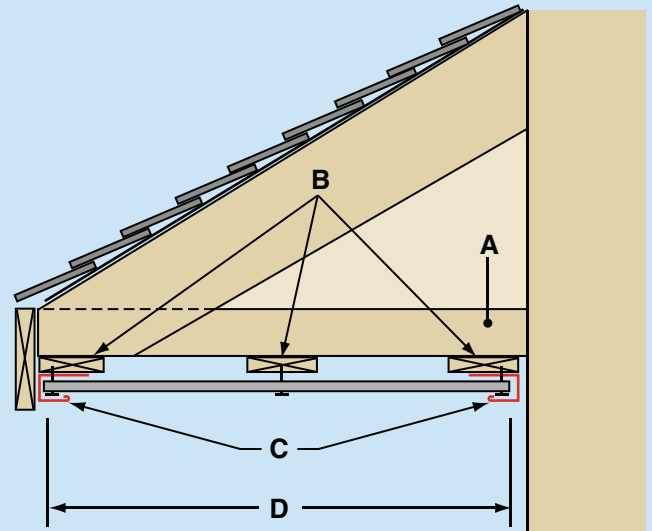
Figure 2. Key soffit installation points.

The details of proper installation of vinyl and aluminum soffits depend on the type of eave to which they are attached. The key elements are illustrated in Figure 2.

A. Roof truss or rafter framing should extend across the bottom of the eaves, or be added to create a structural support for the soffit. As an alternative, soffits can be attached directly to the undersides of the angled rafters.

B. Nailing strips should be provided, if necessary, to allow attachment of the soffit at the ends. Intermediate nailing strips may be needed, depending on the maximum span permitted for the soffit. If this is not known, the span between attachment points should not exceed 12 in high-wind regions.

C. A J-channel (illustrated), F-channel, or other receiver as specified by the manufacturer should cover the ends of the soffit panels. Fasteners should be those specified by the manufacturer. Fasteners should be used through the nailing strip of each panel and at any other points (such as in the “valleys” of the soffit) if specified.

D. The overall span (eave depth) of the soffit should not exceed any limits specified by the manufacturer, and any required intermediate attachment points should be used.

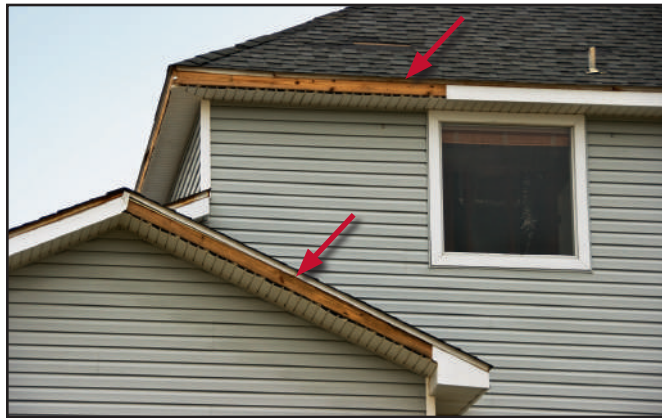
Figure 7. Loss of fascia cover exposes ends of vinyl soffit to direct entry of wind-driven rain.

Fascia cover: Field investigations after Hurricane Ike showed many cases where the aluminum fascia cover (fascia cap) from the fascia board was blown off (Figure 7). The fascia cover normally covers the ends of vinyl and aluminum soffits. When the fascia cover is blown off, the ends of the soffit panels are exposed to wind and wind-driven rain.

The IRC currently has no guidelines for the installation of fascia covers. Aluminum fascia covers are typically tucked under the roof drip edge and face-nailed every few feet. More frequent nailing would help secure the fascia cover, but would also inhibit normal thermal movement, which can cause unattractive warping and dimpling of the cover. Vinyl fascia covers are available, which are attached to a continuous strip of utility trim placed underneath the drip edge. This provides a somewhat more secure, continuous attachment and allows for thermal movement. Aluminum fascia covers can also be field-notched and installed with utility trim.

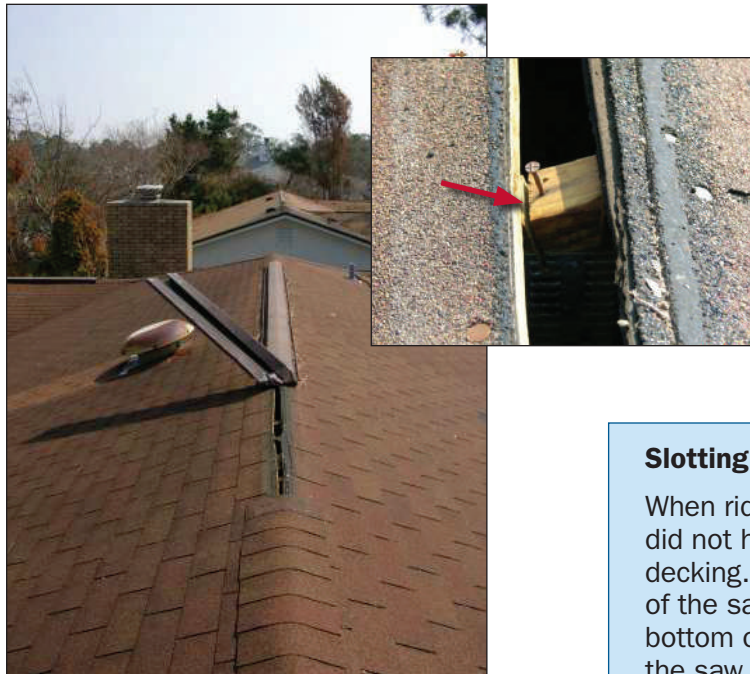
Figure 8. This metal ridge vent was attached with widely spaced roofing nails.

- Ridge vents are frequently fastened down using ordinary roofing nails since these are normally handy. It is pretty common to find ridge vents dislodged or blown off during a hurricane (Figure 8). Even a partially dislodged ridge vent can begin to act like a scoop that collects wind-driven rain and directs it into the attic.
- Most roofing manufacturers now make ridge vents that have passed wind-driven water tests. They are identified as having passed Florida Building Code's Product Approvals or Testing Application Standard (TAS) 100(A). Typically, they include a baffle in front of the vent tubes that provide the passageway for hot attic gasses to escape. This baffle is intended to trip any flow of wind and water blowing up the surface of the roof and deflect it over the top of the roof ridge.

When ridge venting is being added to a roof that previously did not have it, it is necessary to cut a slot through the decking. When doing so, it is important to set the depth of the saw blade so that it only slightly projects below the bottom of the decking. At the residence shown in Figure 8, the saw blade cut approximately 1½" into the trusses and cut a portion of the truss plate (red arrow).

Replace nails with gasketed stainless steel wood screws that are slightly larger than the existing nails and, if possible, try to add fasteners at locations where they will be embedded in the roof structure below and not just into the roof sheathing. Close spacing of fasteners is recommended (e.g., in the range of 3 to 6 on center, commensurate with the design wind loads). If the ridge vents are damaged or are one of the older types that are not resistant to water intrusion, they should be replaced with vents that have passed the wind-driven water intrusion tests.

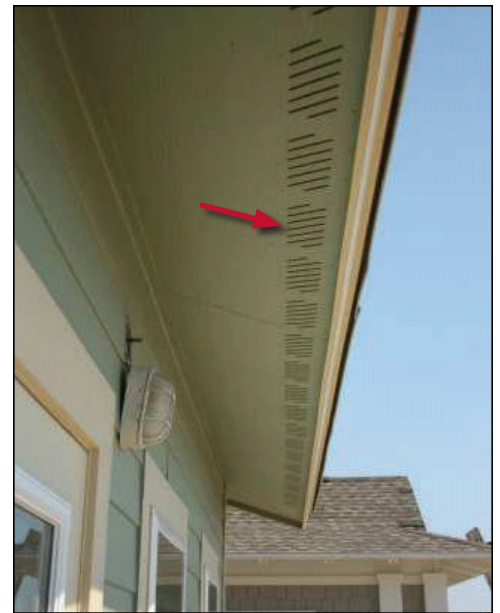
Figure 6. Fiber cement soffit with ventilation slots (red arrow).

Wind-driven rain penetration: Currently there is no adequate standard test method to evaluate the potential for wind-driven rain to enter attics through soffit vent openings, such as those shown in Figure 6. To avoid water entry at soffit vents, options include eliminating soffit vents and providing an alternate method for air to enter the attic, or design for an unventilated attic. Another approach is to place filter fabric (like that used for heating, ventilation, or cooling

[HVAC] system filters) above the vent openings; however, such an approach needs to be custom designed.

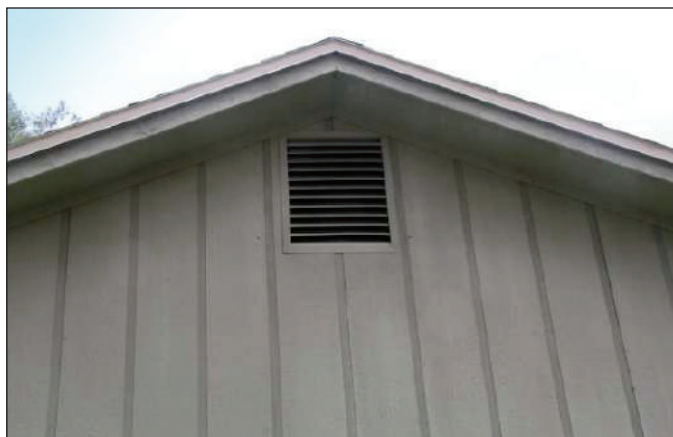
Figure 9. Gable end vent.

- Virtually all gable end vents (Figure 9) will leak when the wall they are mounted on faces into the wind-driven rain. The pressures developed between the outside surface of the wall and the inside of the attic are sufficient to drive water uphill for a number of inches and, if there is much wind flow through the vent, water carried by the wind will be blown considerable distances into the attic.

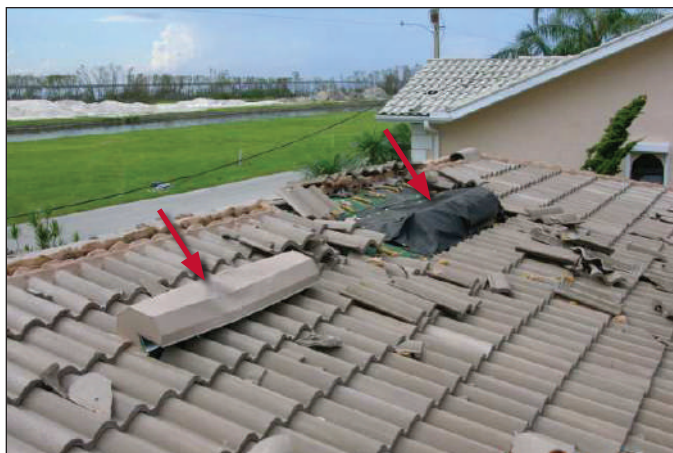
- Poorly anchored off-ridge vents can flip up and become scoops that direct large amounts of wind-driven rain into the attic (Figure 11).

Figure 11. Two off-ridge vents are shown in this photograph. The vent that is covered with roofing felt flipped up and allowed a substantial amount of water to enter the residence. Carpeting, kitchen cabinets, and a large amount of gypsum board had to be replaced because of the water intrusion.

If the off-ridge vent is attached to the roof sheathing with long, thin nails, it may be possible to improve the anchorage by cinching the nails (bending them over against the underside of the roof sheathing). However, if they are short and/or thick, trying to bend them over may cause more harm than good. Some homeowners have had covers made that can be installed from the inside of the attic over the hole where the off-ridge vent is installed. This will be easiest if the vent is larger than the hole and the cover can be attached to the sheathing in an area where the fasteners can't be driven through the roof covering. Otherwise, it will be important to ensure that the fasteners are short enough that they won't extend through the roof sheathing and damage the roof cover. If the edge of the hole in the roof deck is flush with the inside edge of the vent, it may be possible to install metal straps that are screwed into the walls of the vent and attached with short screws to the bottom surface of the roof sheathing. Again, it is critical to use screws that are short enough that they won't extend through the roof sheathing and damage the roof covering. The strapping should be connected to the walls of the vent with short stainless steel sheet metal screws.

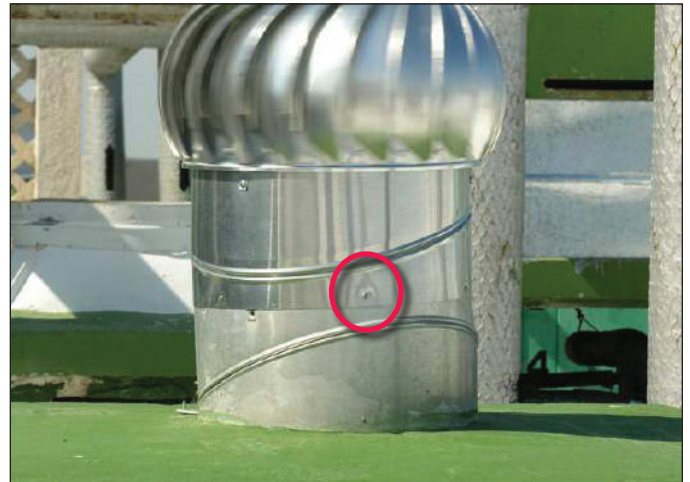
Check any turbines to make sure that the stand pipes are not loose and that the turbine head is anchored to the stand pipe by sheet metal screws and not simply by a friction fit (Figure 13).

Figure 13. This turbine head is attached to the standpipe with dimple punches. Sheet metal screws should be added to strengthen the connection.

Loose standpipes should be securely anchored to the roof sheathing. If the standpipe is attached to the roof sheathing with long, thin nails, it may be possible to improve the anchorage by cinching the nails (bending them over against the underside of the roof sheathing). However, if they are short and/or thick, trying to bend them over may cause more harm than good. Some homeowners have had covers made that can be installed from the inside of the attic over the hole where the standpipe is installed. This will be easiest if the standpipe is larger than the hole and the cover can be attached to the sheathing in an area where the fasteners can't be driven through the roof cover. Otherwise, it will be important to ensure that the fasteners are short enough that they won't extend through the roof sheathing and damage the roof cover. If the edge of the hole in the roof deck is flush with the inside edge of the standpipe, it may be possible to install metal straps that are screwed into the walls of the standpipe and attached with short screws to the bottom surface of the roof sheathing. Again, it is critical to use screws that are short enough that they won't extend through the roof sheathing and damage the roof cover. The strapping should be connected to the walls of the standpipe with short stainless steel sheet metal screws. Beyond any remedial measures taken to anchor the standpipe to the roof sheathing or to plug the hole from the attic side, it is also important to try and seal the standpipe from the outside so that water doesn't build up in the pipe and leak into the roof sheathing around the hole. The best approach is to have a qualified person remove the top active portion of the turbine vent before the storm and plug the hole at the top of the standpipe. A wooden plug can be used that covers the entire hole and has blocks that rest against the walls of the standpipe where screws can be installed to anchor the plug to the standpipe. Some homeowners have had the entire turbine wrapped in plastic to keep water out during a storm (Figure 14). This can work as long as the turbine or wrapping doesn't get dislodged. The smaller area provided by removing the turbine top and plugging the hole is considered preferable.
