Preservation Tech Notes

WINDOWS NUMBER 22

Maintenance and Repair of Historic Aluminum Windows

Kaaren R. Staveteig
Technical Preservation Services
National Park Service

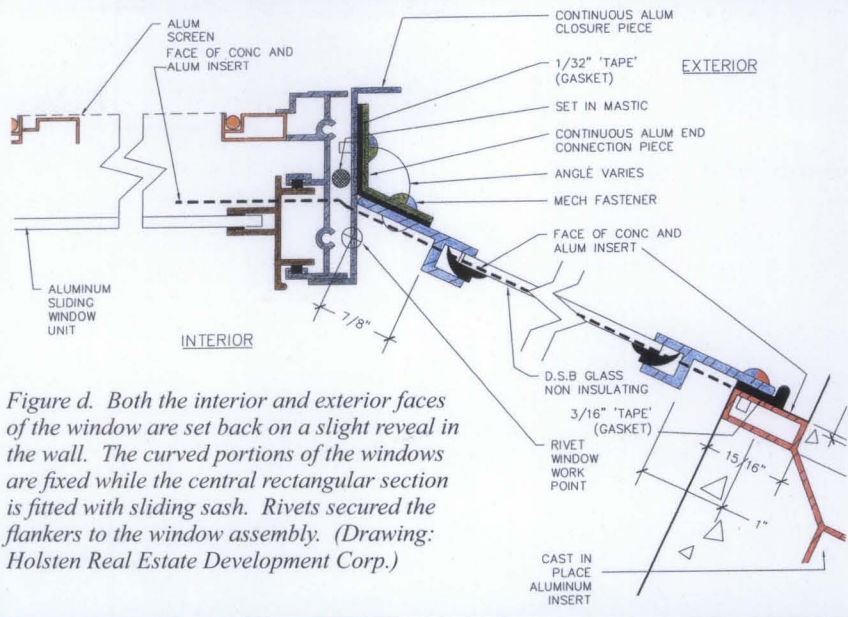
Figure d. Both the interior and exterior faces of the window are set back on a slight reveal in the wall. The curved portions of the windows are fixed while the central rectangular section is fitted with sliding sash. Rivets secured the flankers to the window assembly. (Drawing: Holsten Real Estate Development Corp.)

One of the more time consuming aspects of the project involved the radial flankers. Many of these historic window units were broken and had been caulked together in a repair effort. Due to age and stiffness, it was necessary to first heat the sealing gasket for

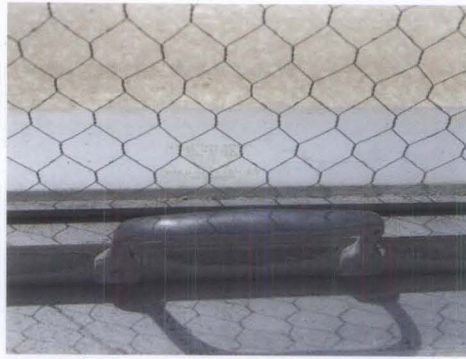
Figure 14. Hardware for early aluminum windows came in a variety of materials including steel, bronze, and nickel. Specialty hardware manufacturers can easily replicate suitable replacements today, matching the originals in both material and finish. The manufacturer's stamp, visible through the glass on the exterior sill of this window at the Folger Shakespeare Library in Washington DC, identifies Wm. H. Jackson Company of New York as the maker and dates the window patent to 1926.
