HISTORIC STRUCTURE REPORT

THE BARNES HOUSE

Independent Hill vicinity
Prince William County, Virginia

OCTOBER 2004

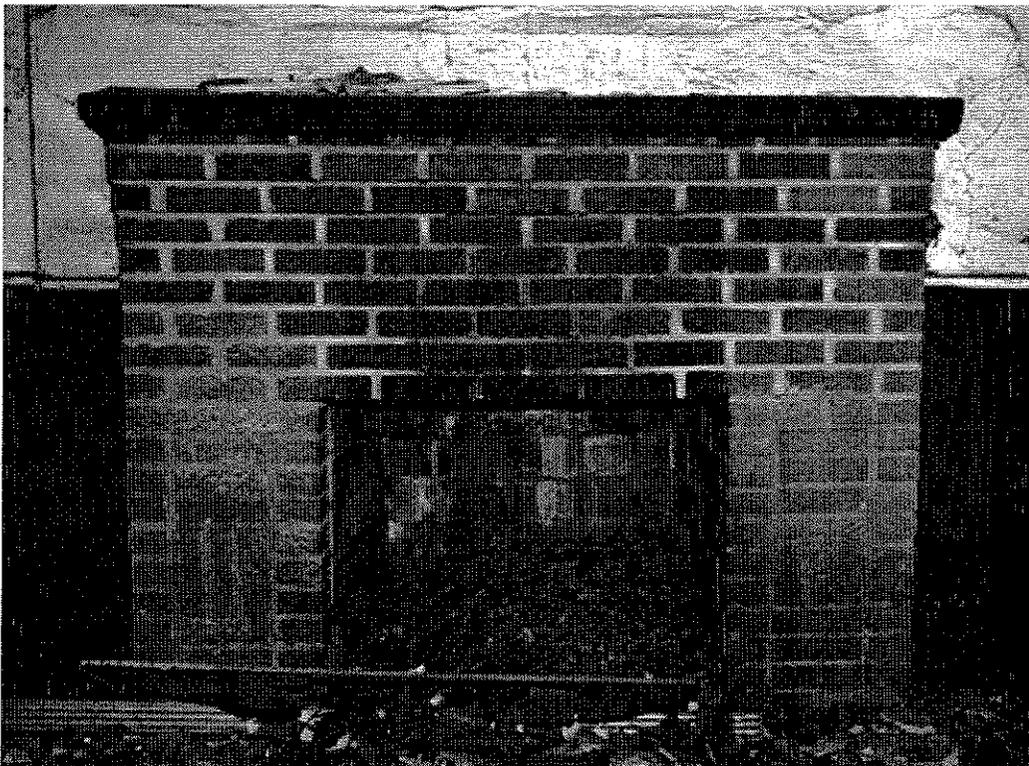
Figure 5: The brick mantelpiece (now gone) and knotty pine paneling dated from around 1960

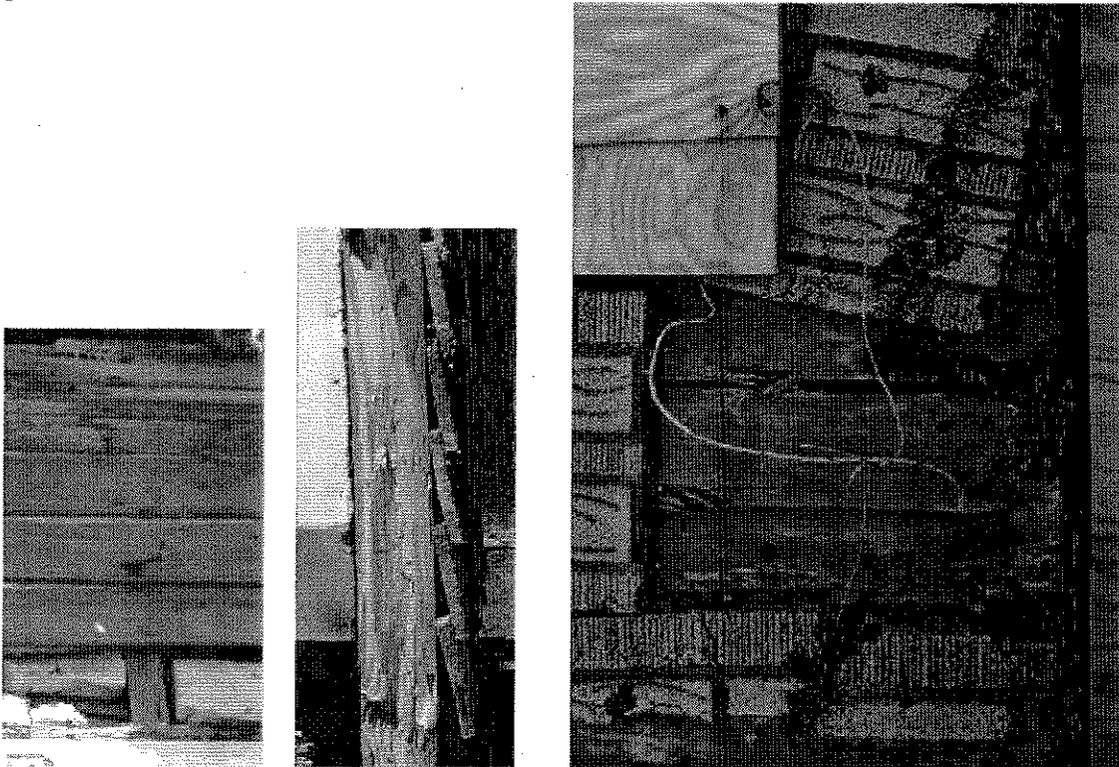
Figures 16-18: Three layers of siding. The view on the left is of the small area of the original beaded 4-inch-wide weatherboarding that was hidden in the attic of the catslide addition until recently. The center view shows the lapped plain boards used when the house was re-sided around 1900. The view on the right shows some shifting sections of Inselstone siding nailed over a section of this second layer of siding.

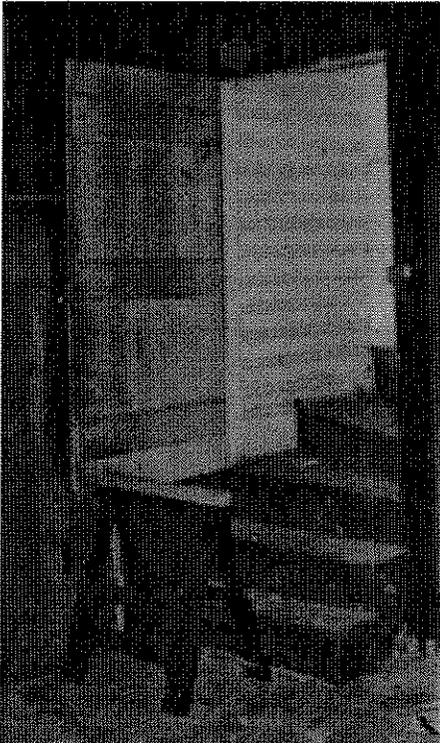
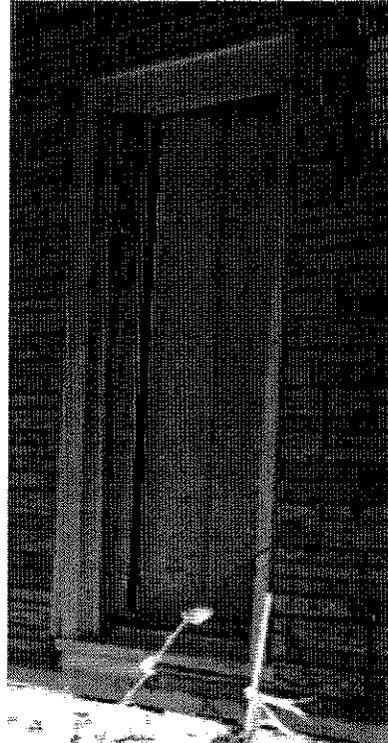
*Figures 21 & 22:
The plank doors at
the front entrance
and in the opening
to the enclosed stair
are excellent
examples of the style
and craftsmanship
that accompanied
the Tidewater frame
tradition. They are
constructed of
beaded vertical
boards with
horizontal braces on
the back.
Fortunately, they
are in good
condition and can be
repaired and
retained. The house
formerly had several
others just like these
two.*

The house has intact plank doors, which are in good condition, at two doorways: at the front door to the smaller first story room and at the door to the enclosed stair. The doors are hung with wrought iron hinges of two or three knuckles each, with wrought nails, some of which have rose heads. The doors likewise have wrought iron latches and other hardware components typical of the period before the Civil War, with about four vertical planks per door, secured by three beveled horizontal battens. The proportions of the two front door openings and the door to the stair enclosure are consistent with an earlier (pre-1860) construction date, rather than a later one.

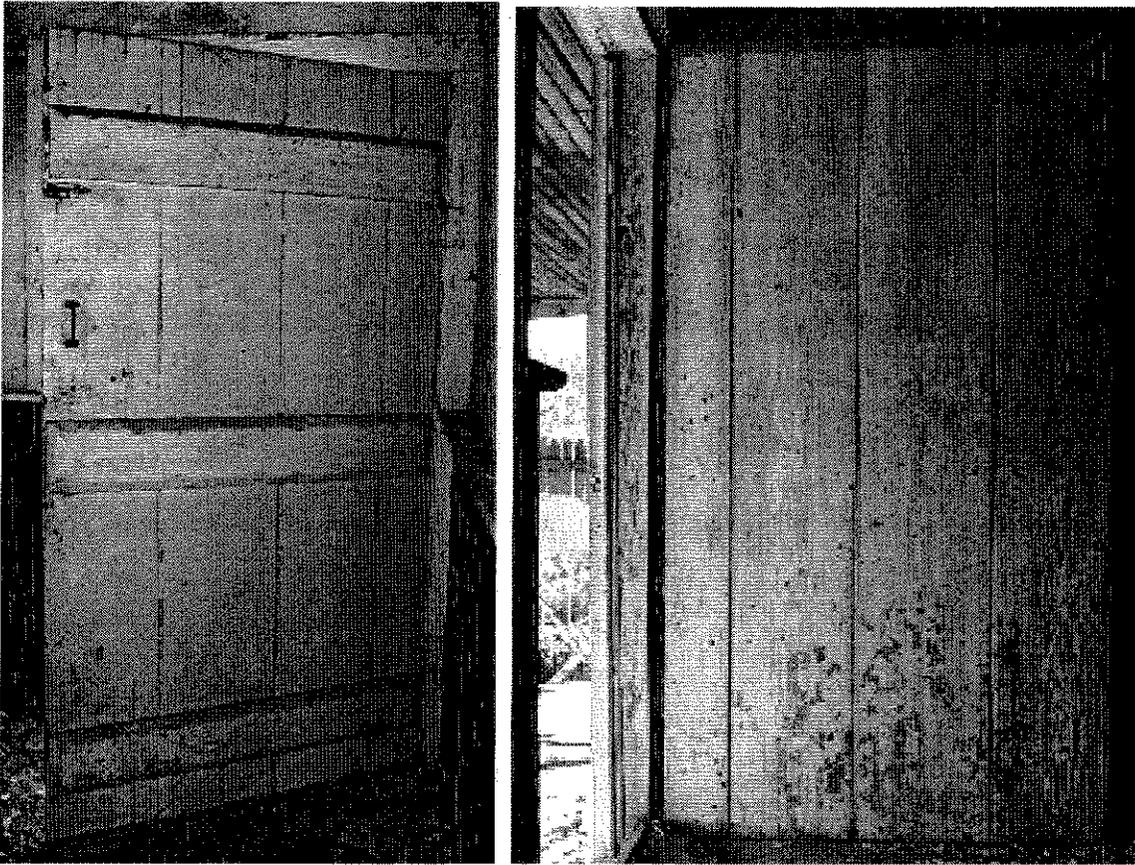
Figures 23 & 24: These views of the front door, taken just before the house was moved, show the beading, the beveled cross-braces, and the hardware on the front door to the smaller first floor room.

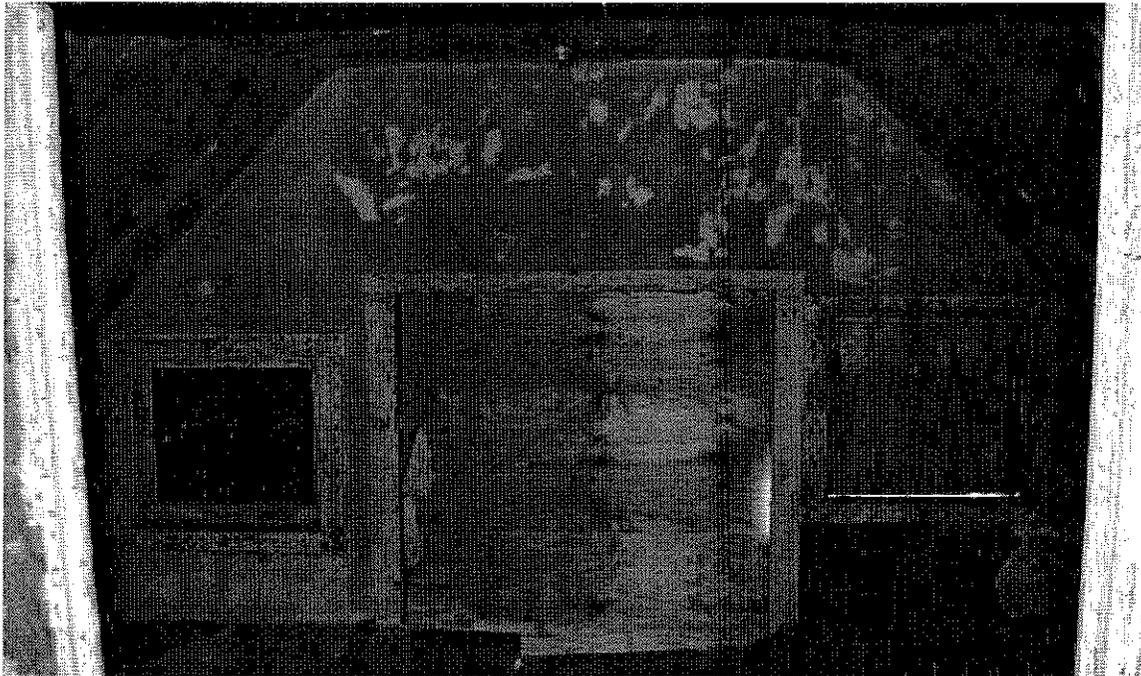
Figure 25: The second story (or attic) consists of two large rooms shaped by the roofline, knee-walls, and a narrow ceiling. Beneath twentieth century plaster on expanded metal lath, the original wall treatment of horizontal bands of beaded interior sheathing appears to be intact.

The second story plaster was applied wet over metal mesh lath. It is most likely composed mainly of gypsum. It was installed at some point between about 1920 and about 1950. The metal mesh lath was nailed directly on to beaded horizontal wall boards. The earlier boards appear to be relatively intact under the plaster. The second story plaster is intact in some areas and damaged by water in others, with some large sections missing. However, it would be appropriate to remove it to expose and restore the earlier wall treatment design, the beaded boards (see Recommendations).

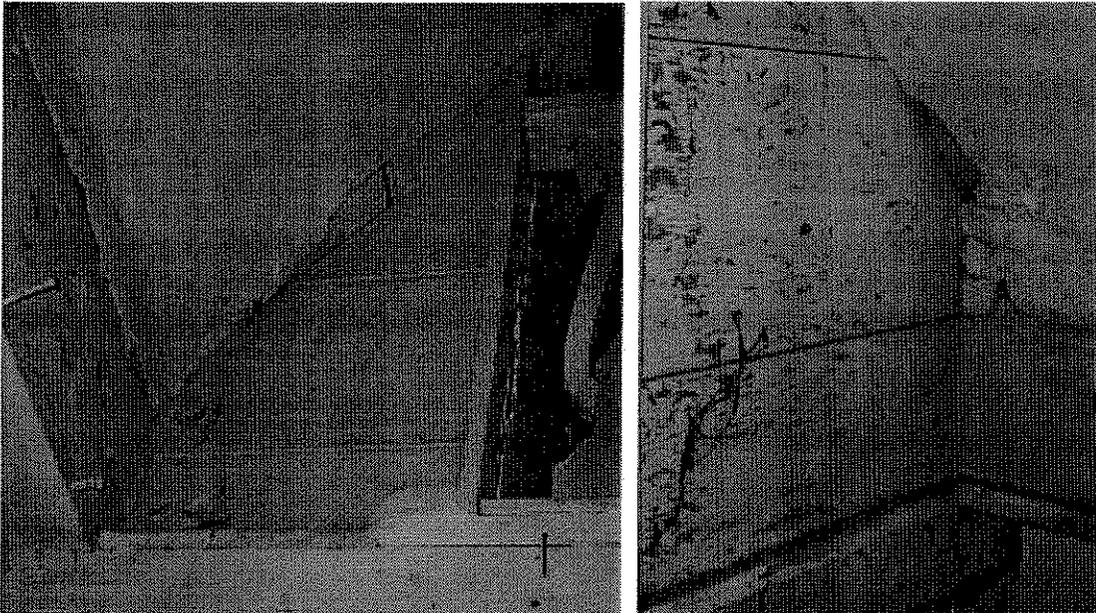
Figures 26 & 27: Small areas of the beaded sheathing wall treatment in the second story are exposed, especially in the area immediately above the winder part of the stairs.

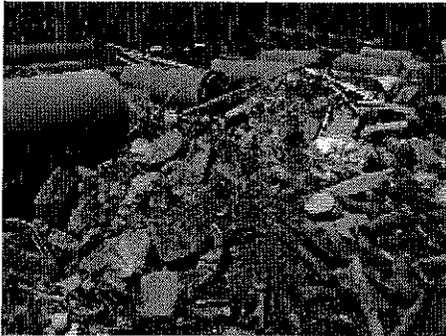
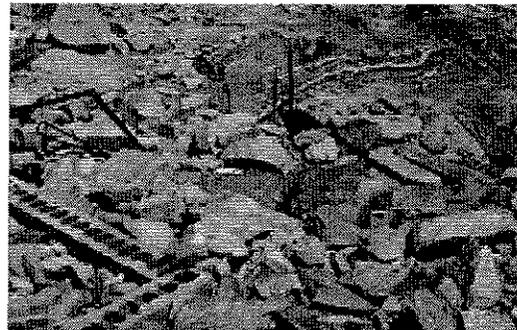
There are two or three piles of stone rubble and brickbats that came from the chimneys. Generally the stone is random, apparently fieldstone, consisting of some sandstone and possibly some other kinds of sedimentary stone. No record was kept of which stone went where, except that photographs were taken before the chimneys were torn down. The stone appears to be re-

Figures 29 & 30: Some of the stone from the Barnes House chimneys was moved to the temporary site at the Prince William County Landfill (left) and some is still to be found at the house's original site (view on right).

usable. The photographs show several distinctive shapes in the chimneys, notably the shouldering of the exterior shape of the chimneys toward the center and toward the top, and the ogival-arched openings of the second story fireplaces. These shapes should be followed very carefully in restoring the chimneys. The first story had at least one red brick interior mantelpiece. This was a design from the mid twentieth century. All the bricks in the piles of discarded masonry are from this period. It would probably be appropriate to restore all the fireplaces to the earliest known design, based on the ogival-arched stone openings seen in the photographs of the second story.
