LYNDHURST GATEHOUSE

Tech Notes

NUMBER 3

Exterior Storm Windows: Casement Design Wooden Storm Sash

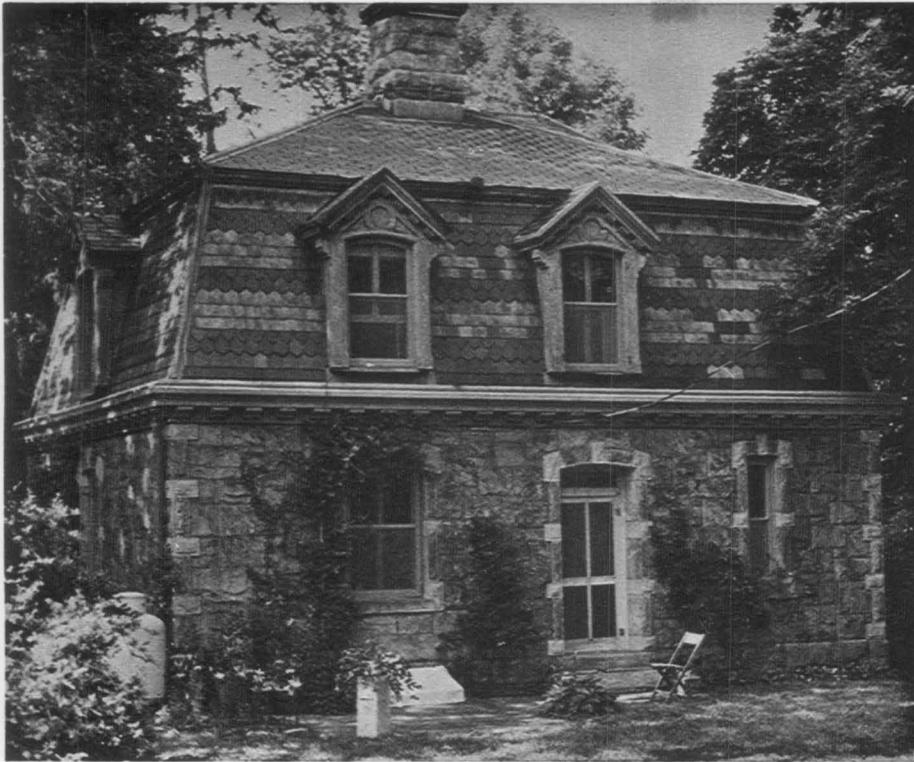
Figure 1. The single casement, wooden storm window had two removable panels for screen and glass inserts. This custom design fulfilled a variety of requirements established for the project with minimum physical damage and visual changes to the historic windows. Drawing: Martha L. Werenfels

dows and attached to the existing frame (see figure 1). The arched-headed wooden storm window with one-over-one glass panes matched the size of the original double-hung sash. Molding details similar to the original were incorporated in the new storm sash. Each of the two panes in the storm sash was set in thin aluminum frames and secured in the wood storm window with standard clips. This installation technique enables the storm panels to be easily removed by a person on the inside of the house and replaced during the summer with screens (see figure 2).
