## CHALMERS UNITED CHURCH

### Kingston, Ontario

# Tech Notes

### Reinforcing Deteriorated Wooden Windows

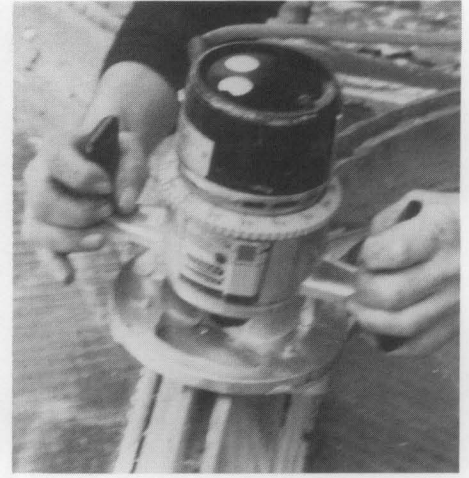
Figure 4. Once the old paint had been carefully removed, grooves were cut in the mullions using an electric router fitted with special guide rollers.

ting bit (see figure 4). Notwithstanding the usefulness of this apparatus, the real success of the operation can be attributed to the skill of the craftsman who guided the tool. The wooden mullions varied in size; on a typical 3 1/4" wide mullion, the outer edge where the groove was cut was 1 1/2" wide. In cutting a 1/2" groove on the outer edge, only 1/2" of wood remained on either side. A slight deviation of the tool could have seriously damaged the mullions.
