## 9 ROXBURY ROAD SCARSDALE, NEW YORK

### NUMBER 19

## Repairing Steel Casement Windows

Technical Preservation Services  
National Park Service

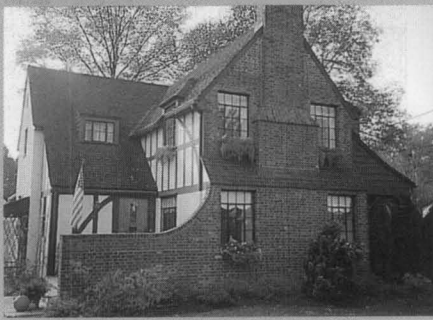
**Inappropriate replacement windows dramatically affect the appearance of a historic home that once featured steel casement windows.**
