**BEATTY'S MILL  
(CORAL STREET ARTS HOUSE)  
Philadelphia, Pennsylvania**

Preservation  
**Tech Notes**

**NUMBER 21**

**Replacement Wood Sash  
Utilizing True Divided  
Lights and An Interior  
Piggyback Energy Panel**

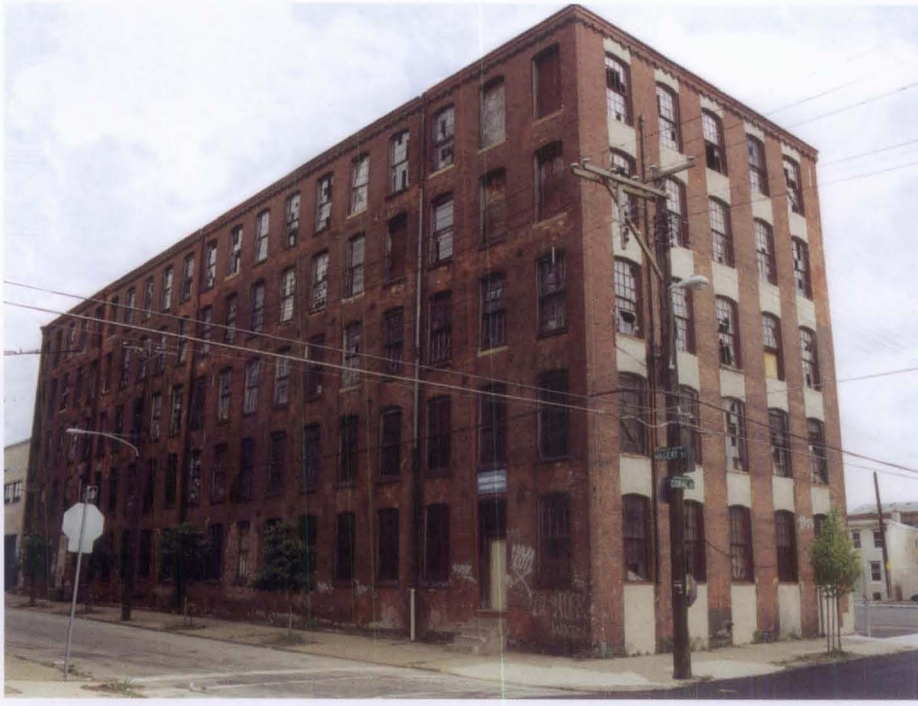
**Figure 1.** Constructed in 1886, the Betty's Mill is located at a street intersection. The segmental arched windows are a distinguishing feature of the building.
