Tech Notes

MASONRY

Substitute Materials: Replacing Deteriorated Serpentine Stone with Pre-Cast Concrete

SIX LOGAN CIRCLE Washington, D.C.

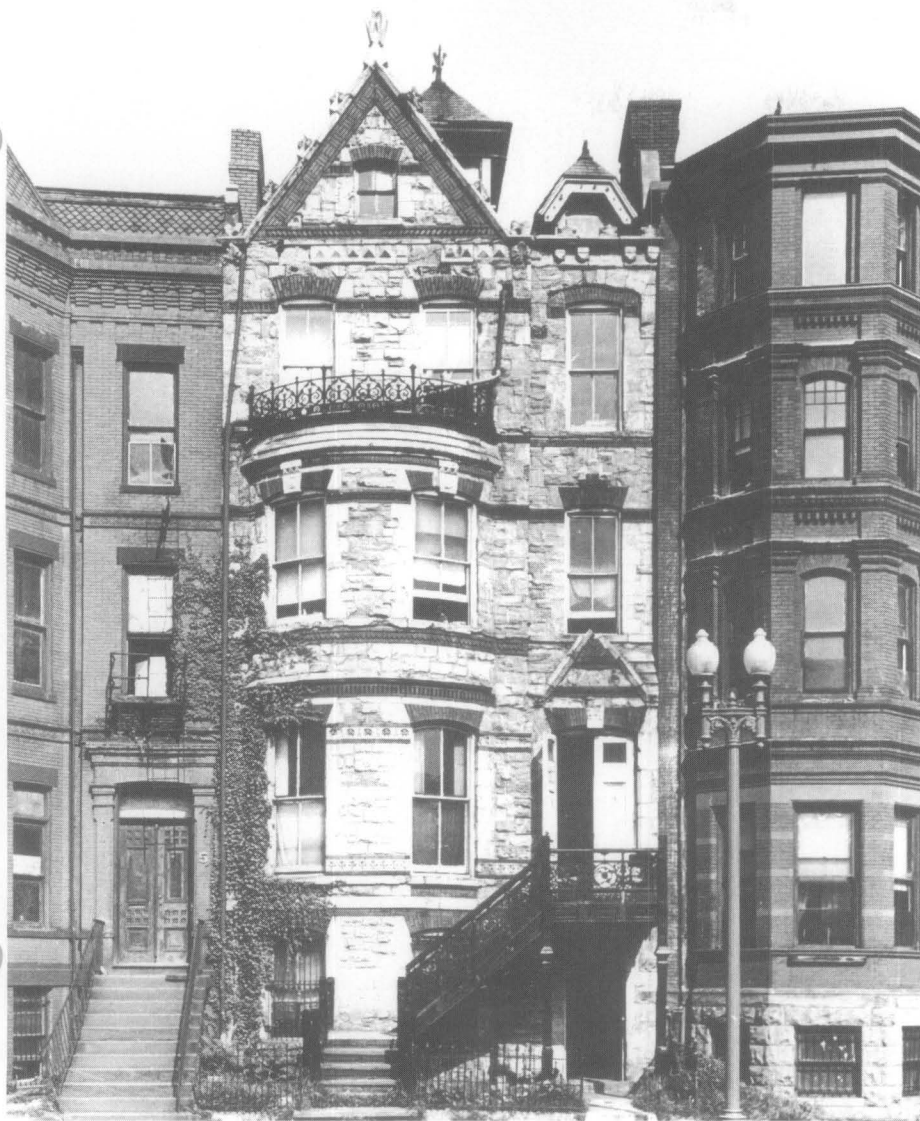
Figure 1. Close-up view of the deteriorated serpentine stone facade showing substantial surface delamination. Photo: Anne Grimmer

retained their integrity (i.e., how many remained substantially free of fractures and crumbling and retained their surface tooling, texture, and shape). The survey showed that 868 of the original 946 face stones which made up the facade no longer retained their integrity. In fact, many were so deteriorated that they could literally be pulled apart by hand (see figure 1).

Because only 78, or less than nine percent, of the stones remained intact, total replacement of the historic stone was justified in this particular case. However, the replacement material needed to closely match the historic stone in size, shape, dimension, texture and color in order to preserve the historic character of the facade. To meet these requirements, three replacement alternatives were considered:

Therefore, the material that offered the most potential for use as a replacement material was pre-cast concrete. This material had recently been used to replace extensively deteriorated brownstone on the Renwick Gallery of the Smithsonian Institution in Washington, D.C., and it was determined by the consultant (who had worked on the Renwick Gallery restoration), that the same technology could be successfully applied to replace the serpentine stone at Six Logan Circle.
