COLCORD BUILDING Oklahoma City, Oklahoma

Tech Notes

NUMBER 8

Thermal Retrofit of Historic Wooden Sash Using Interior Piggyback Storm Panels

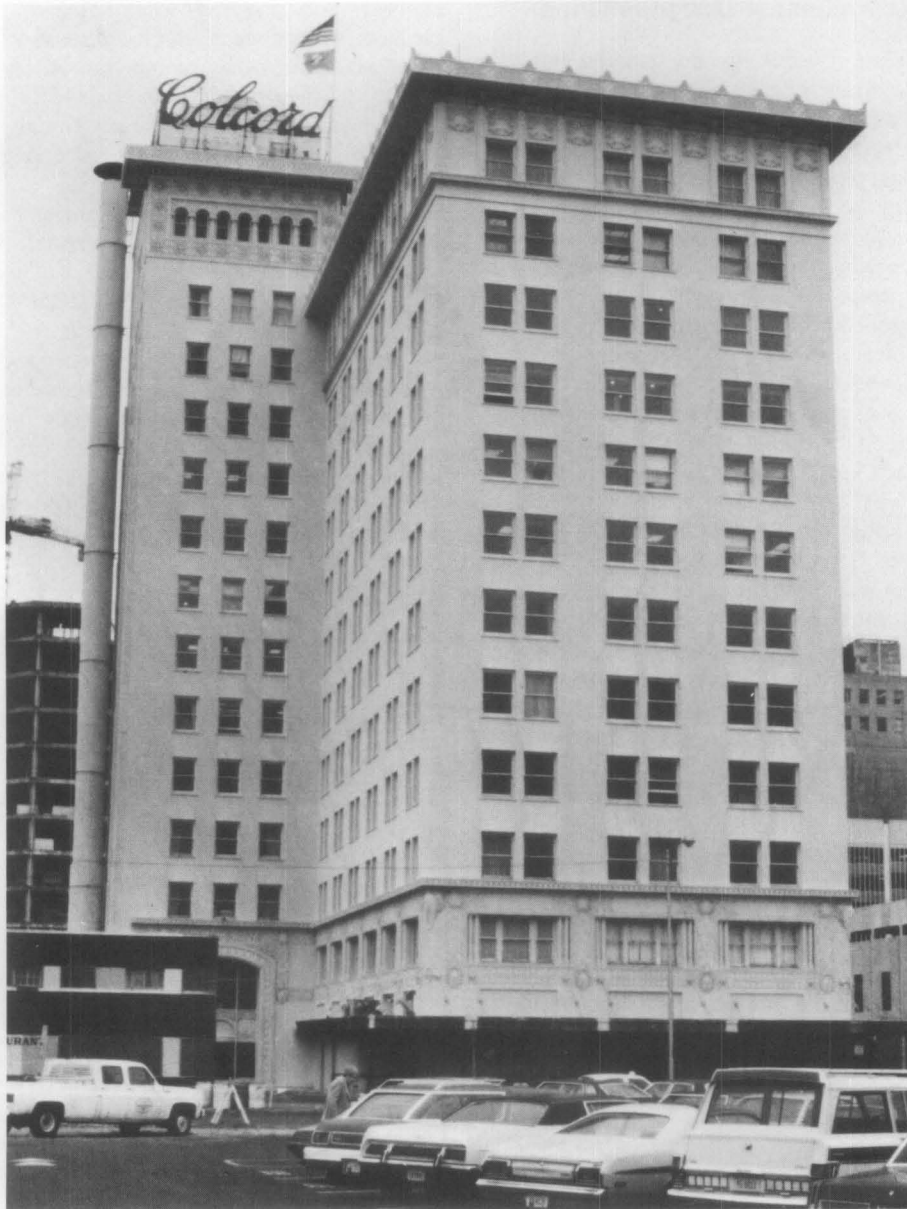
The Colcord Building, constructed in 1910, is one of the few remaining historic office buildings in downtown Oklahoma City. Designed by William A. Wells, the 12 story concrete structure is elaborately decorated with ornamental terra-cotta panels at the first, second and twelfth floors. The bold scale and setbacks of the wooden windows surrounded by terra-cotta are significant design features of this National Register property (see figure 1).
