EAST BAY MUNICIPAL UTILITY DISTRICT

Asbestos Cement Pipe Study

Phase 1 Asbestos Cement Pipe Corrosion Study

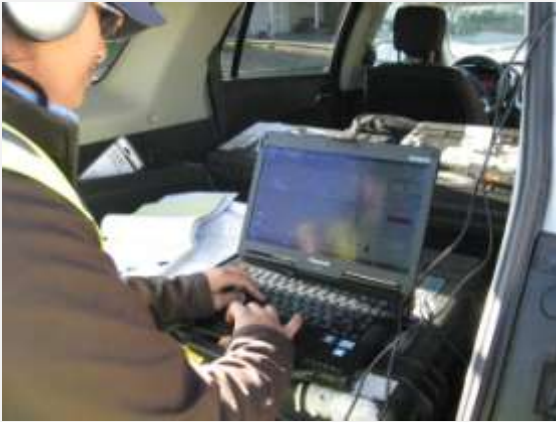
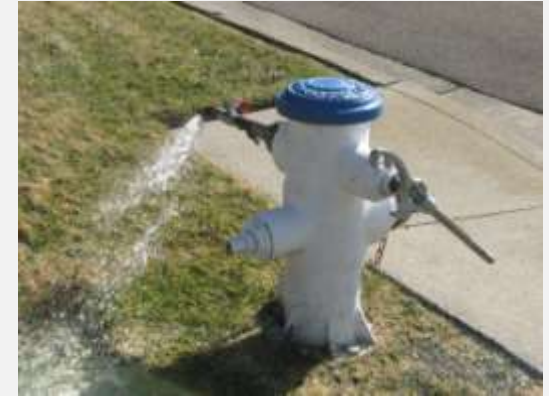
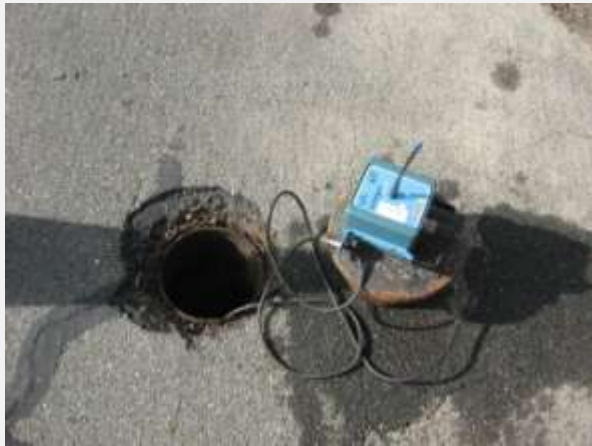
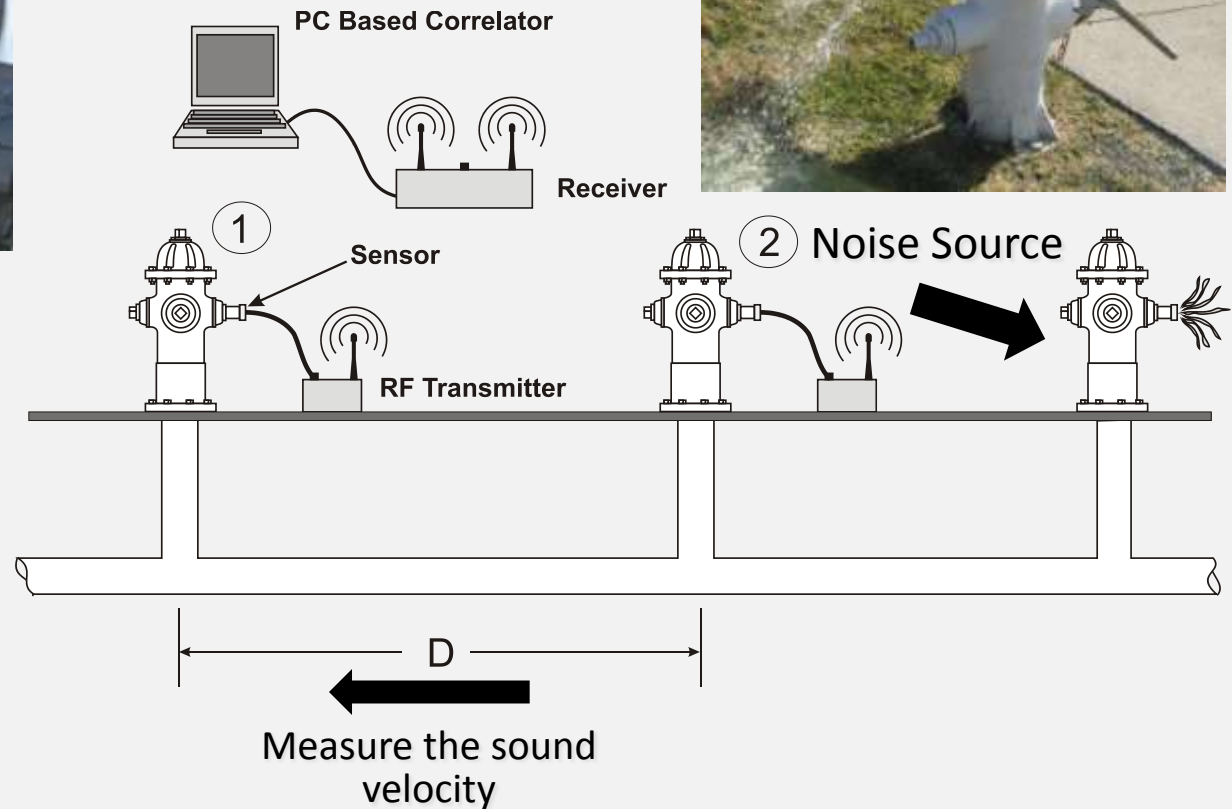
Echologics Acoustic Surveys

Stain Test results compared to Echologics Surveys.

4 out of 6 pipe samples (non-break) have good correlation

vs.

4 out of 9 for coupons
