# Understanding the Nature and Characteristics of Dark-Black Stains on Rooftops in Uyo Metropolis-Nigeria

Ihom A.P.<sup>1</sup>, Uko D.K.<sup>1</sup>, Markson I.E.<sup>1</sup>, Eleghasim O.C.<sup>1</sup>

<sup>1</sup> – Department of Mechanical Engineering, University of Uyo, Uyo, PMB, Uyo, Nigeria

**ABSTRACT.** Understanding the Nature and Characteristics of Dark-Black Stains on Roof-Tops in Uyo Metropolis-Nigeria; a study aimed at knowing the nature and characteristics of dark black stains on rooftops in Uyo metropolis has been undertaken. The study which covered key areas of the town, involved taking samples from rooftops, these samples were sent out for tests using Energy Dispersive X-Ray Fluorescence (ED-XRF), Optical Emission Spectrometer (OES), X-Ray Diffractometer (XRD) and Scanning Electron Microscope (SEM). The tests were carried out on the dark black stains which were scrapped from the rooftops. Tests were also carried out on the sheets, which were directly cut from the roofs. The work was able to establish that the dark black stains on the roofs can be cleaned using soft brush and water. The results of the work equally provided the nature and characteristics of the da

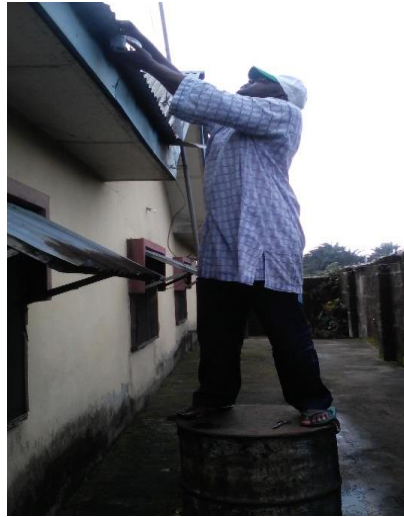
Critical examinations of the roofs were also carried out using visual examination to ascertain the nature of the deposit and also to establish whether it was living things growing on the roof. Remedial steps were taken to remove the dark-black coating from the roof by cleaning with water and soft brush (See fig. 7-8. No chemical was used for the cleaning, since there was no chemical reaction between the deposits and the roof base. The dark-black deposit was stuck to the roof purely by adsorption, which upon cleaning revealed a clean-shining surface of the roof. See fig.7. Only few growths were seen on the roofs and where they existed the zinc coating was eroded and accompanied by corrosion. The colour of the growth was also different from that of the dark-black deposit.

Fig. 7. Field Work and Sample taking in Progress.

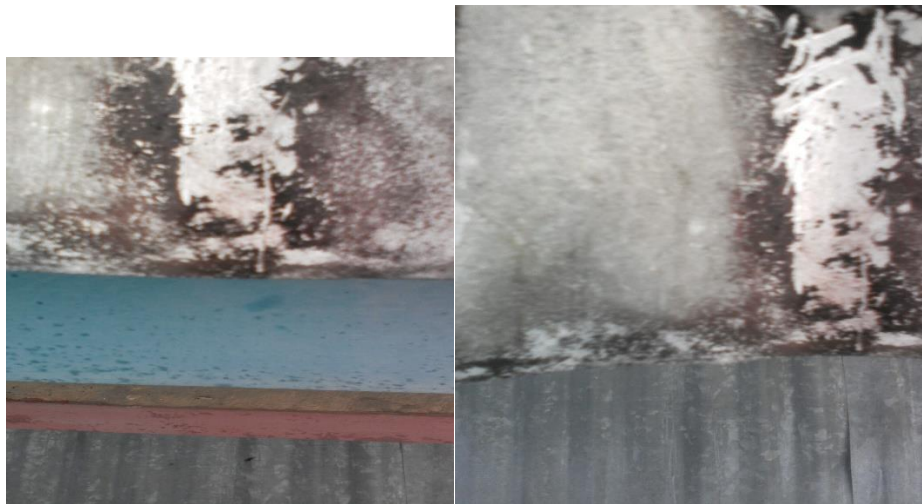
Fig. 8. Roofs showing Reflective Surfaces where test specimens were scrapped from the roofs.

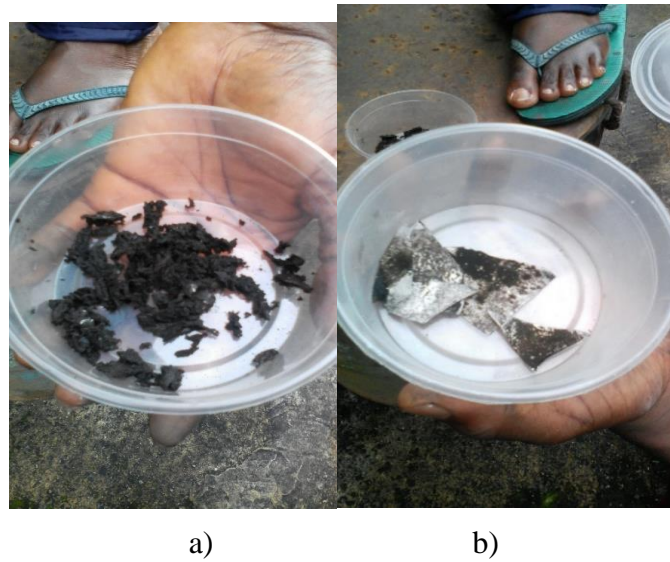
*Fig. 10. Dark-Black Material Scrapped in (a), Test Specimens cut from the roofs in (b).*

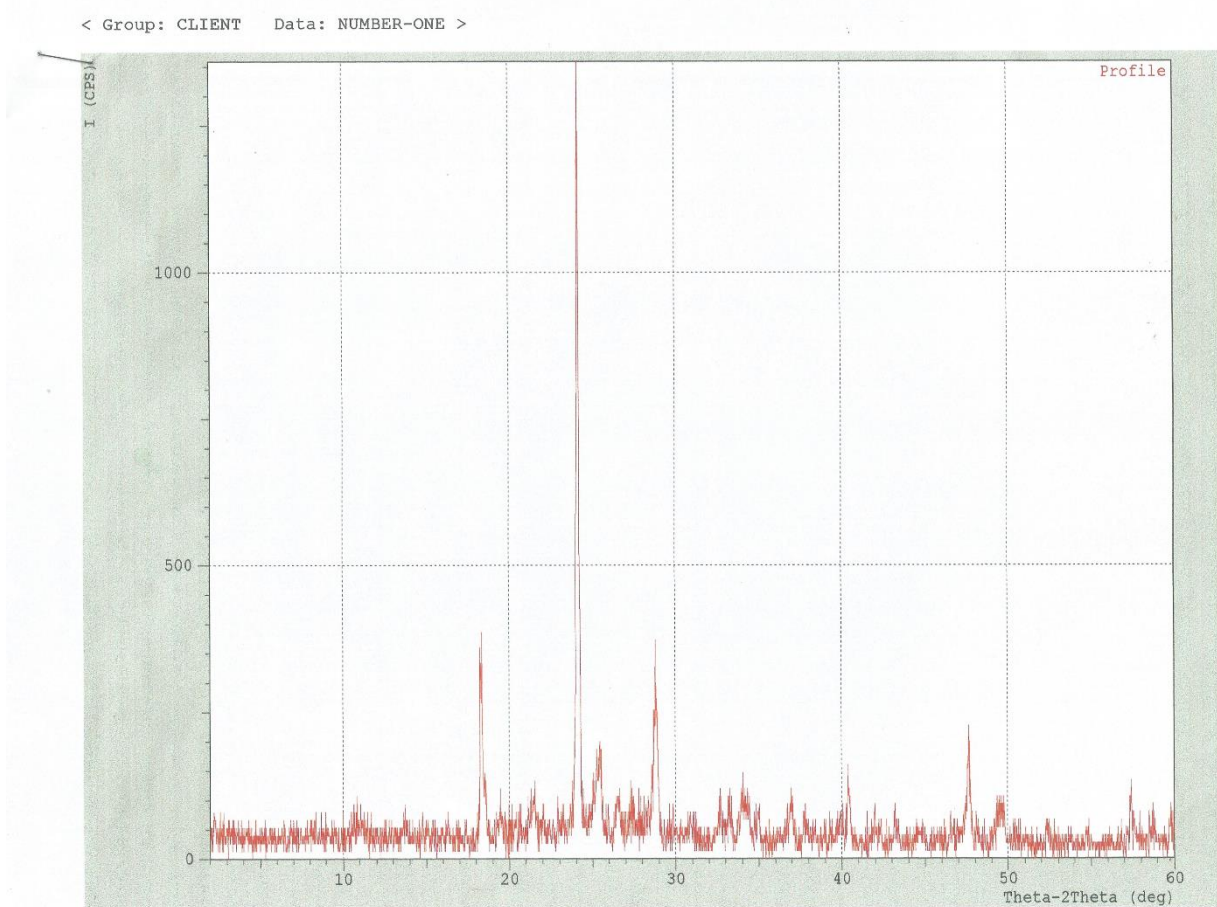
Fig. 14. X-Ray Diffractometer Plot of Intensity against Theta-2Theta for the Dark-Black Material from the Roof-Tops.

X-Ray Diffractometer (XRD) Analysis was also carried out on the dark black stains scrapped from the roof, dark-black stains on zinc substrate and dark-black stains on aluminium substrate, which were taken directly from the roofs (see Figs. 14-16). The X-Ray Diffractometer analysis of the scrapped dark black stains showed that in addition to the composition given by ED-XRF; the dark-black stains contained polytetrafluoroethylene, Calcium Fluoride, zinc phosphate hydrate, carbon (graphite) and magnesium. This result explains the structure seen in the SEM micrographs for the dark-black stains; the polytetrafluoroethylene may be responsible for the amorphous polymer structure seen and the carbon may be responsible for the carbon structure sighted in the SEM. The Zinc phosphate hydrate was scrapped along with the dark-black stains when samples were taken. This compound is normally at the surface of zinc coated roofing sheets. The XRD identification of components present in the dark black stains scrapped from roof-tops agreed with composition of soot and particulate as stated by [3].

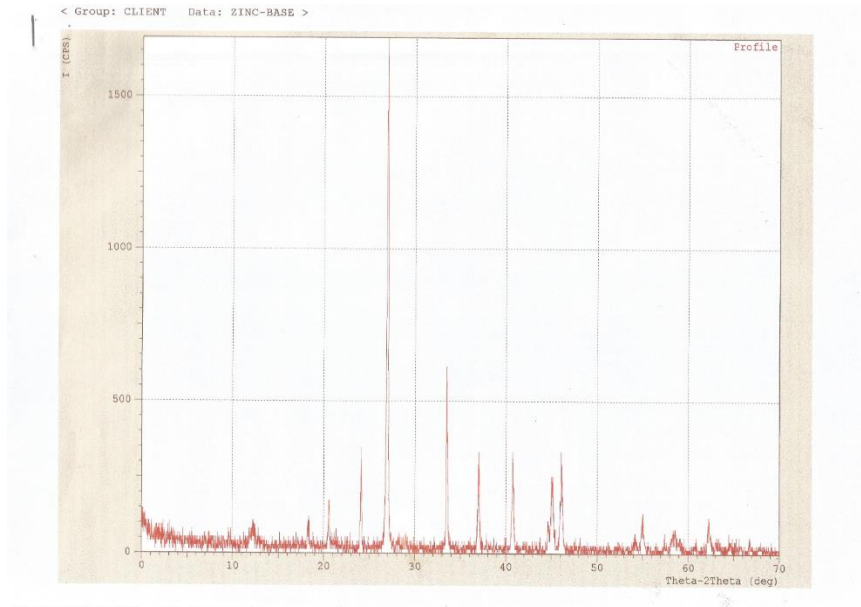
Fig. 16. X-Ray Diffractometer Plot of Intensity against Theta-2Theta for the Zinc Coated Sheet Covered with Dark-Black Material.

The only new compounds in the analysis of the dark-black stains on zinc and aluminium substrate are chromium nitride, molybdenum carbide, and barium oxide. The chromium nitride indicate the presence of nitrogen. The molybdenum carbide indicate the presence of molybdenum on the substrate. The barium oxide indicate the presence of barium on the substrate. Table 3 which is the result of chemical analysis of the aluminium alloy roofing sheet using Optical Emission Spectrometer, confirms the presence of barium.

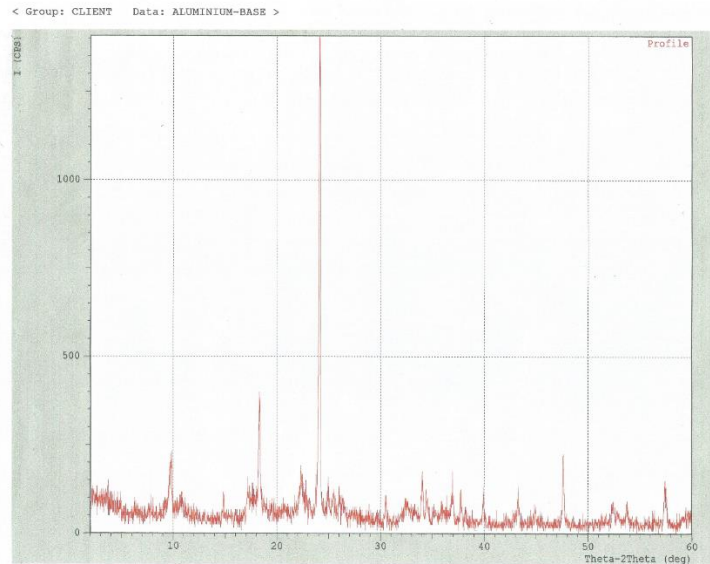
Fig. 18. X-Ray Diffractometer Plot of Intensity against Theta-2Theta for the Aluminium Roofing Sheet Covered with Dark-Black Material.
