Robustness of large-span timber roof structures – Two examples

Jørgen Munch-Andersen^a, Philipp Dietsch^{b,*}

This paper discusses the robustness of large-span timber roof structures, based on findings from failures of two roof structures. One is the Siemens arena in Ballerup, Denmark and the other the Bad Reichenhall ice-arena in Germany. The structures are described as well as the flaws that are believed to have caused the failures. The two cases serve as examples of different design strategies for large-span timber roof structures and the consequences of such strategies for robustness. It is demonstrated that robustness is not a straightforward concept because the best strategy depends on the cause of the failure – which is obviously not known during planning and design.

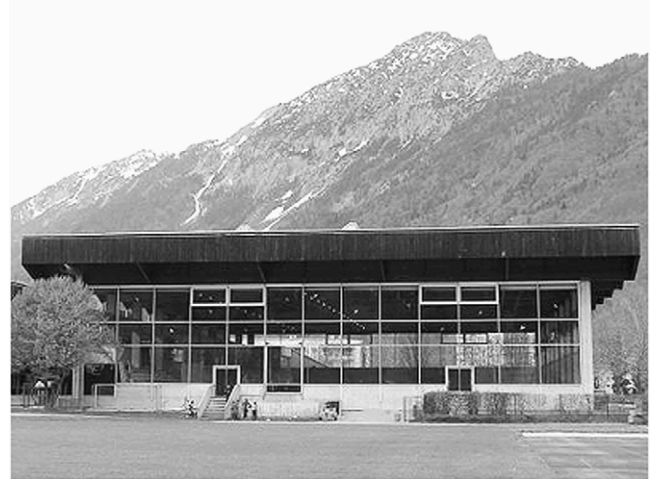
Fig. 4. The ice-arena in Bad Reichenhall.

The Bad Reichenhall ice-arena, built in 1971/1972, was a structure of approx. 75 m in length and approx. 48 m in width,

see Figs. 4 and 6. The roof was supported by 2.87 m high main girders, which were produced as timber box-girders, see Fig. 7. The box-girders featured upper and lower glulam members and lateral web boards made from so-called “Kämpf web boards” – a type of cross-laminated timber. The 48 m long girders were produced from three 16 m long sections, which were joined with general finger joints [5].

The design and construction of the girders were identified as one cause for the failure. There were several contributions to the failure:

The box girders were produced using a urea-formaldehyde glue. The technical rules both then and now allow the use of this type of glue for load-bearing components only in a dry ambient climate because that glue is not permanently moisture-resistant.

Due to the humidity exposure over the years, the glue-lines and finger joints were significantly damaged. This primarily affected

the general finger joints in the lower girder and the bonding between the girders and the web-boards. It was found that in some cases, there was no adhesive effect to a depth of 50–80 mm in the lower girders. In combination with the errors in the structural calculations, this represents the most significant cause for the collapse of the Bad Reichenhall ice-arena.
