REDUCING THE FIRE HAZARD

IN ALUMINUM-WIRED HOMES

Jesse Aronstein, PH.D., P.E.

Latest update: November 25, 2011

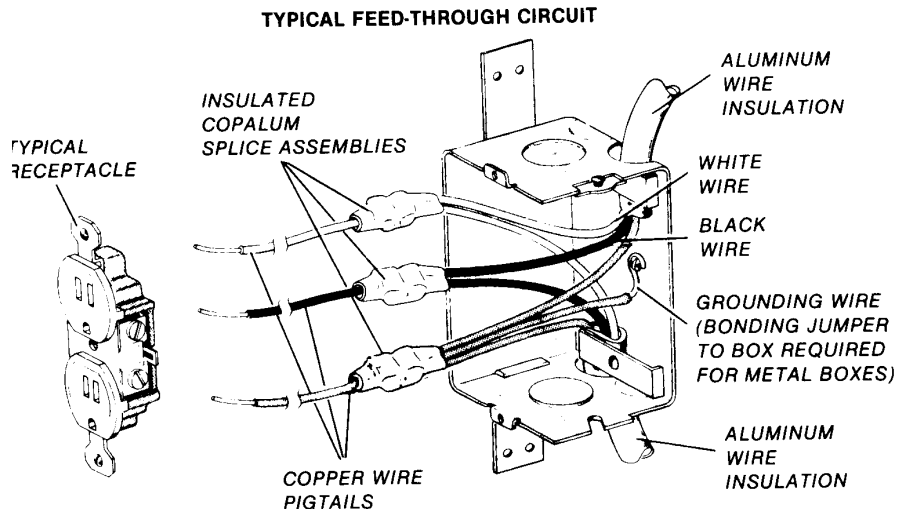
FIGURE 3 - Illustration of copper wire pigtails spliced to aluminum circuit wires using COPALUM connectors (Source: CPSC)

Repair by pigtailing, using COPALUM* connectors installed by a qualified electrician, is considered by the U.S. Consumer Product Safety Commission ("CPSC") to be the best method for a permanent repair short of rewiring with copper.[7] Their recommendation is based on extensive testing and successful long-term field experience. The application of COPALUM connectors is considered to be satisfactory without special preparation of the aluminum conductor.

The “COPALUM” connector is applied using a special set of dies in a power-driven tool. After application of the connector, a heat-shrink insulator is applied. Solid copper wire "pigtails" spliced to the aluminum wire this way may be connected to receptacles, switches, circuit breakers, lamps, appliances, and all other terminations in the normal manner. (Note: all aluminum branch circuit wire terminations in the home, including the ground wires, must be treated this way for a complete and permanent repair, as the overheating problem involves all types of aluminum-wired connections.) The COPALUM repair can only be obtained through an installer who has been trained and certified by the connector manufacturer. For information on availability in your location, call the manufacturer at 800-722-1111.
