**U.S. CONSUMER PRODUCT SAFETY COMMISSION
DIRECTORATE FOR ENGINEERING SCIENCES**

**EVALUATION OF
ELECTRIC LIGHTING PRODUCTS**

December 2007

Anna Luo
Electrical Engineer
Division of Electrical Engineering
Directorate for Engineering Sciences

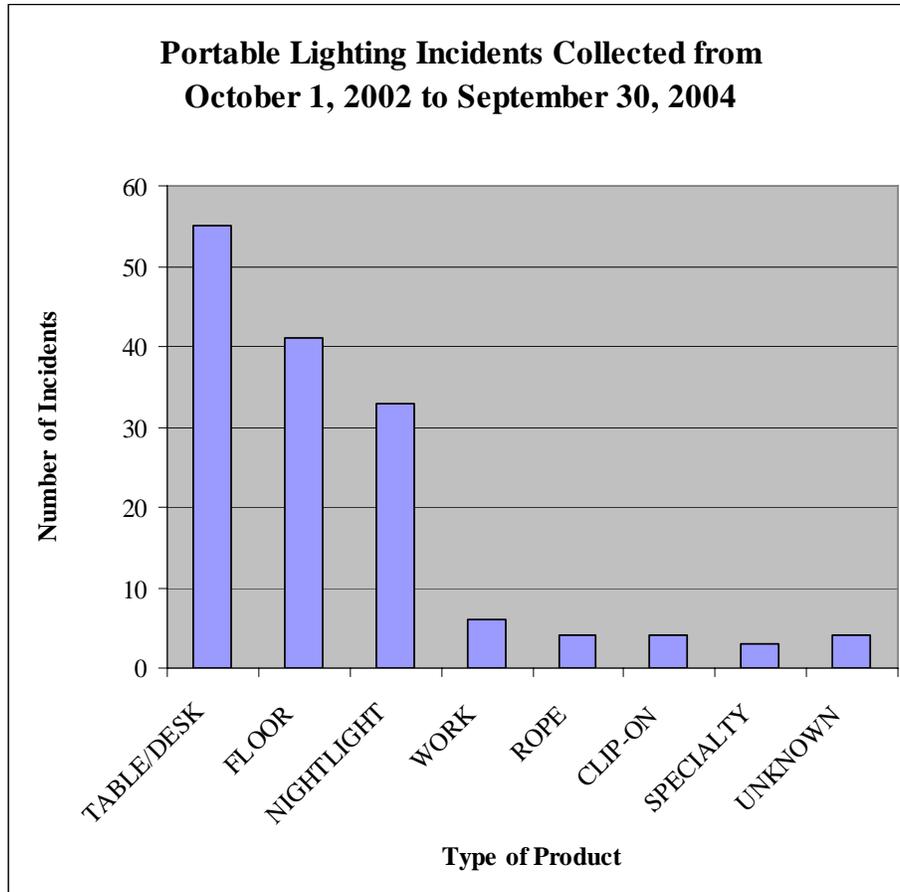
Figure 1. Incidents Involving Portable Lighting Products

The hazards described in the 150 IDIs were identified as: fire (60), potential fire⁵ (78), explosion (7), electrocution (3), and electrical shock (2). Product or component failures identified in the IDIs included bulb (31), power cord (29), fixture (28), combination of components (9), other such as switch, shade, socket, etc. (22), and unknown (31).

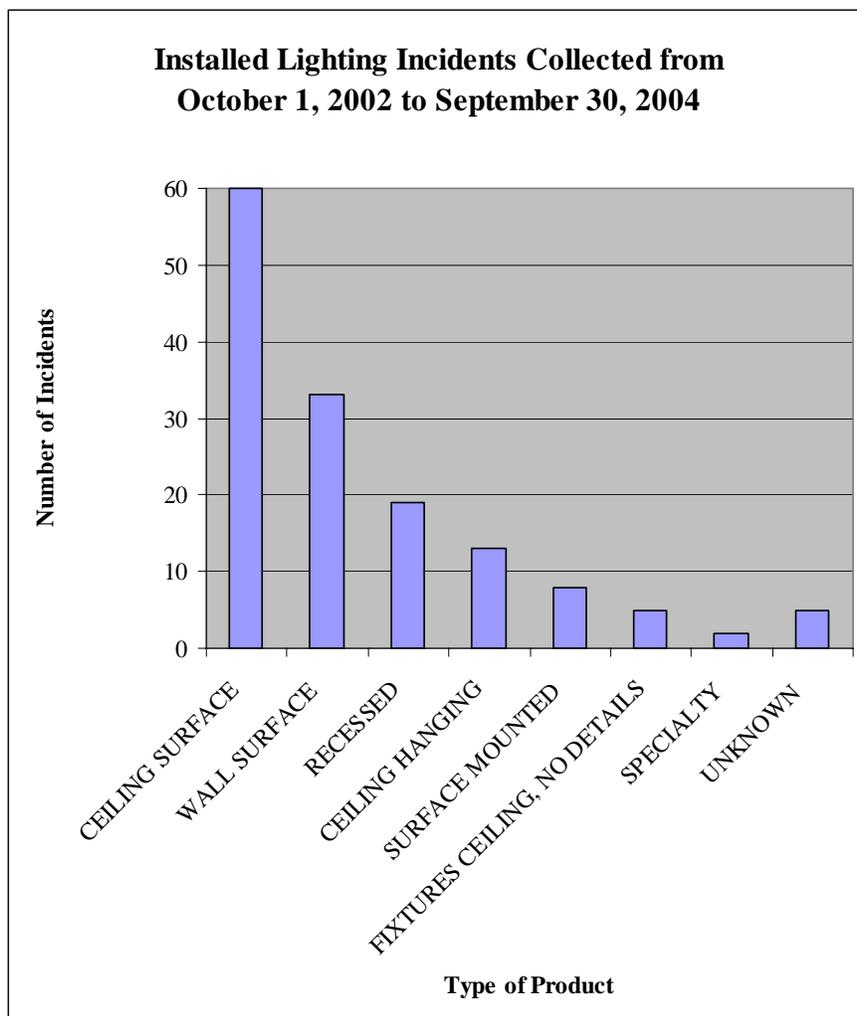
Figure 2. Incidents Involving Installed Lighting Products

The hazards identified in the 145 IDIs were: fire (74), potential fire (57), explosion (11), electrical shock (2), and electrocution (1). Product or component failures identified in the IDIs included: bulb (44), wiring (24), fixture (25), other such as ballast, connection, switch, housing, etc. (22), combination of components (5), and unknown (25).
