Tests of Materials and
Systems for Flood
Proofing Structures

August 1988

Prepared by
Structures Laboratory
US Army Engineer Waterways Experiment Station
for
Corps of Engineers
National Flood Proofing Committee

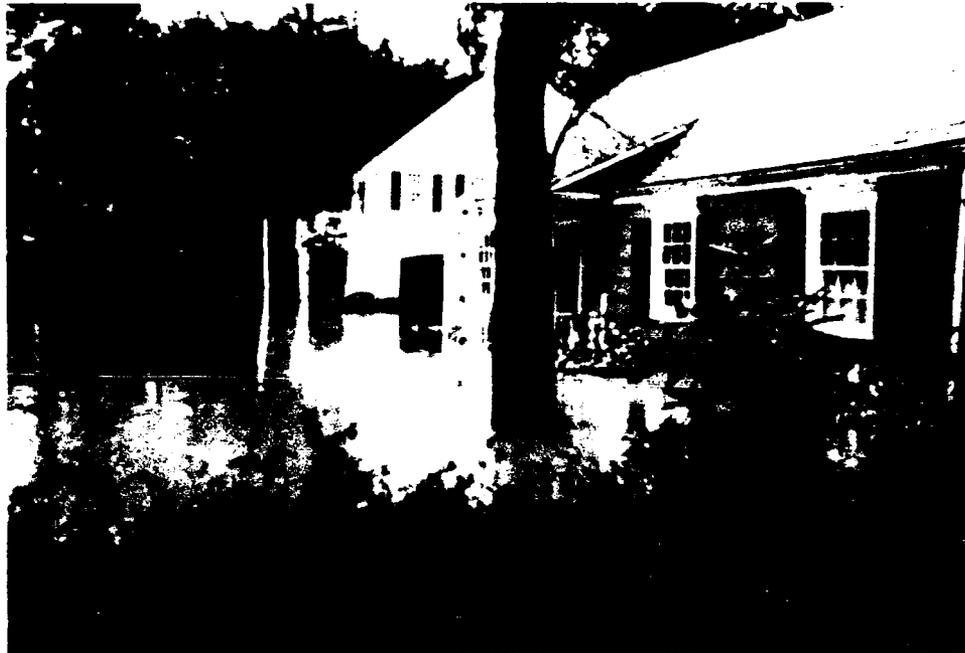
Despite the construction of flood control projects and the development of public programs to reduce flood losses, flood damage to homes and other buildings in the United States has increased dramatically (Figure 1 is an example of a flooded home). The growing exposure of structures to flooding is largely due to rising land costs and a reduction in the quantity of available land for building, thus resulting in an encroachment on flood plains.

Figure 1. Example of a flooded home

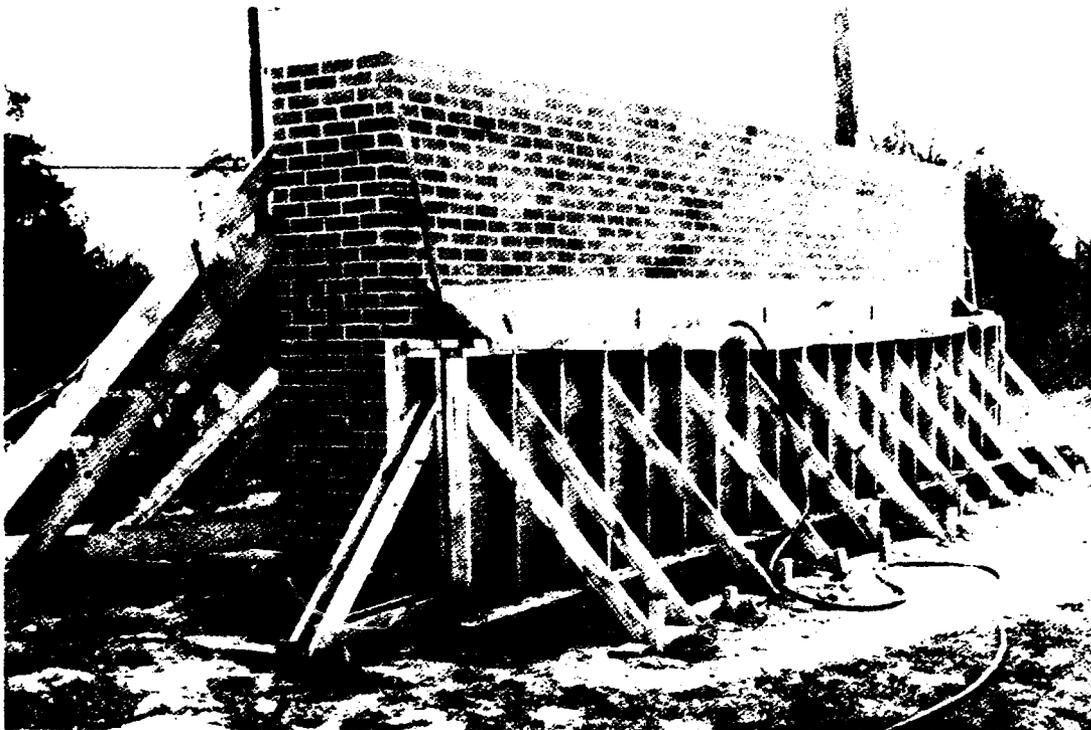
Of the three brick-veneer walls built for testing, Wall 1 (Figure 3) was a typical end wall of a home. In supporting loads, this wall is most critical because the top plate has no roof rafter and ceiling joist restraints to transfer resistance through the wall ties to the brick-veneer wall. Wall 2 and Wall 3 differed from Wall 1 as follows:

Figure 3. Overall view of Wall 1

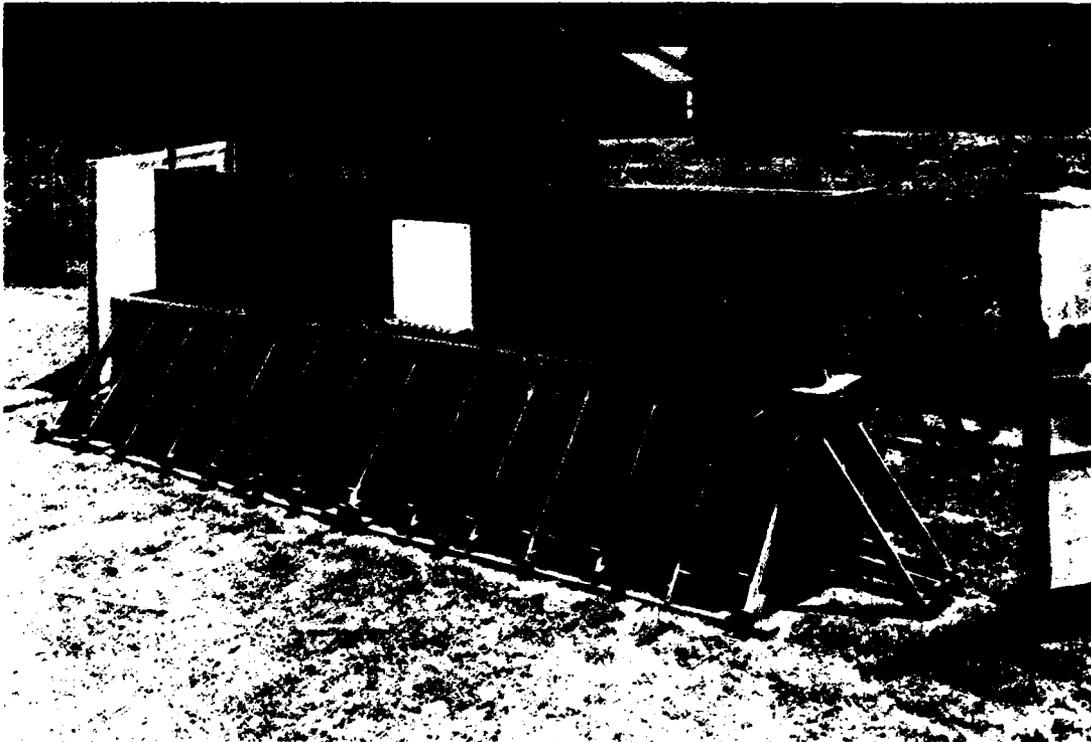
- Wall 2 had a 3-ft* door in its center (Figure 4).
- Wall 3 had roof rafter and ceiling joist restraints (Figure 5).

Figure 4. Overall view of Wall 2

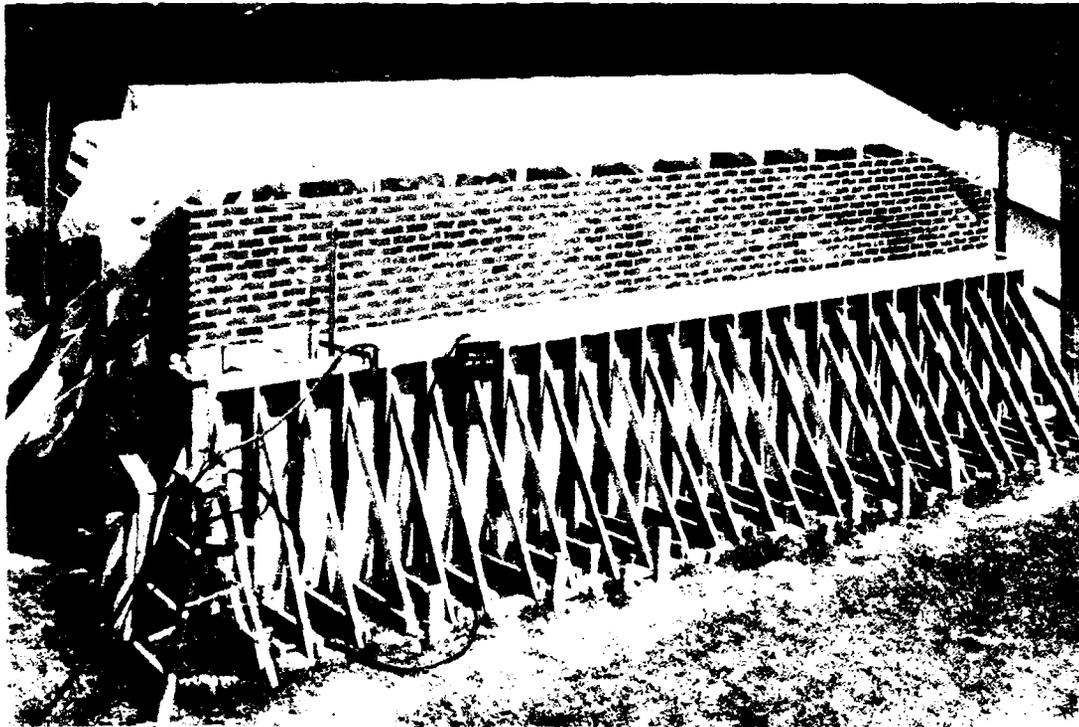
Figure 5. Overall view of Wall 3

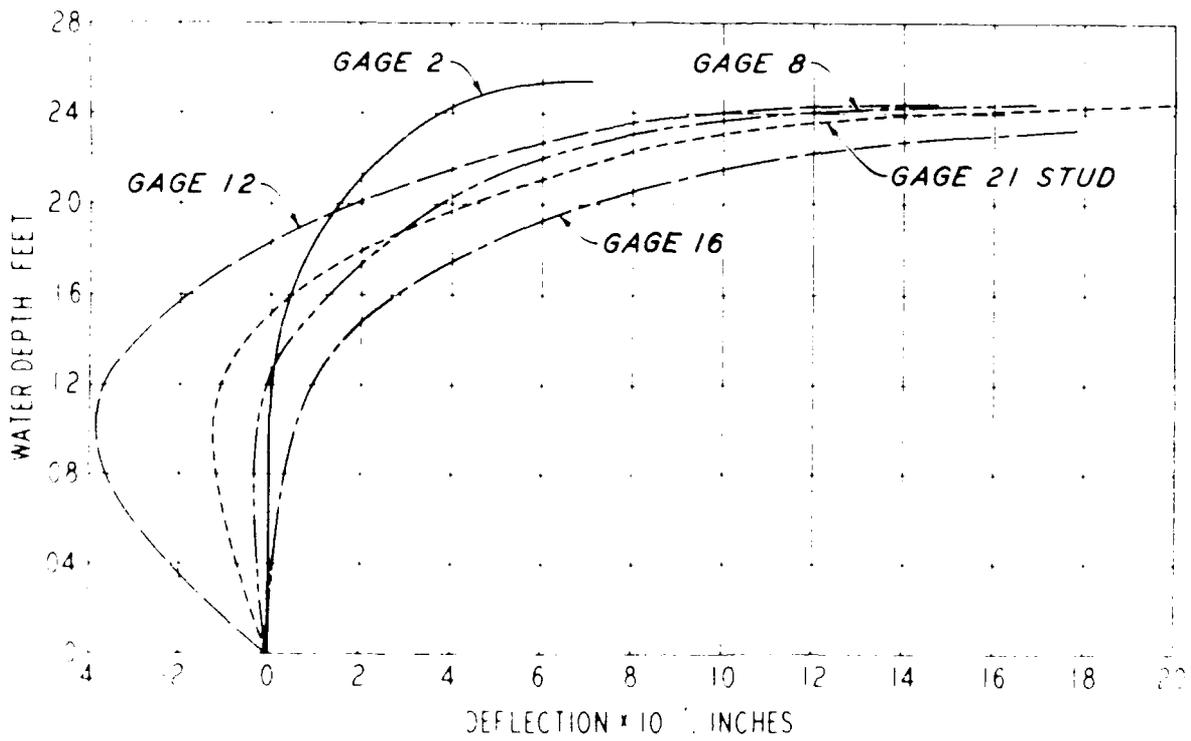
A severe loss of integrity began at 2 ft of water with complete loss occurring at 2.4 ft (Figure 8). The failure at 2.4 ft of water is presented in Figures 10 and 11.

Figure 8. Wall 1. Brick-veneer wall and stud deflections, vertical gage line

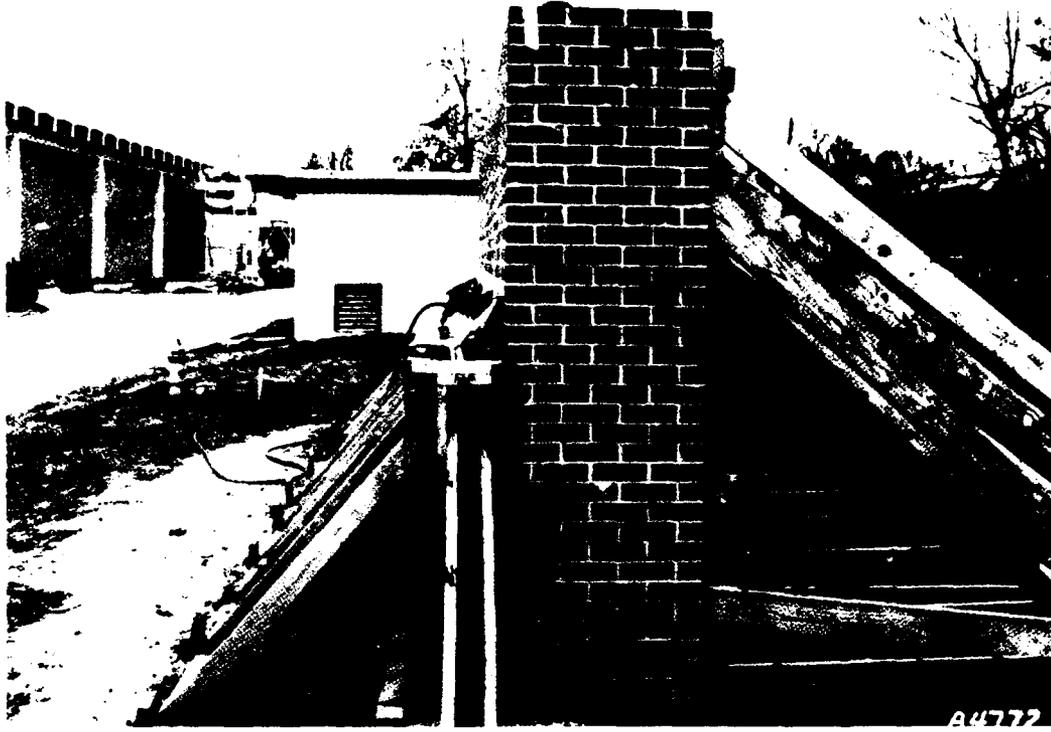
Figure 9. Wall 1. Wall deflection

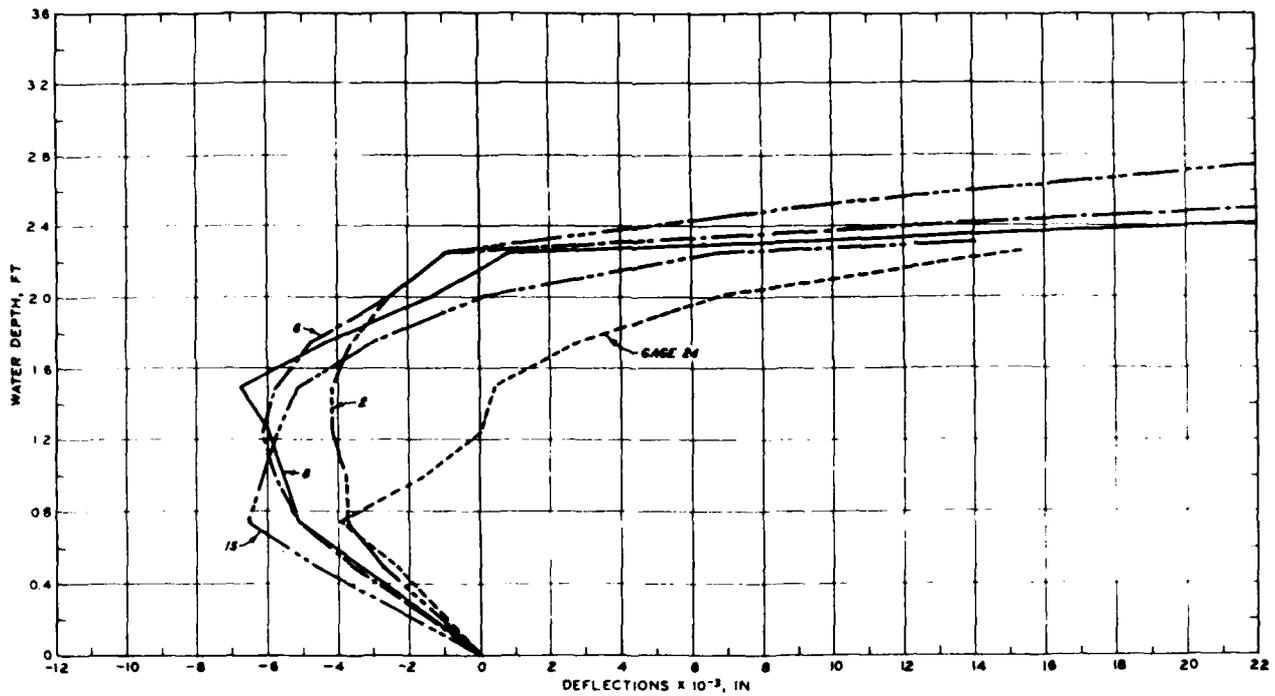
Figure 12. Wall 2. Brick-veneer wall deflections, vertical gage line, initial loading

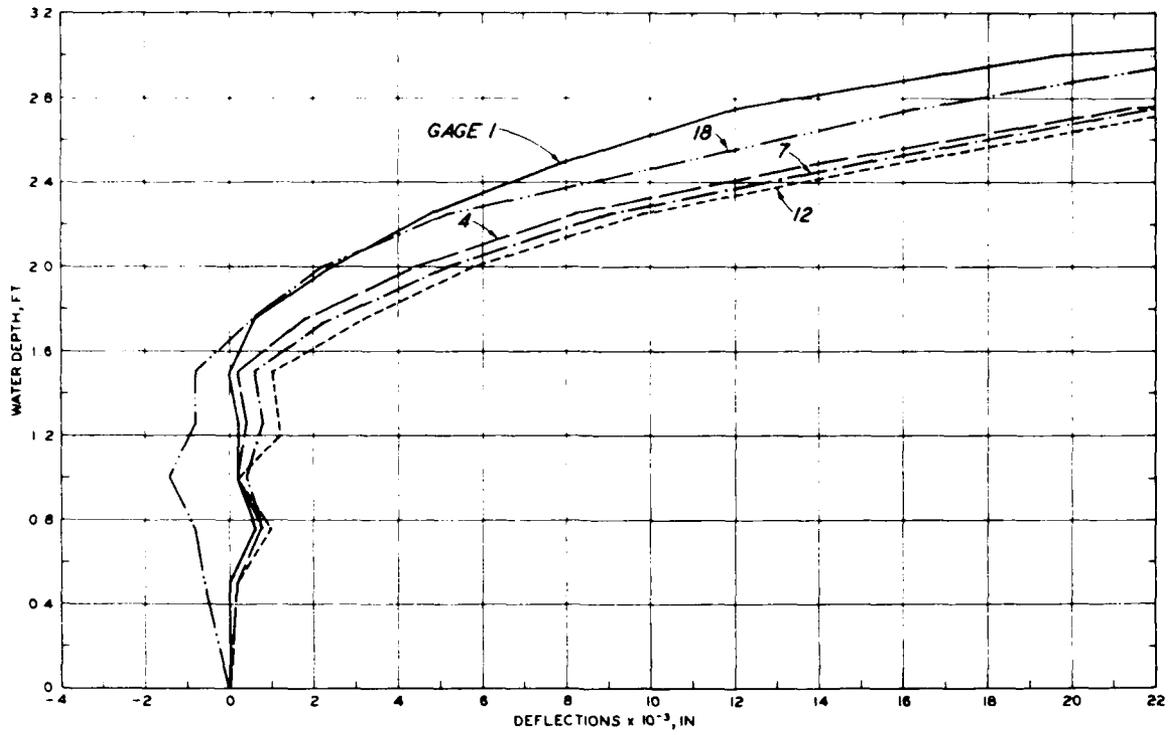
Figure 15. Wall 3. Brick-veneer wall deflection, vertical gage line

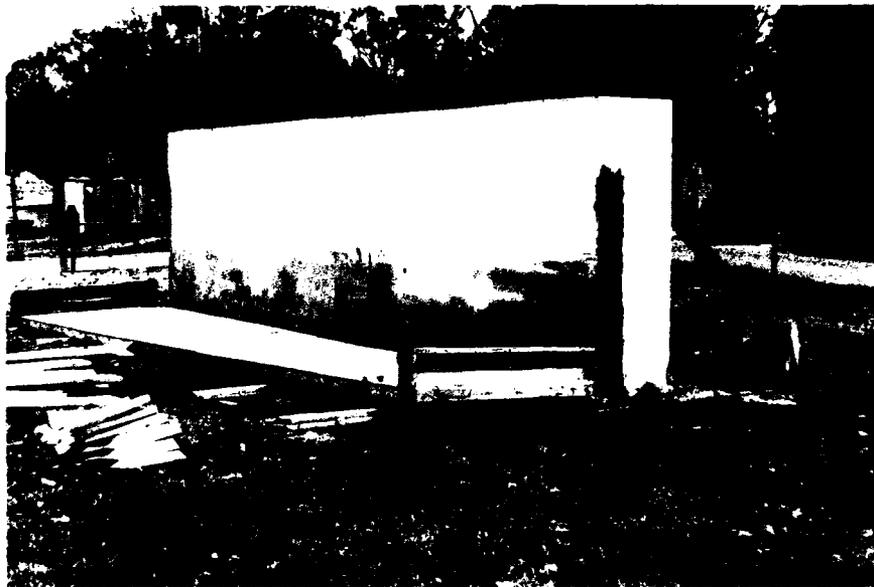
Figure 18. Block Wall 1

a. Before testing

b. After testing

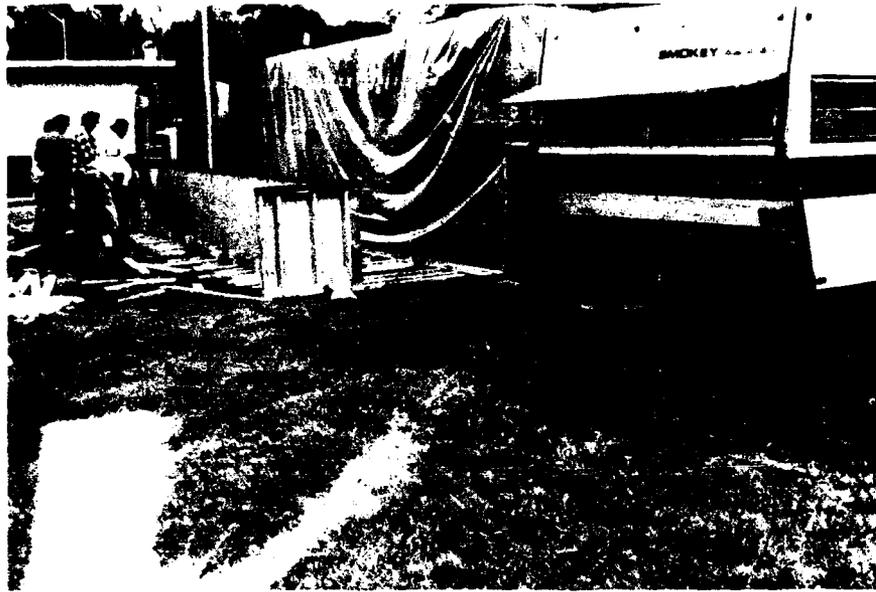
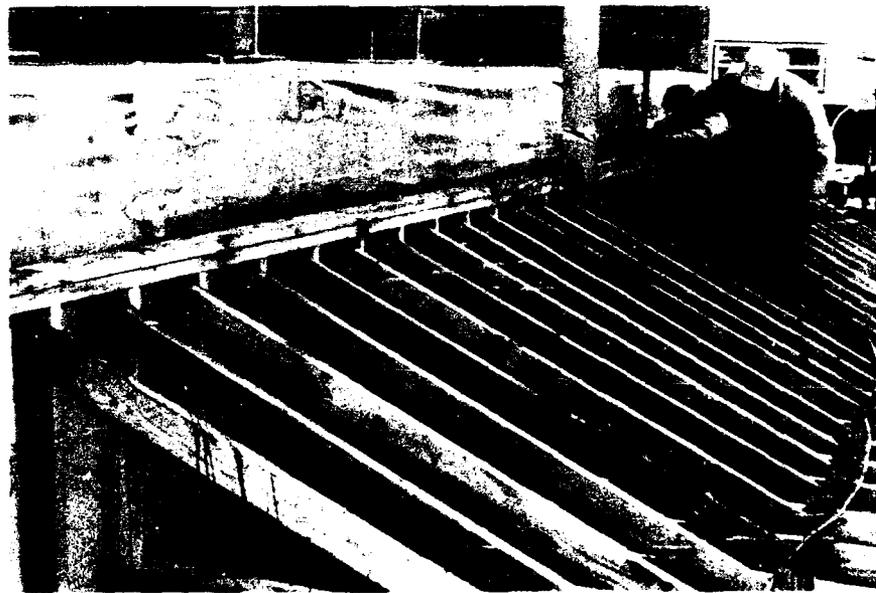
Figure 19. Block Wall 2

a. Preparing for testing

b. During testing

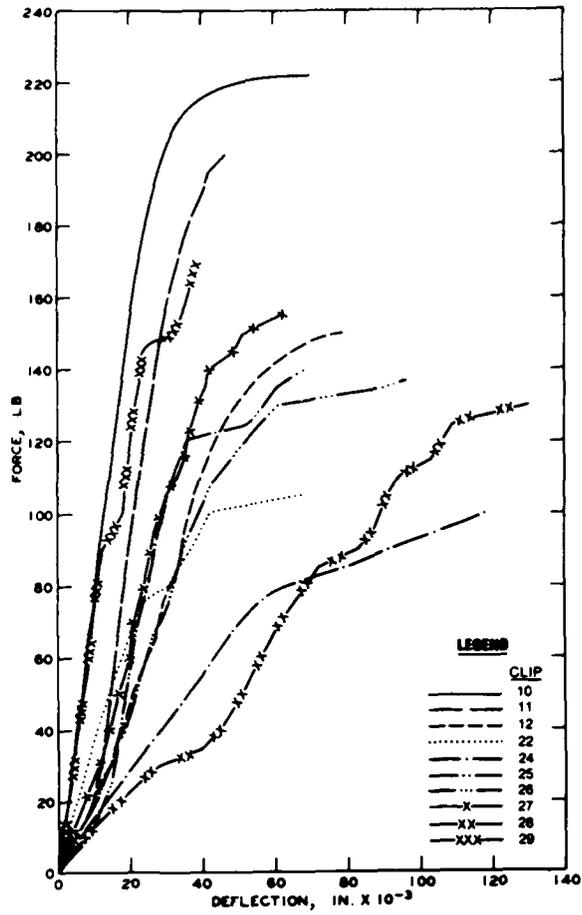
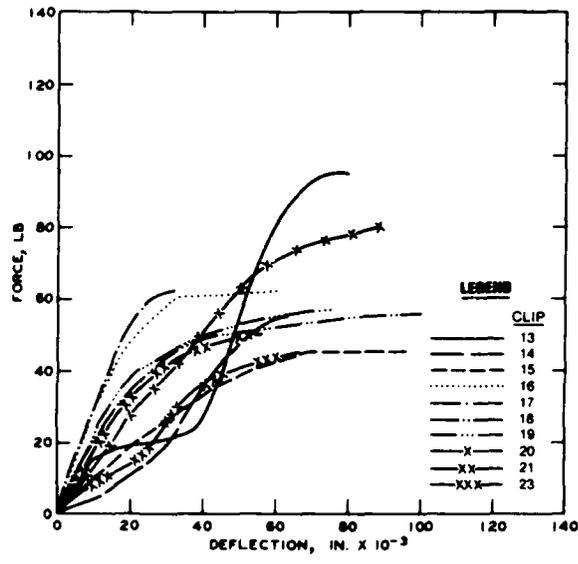
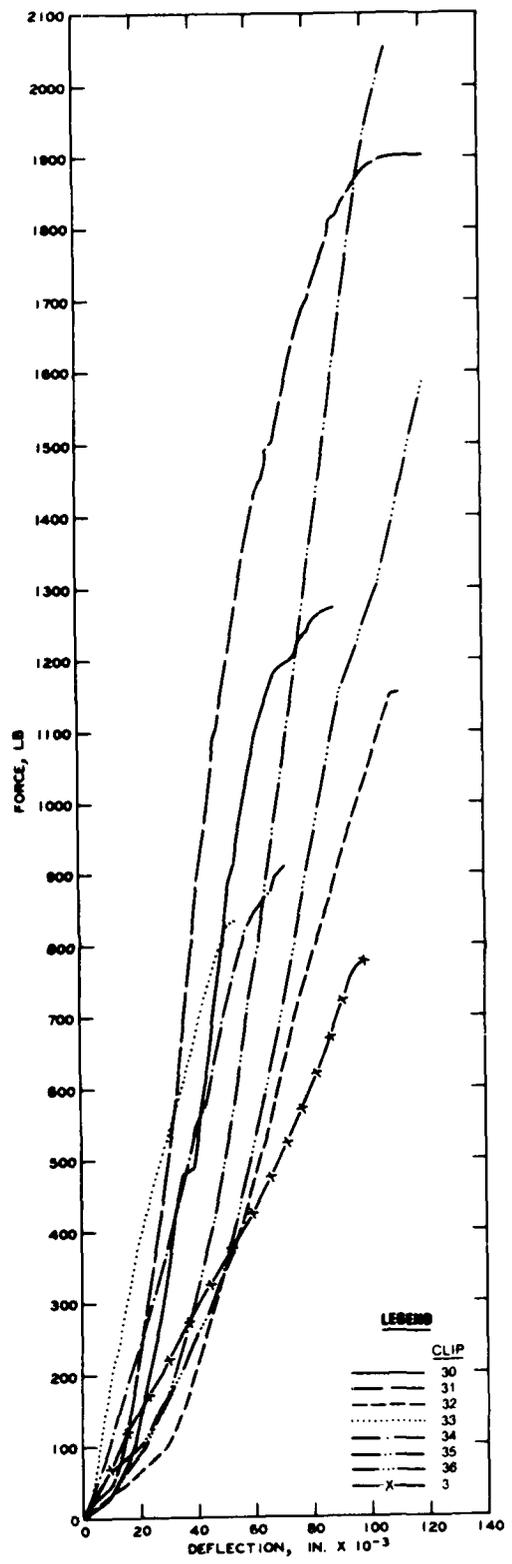
Figure 27. Load deflection curves for wall ties

The restraint due to wall ties was determined. There are several types and thicknesses of wall ties (Figure 25) but the two most commonly used (22 and 28 gage) were tested. The test setup is presented in Figure 26. The clips have a wide variation in load deflection characteristics. In general, the 22-gage clips have a maximum strength of 100 to 200 lb (Figure 27a). The 28-gage clips have a maximum strength of about 40 to 60 lb (Figure 27b). The variation of the strength of the 28-gage clips is greater than that of the

22-gage clips. Mortar that collects on the wall tie is the main factor that affects the load transfer capacity. Figure 27c shows that the load transfer increases drastically if mortar has caught on the wall clip between the studs and the brick wall. The load transfer, because of mortar, may be at least as high as 750 lb. The amount of mortar on a clip varies from none to a considerable amount. At first, it seems that the individual load deflection curves must be known for a wide variation in wall clip and mortar restraint. Fortunately, this is not the case because, for reasonable water loads, the required load transfer is much lower than the maximum. In fact, it is within a range where the slope of all curves is very similar and one relationship will reasonably represent the load transfer relation.

a. 22-gage wall ties

b. 28-gage wall ties

c. 22-gage wall ties with varying thicknesses of mortar
