**"OLE JIM"
GALLAUDET COLLEGE
Washington, D.C.**

Tech Notes

**EXTERIOR
WOODWORK**

**Proper Painting
And Surface Preparation**

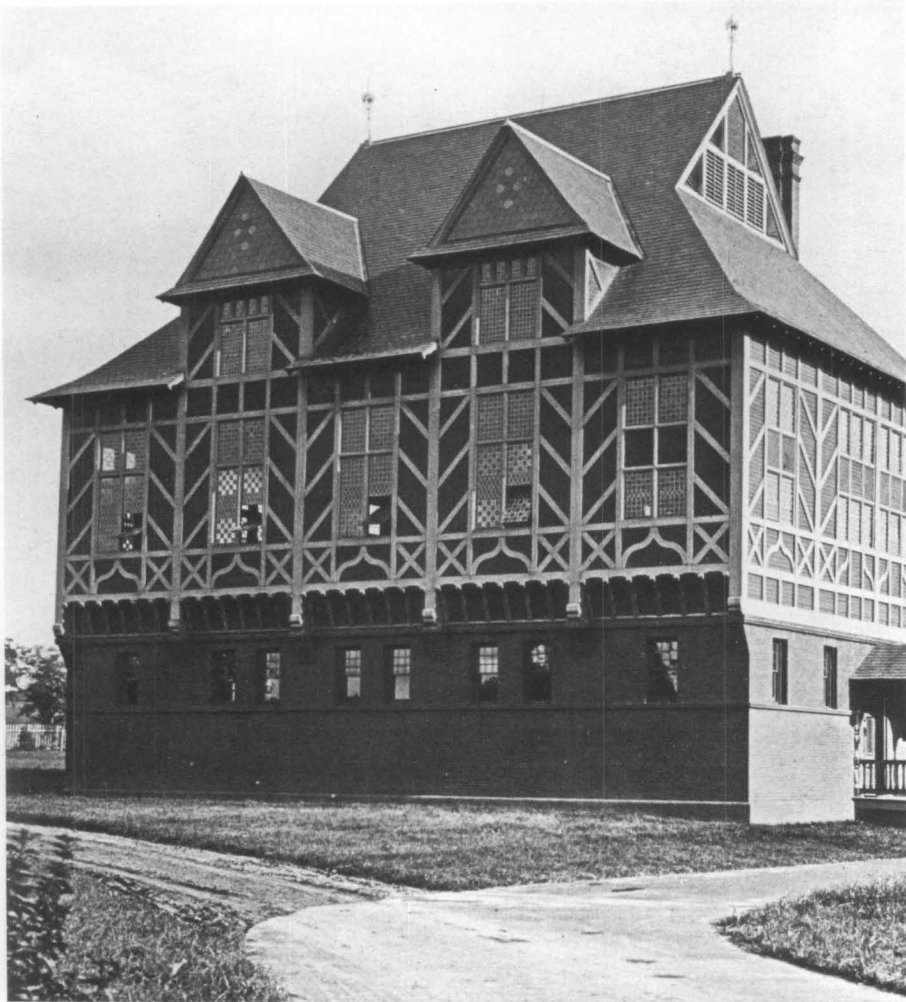
Figure 1. The stucco, applied circa 1910, is shown here being removed as part of the 1980 restoration. The wooden siding and "half-timbering" was largely intact underneath. Photo: Courtesy of Gallaudet College
