## MASONRY NUMBER 3

### Water Soak Cleaning of Limestone

### THE WIDENER BUILDING Philadelphia, Pennsylvania

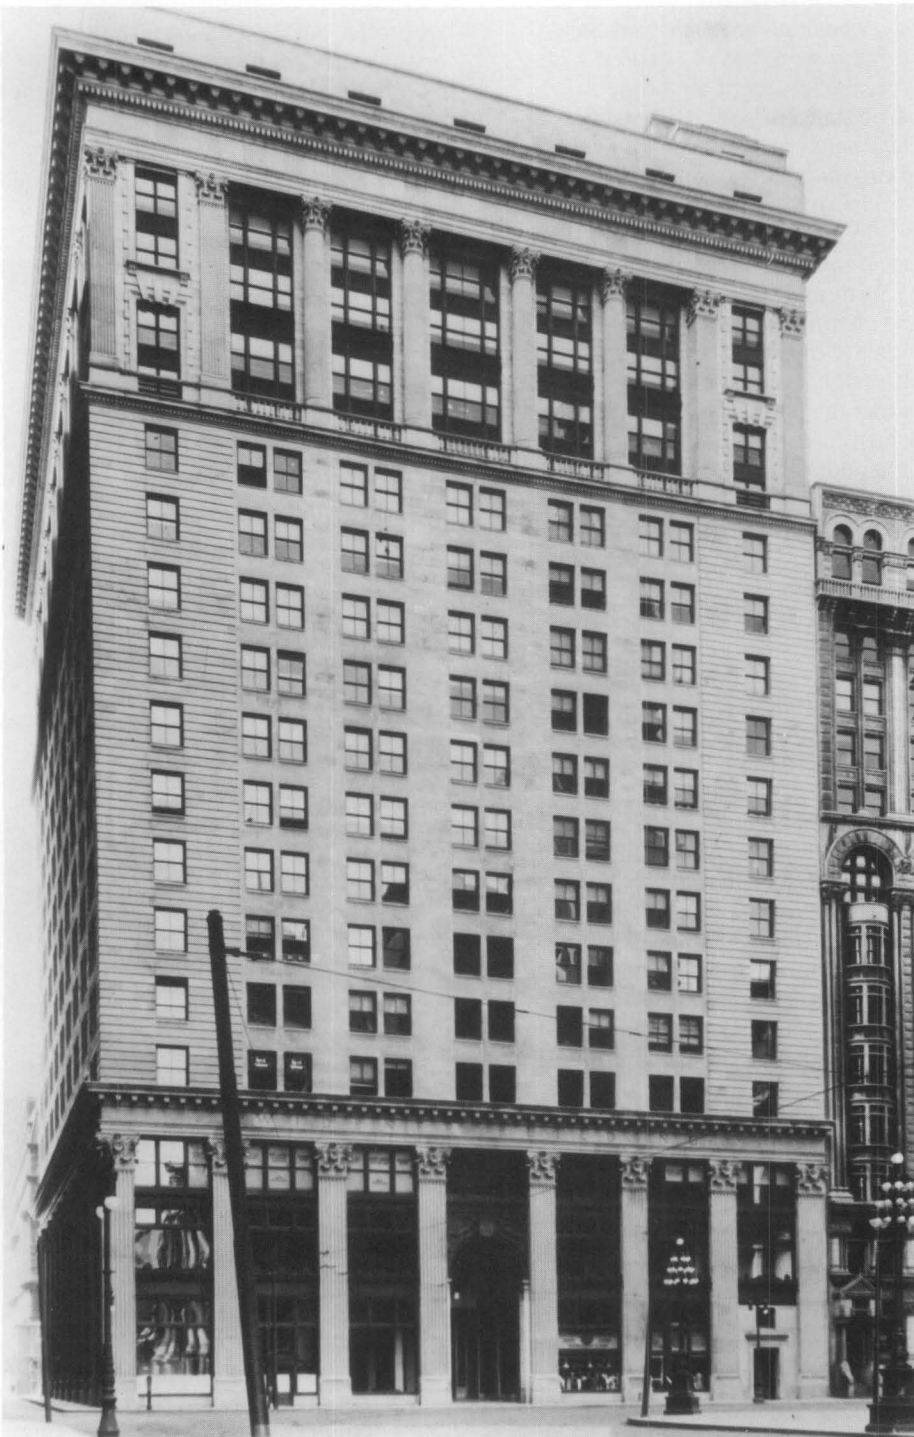
modernization to recapture the prestige and luster of a first class office building. The most drastic alterations occurred in 1963, when the elaborately detailed arcade that connected Chestnut Street with South Penn Square was closed off to pedestrian traffic. At the same time, the original limestone and bronze commercial storefronts on Chestnut Street were replaced with a contemporary design of marble, glass and aluminum that was incompatible with the historic character of the building. Other than these changes at street level, the exterior was unaltered and had never been cleaned (see figure 1).
