# Furnace and Water Heater Venting Field Demonstration

**May 2019**

Prepared by  
OAK RIDGE NATIONAL LABORATORY  
Oak Ridge, TN 37831-6283  
managed by  
UT-BATTELLE, LLC  
for the  
US DEPARTMENT OF ENERGY  
under contract DE-AC05-00OR22725

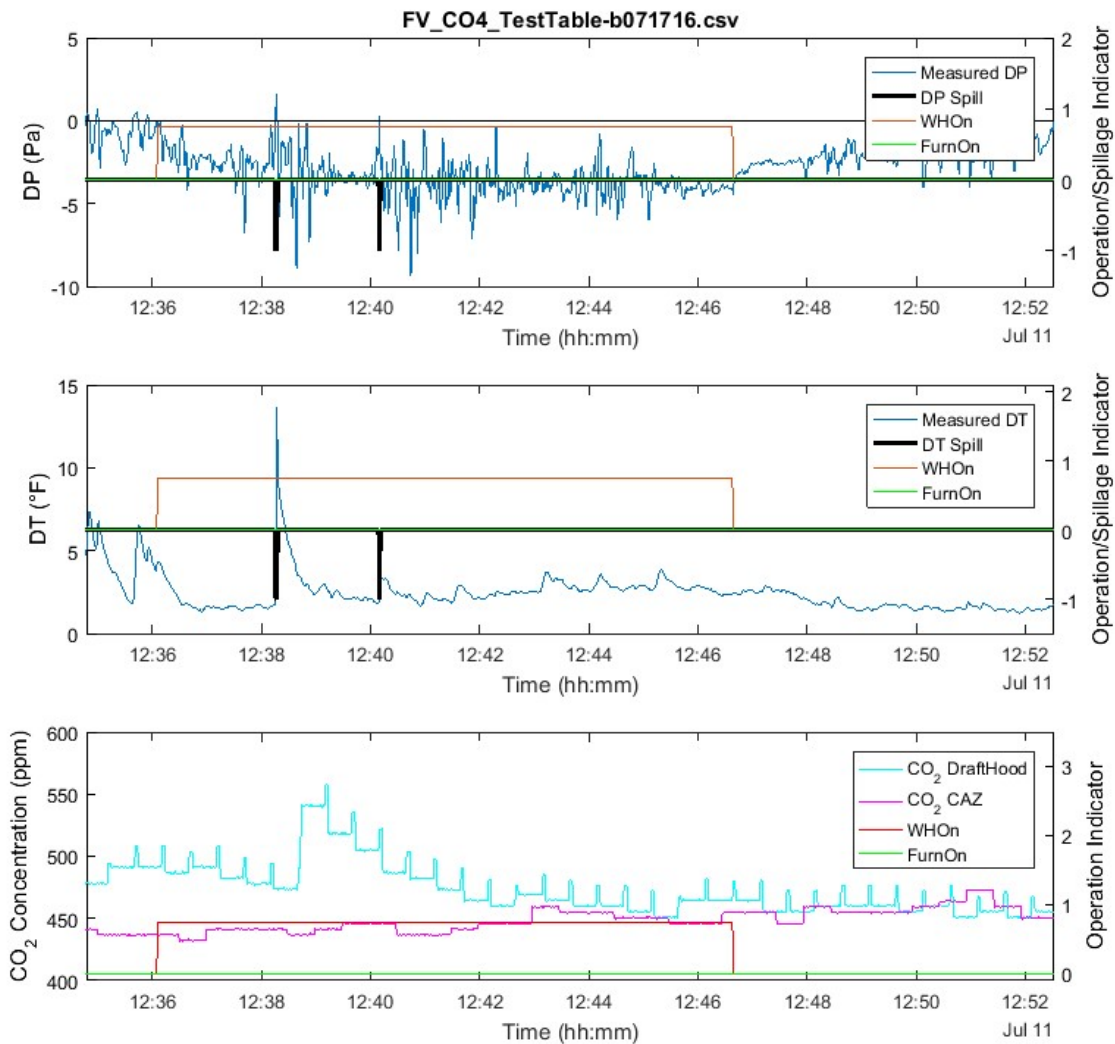
Spillage does not necessarily occur just at the beginning of a water heater cycle. Although it may occur most frequently at the start of a water heater cycle, spillage can occur at any time during a cycle. As shown in Figure 5.4, spillage occurred twice during this ~11 minute water heater cycle (from ~12.36 to ~12.47) in the middle of the cycle rather than at the start, with each spillage event occurring for just a few seconds. The DP and DT methods both detected these events and detected the same duration for the events (see the black lines generated by the analysis software in the top and middle plots that indicate that these spillage events occurred at ~12.38 and ~12.40). The CO<sub>2</sub> measurement confirmed the occurrence of the first spillage event.

**Figure 5.4. Two spillage events detected by DP, DT, and CO<sub>2</sub> in the middle of a 10 minute water heater cycle.**

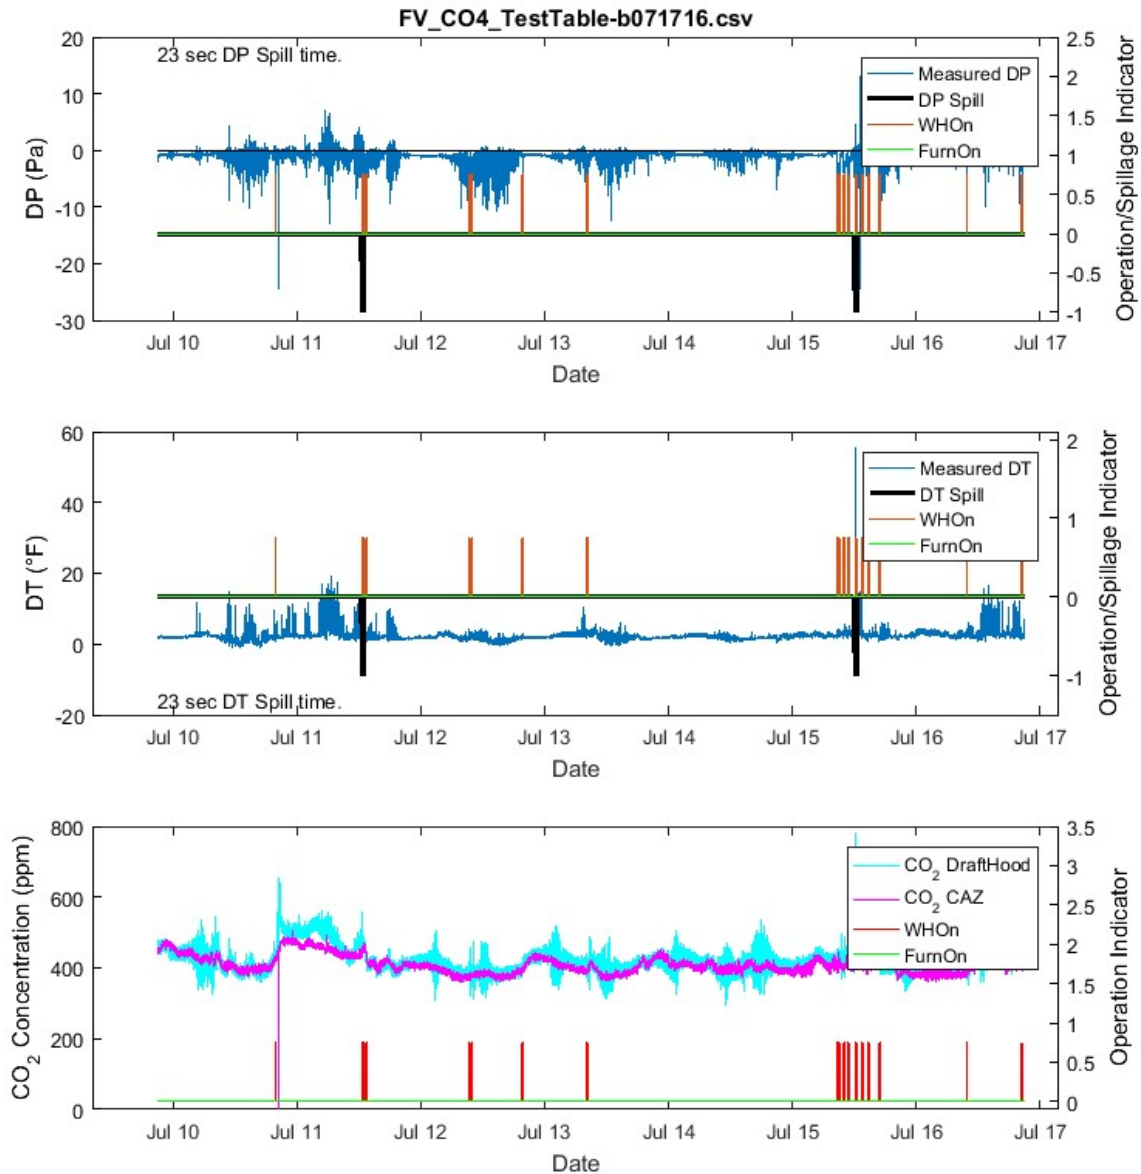
Figure 5.5 is another example demonstrating that the DP and DT methods are generally consistent in identifying spillage events at the water heater and determining their duration over an extended period. Figure 5.5 shows a week of monitoring (from July 10 to July 17) that included 18 water heater cycles (see the red lines in the three plots labeled WHOn). Both the DP and DT plots show that spillage occurred during the second, third, and thirteenth water heater cycles, as marked by the black lines generated by the analysis software. Both methods determined that the total spillage time over this week was 23 seconds, as labeled on the plots. The spikes on the CO<sub>2</sub> plot during the second and thirteenth water heater cycles

confirm these two spillage events. Spillage during the third water heater cycle was not detected by the CO<sub>2</sub> method because of its proximity in time to the second water heater cycle.

Figure 5.5. Alignment of the DT, DP, and CO<sub>2</sub> methods for detecting spillage over a week.

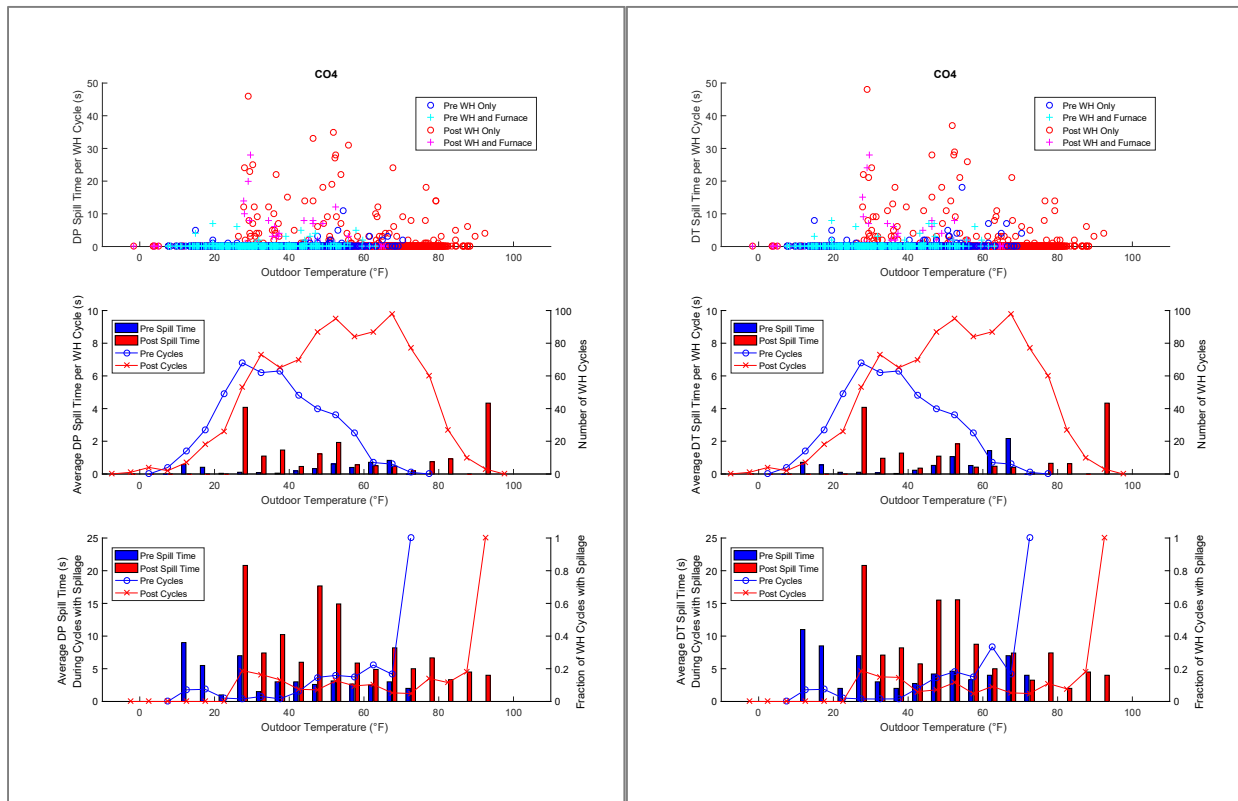
Figure 5.6 for House CO4 demonstrates that the DP method (left) and DT method (right) produce similar, if not identical, results when evaluating spillage events and durations. The two scatter plots in Figure 5.6 show that the DP and DT methods produce similar scatter of total water heater cycle spillage times at varying outdoor air temperatures for House CO4. The DP and DT methods also produce pre- and post-retrofit histograms for House CO4 that are similar. All other homes exhibited similar agreement between the DP and DT methods; as a result, and as already discussed in Sect. 5.3, the DP method is used to present the results in the remainder of this section because it is the more direct measurement of when a spillage event occurs and especially the duration of a spillage event.

**Figure 5.6. Spillage summary plots based on DP (left) and DT (right) methods for House CO4.** (In the bottom plots, the left axis refers to the histogram and the right axis refers to the lines.)

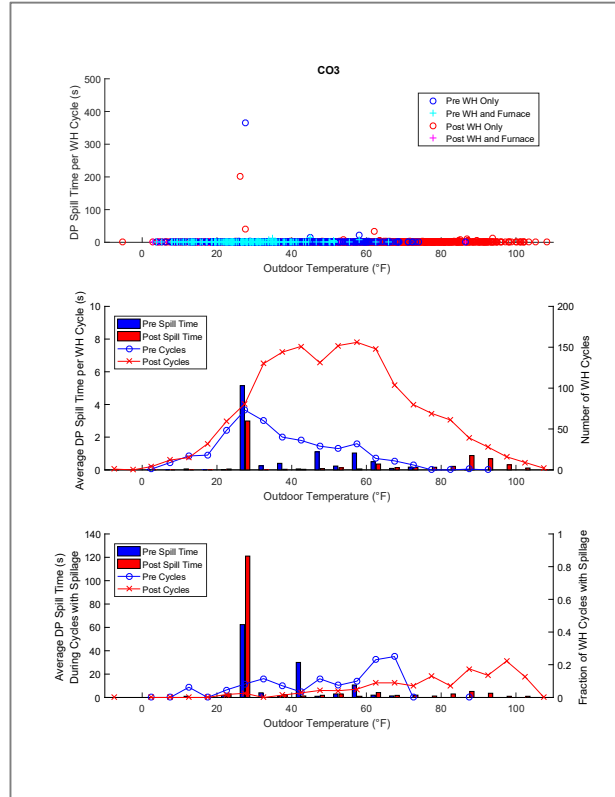
**Figure 5.7. High average spillage time caused by one or two water heater cycles.**

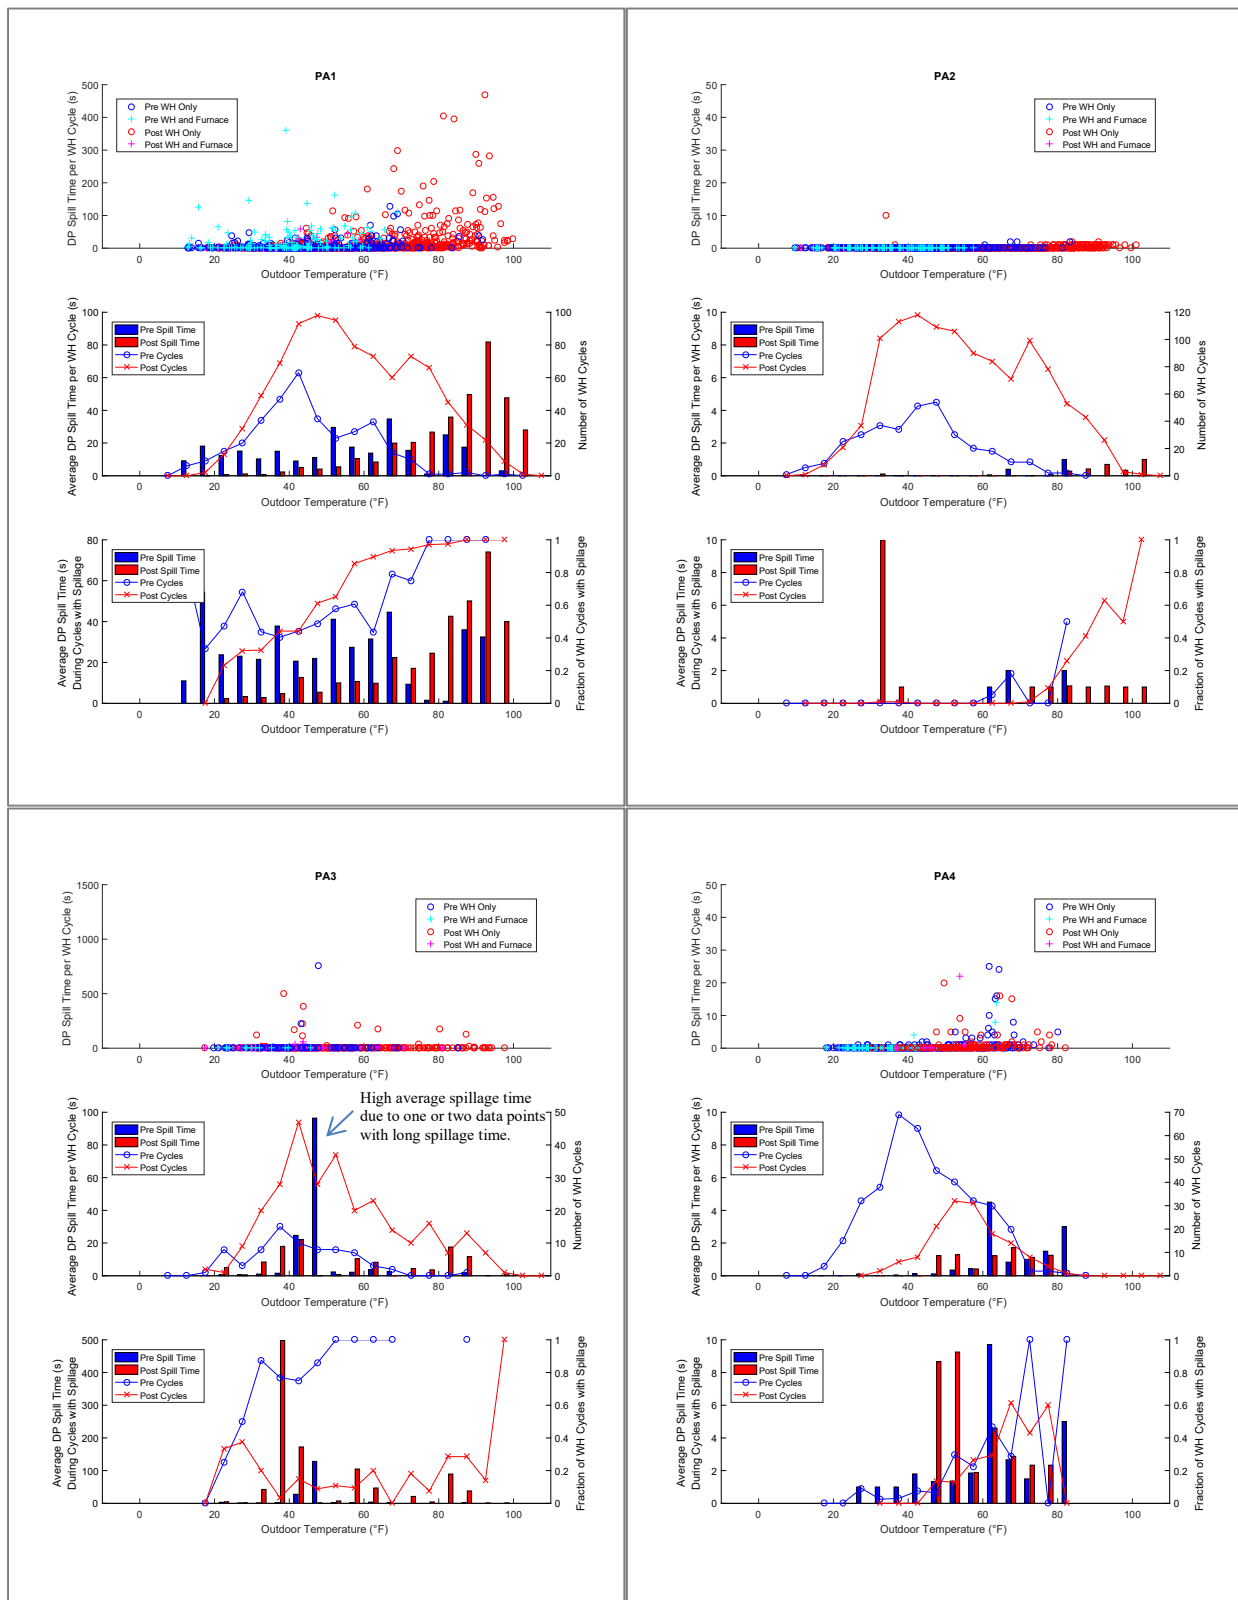
Figure 5.9. Spillage summary plots for the Philadelphia houses.

Closer examination of the scatter plot for this house (Figure 5.9) indicates that the pre- and post-retrofit spillage behavior was similar and did not effectively change following the installation of the FasNSeal 80/90 venting system. The scatter plot shows that long total spillage times on the order of several hundred seconds and more occurred in this house in both the pre- and post-retrofit periods, with more such events being shown in the scatter plot for the post-retrofit period because it spanned a full year rather than only 3 months for the pre-retrofit period. As seen from Table 5.3, there was only one spillage event at startup before retrofit where the spillage lasted more than 120 seconds and only two such events after retrofit. The reason for the long spillage times occurring intermittently during the water heater cycles is not known.

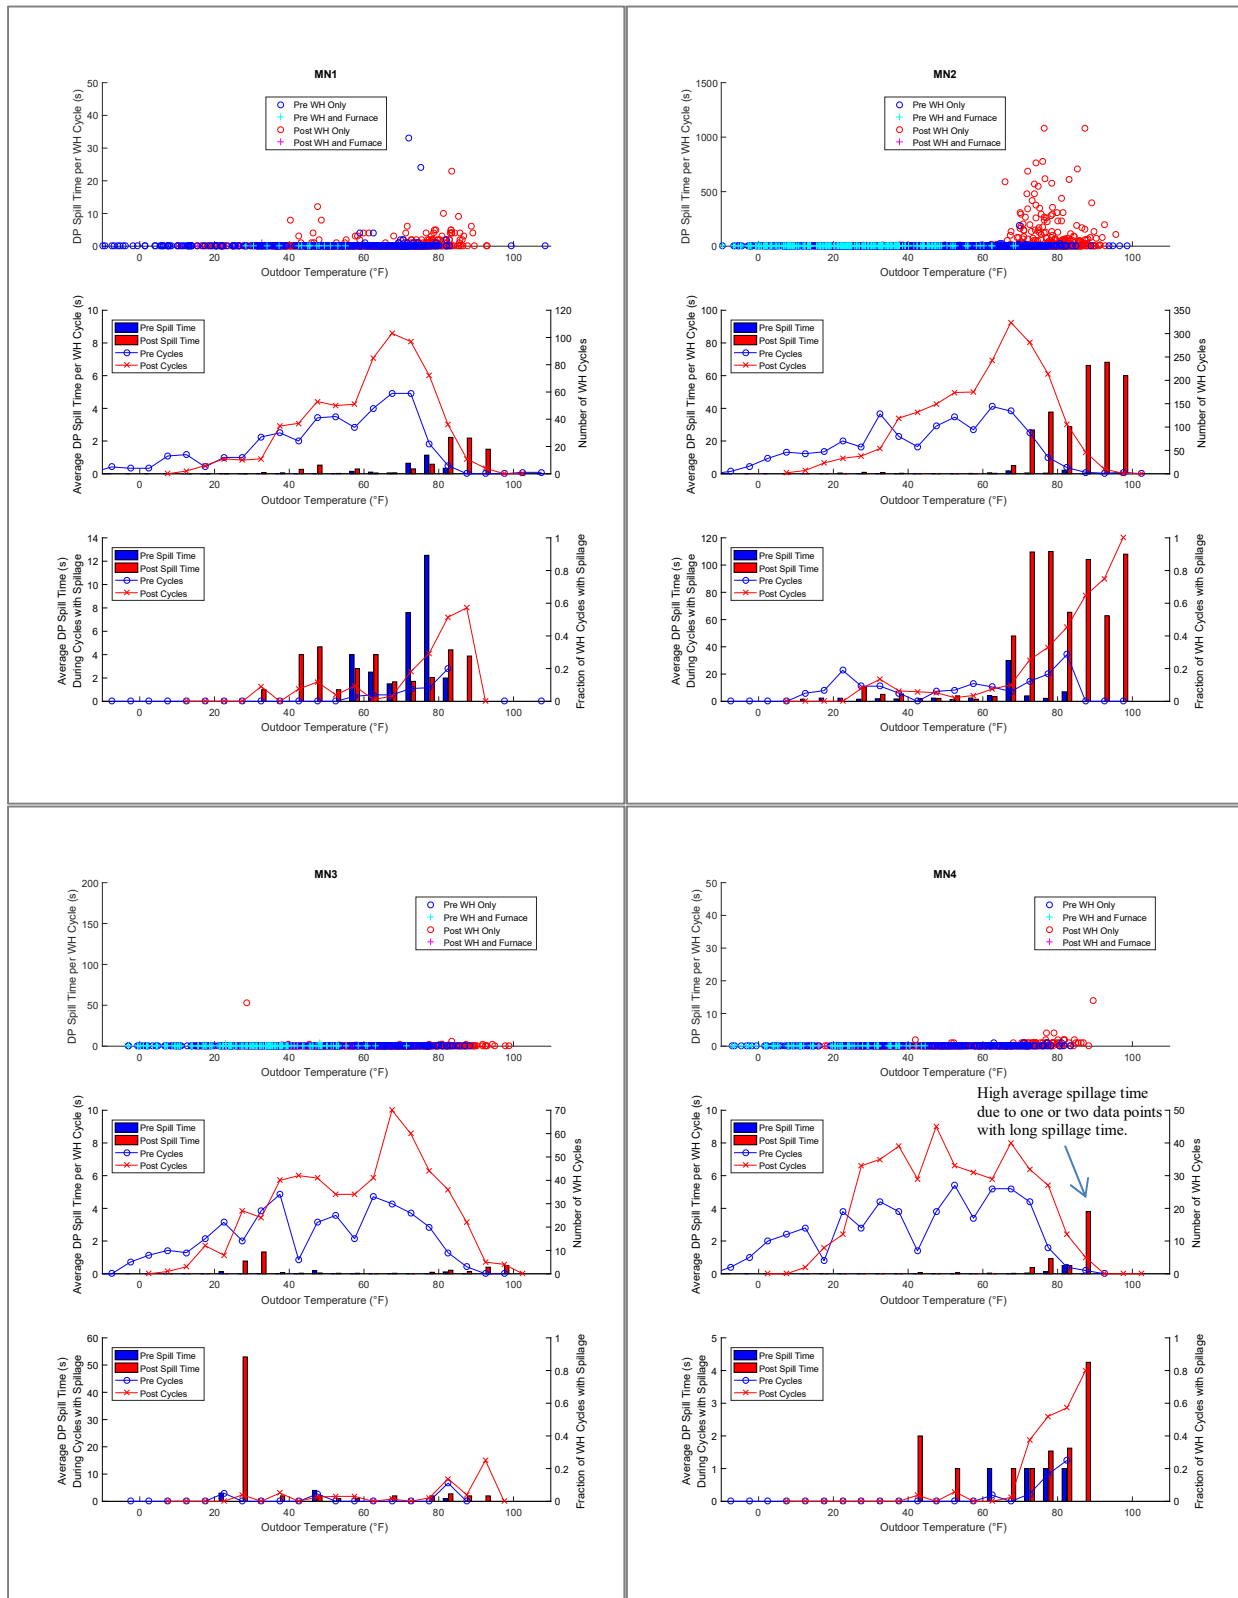
Figure 5.10. Spillage summary plots for the Minneapolis houses.

A greater depressurized CAZ when the supply air blower is running presents more challenging conditions for the water heater to establish a draft when it is firing while the supply air blower is running. This would lead to increased spillage during the post-retrofit water heater cycles, but only for those cycles that coincided with times when the supply air blower was also running. Therefore, in Figure 5.10 for MN2, there were still water heater cycles where the spillage was zero during the post-retrofit period. Because the air-conditioner uses the furnace's supply air blower, CAZ depressurization would also occur when the

air-conditioner ran. Therefore, in Figure 5.10 for MN2, spillage across all post-retrofit outdoor temperatures was observed.

A decrease in the CAZ pressure relative to the outdoors when a supply air blower runs is indicative of a leak in the return duct located in the CAZ. It is possible that a return leak was introduced when the condensing furnace was installed, perhaps where the return connects to the new furnace.

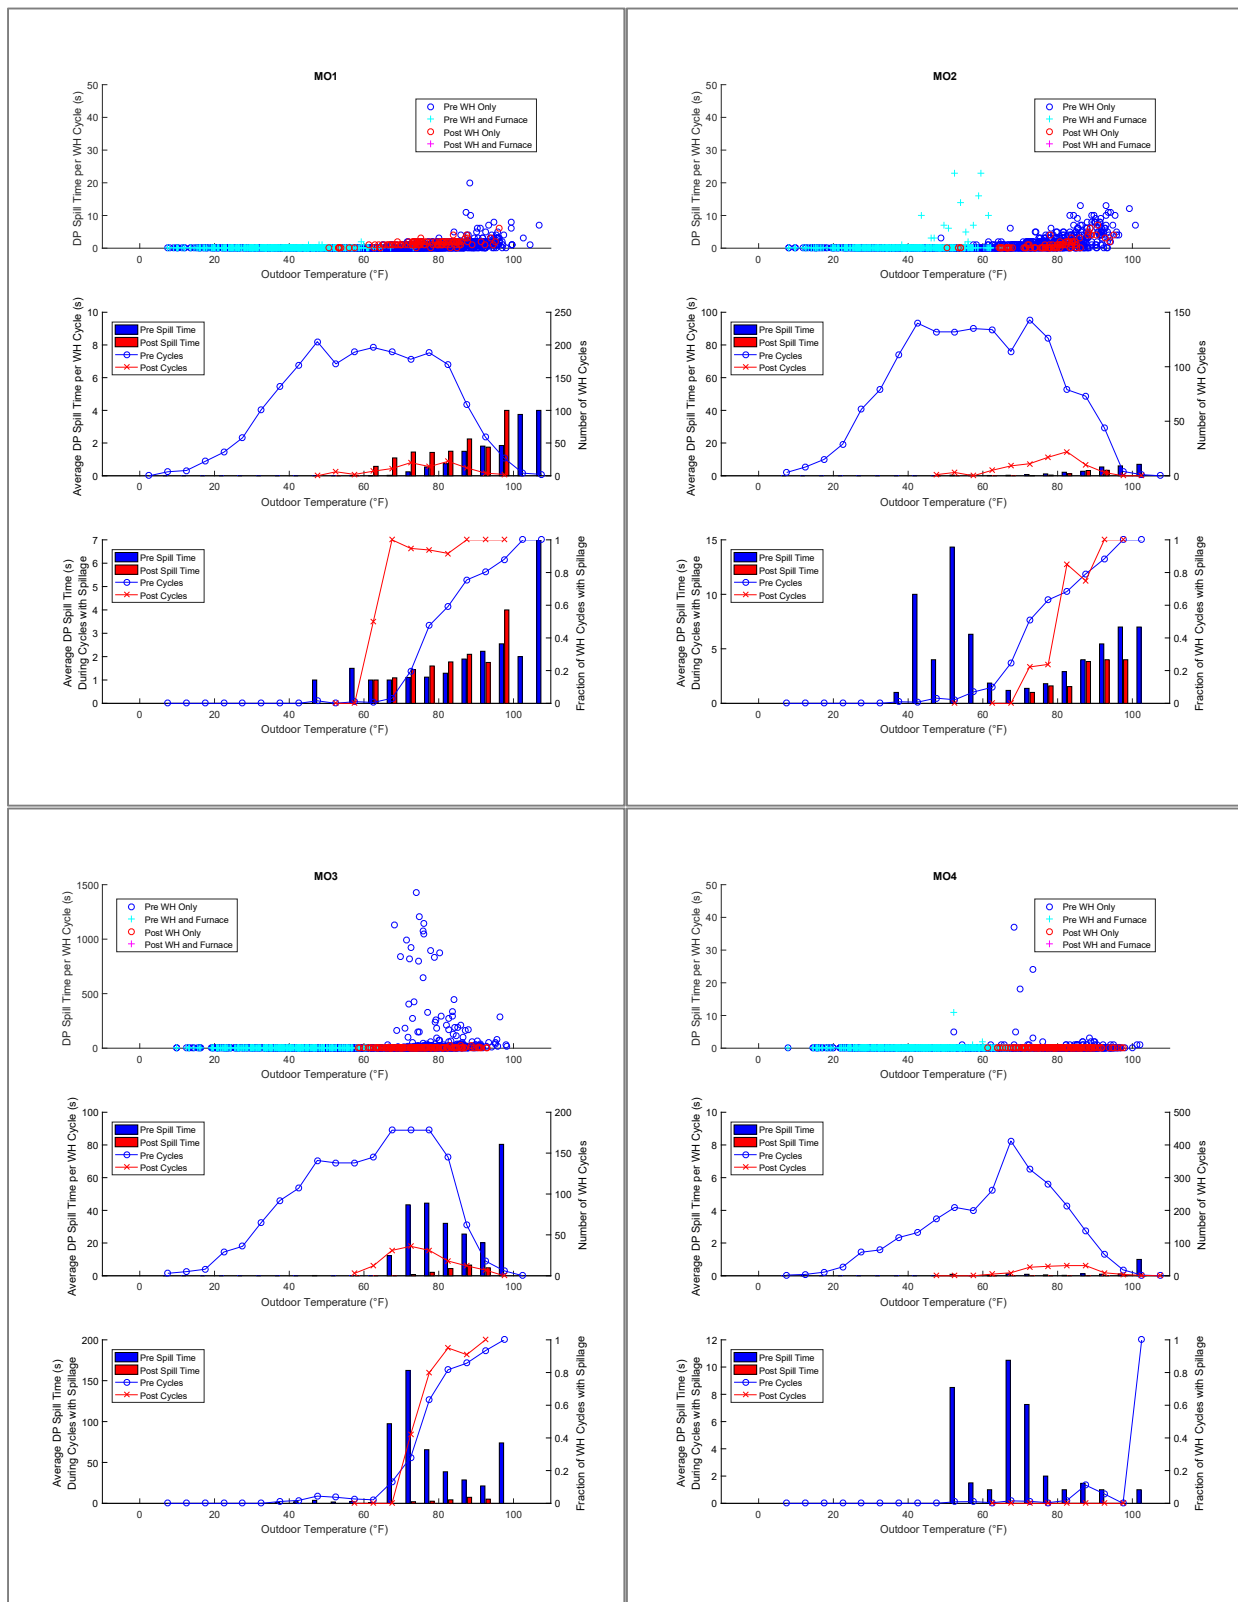
Figure 5.11. Spillage summary plots for the St. Louis houses.

The high frequency of spillage calculated for the outdoor temperature range of 65 to 85°F is likely because it is more difficult to establish a draft at high outdoor temperatures. This same behavior was observed for Houses MO1 and MO2. As seen in the scatter plots for these three houses provided in Figure 5.11, there are many spillage cycles of short duration as evidenced by the number of data points just above the x-axis.

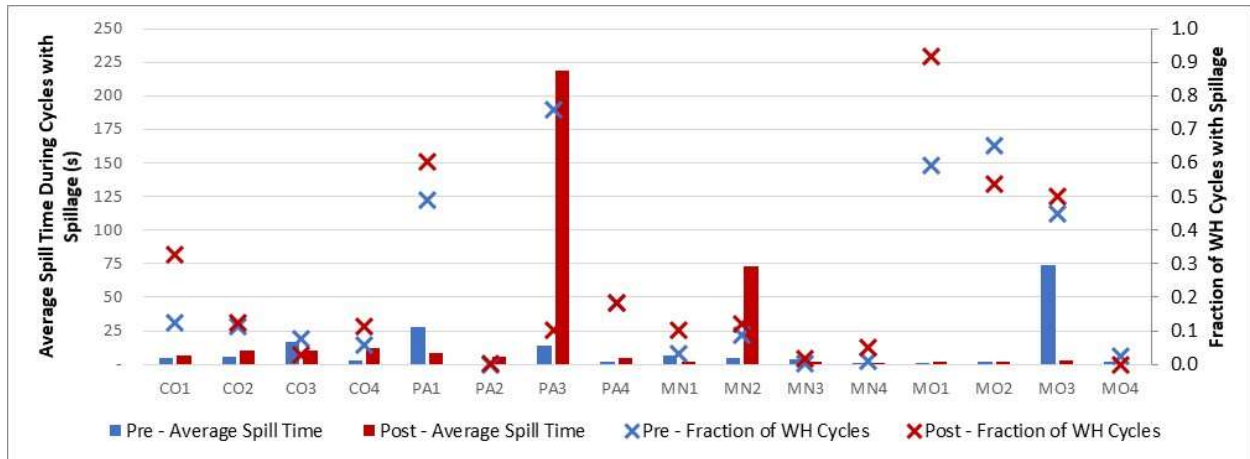
Figure 5.12. Average spillage for all houses.

Figure 5.12 shows that the pre-and post-retrofit values calculated for the frequency of spillage and average spillage time with non-zero spillage were the same before and after retrofit for nine houses: CO2, CO3, CO4, PA2, PA4, MN1, MN3, MN4, and MO4. For these houses, the fractions of water heater cycles with spillage were less than 0.1 with one exception (the pre- and post-retrofit fractions were both just less than 0.2 for House PA4) and the average spillage times with non-zero spillage were less than 25 seconds (with the BPI 2015 spillage limit being 120 seconds as a source of reference).

It can also be concluded that the pre- and post-retrofit performance of the conventional and FasNSeal venting systems are the same in Houses MO1 and MO2. The fraction of water heater cycles with spillage was high for both houses both before and after retrofit (the post-retrofit value was higher than the pre-retrofit value for House MO1 while this was reversed for House MO2); however, the average spillage times for these houses were extremely short (on the order of 1 second). This can be seen in the scatter plots for these two houses provided in Figure 5.11, where many spillage cycles of short duration are shown as evidenced by the number of data points just above the x-axis. One possible explanation for the frequent spillage could be that the outdoor temperature range used for both houses was restricted to higher outdoor temperatures when it is more difficult to establish a draft; a similar high spillage frequency was measured in House MO3, but not MO4, under the same outdoor temperature conditions.

For the remaining five houses shown in Figure 5.12 (Houses CO1, PA1, PA3, MN2, and MO3) differences in the pre- and post-retrofit performance of the venting system is evident in individual houses and/or data indicating frequent spillage or long spillage times are observed. The anomalies with these five houses are discussed in Sect. 5.5.

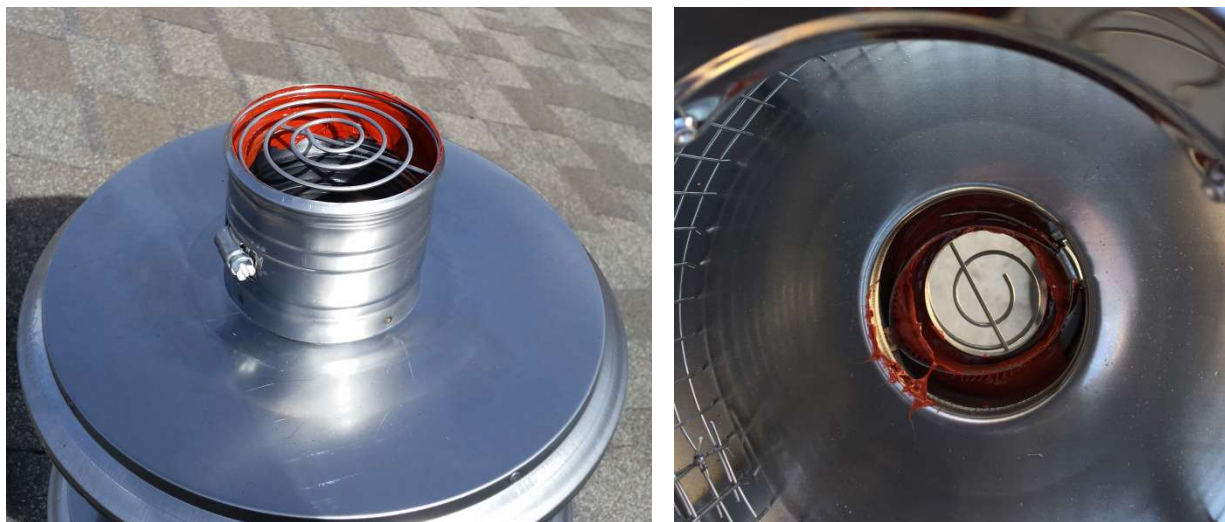
Several agencies reported difficulty in connecting the 2 in. flexible inner liner to the vent cap. The vent cap may be designed to accept both a 2 in. and 3 in. inner liner, with a bushing used with the 2 in. inner liner to accommodate the smaller diameter. One agency reported that the worm-drive hose clamp (Figure 6.2a) forms an oval rather than a circle (Figure 6.2b) when tightened, which makes for a less-than-secure fit. At the first house this agency worked on, the vent cap came loose from the liner on the first tightening attempt, although additional tightening produced a secure connection. A second agency found that they needed to use an impact drill to tighten the clamp sufficiently. At a third agency, a DuraVent representative who was on-site provided some instruction on how to overcome this problem: remove the exhaust screen, use a screwdriver to get the liner installed the last ½ in. into the vent cap, and then tighten the hose clamp. Additionally, one agency reported a concern with the amount of high-temperature sealant needed to seal the inner liner to the vent cap, possibly because they were doing so from the inside of the vent cap (i.e., from the perspective of Figure 6.2b) rather than from the top.
