REPORT ON EXCAVATION SURVEYS ON INTERLOCKING BLOCK PAVEMENTS WITH GEOTEXTILE

Ando, Y., Noda, E. and Yaginuma, H.

Yutaka Ando, Sumitomo Osaka Cement Co., Ltd. Etsuro Noda, Nippon Road Co., Ltd.
Hiroshi Yaginuma, ILB Co., Ltd.

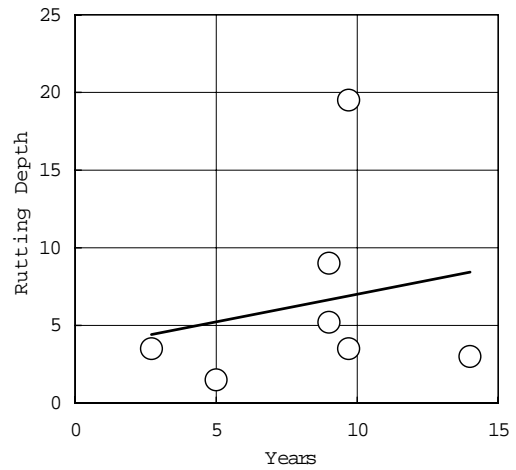
Figure 2. Relationship between Number of Service Years and Degree of Roughness.

Figure 2 shows the relationship between the number of service years and degree of roughness. A longer period in service does not necessarily mean a higher degree of roughness, which remained at around 3 mm to 4 mm. One of the reasons why the roughness remained intact would have been that the geotextile helped maintain regularity. Figure 3 shows the relationship between the number of service years and rutting depth. The ruts tend to become deeper with increasing years in service, but the deepening rate is small, and the ruts remain at favorable values of around 5 to 10 mm even after 15 years in service. Figure 4 shows the relationship between the number of service years and block breakage rate, as compared with the existing data on pavements without geotextile. The rate of block breakage is a half or less of that of pavements without geotextile, which proves the beneficial effect of installing geotextile in interlocking block pavements.
