## **THE HEXAGON (Ephraim Shay House) Harbor Springs, Michigan**

### **NUMBER 3**

## **In-Kind Replacement of Historic Stamped Metal Exterior Siding**

**Rebecca A. Shiffer**  
Mid-Atlantic Regional Office  
National Park Service

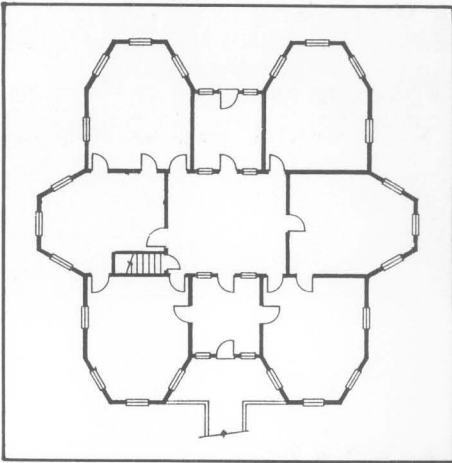
1. Windows in each elevation of the hexagonal wings offer views in every direction from the center of the house. This first floor plan of the Hexagon shows the new, post-rehabilitation uses. Drawing: Jeffrey Pascale, from plans by Richard Hiler.

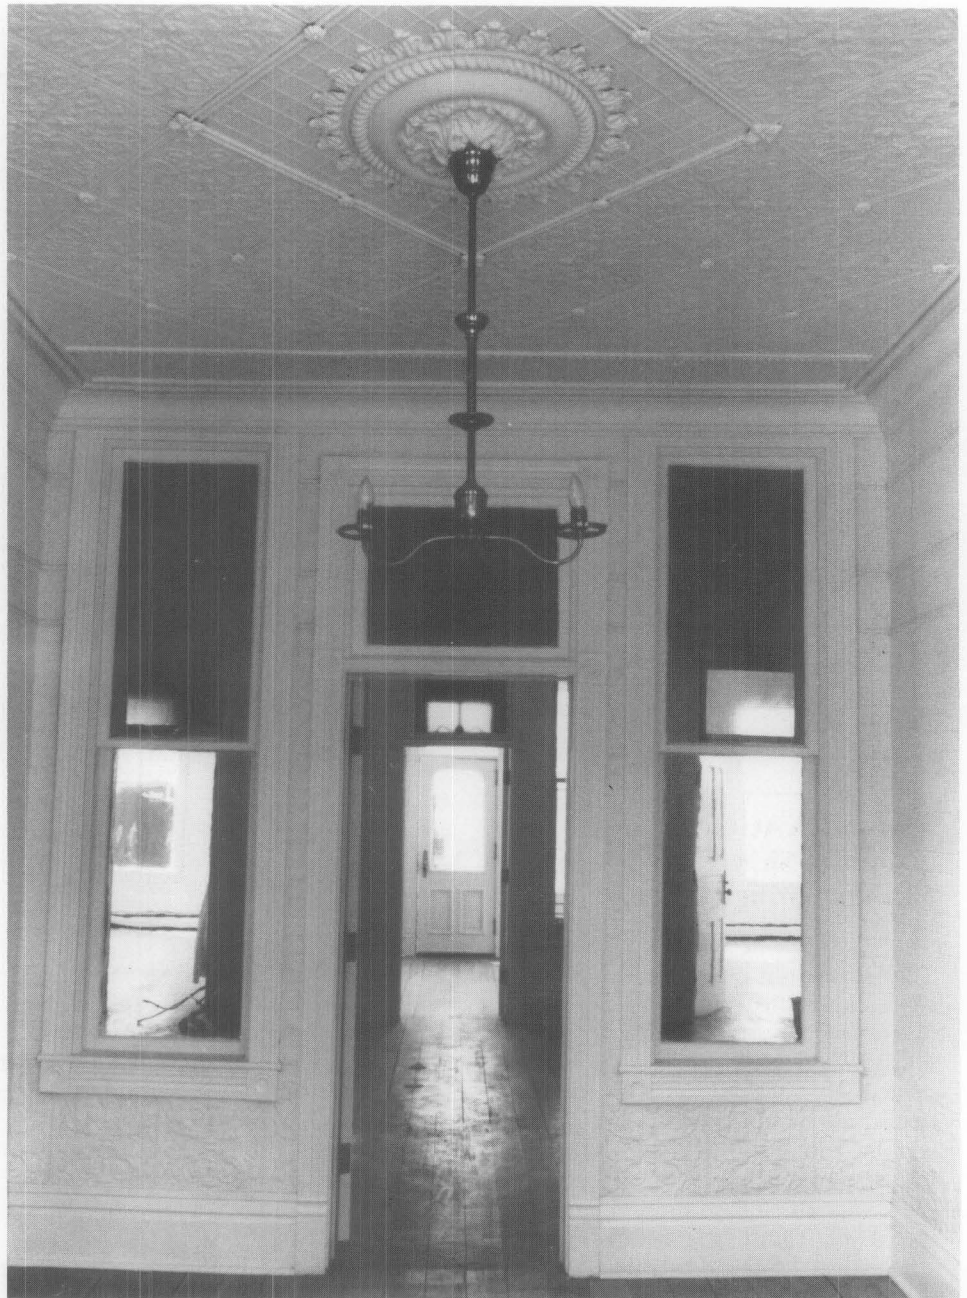
2. The walls and ceilings of each interior room are sheathed with stamped metal siding in a variety of decorative patterns. Photo: Brian Conway.

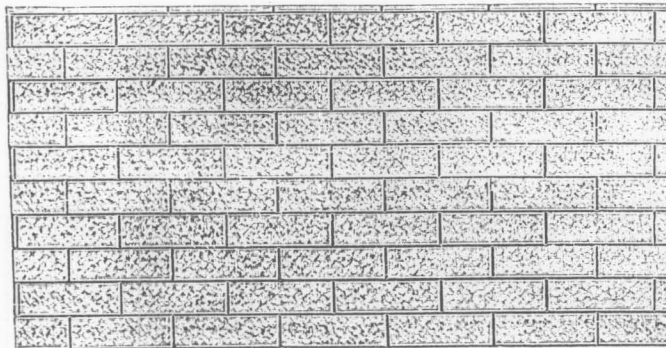
PRESSED STEEL, BRICK SIDING.

Galvanized or Painted.
