J. ARONSTEIN
CONSULTING ENGINEER
MECHANICAL AND MATERIALS ENGINEERING
BME, MSME, Ph.D., N.Y.S. P.E. LIC. NO. 39860
50 PASTURE LANE POUGHKEEPSIE, N.Y. 12603
(845) 462-6452 aronsteinj@verizon.net

HAZARDOUS FPE CIRCUIT BREAKERS **AND PANELS**

Information for Homeowners, Inspectors, and Electricians

(Updated December 2, 2011)

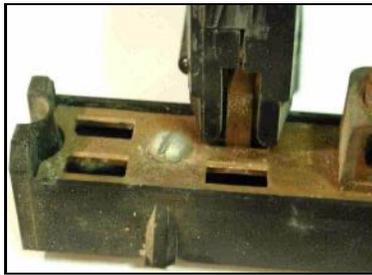
A. Copper buss bar with punched openings.

The "panel" is the unit within the enclosure, on which the breakers are mounted. The main electrical service feeders (electrically live, from the meter) are connected at the panel, and the panel has an internal conductor system that distributes the power to the individual circuit breakers. The internal conductor system consists essentially of "bussbars" (thick metal bars) that have sockets incorporated or attached, into which to which the breakers' "stab" contacts are inserted. There are many different types of bussbar constructions in FPE panels, three of which are shown in Figure 2.
